**Preliminary report into the recent electricity
transmission faults affecting South London
and East Birmingham**

30 September 2003

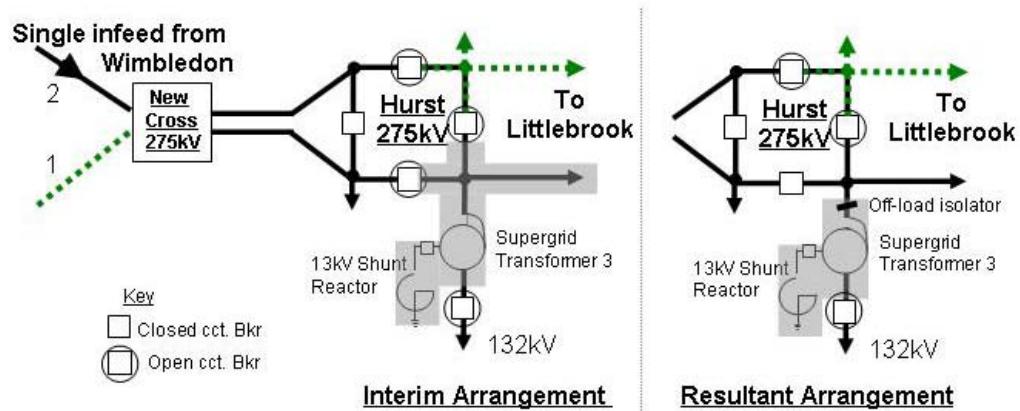
FIGURE 1.3

- 1.9 The sequence of events started at 18:11. Engineers at the Electricity National Control Centre (National Control) received an alarm indicating that a transformer, or its associated shunt reactor, at Hurst substation was in distress. This “Buchholz alarm” detects potential breakdown of the equipment insulation, which, left unattended, could proceed to a major fire or explosion.
- 1.10 National Control therefore agreed with EDF to temporarily disconnect mesh corner 4 at Hurst, in order to isolate the transformer and shunt reactor and then return the mesh corner to service. This would leave all supplies to Hurst and New Cross dependent on the single remaining transmission circuit from Wimbledon during the switching sequence (up to 10 minutes). This sequence commenced at 18.20. The interim and resultant system arrangement was to be as shown in Figure 1.3 below.

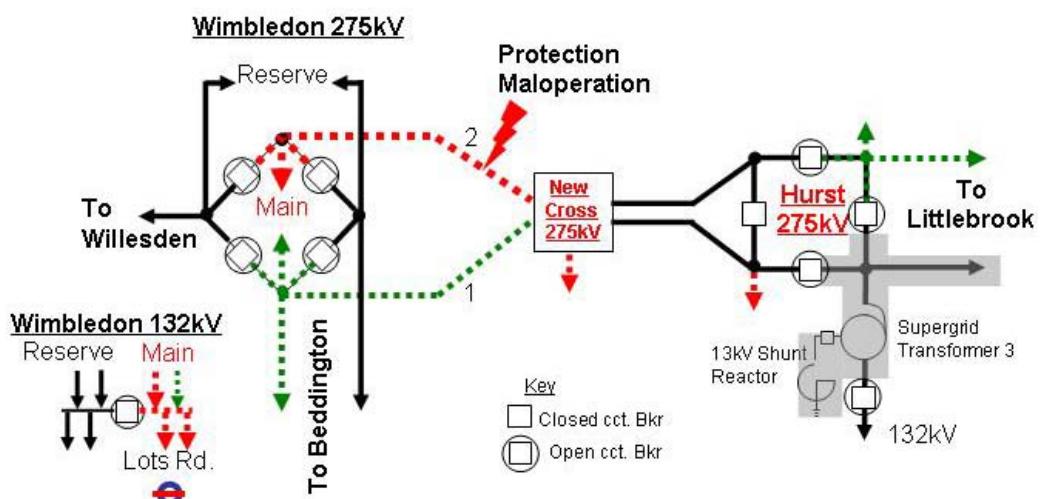
FIGURE 1.4

- 1.11 However, within a few seconds of the Hurst-Littlebrook circuit being taken out of service, the protection equipment on the single infeed circuit (Wimbledon to New Cross No. 2) operated incorrectly. This disconnected supplies to New Cross, Hurst and part of Wimbledon. This left the system as shown in Figure 1.4.
- 1.12 As a result, 724MW of supplies were lost, amounting to around 20 per cent of total London supplies at that time. This affected almost half a million EDF customers, with supplies being lost to parts of London Underground and NetworkRail.

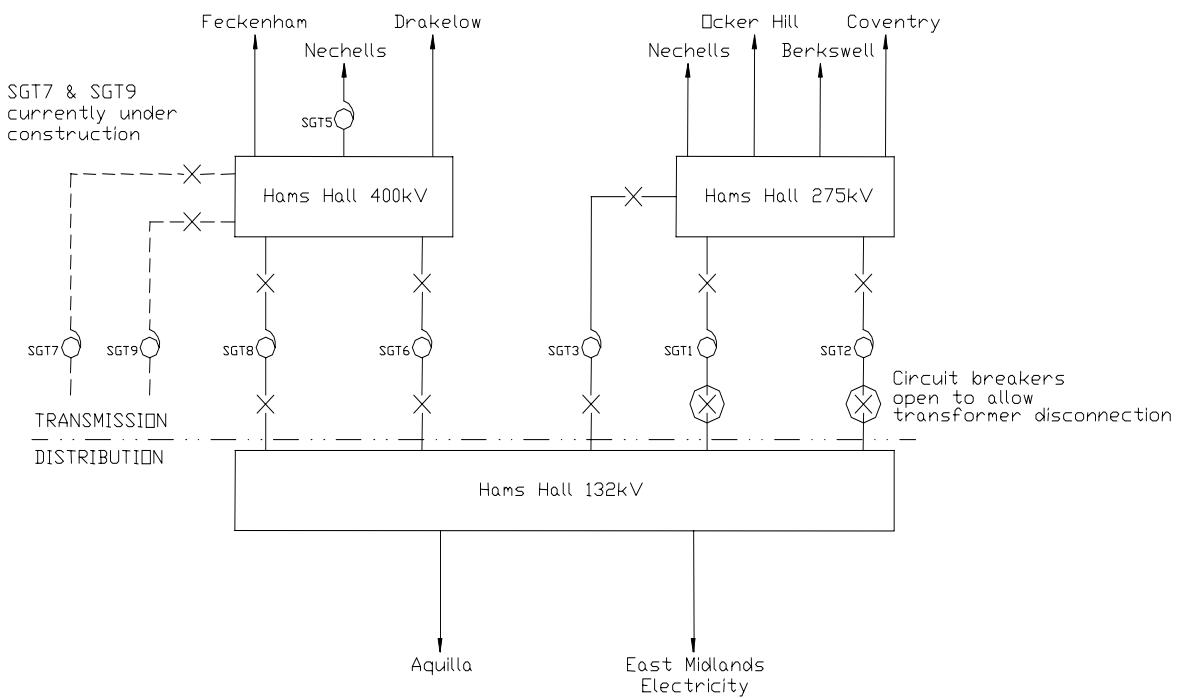
FIGURE 1.5

- 1.18 Part of this program is to replace three 120MVA 275/132kV super grid transformers, which are close to the end of their lives, with two 240MVA 400/132kV transformers along with the complete rebuilding, in sections, of the 132kV substation. The anticipated completion of the project is 2005.
- 1.19 On the evening prior to the event (4 September) the existing supergrid transformer SGT6 circuit had been re-commissioned after the transfer of primary connections and changes to its control circuitry. SGT8 was a new transformer that had been in service for approximately 3 weeks, while SGT7 and SGT9 were still undergoing construction works.
- 1.20 By the morning of 5th September, SGT6 was in service and two of the 275/132kV transformers had been switched out and were being prepared for decommissioning. This is shown in Figure 1.5 below.
