**Preliminary report into the recent electricity
transmission faults affecting South London
and East Birmingham**

30 September 2003

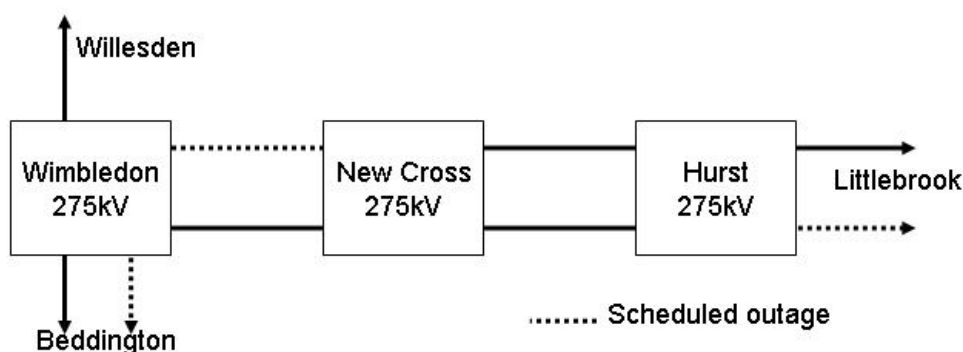
FIGURE 1.1

- 1.1 The 275kV transmission system in south London consists of three 'mesh' substations at Hurst, New Cross and Wimbledon¹⁰. EDF then provide the distribution connection between these substations and consumers in the area, including large users such as NetworkRail and London Underground. Following the incident supplies were lost from Hurst, New Cross and part of Wimbledon.
- 1.2 Prior to the event three of the nine circuits were out of service for scheduled maintenance. This had been coordinated and agreed with the distribution network operator (DNO) EDF. This is shown very simply in Figure 1.1 below:

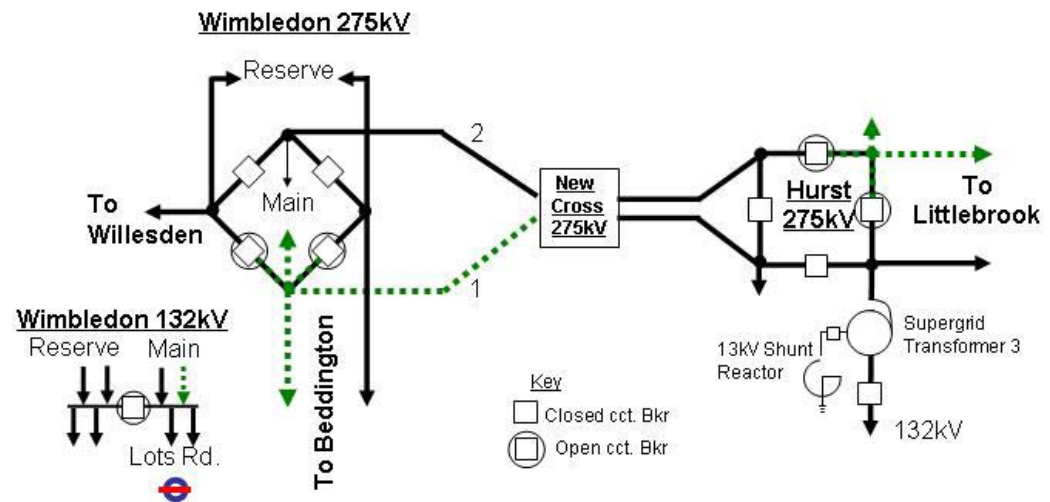
FIGURE 1.2

- 1.3 Two of the scheduled circuit outages were part of a major upgrade to mesh corner [1] at Wimbledon, which is illustrated in slightly more detail by Figure 1.2 below:

- 1.4 This diagram also indicates that for the initially planned 3 month outage duration of the Wimbledon mesh corner, the supplies to the Main section of the Wimbledon 132kV busbars were supported solely from diagonally opposed mesh corner 3. This section of busbar supplies Lots Road, one of the four main points in London where London Underground derives power. In the event of a fault affecting this mesh corner, supplies would be lost, although they could be rapidly restored by post fault switching - closing the open Bus Coupler circuit breakers between the Wimbledon 132kV main and reserve busbars. (Busbar sections 3 and 4). Note ideally this would operate normally closed, but safety considerations prevent this because it would increase potential fault currents above equipment ratings.

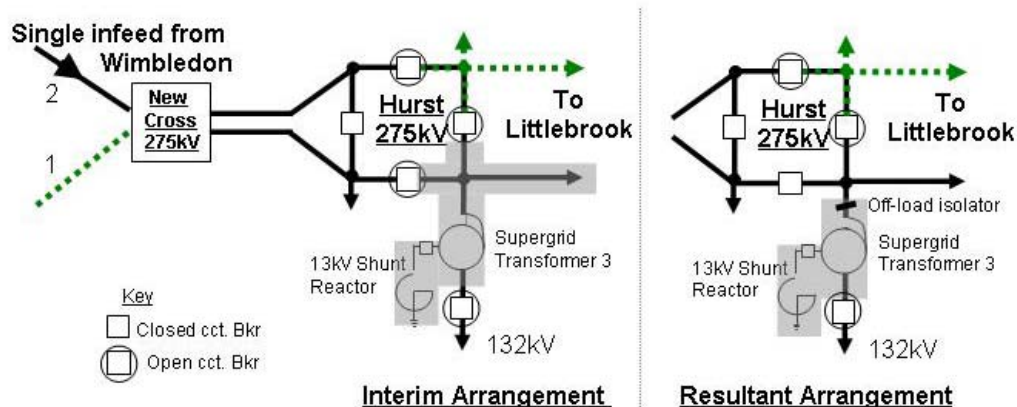
FIGURE 1.3

- 1.9 The sequence of events started at 18:11. Engineers at the Electricity National Control Centre (National Control) received an alarm indicating that a transformer, or its associated shunt reactor, at Hurst substation was in distress. This “Buchholz alarm” detects potential breakdown of the equipment insulation, which, left unattended, could proceed to a major fire or explosion.
- 1.10 National Control therefore agreed with EDF to temporarily disconnect mesh corner 4 at Hurst, in order to isolate the transformer and shunt reactor and then return the mesh corner to service. This would leave all supplies to Hurst and New Cross dependent on the single remaining transmission circuit from Wimbledon during the switching sequence (up to 10 minutes). This sequence commenced at 18.20. The interim and resultant system arrangement was to be as shown in Figure 1.3 below.

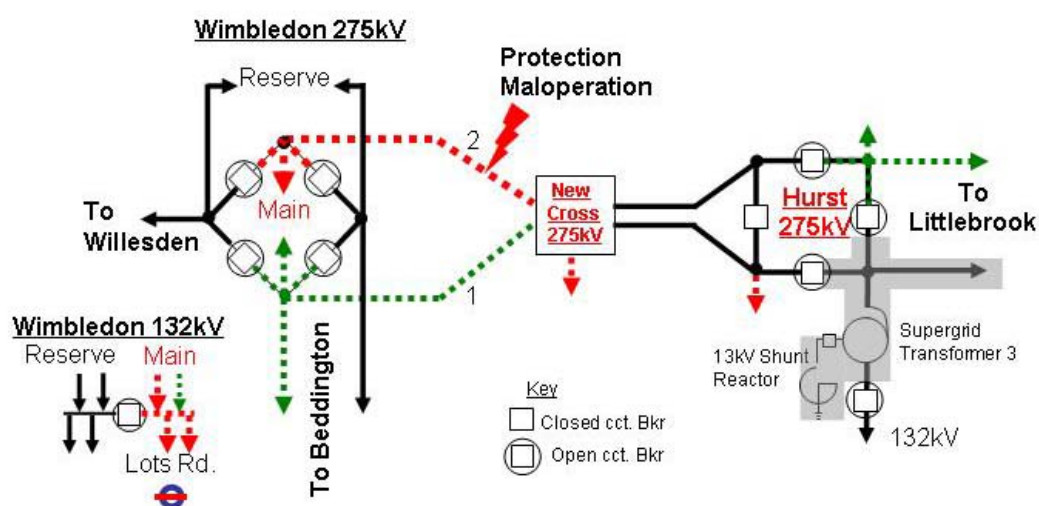
FIGURE 1.4

1.11 However, within a few seconds of the Hurst-Littlebrook circuit being taken out of service, the protection equipment on the single infeed circuit (Wimbledon to New Cross No. 2) operated incorrectly. This disconnected supplies to New Cross, Hurst and part of Wimbledon. This left the system as shown in Figure 1.4.

1.12 As a result, 724MW of supplies were lost, amounting to around 20 per cent of total London supplies at that time. This affected almost half a million EDF customers, with supplies being lost to parts of London Underground and NetworkRail.

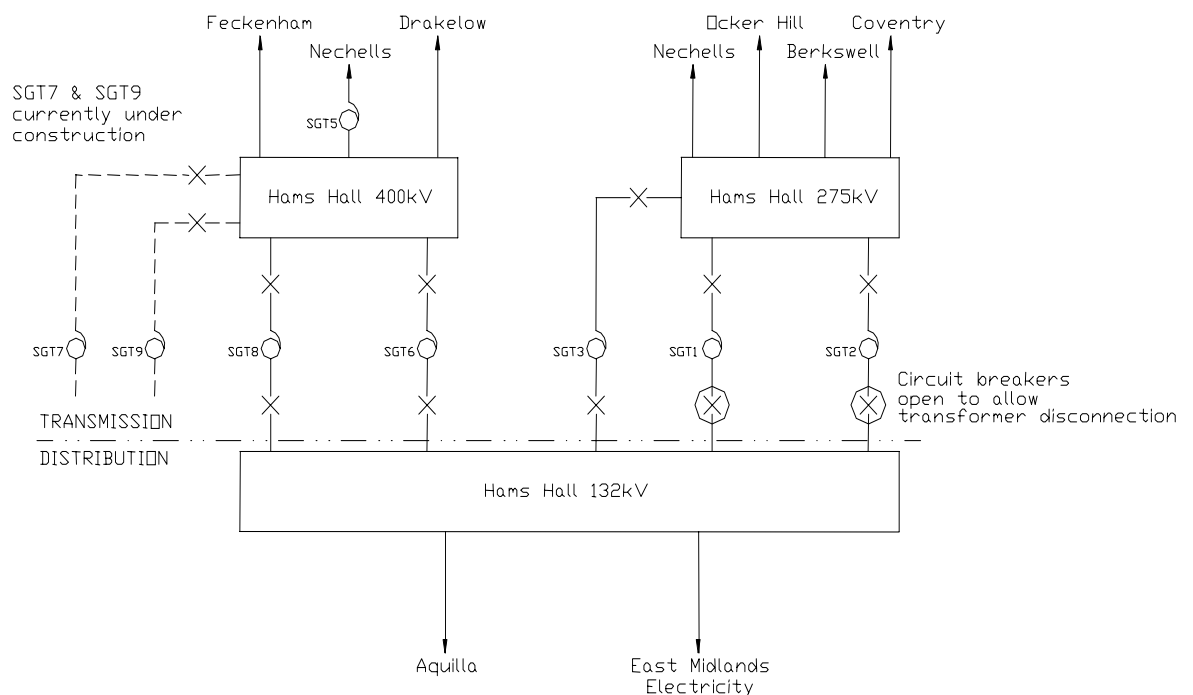
FIGURE 1.5

- 1.18 Part of this program is to replace three 120MVA 275/132kV super grid transformers, which are close to the end of their lives, with two 240MVA 400/132kV transformers along with the complete rebuilding, in sections, of the 132kV substation. The anticipated completion of the project is 2005.
- 1.19 On the evening prior to the event (4 September) the existing supergrid transformer SGT6 circuit had been re-commissioned after the transfer of primary connections and changes to its control circuitry. SGT8 was a new transformer that had been in service for approximately 3 weeks, while SGT7 and SGT9 were still undergoing construction works.
- 1.20 By the morning of 5th September, SGT6 was in service and two of the 275/132kV transformers had been switched out and were being prepared for decommissioning. This is shown in Figure 1.5 below.
