John Sinclair  
Gwynt y Môr OFTO plc  
Focus Point  
3rd Floor  
21 Caledonian Road  
London  
N1 9GB

## **DIRECTION UNDER PARAGRAPH 9 OF AMENDED STANDARD CONDITION E12-J4 OF THE OFFSHORE TRANSMISSION LICENCE**

## REASONS FOR ACCEPTANCE OF AN EXCEPTIONAL EVENT CLAIM SUBMITTED BY GWYNT Y MÔR OFTO PLC UNDER PARAGRAPH 9 OF AMENDED STANDARD CONDITION E12-J4

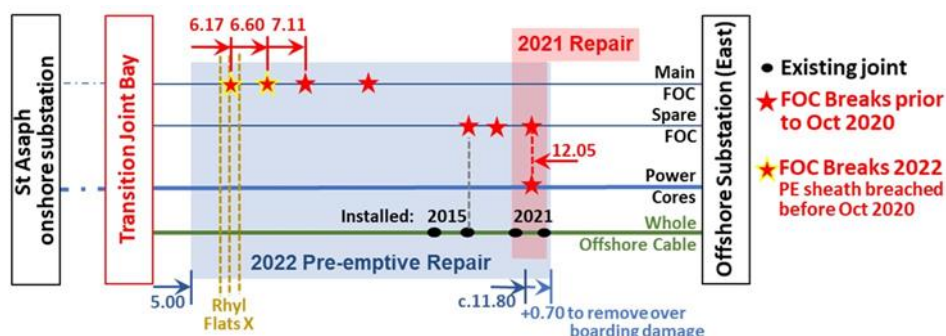
- 4.3 The Licensee first became aware of breaks in the Fibre Optic Cable (**FOC**) in Subsea Export Circuit 3 (**SSEC3**) in January 2020. The Licensee monitored the FOC for further signs of failure – a number of breaks in the FOC developed on both the spare and main FOC between January 2020 and 15 October 2020, when SSEC3 failed (**the Cable Failure**). FOC breaks continued to develop on SSEC3; the latest being discovered in February and April 2022.

- 4.4 The graphic below shows the total number of FOC breaks identified on SSEC3, to date:
