STRICTLY PRIVATE AND CONFIDENTIAL

Gwynt y Môr OFTO plc (the Licensee) – Income adjusting Event (IAE) Notice pursuant to amended standard licence condition E12-J3 (the IAE Condition) regarding failure of subsea export cable 3 (SSEC3)

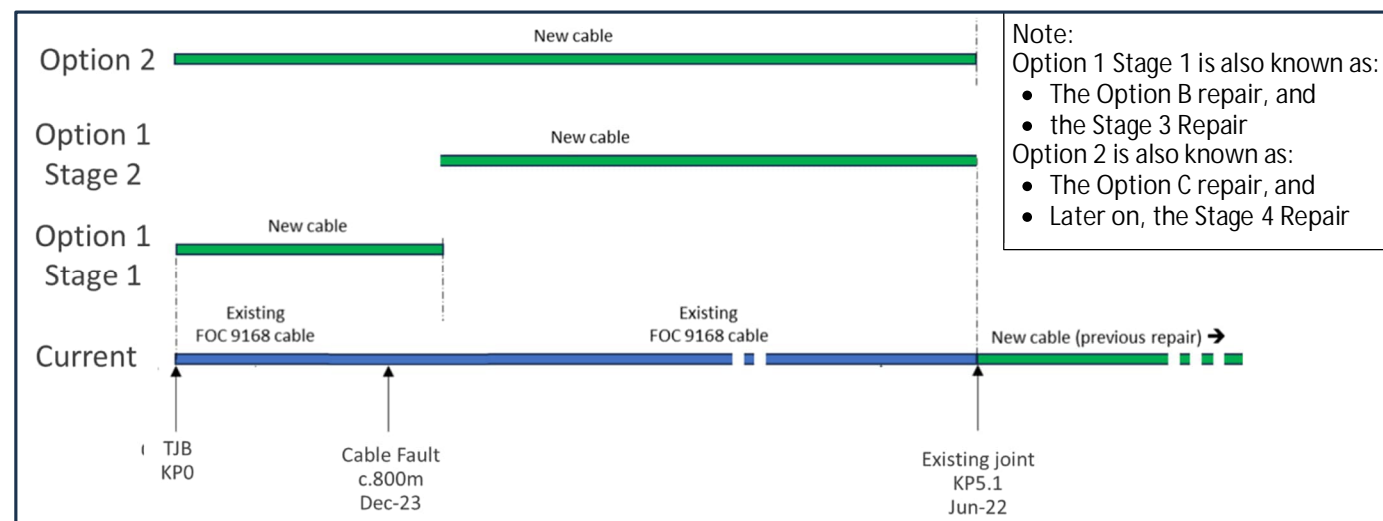
- (a) Option 1: A two stage repair where: Stage 1 replaced the first 1km of subsea cable from the TJB to c.KP1.0 removing the cable fault and Stage 2 used 6km of new cable to replace the cable (and two joints) from c.KP0.9 to c.KP5.2 and return the surplus cable to storage.

- (b) Option 2: A single repair utilising 6km of new cable to replace the cable (and one joint) from the TJB to c.KP5.2

- 5.6 Contractor B proposed a variant of Option 1 Stage 2 to replace cable between the TJB (rather than KP0.9) and c.KP5.2. This meant that a less expensive cable laying barge (rather than a jack-up barge) could be used and only one subsea joint would be required. This would offset the extra 1km of cable required.
- 5.7 A schematic of the proposed options is provided below:
