Statement by the Gas and Electricity Markets Authority, following an investigation into compliance by National Grid Company plc with its obligations under section 9(2)(a) of the Electricity Act 1989 and Special Licence Condition AA4.1 of its Electricity Transmission Licence in relation to a transmission failure in London and in relation to a transmission failure in Birmingham

25 June 2004.

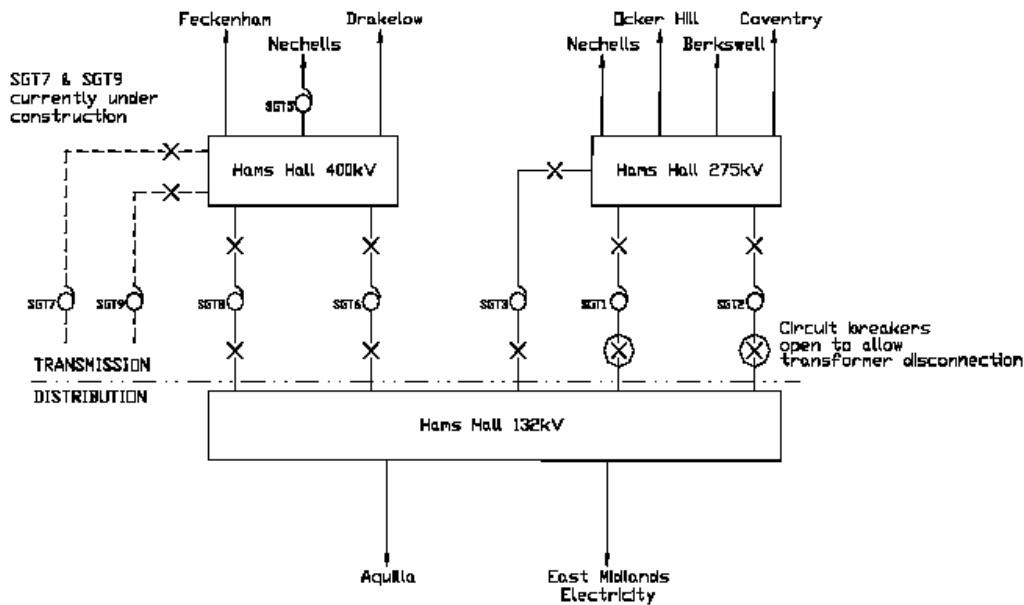
FIGURE 2: Status of transmission system that supplies East Birmingham,

29. NGC supplies both the East Midlands Electricity (EME) and Aquila distribution networks from their Hams Hall substation, located near Coleshill. The Hams Hall site has three substations operating at 400 kV, 275 kV and 132 kV (Figure 2).

30. Major re-development was in progress at the time of the incident as part of NGC’s plans for strengthening this part of the Midlands network. A new supergrid transformer (SGT8) was commissioned at Hams Hall on 17 August 2003 and had been operating satisfactorily. On 4 September — the day before the transmission failure occurred — the 132 kV load at Hams Hall was supplied from the new supergrid transformer SGT8 along with SGT3 and two further supergrid transformers (SGT1 and SGT2). SGT7 was out of service for re-configuration throughout.

31. On the evening prior to the loss of supplies, a supergrid transformer (SGT6) was re-commissioned and put back into service. After SGT6 had been operating successfully overnight on 4 September, SGT1 and SGT2 were taken out of service at 6.12am on 5 September in preparation for their de-commissioning. The load was then being supplied by SGT8, SGT3 and the newly re-commissioned SGT6.
32. The sequence of events that led to the eventual loss of supplies commenced with the discovery of a problem with a recently re-commissioned transformer (SGT 6), whereby part of the transformer ancillary measurements wiring was emitting sparks and smoke, requiring the urgent removal of the transformer from service for safety reasons. The problem had arisen as a result of equipment and wiring having been

37. Given the potentially hazardous situation, this transformer was taken out of service without delay for safety reasons, diverting all load to the remaining transformers SGT8 and SGT3. The loss of supply then resulted due to the subsequent operation of newly commissioned protection equipment, as the load on alternative transformers increased.

38. The reason for the protection equipment operation was that NGC's contractor engineered and delivered a protection scheme, based on a multi-functional relay, which provided the required protection but also provided unwanted protection. These unwanted functions had not been disabled and subsequently resulted in the protection relay on SGT8 operating to trip the transformer inappropriately.

39. With SGT8 disconnected, the full load was carried by the remaining transformer, SGT3, exceeding its rating, and as a result the protection equipment on SGT3 operated correctly to trip the transformer and the supply to Hams Hall substation and with it the supply to Aquila and EME customers.
