Quality of Service Incentive Scheme – Exceptional Events

Appointed Examiner's Report	
Reporting year	2010/11
DNO	ENWL
Cause	Theft of 132/33kV Grid Transformer components
Date of event	27 October 2010

Title: Exceptional Events Report – ENWL – theft – Wigan Grid Substation resulting in loss of customers' supplies – 27 October 2010

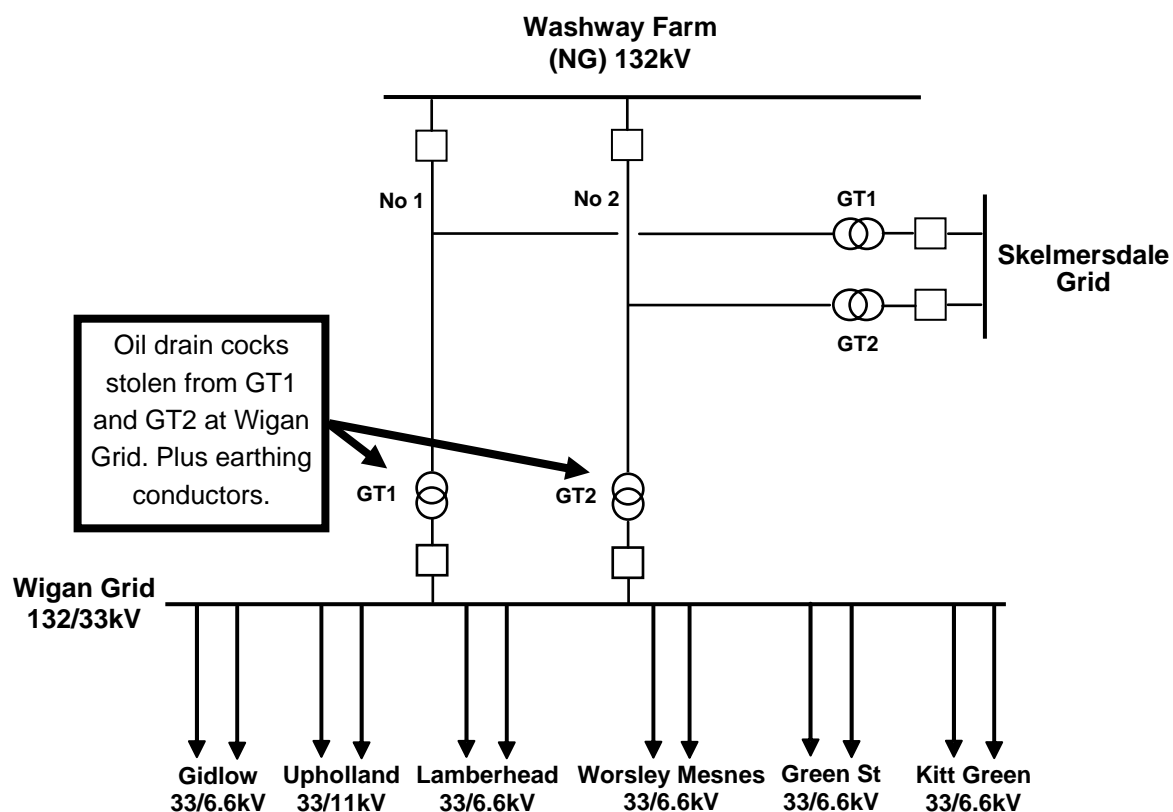
Figure 1 – Simplified Network Diagram of ENWL’s 132/33kV distribution network affected by the incident

- 1.10 55,100 of ENWL's customers' supplies were interrupted for periods of between ten and sixty eight minutes.
- 1.11 A simplified view of the section of ENWL's 132/33kV network affected by this event is shown in Figure 1.

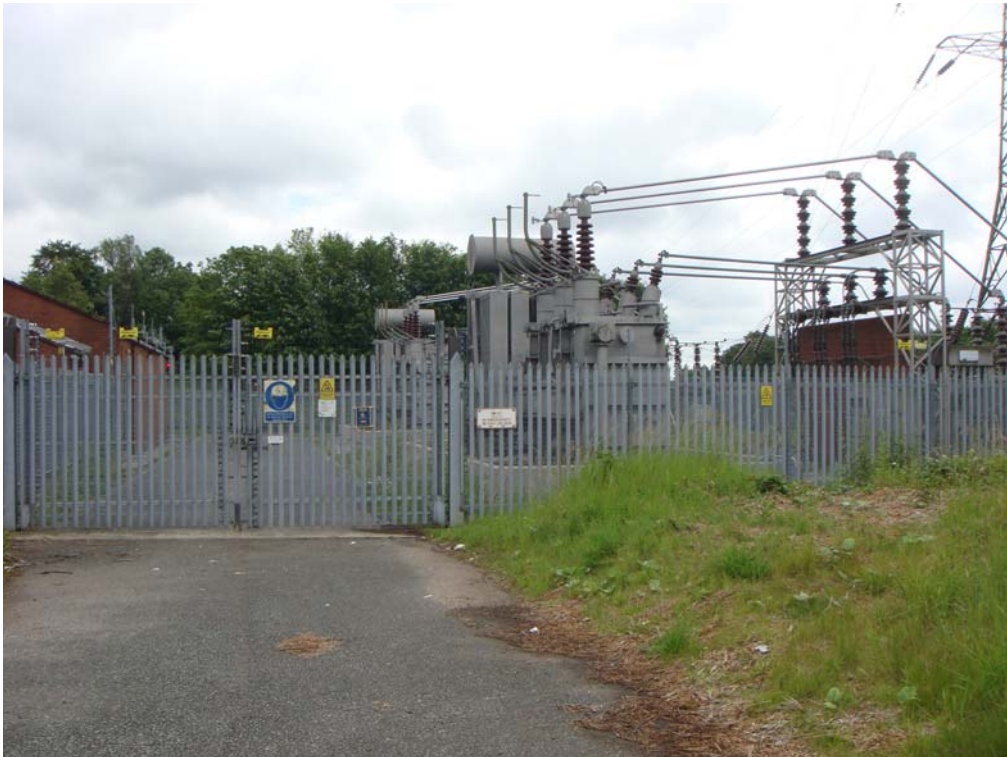
Photograph 1 – General view from the access road

- 2.5 Statutory notices are clearly displayed on the outside of the palisade fencing and gates as shown in the AE's photograph 1 of the general view from the access road.

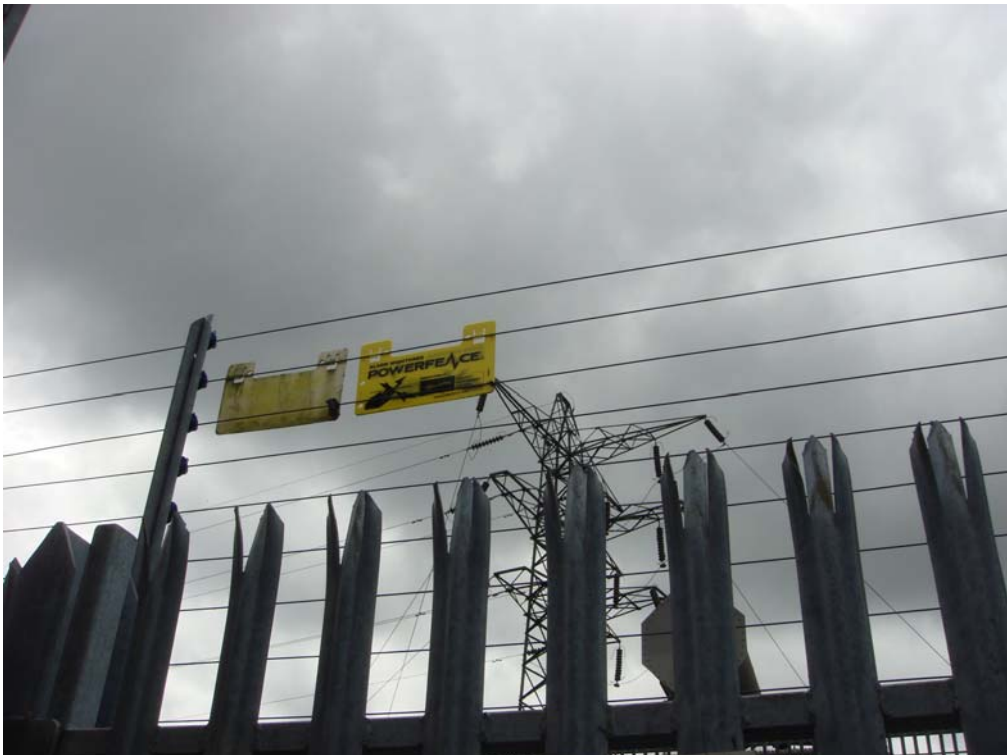
Photograph 2 – The warning signs on the electric fence

- A3(d). There are warning signs on the compound gates alerting people of the need to turn off the electric fence before entering and the wires of the electric fence itself carry warning signs as to its electrified nature.

- 2.6 In addition, there is an open-wire electric fence around the whole of the inside of the palisade fencing and around the roof of the 33kV switchroom where it abuts the compound.
