Quality of Service Incentive Scheme – Exceptional Events

Appointed Examiner's Report	
Reporting year	2010/11
DNO	CE Electric – NEDL Licensed Area
Cause	Vandalism to 132kV insulators on a lattice steel tower
Date of event	26 June 2010

Title: Exceptional Events Report – NEDL – vandalism damage - Stella South to Annfield n°1 132kV feeder resulting in loss of customers' supplies – 26 June 2010

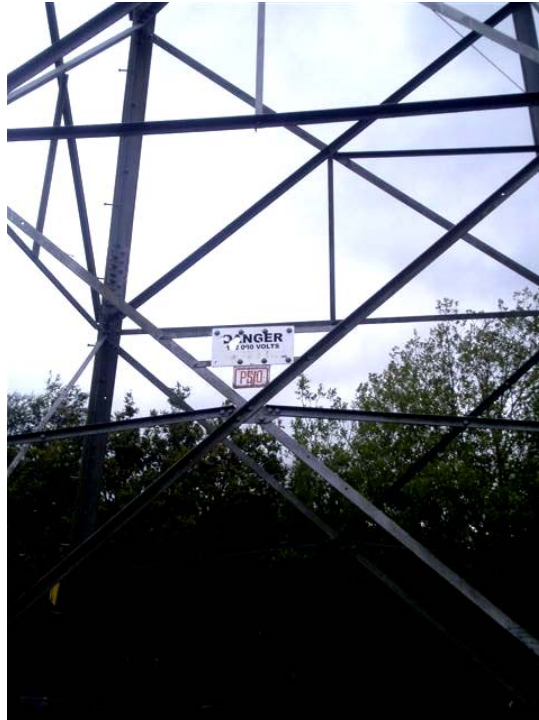
- 2.3 NEDL's control room log clearly states the situation regarding the evidence of vandalism (shotgun damage) at tower 10. Photograph 1 of tower 10, recently taken by NEDL's personnel, shows the shotgun damage to the original danger notice. *[AE's note: the original danger plates have been superseded by the mandatory yellow-coloured "Danger to Life" signs that are affixed to the corners of tower 10. The "PS10 plate below the damaged danger plate indicates it is tower number 10 on the line that has the "PS" identity; i.e. the section of the Stella South to Annfield n°1 132kV tower line that is strung as a single circuit].*

- 2.14 The hole in the tower's original danger plate and the site report of shotgun damaged tin cans and blown off insulators are all consistent with third party damage by shotgun blasts. The damage to a complete set of insulators on the blue phase combined with the heavy rain of the evening of 26 June 2010 are also consistent with a flashover of blue phase to the structure of the earthed tower as 'seen' by the distance protection.

Photograph 1 – The shotgun damage to the original danger plate at tower 10

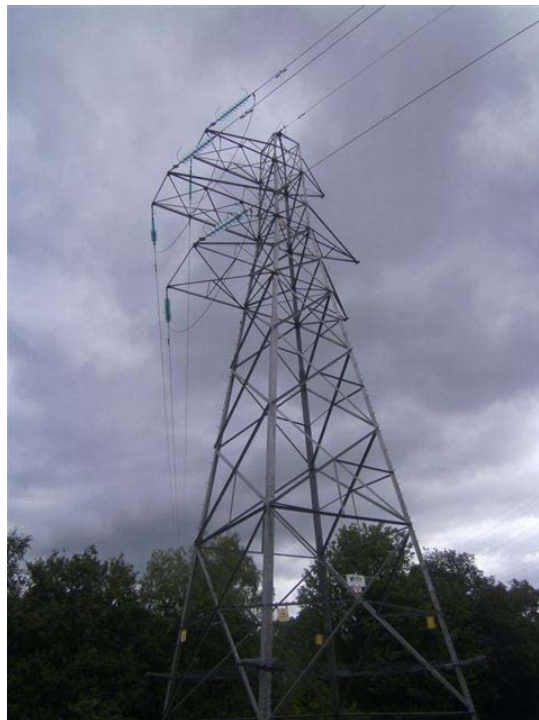
- 2.4 NEDL's photograph n°2 shows the construction of tower 10.
- 2.5 Whilst NEDL has no contemporaneous photographic evidence of the damaged insulators, a close inspection of the high-resolution photograph (photograph n°3) taken during the helicopter patrol in August 2010 shows the then recently replaced insulators. *[AE's note: from a high magnification examination of this photograph and NEDL's photograph n°2 it is possible to see the different colouration of the replaced insulators].*

Photograph 2 – Showing the construction of tower 10

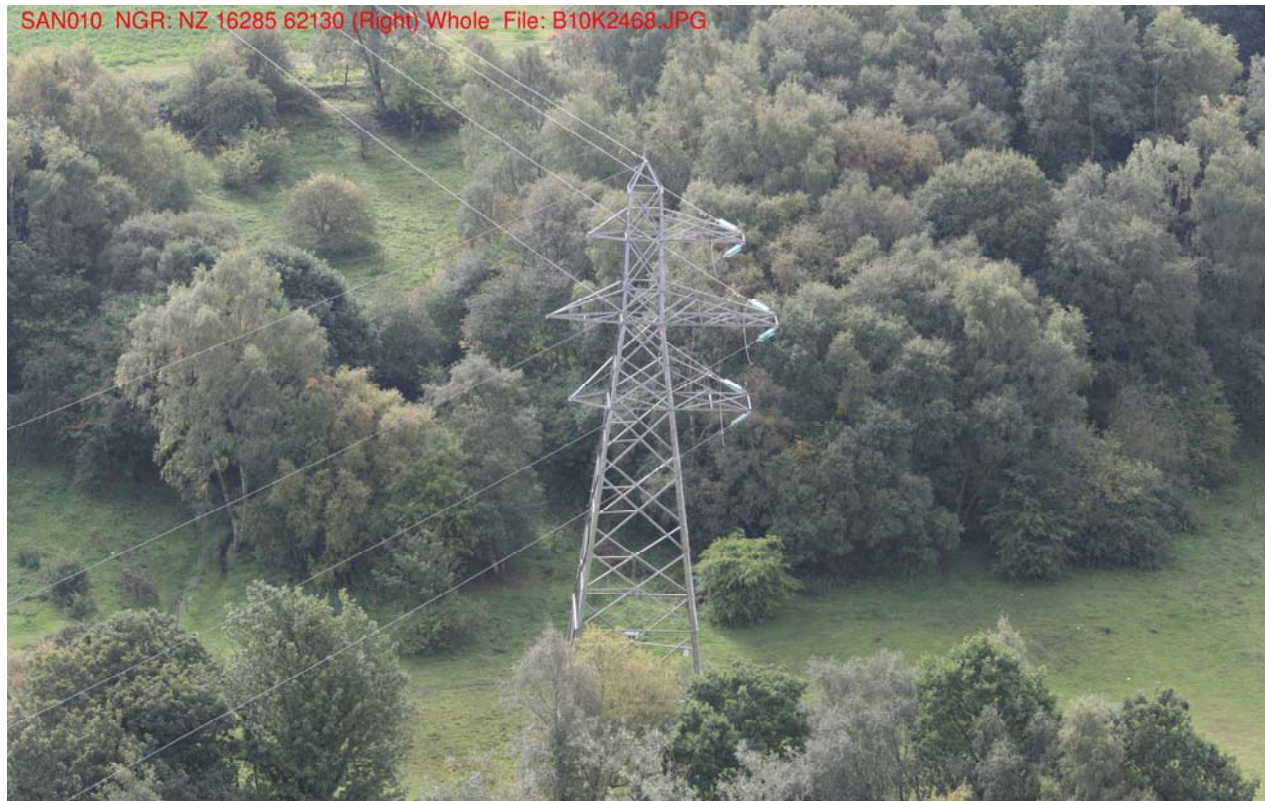
Photograph 3 - High resolution photograph of tower 10 taken during the helicopter patrol of August 2010
