## **Quality of Service Incentive Scheme – Exceptional Events**

<b>Appointed Examiner's Report</b>	
<b>Reporting year</b>	2010/11
<b>DNO</b>	Western Power Distribution – South West Licensed Area
<b>Cause</b>	Windborne material damaging 33kV Switchgear
<b>Date of event</b>	30 July 2010

Title: Exceptional Events Report – WPD South West – Lockleaze BSP – Damaged 33kV switchgear – 30 July 2010

Reference: EE 2010/11 – WPD South West

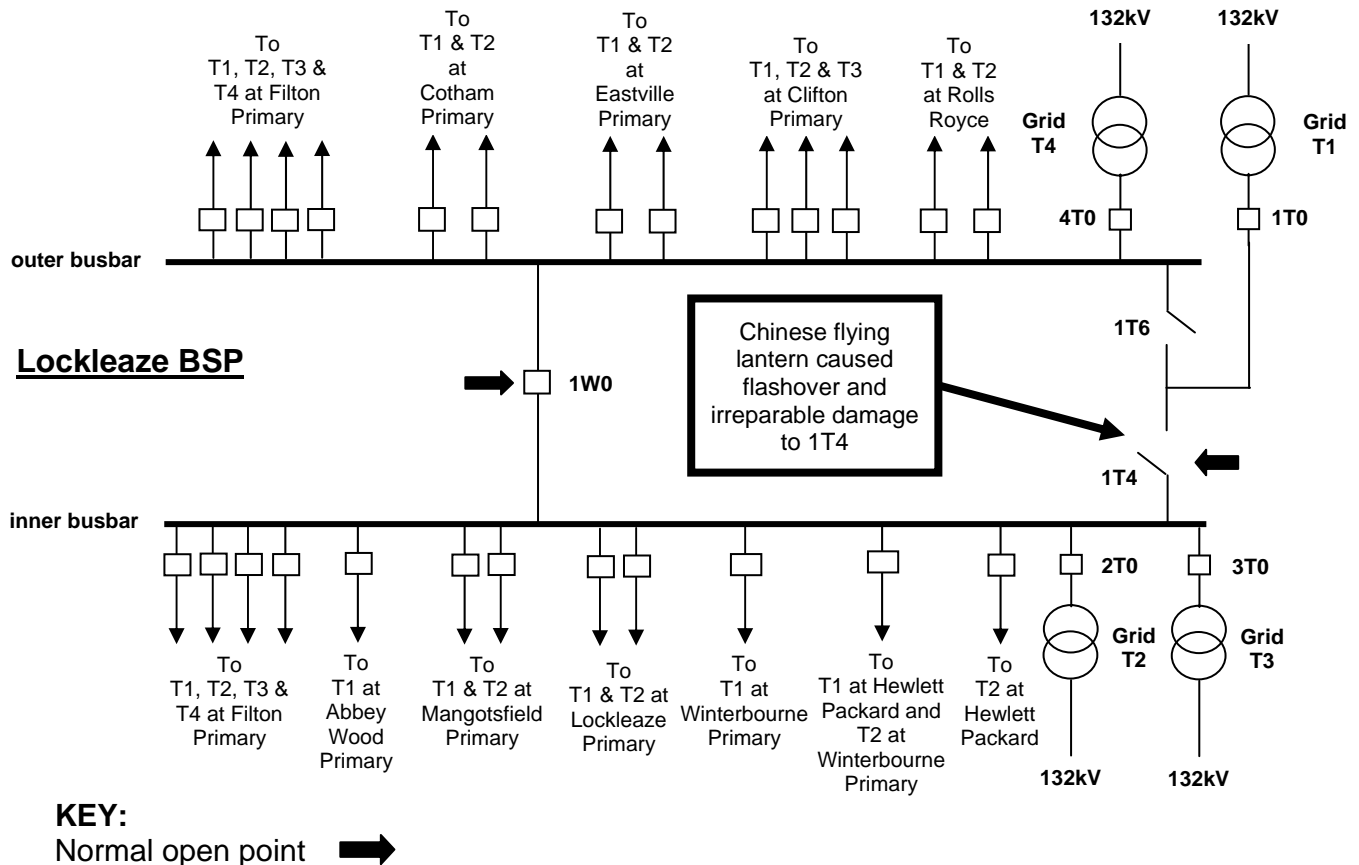
Figure 1 – Simplified Network Diagram of WPD's 132/33kV distribution network affected by the incident

- 1.3 The ensuing flashover irreparably damaged 33kV normally open, busbar selector isolator 1T4, and caused a busbar fault that affected both inner and outer busbars, resulting in the loss of 33kV infeeds to 11 of WPD's 33/11kV Primary Substations.

1. WPD's network was running normally at the time of the incident.
2. Only the normal feeding arrangements are shown. All infeeds and outfeeds can be selected to either busbar via busbar selector isolators such as the damaged 1T4.
3. WPD's protection operated correctly to trip CBs 1T0, 2T0, 3T0 and 4T0.
4. Supplies to WPD's customers fed from Filton and Merton Road Primary Substations were restored by automated switching in less than one minute (an SI).
5. WPD's control engineer restored the other customers' supplies in five minutes using tele-controlled switching by closing circuit-breakers 2T0 (inner busbar) and 1T0 (outer busbar).

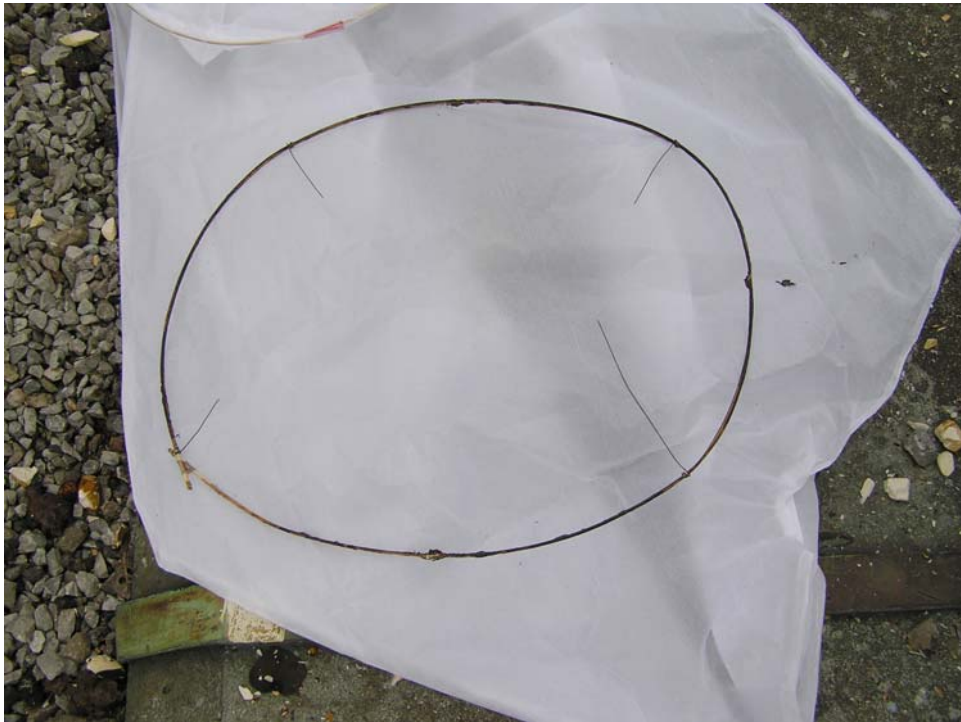
- 1.4 WPD has recovered the remains of the Chinese 'flying' lantern which was found at the base of isolator 1T4. The remains show signs of electric arc damage.

- 2.4 The remains of the Chinese flying lantern are readily visible in WPD's Photograph 1 and the actual remains were shown to the AE during his visit to WPD on 28 June 2010.

**Photograph 1 – Remains of Chinese flying lantern showing the metal ring**

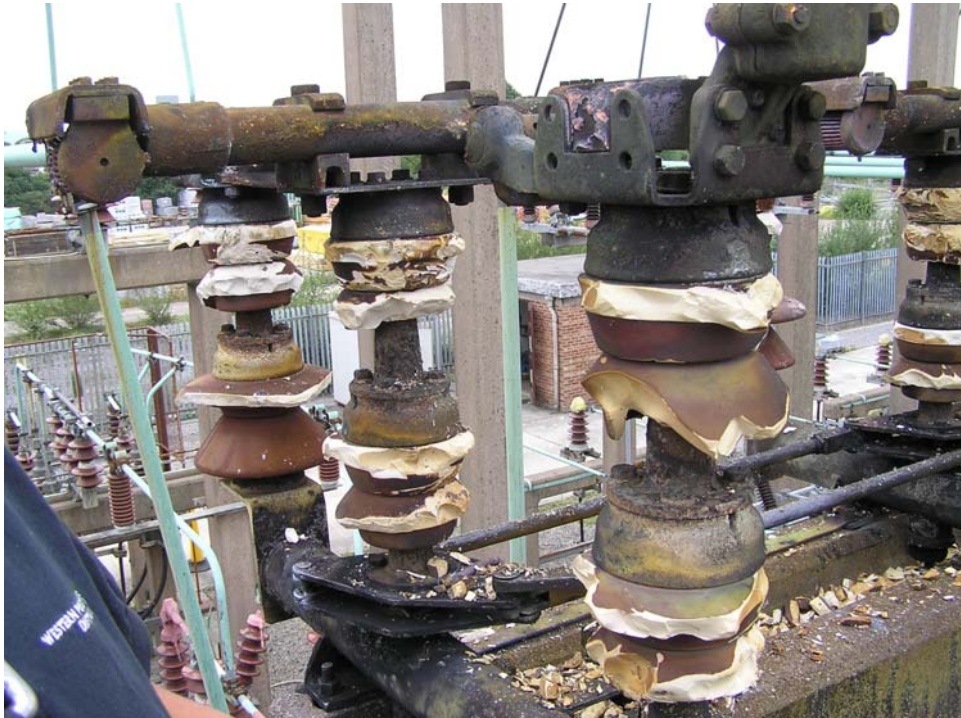
- 1.17 At 07:08 on Friday, 30 July 2010, a Chinese 'flying' lantern with a metal ring at its base came into contact with the normally open busbar selector isolator 1T4. The ensuing flashover irreparably damaged 1T4 and precipitated a busbar fault that shutdown both the inner and outer busbars.

- 2.5 The extensive damage to 1T4 is readily apparent from WPD's Photograph 2. All insulators, both fixed and moving were shattered in the incident.
- 2.6 A comparison with an undamaged isolator of the same type at Lockleaze BSP can be gauged from Photograph 3.

- 2.18 The damage to isolator 1T4 is consistent with the metal ring of the Chinese flying lantern coming into contact with the exposed 33kV conductors. The resultant flashover would have created virtually simultaneous faults on the inner and outer busbars at WPD's Lockleaze BSP.

**Photograph 2 – The damage to 1T4 with blue phase nearest the camera**

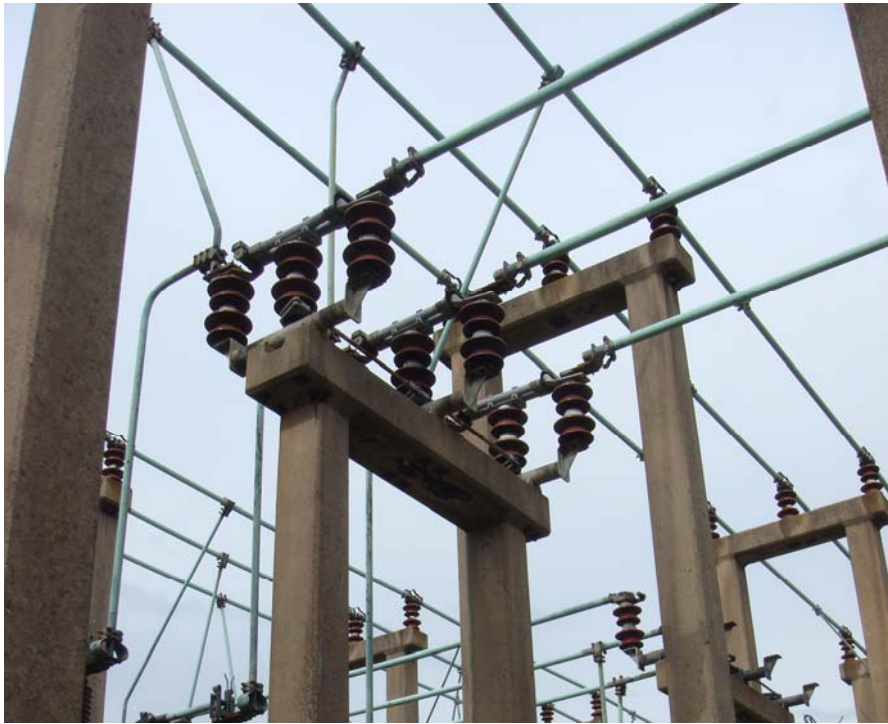
**Photograph 3 – View of an undamaged isolator of the same type**

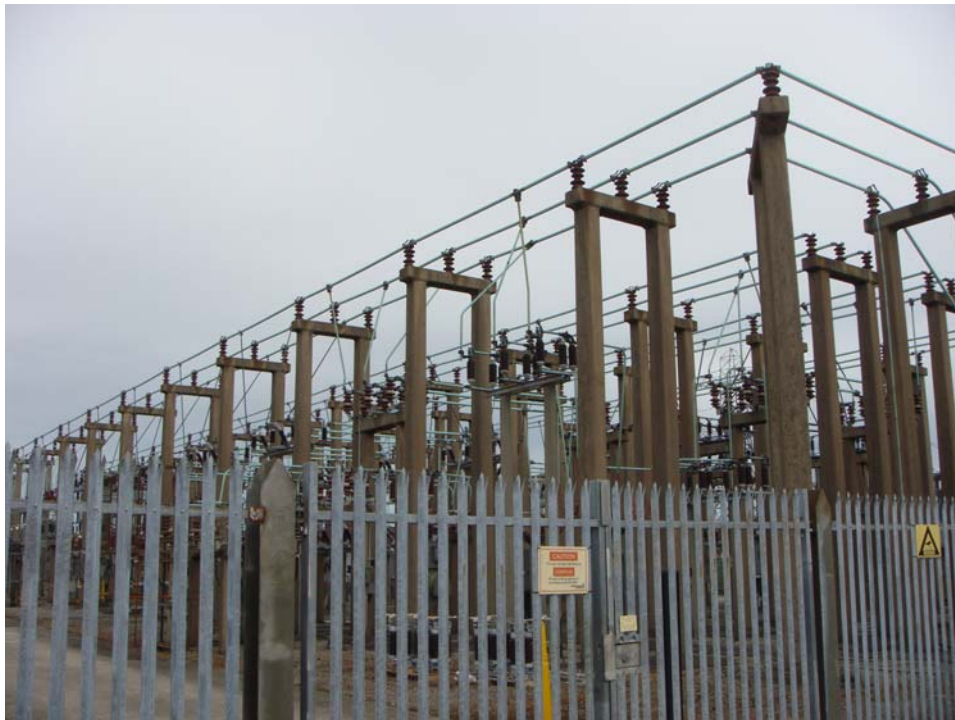
- 2.8 The general layout of the 33kV outdoor switchgear compound at Lockleaze BSP is shown in Photograph 4. Both busbars are in the form of a 'U', the closed ends of which are to the right of the photograph. The outer busbar is nearest the camera. Both 'arms' of the inner busbar can be seen running parallel to the outer busbar, through the centre of the site.

- 2.9 Whilst it is practically impossible to insulate all the live exposed conductors in 33kV compounds such as at Lockleaze BSP, the AE is pleased to note that WPD's preventative measures are in accordance with its policy of applying heat-shrink insulation to arcing horns and switchgear bushings where appropriate and practicable.

**Photograph 4 – General view of the 33kV outdoor compound at Lockleaze BSP**
