CERT Demonstration Action UK Park Homes

Alba Report 21050

Appendix 4D

Pre v Post-Improvement Thermographic Image Data

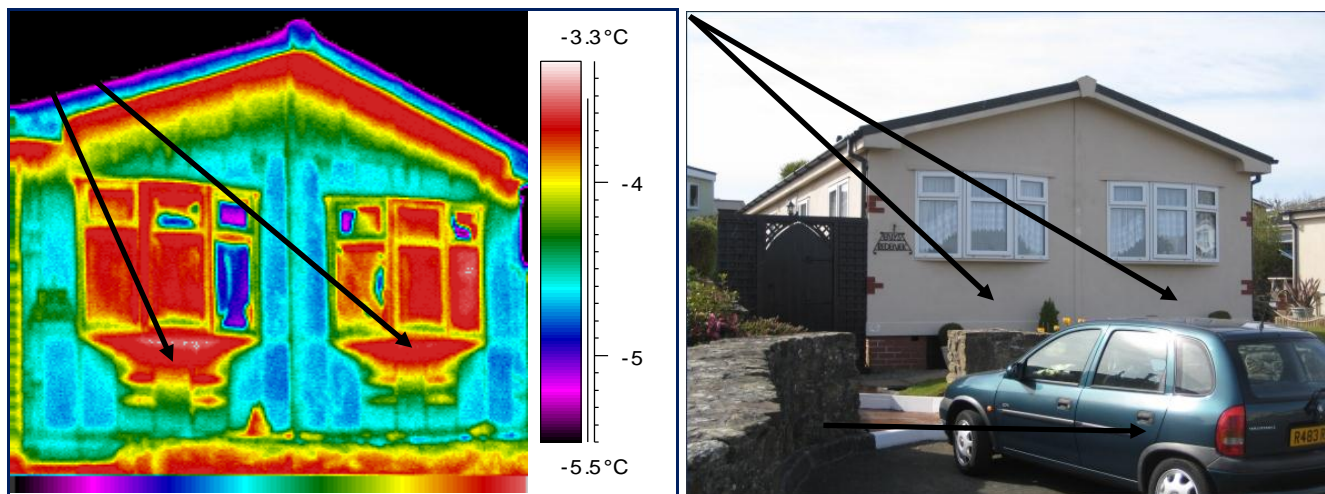
Pre-Improvement Inspection

In the thermal image “pre-improvement”, it is clear that significant heat loss is occurring across the building envelope and that this can be attributed to thermal bridging across the timber frame construction in addition to warm air leakage at critical junction details.

The thermographic inspection also identified a number of anomalies that were indicative of heat loss occurring across the floor construction.

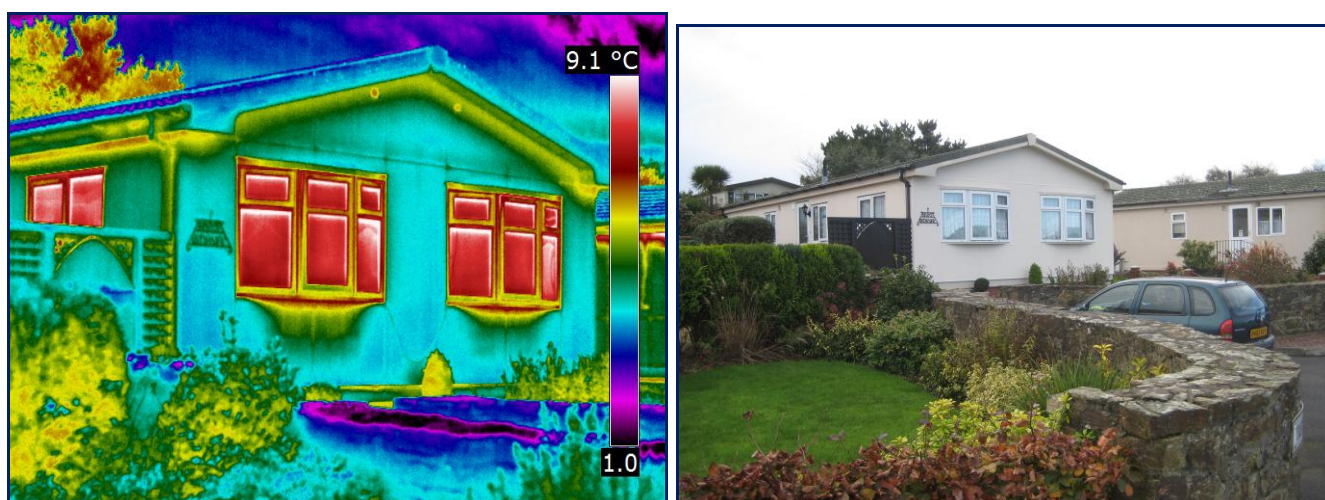
Post-Improvement Inspection

It can be seen in the above thermal image “post-improvement” that the number of heat-loss pathways across the building envelope have been significantly reduced (i.e. when compared to the “pre-improvement” image).

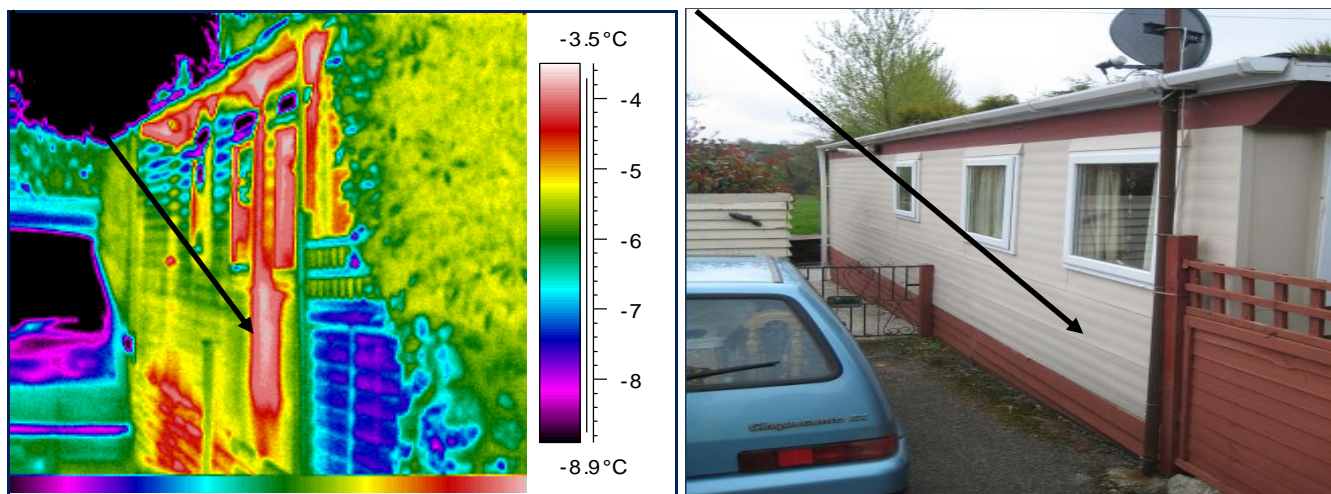
Pre-Improvement Inspection

In the thermal image “pre-improvement”, it is clear that significant heat loss is occurring across the building envelope and that this can be attributed to thermal bridging across the timber frame construction in addition to warm air leakage at critical junction details.

The thermographic inspection also identified a number of anomalies that were indicative of heat loss occurring across the floor construction.

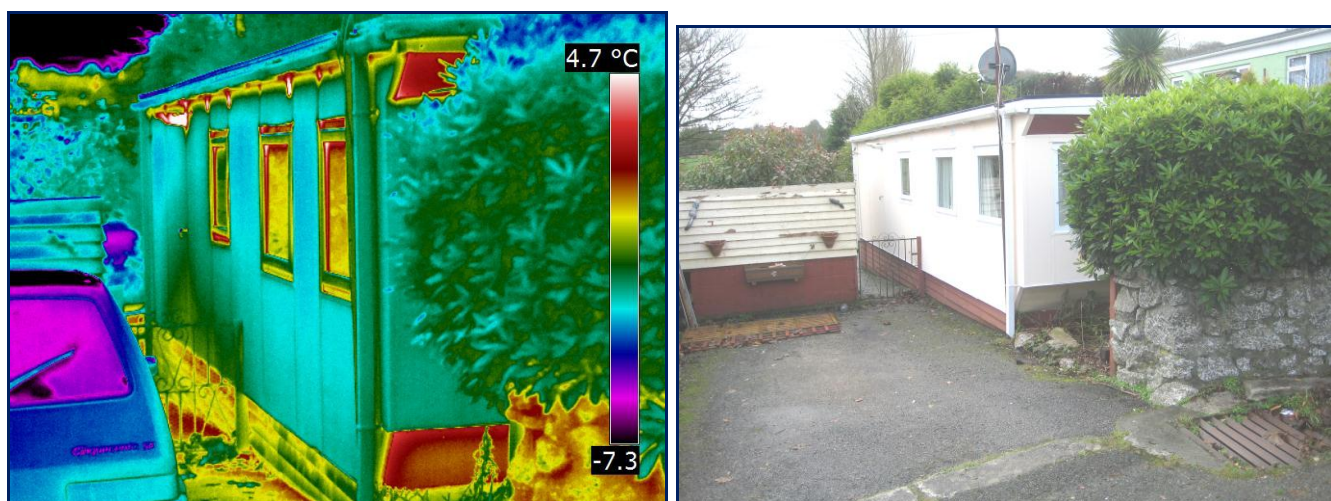
Post-Improvement Inspection

It can be seen in the above thermal image “post-improvement” that the number of heat-loss pathways across the building envelope have been significantly reduced (i.e. when compared to the “pre-improvement” image).

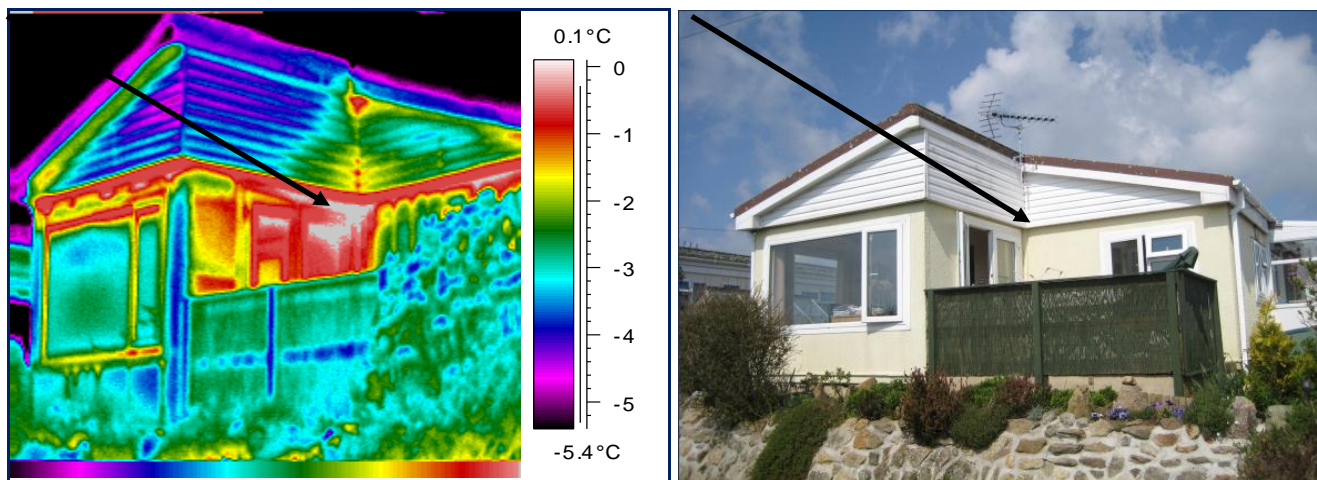
Pre-Improvement Inspection

In the thermal image “pre-improvement”, it is clear that significant heat loss is occurring across the building envelope and that this can be attributed to thermal bridging across the timber frame construction in addition to warm air leakage at critical junction details.

The thermographic inspection also identified a number of anomalies that were indicative of heat loss occurring across the floor construction.

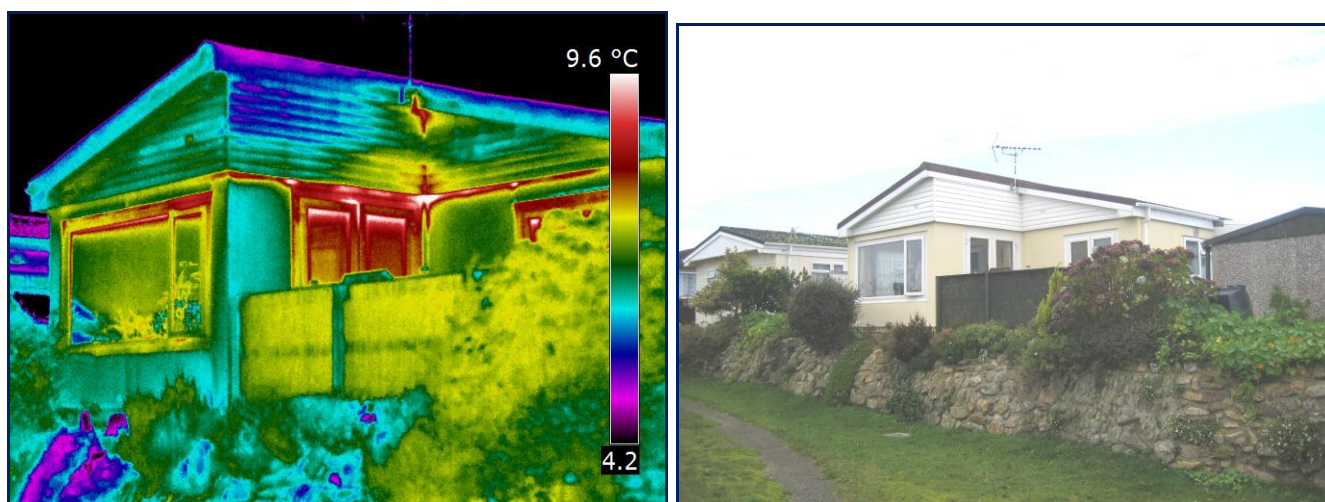
Post-Improvement Inspection

It can be seen in the above thermal image “post-improvement” that the number of heat-loss pathways across the building envelope have been significantly reduced (i.e. when compared to the “pre-improvement” image).

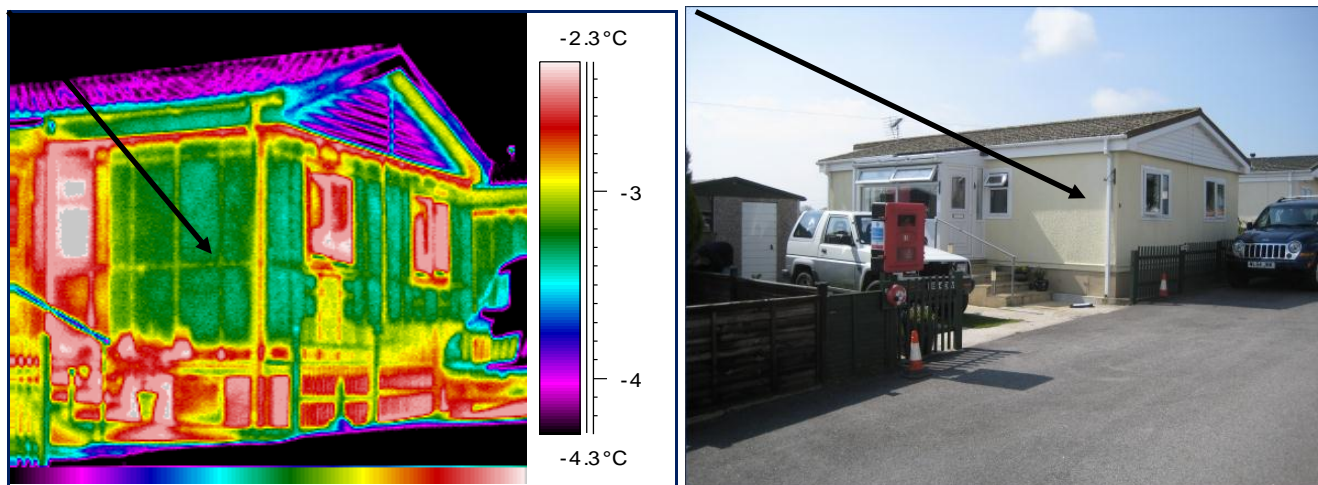
Pre-Improvement Inspection

In the thermal image “pre-improvement”, it is clear that significant heat loss is occurring across the building envelope and that this can be attributed to thermal bridging across the timber frame construction in addition to warm air leakage at critical junction details.

The thermographic inspection also identified a number of anomalies that were indicative of heat loss occurring across the floor construction.

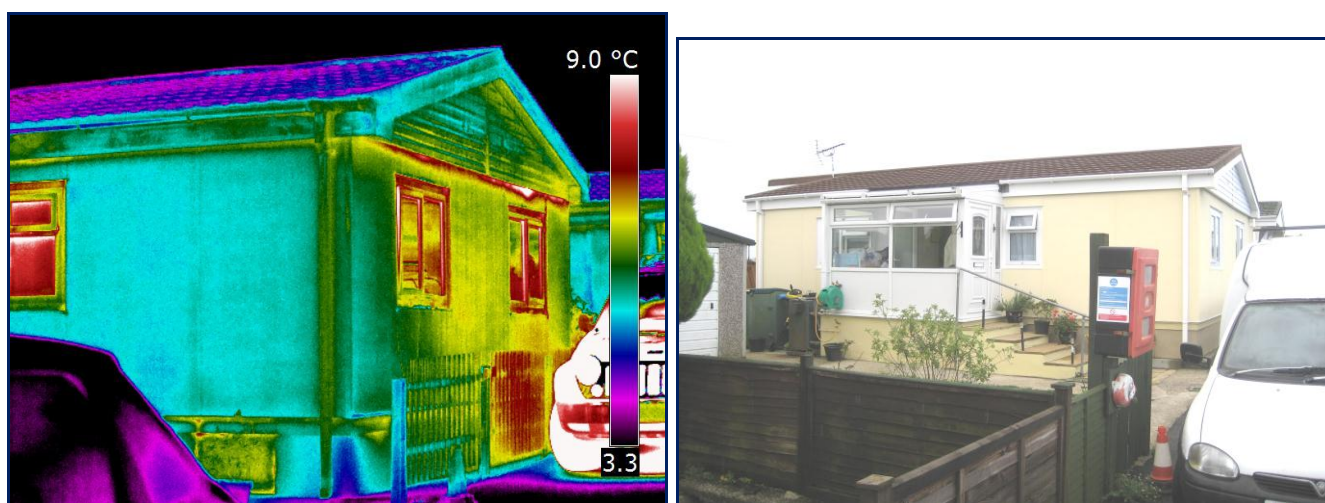
Post-Improvement Inspection

It can be seen in the above thermal image “post-improvement” that the number of heat-loss pathways across the building envelope have been significantly reduced (i.e. when compared to the “pre-improvement” image).

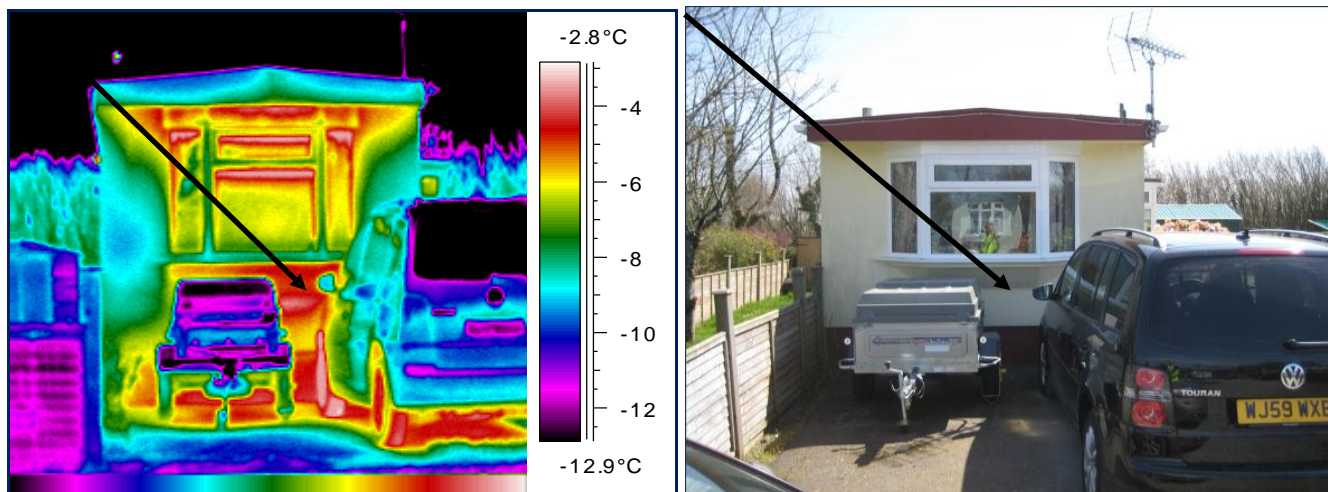
Pre-Improvement Inspection

In the thermal image “pre-improvement”, it is clear that significant heat loss is occurring across the building envelope and that this can be attributed to thermal bridging across the timber frame construction in addition to warm air leakage at critical junction details.

The thermographic inspection also identified a number of anomalies that were indicative of heat loss occurring across the floor construction.

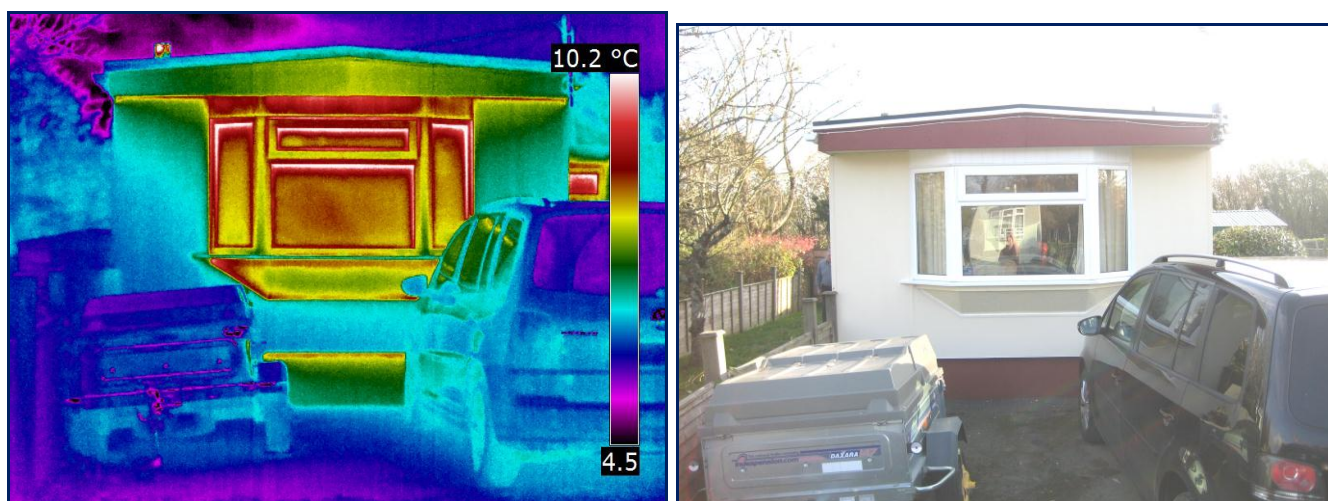
Post-Improvement Inspection

It can be seen in the above thermal image “post-improvement” that the number of heat-loss pathways across the building envelope have been significantly reduced (i.e. when compared to the “pre-improvement” image).

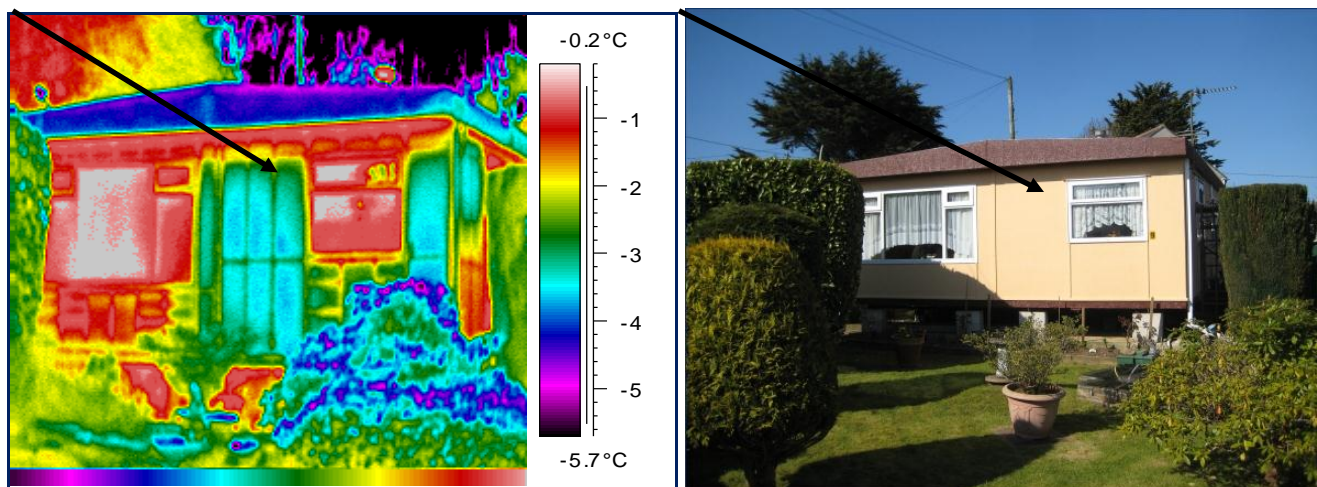
Pre-Improvement Inspection

In the thermal image “pre-improvement”, it is clear that significant heat loss is occurring across the building envelope and that this can be attributed to thermal bridging across the timber frame construction in addition to warm air leakage at critical junction details.

The thermographic inspection also identified a number of anomalies that were indicative of heat loss occurring across the floor construction.

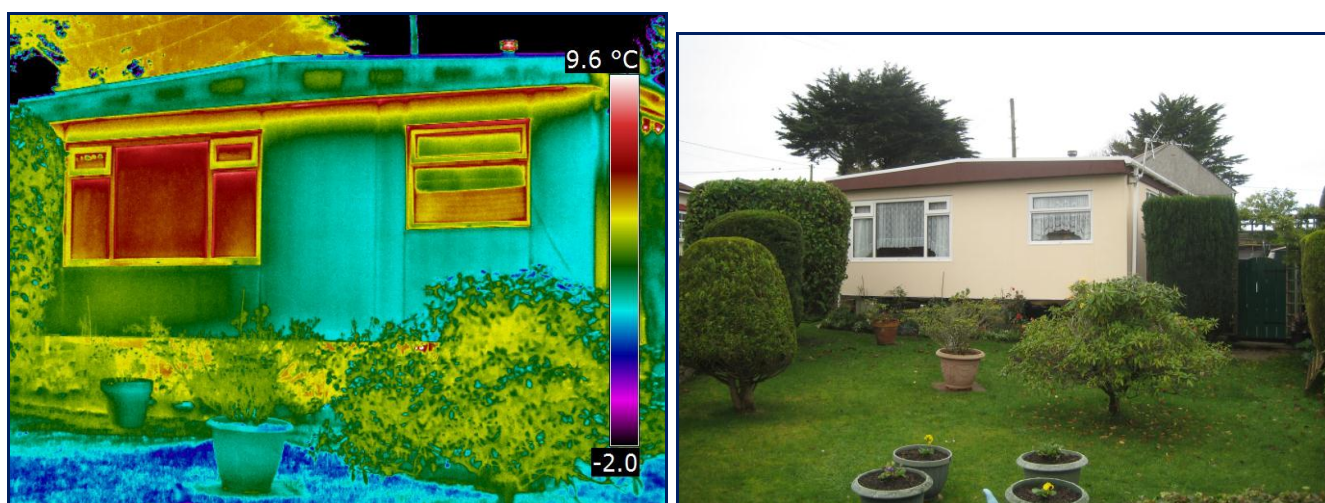
Post-Improvement Inspection

It can be seen in the above thermal image “post-improvement” that the number of heat-loss pathways across the building envelope have been significantly reduced (i.e. when compared to the “pre-improvement” image).

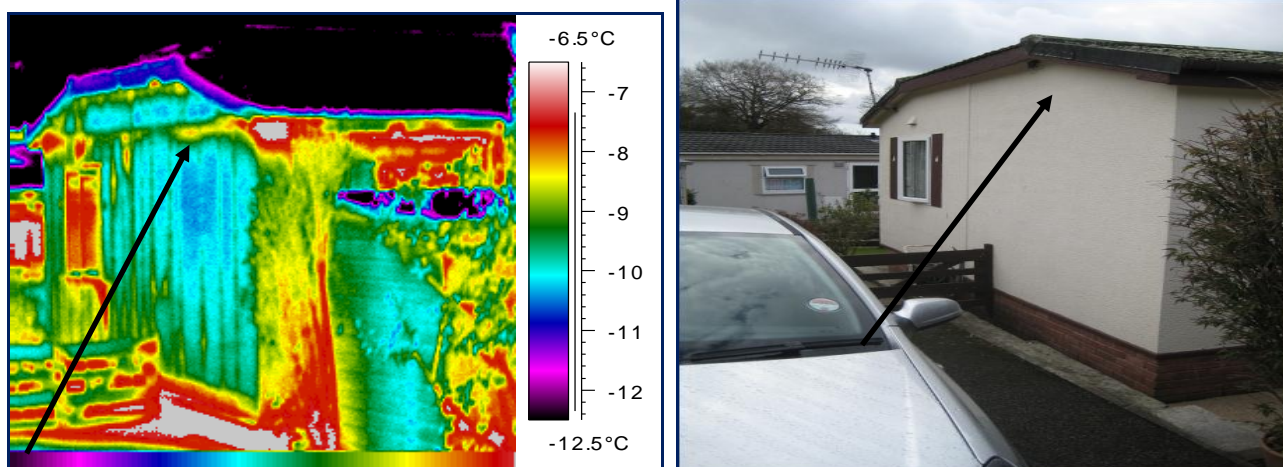
Pre-Improvement Inspection

In the thermal image “pre-improvement”, it is clear that significant heat loss is occurring across the building envelope and that this can be attributed to thermal bridging across the timber frame construction in addition to warm air leakage at critical junction details.

The thermographic inspection also identified a number of anomalies that were indicative of heat loss occurring across the floor construction.

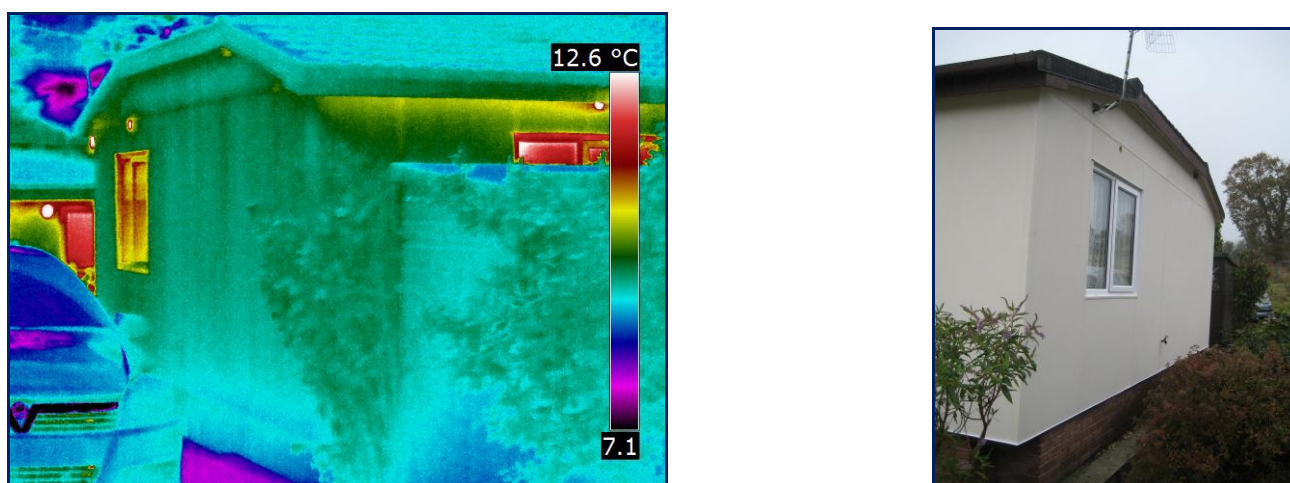
Post-Improvement Inspection

It can be seen in the above thermal image “post-improvement” that the number of heat-loss pathways across the building envelope have been significantly reduced (i.e. when compared to the “pre-improvement” image).

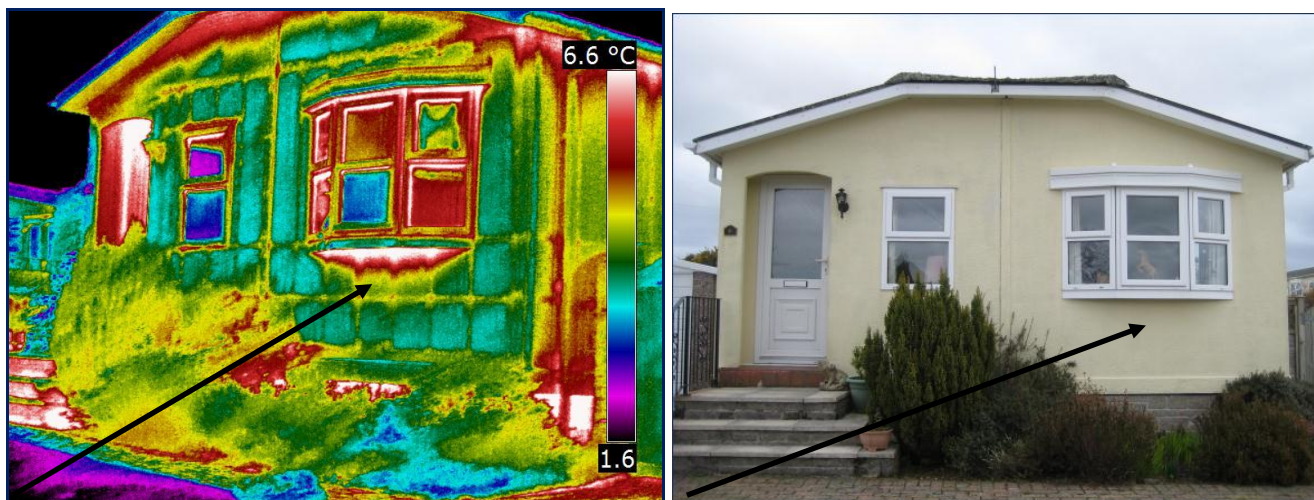
Pre-Improvement Inspection

In the thermal image “pre-improvement”, it is clear that significant heat loss is occurring across the building envelope and that this can be attributed to thermal bridging across the timber frame construction in addition to warm air leakage at critical junction details.

The thermographic inspection also identified a number of anomalies that were indicative of heat loss occurring across the floor construction.

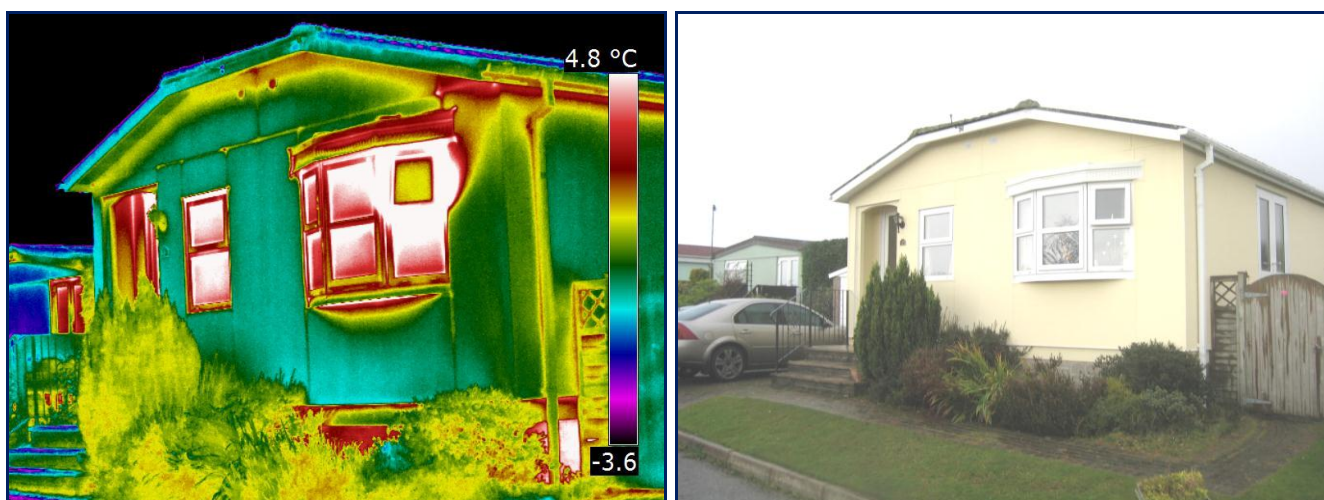
Post-Improvement Inspection

It can be seen in the above thermal image “post-improvement” that the number of heat-loss pathways across the building envelope have been significantly reduced (i.e. when compared to the “pre-improvement” image).

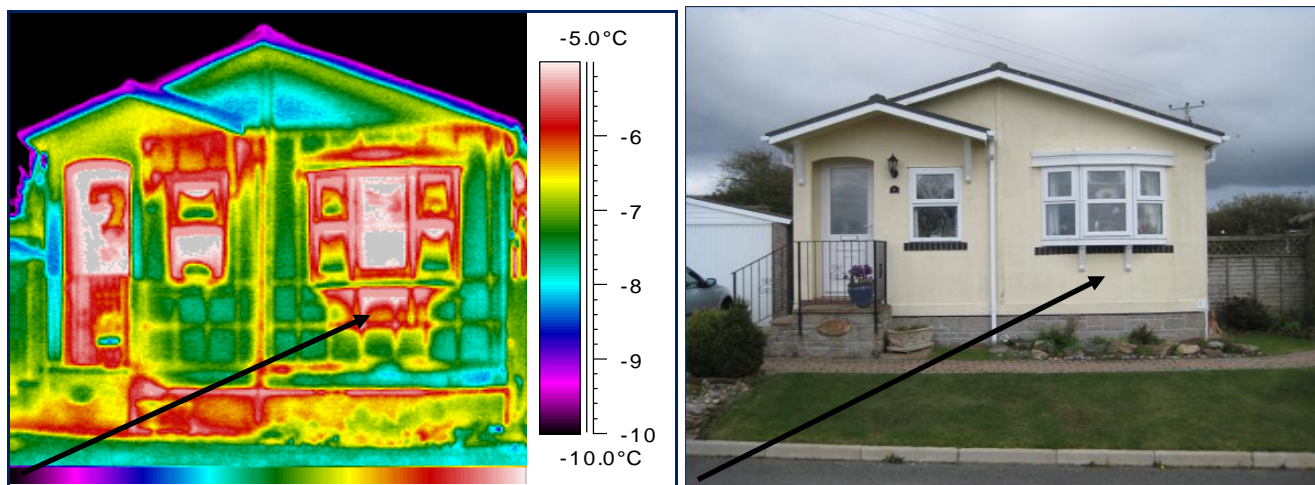
Pre-Improvement Inspection

In the thermal image “pre-improvement”, it is clear that significant heat loss is occurring across the building envelope and that this can be attributed to thermal bridging across the timber frame construction in addition to warm air leakage at critical junction details.

The thermographic inspection also identified a number of anomalies that were indicative of heat loss occurring across the floor construction.

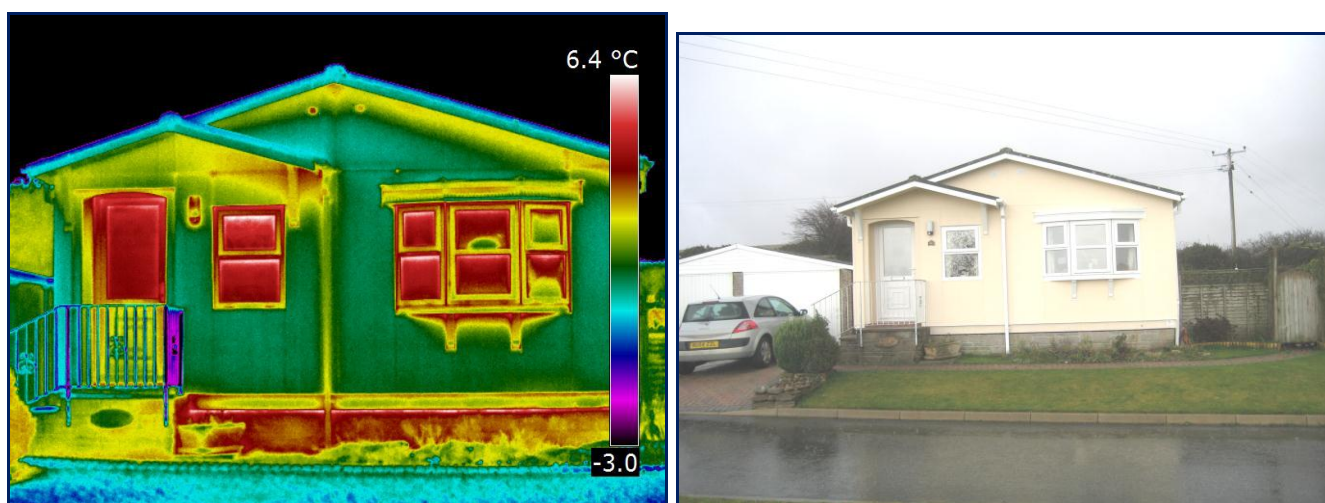
Post-Improvement Inspection

It can be seen in the above thermal image “post-improvement” that the number of heat-loss pathways across the building envelope have been significantly reduced (i.e. when compared to the “pre-improvement” image).

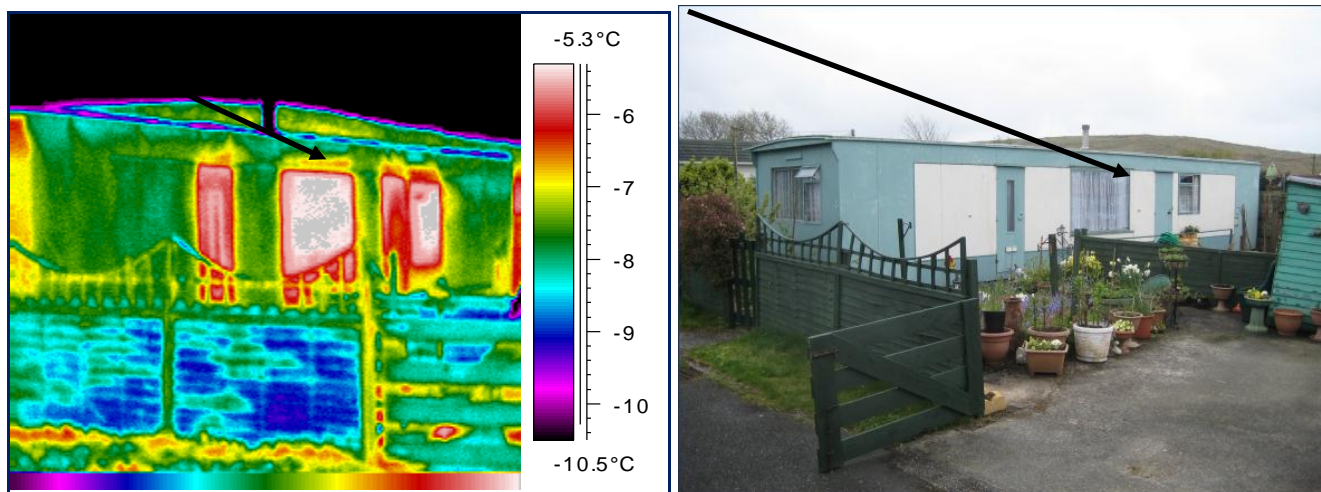
Pre-Improvement Inspection

In the thermal image “pre-improvement”, it is clear that significant heat loss is occurring across the building envelope and that this can be attributed to thermal bridging across the timber frame construction in addition to warm air leakage at critical junction details.

The thermographic inspection also identified a number of anomalies that were indicative of heat loss occurring across the floor construction.

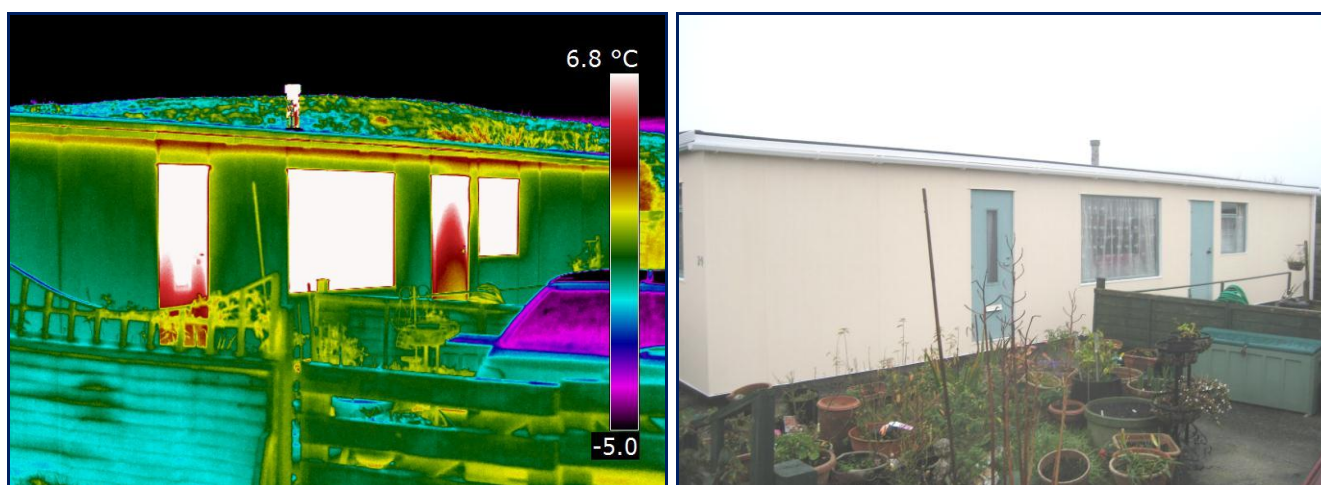
Post-Improvement Inspection

It can be seen in the above thermal image “post-improvement” that the number of heat-loss pathways across the building envelope have been significantly reduced (i.e. when compared to the “pre-improvement” image).

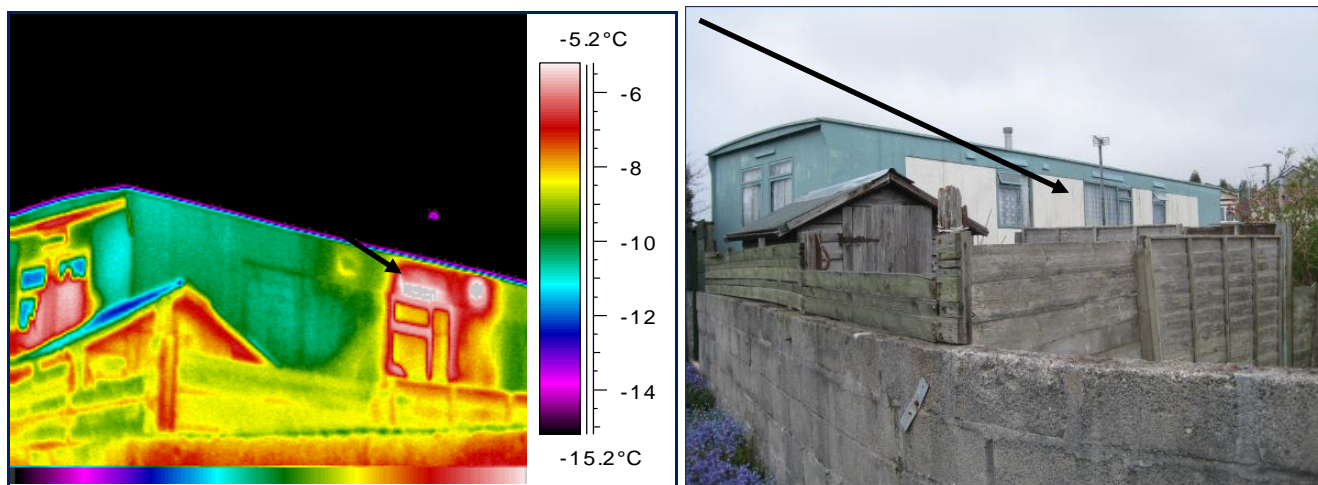
Pre-Improvement Inspection

In the thermal image “pre-improvement”, it is clear that significant heat loss is occurring across the building envelope and that this can be attributed to thermal bridging across the timber frame construction in addition to warm air leakage at critical junction details.

The thermographic inspection also identified a number of anomalies that were indicative of heat loss occurring across the floor construction.

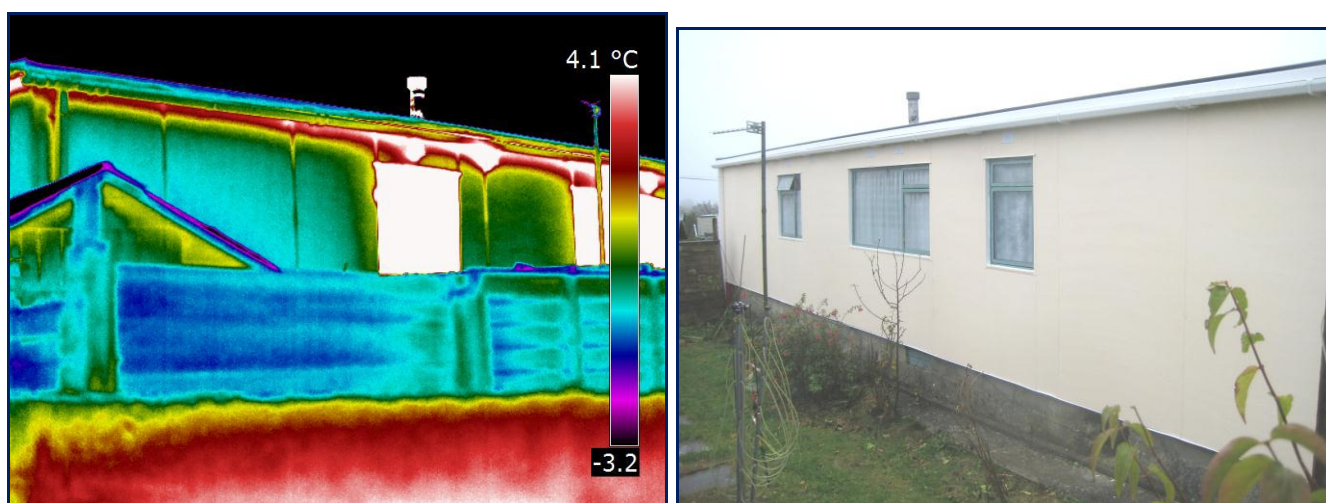
Post-Improvement Inspection

It can be seen in the above thermal image “post-improvement” that the number of heat-loss pathways across the building envelope have been significantly reduced (i.e. when compared to the “pre-improvement” image).

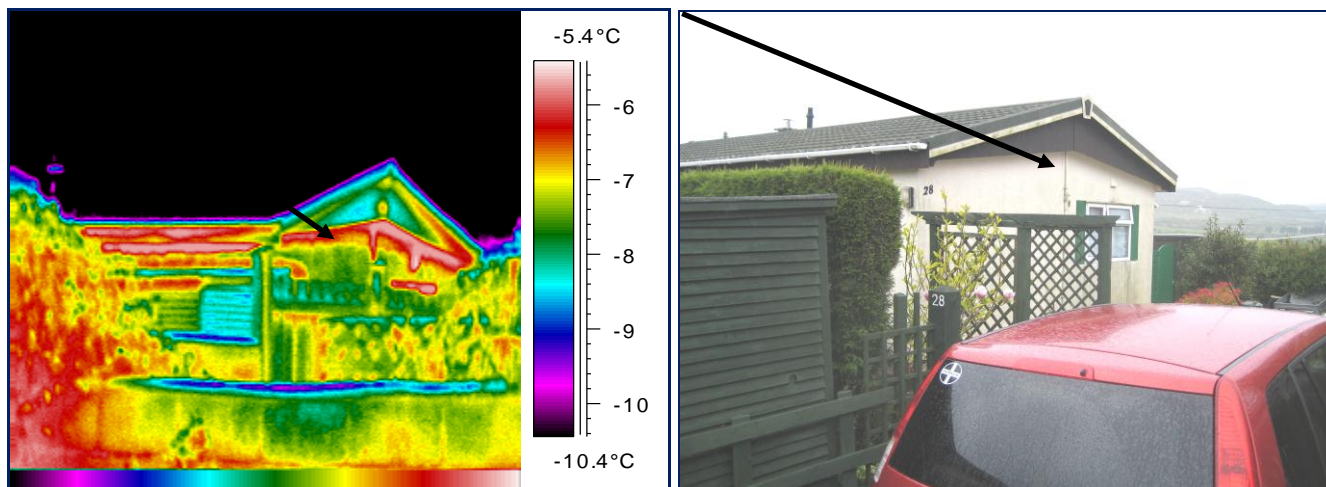
Pre-Improvement Inspection

In the thermal image “pre-improvement”, it is clear that significant heat loss is occurring across the building envelope and that this can be attributed to thermal bridging across the timber frame construction in addition to warm air leakage at critical junction details.

The thermographic inspection also identified a number of anomalies that were indicative of heat loss occurring across the floor construction.

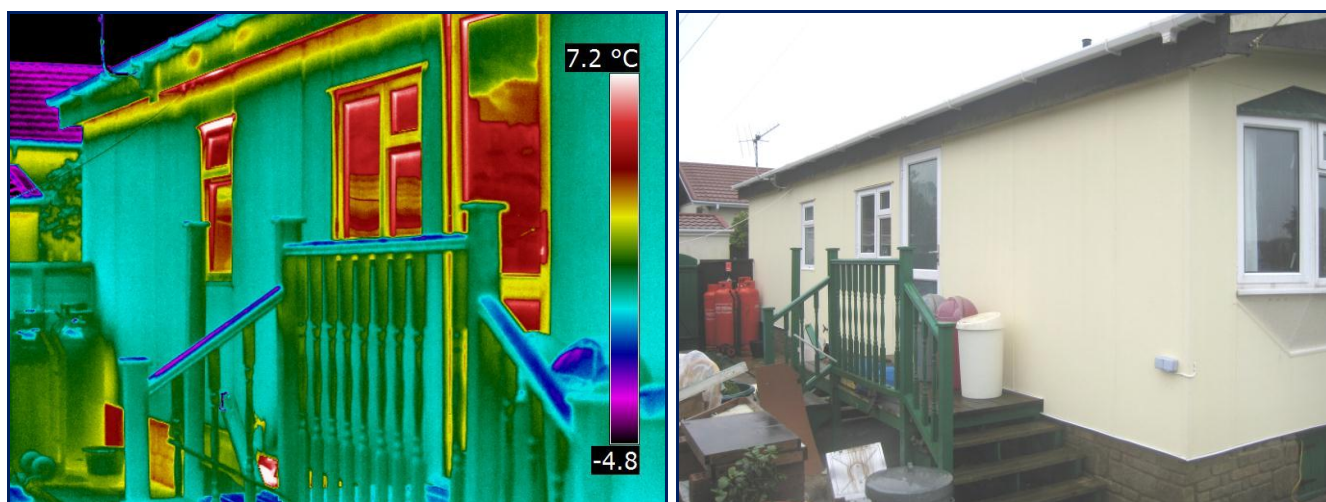
Post-Improvement Inspection

It can be seen in the above thermal image “post-improvement” that the number of heat-loss pathways across the building envelope have been significantly reduced (i.e. when compared to the “pre-improvement” image).
