CERT Demonstration Action UK Park Homes

Alba Report 21050

Appendix 4C

Thermographic Image Data

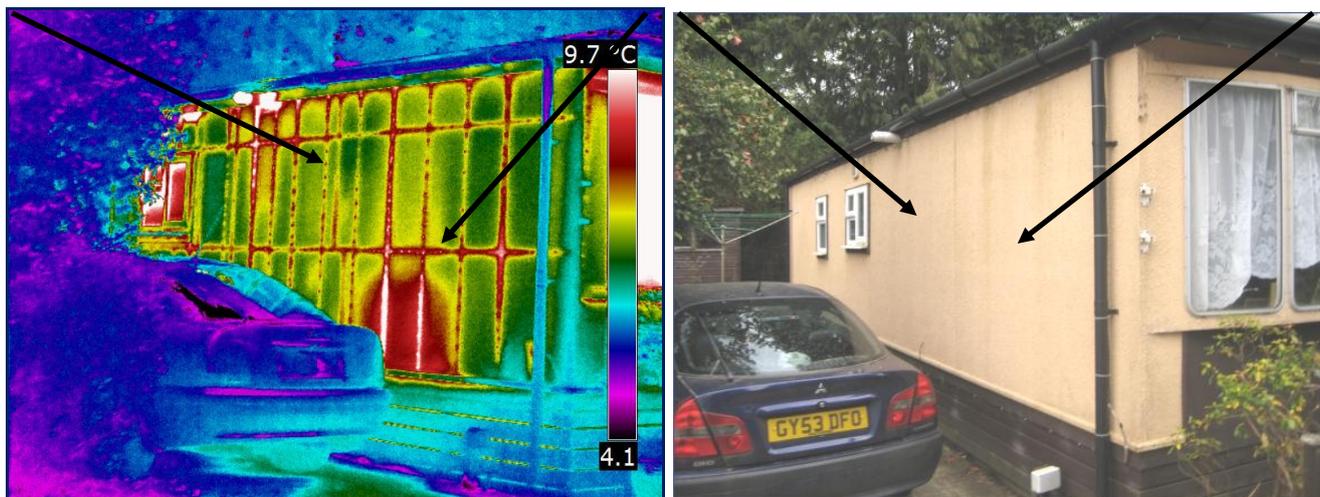
Pre-Improvement Inspection

In the thermal image “pre-improvement”, it is clear that significant heat loss is occurring across the building envelope and that this can be attributed to thermal bridging across the timber frame construction in addition to warm air leakage at critical junction details.

The thermographic inspection also identified a number of anomalies that were indicative of heat loss occurring across the floor construction.

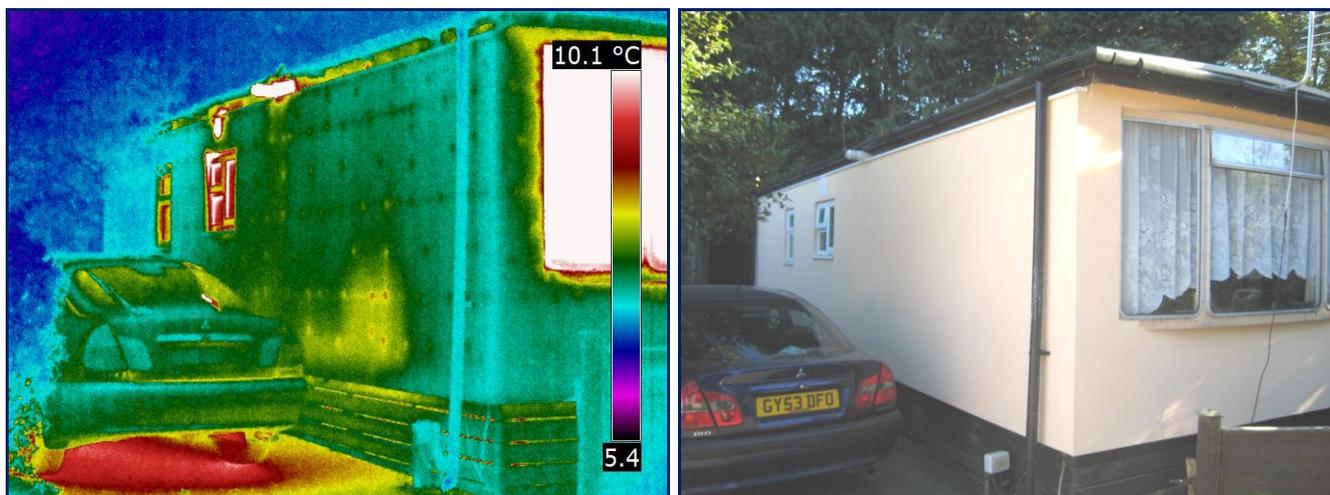
Post-Improvement Inspection

It can be seen in the above thermal image “post-improvement” that the number of heat-loss pathways across the building envelope have been significantly reduced (i.e. when compared to the “pre-improvement” image).

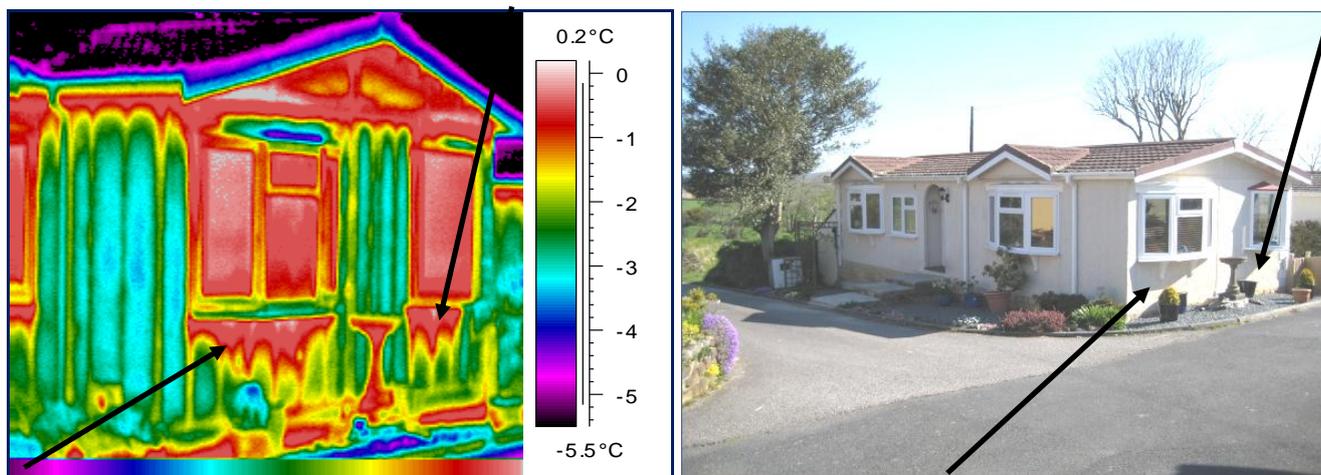
Pre-Improvement Inspection

In the thermal image “pre-improvement”, it is clear that significant heat loss is occurring across the building envelope and that this can be attributed to thermal bridging across the timber frame construction in addition to warm air leakage at critical junction details.

The thermographic inspection also identified a number of anomalies that were indicative of heat loss occurring across the floor construction.

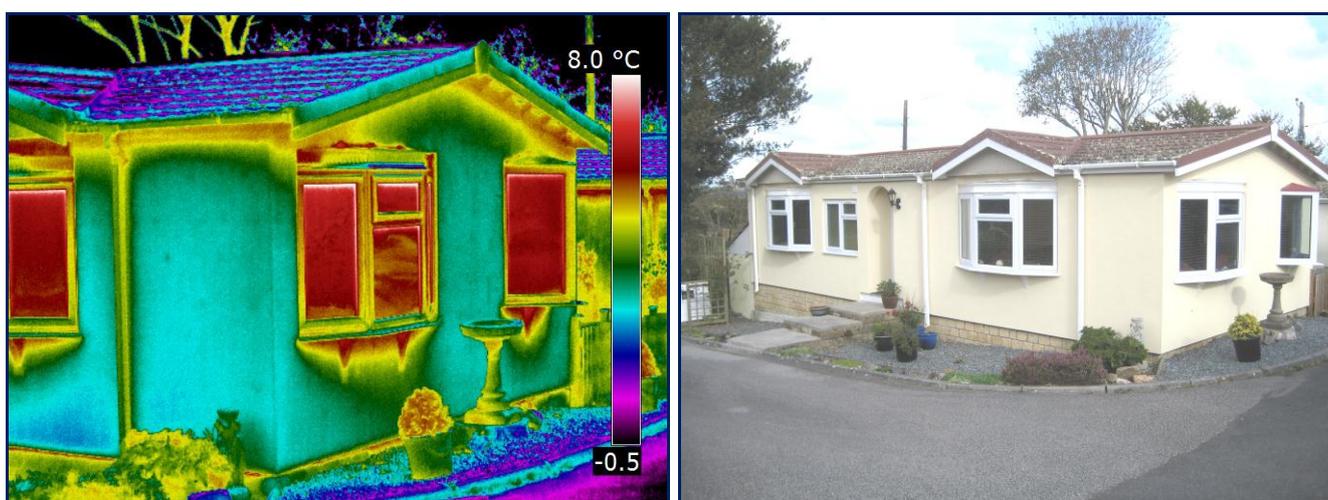
Post-Improvement Inspection

It can be seen in the above thermal image “post-improvement” that the number of heat-loss pathways across the building envelope have been significantly reduced (i.e. when compared to the “pre-improvement” image).

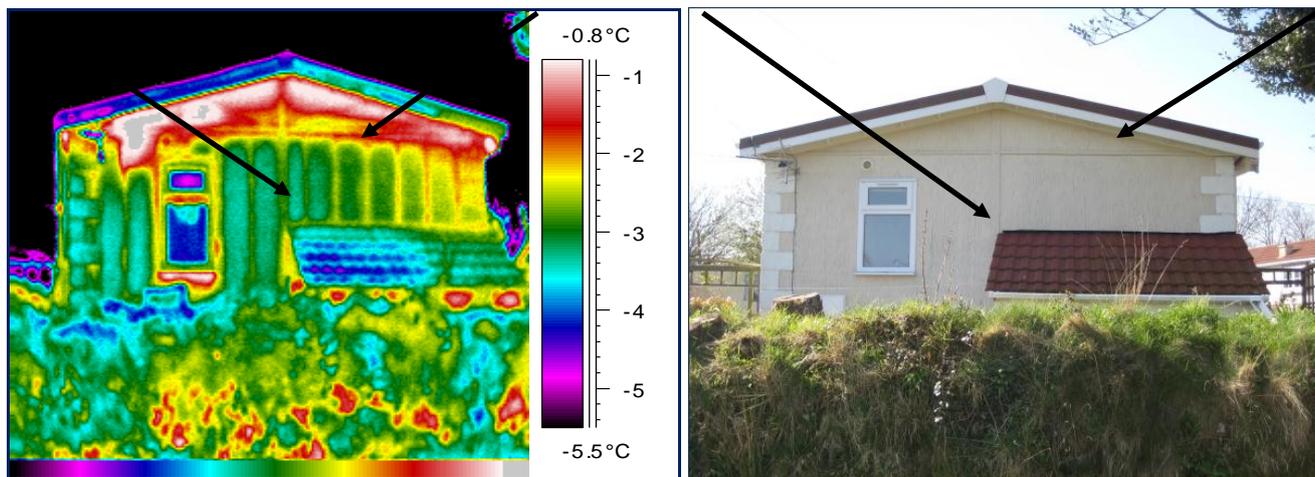
Pre-Improvement Inspection

In the thermal image “pre-improvement”, it is clear that significant heat loss is occurring across the building envelope and that this can be attributed to thermal bridging across the timber frame construction in addition to warm air leakage at critical junction details.

The thermographic inspection also identified a number of anomalies that were indicative of heat loss occurring across the floor construction.

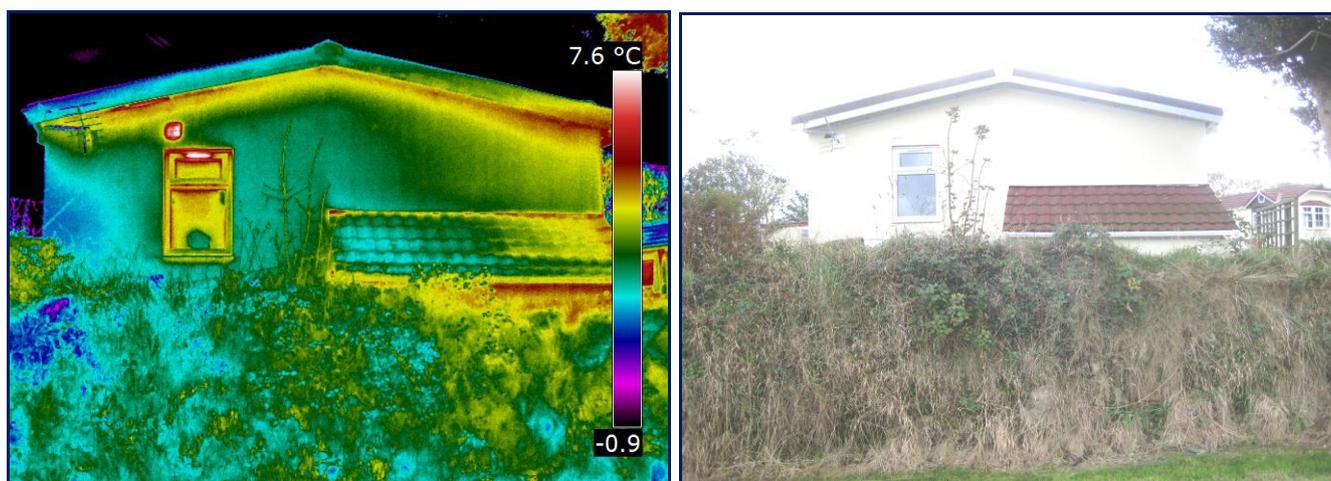
Post-Improvement Inspection

It can be seen in the above thermal image “post-improvement” that the number of heat-loss pathways across the building envelope have been significantly reduced (i.e. when compared to the “pre-improvement” image).

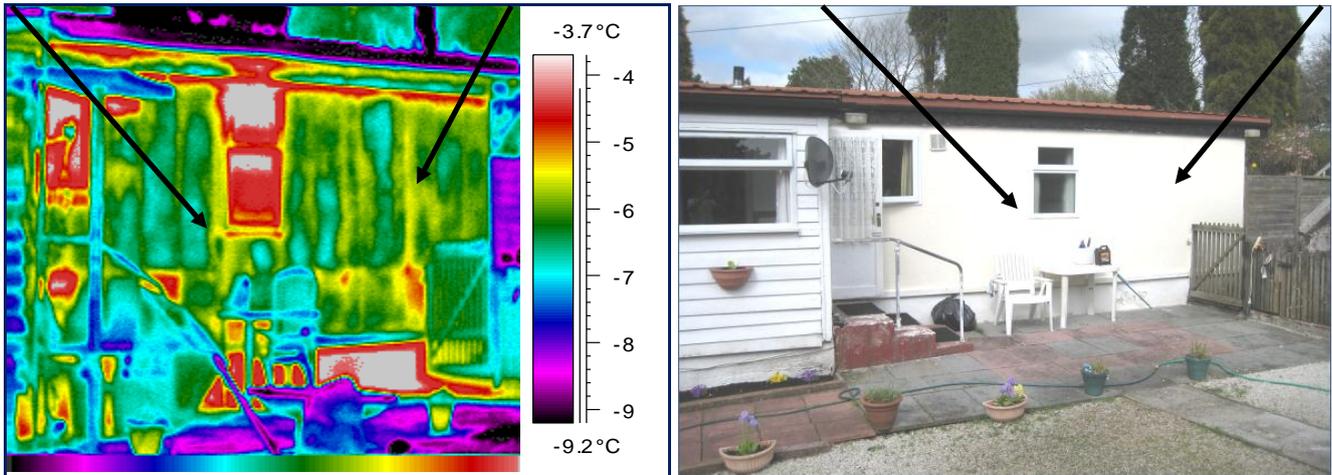
Pre-Improvement Inspection

In the thermal image “pre-improvement”, it is clear that significant heat loss is occurring across the building envelope and that this can be attributed to thermal bridging across the timber frame construction in addition to warm air leakage at critical junction details.

The thermographic inspection also identified a number of anomalies that were indicative of heat loss occurring across the floor construction.

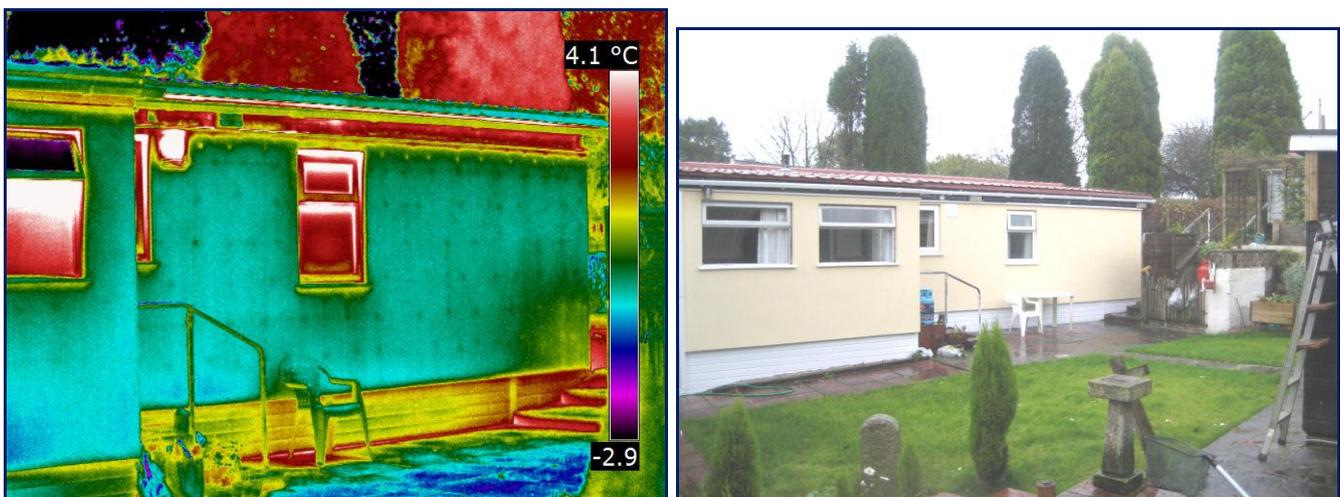
Post-Improvement Inspection

It can be seen in the above thermal image “post-improvement” that the number of heat-loss pathways across the building envelope have been significantly reduced (i.e. when compared to the “pre-improvement” image).

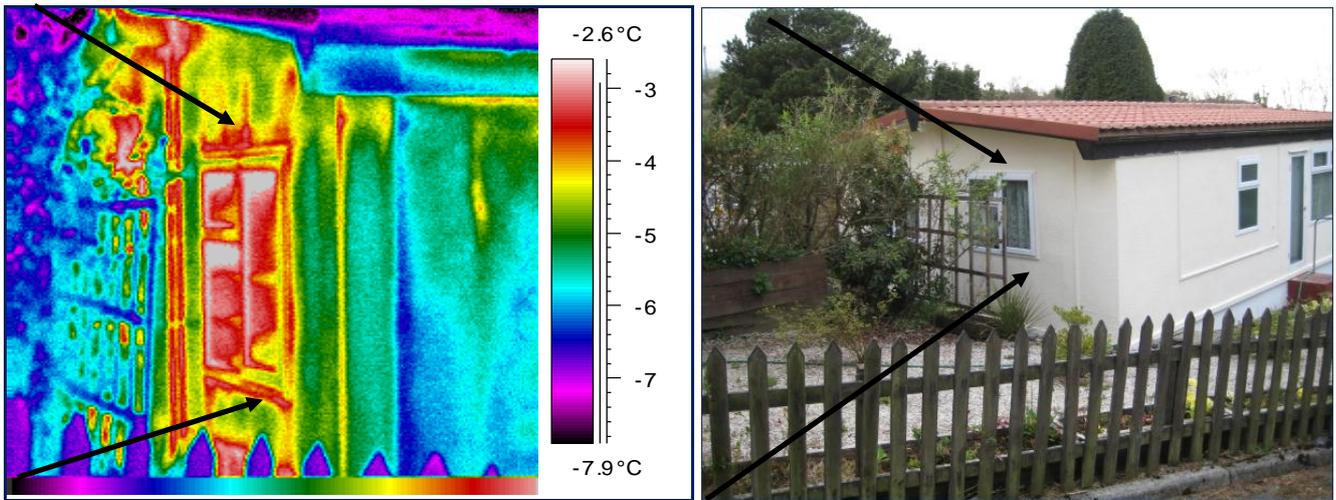
Pre-Improvement Inspection

In the thermal image “pre-improvement”, it is clear that significant heat loss is occurring across the building envelope and that this can be attributed to thermal bridging across the timber frame construction in addition to warm air leakage at critical junction details.

The thermographic inspection also identified a number of anomalies that were indicative of heat loss occurring across the floor construction.

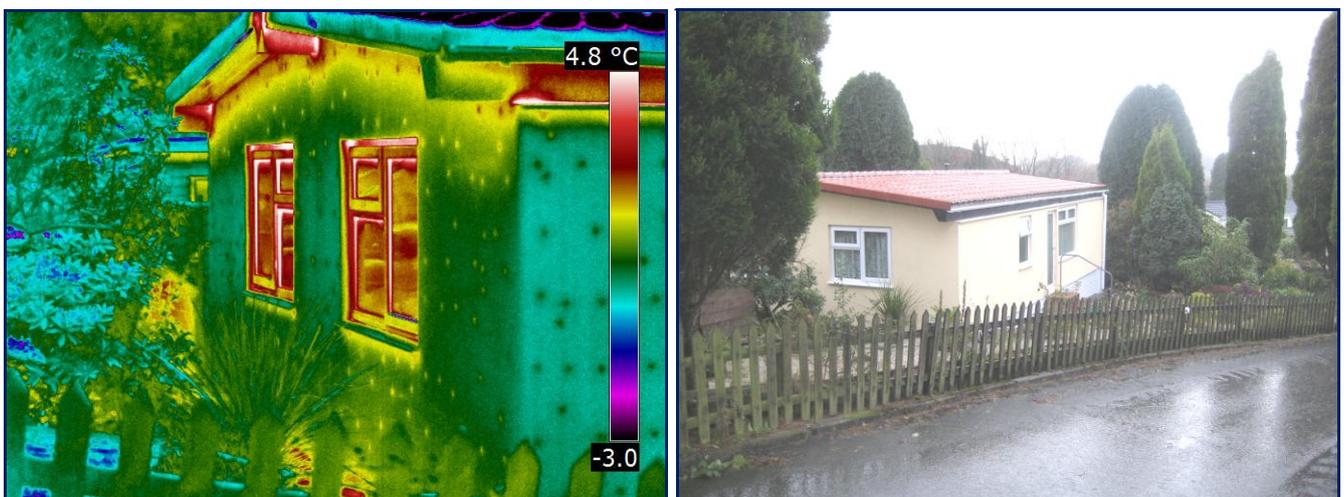
Post-Improvement Inspection

It can be seen in the above thermal image “post-improvement” that the number of heat-loss pathways across the building envelope have been significantly reduced (i.e. when compared to the “pre-improvement” image).

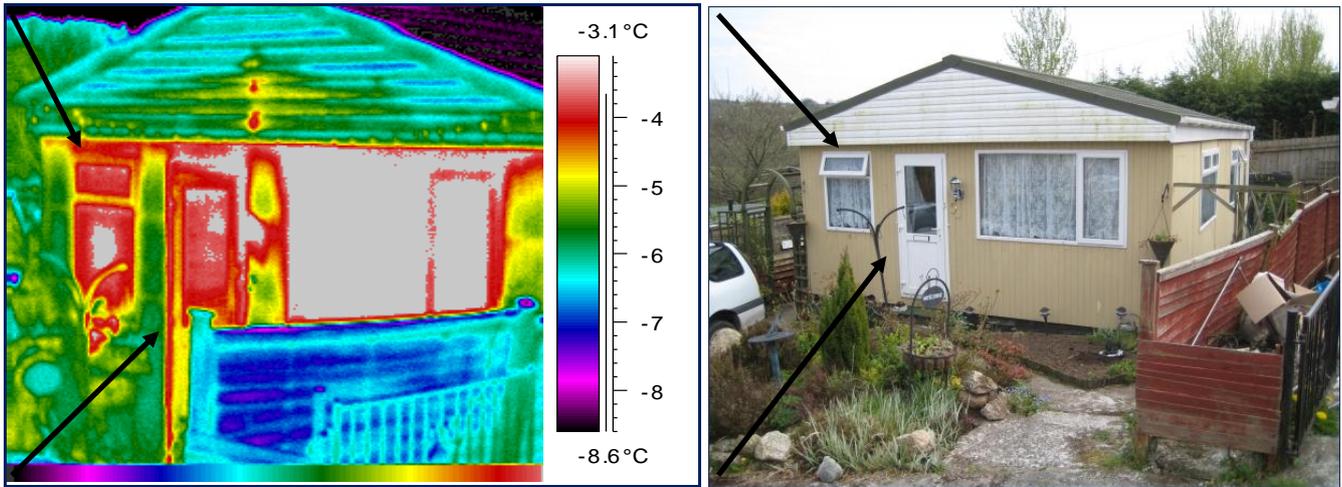
Pre-Improvement Inspection

In the thermal image “pre-improvement”, it is clear that significant heat loss is occurring across the building envelope and that this can be attributed to thermal bridging across the timber frame construction in addition to warm air leakage at critical junction details.

The thermographic inspection also identified a number of anomalies that were indicative of heat loss occurring across the floor construction.

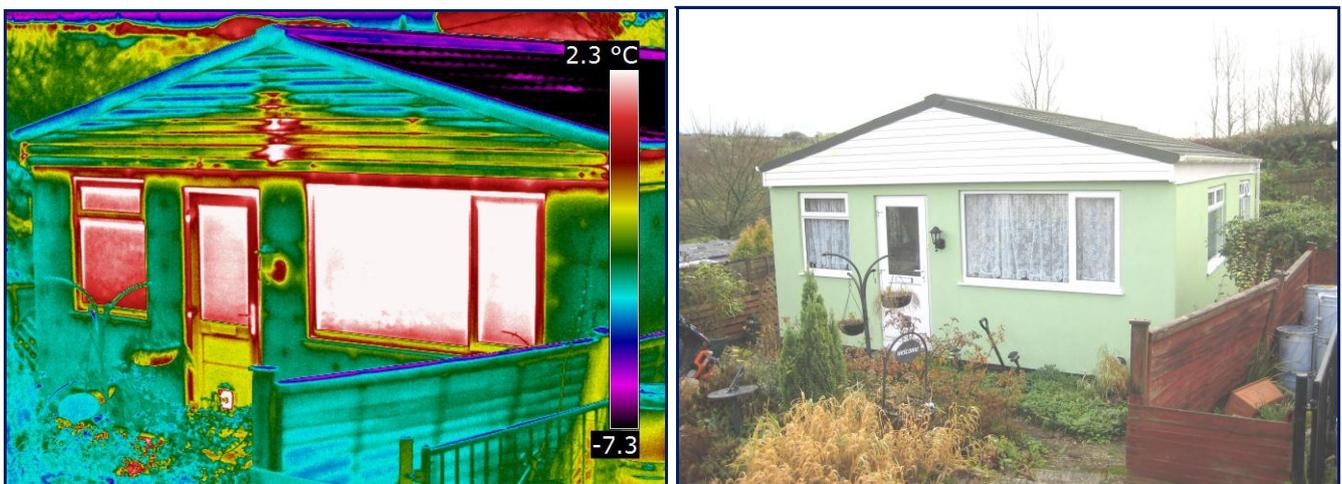
Post-Improvement Inspection

It can be seen in the above thermal image “post-improvement” that the number of heat-loss pathways across the building envelope have been significantly reduced (i.e. when compared to the “pre-improvement” image).

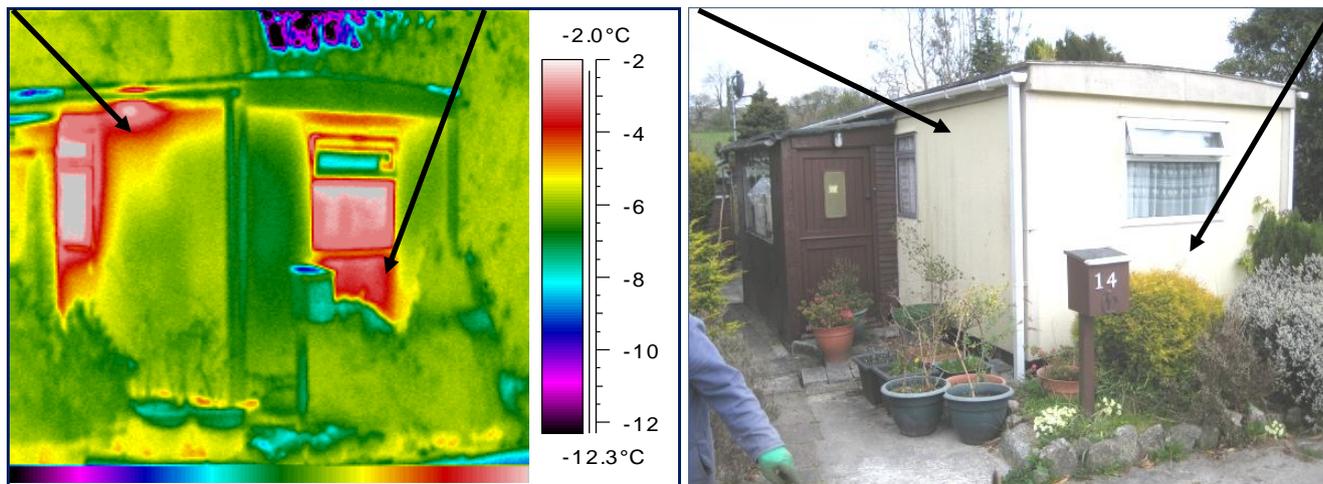
Pre-Improvement Inspection

In the thermal image “pre-improvement”, it is clear that significant heat loss is occurring across the building envelope and that this can be attributed to thermal bridging across the timber frame construction in addition to warm air leakage at critical junction details.

The thermographic inspection also identified a number of anomalies that were indicative of heat loss occurring across the floor construction.

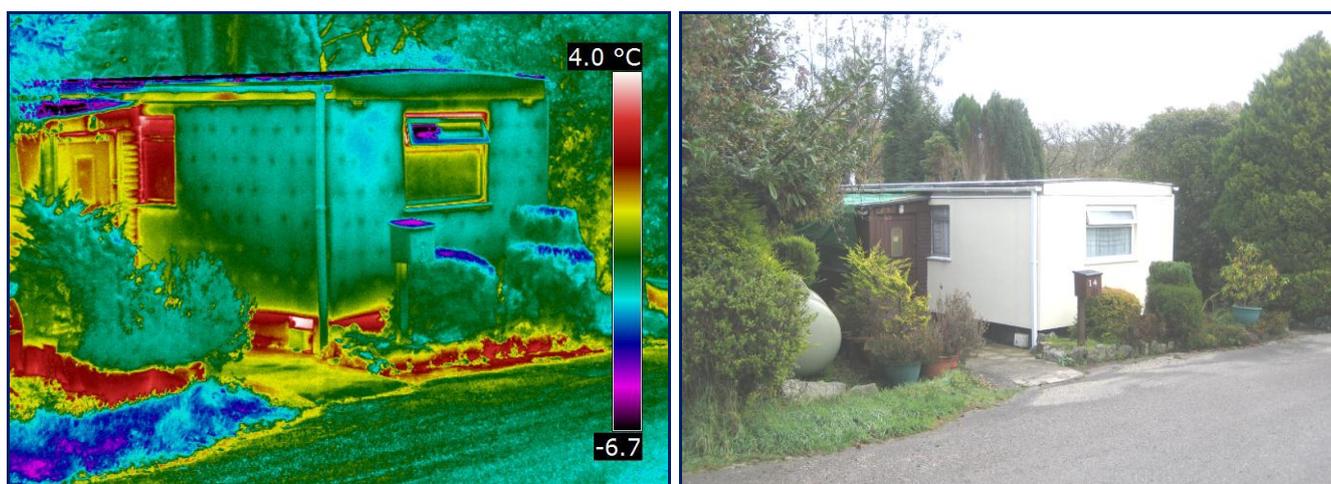
Post-Improvement Inspection

It can be seen in the above thermal image “post-improvement” that the number of heat-loss pathways across the building envelope have been significantly reduced (i.e. when compared to the “pre-improvement” image).

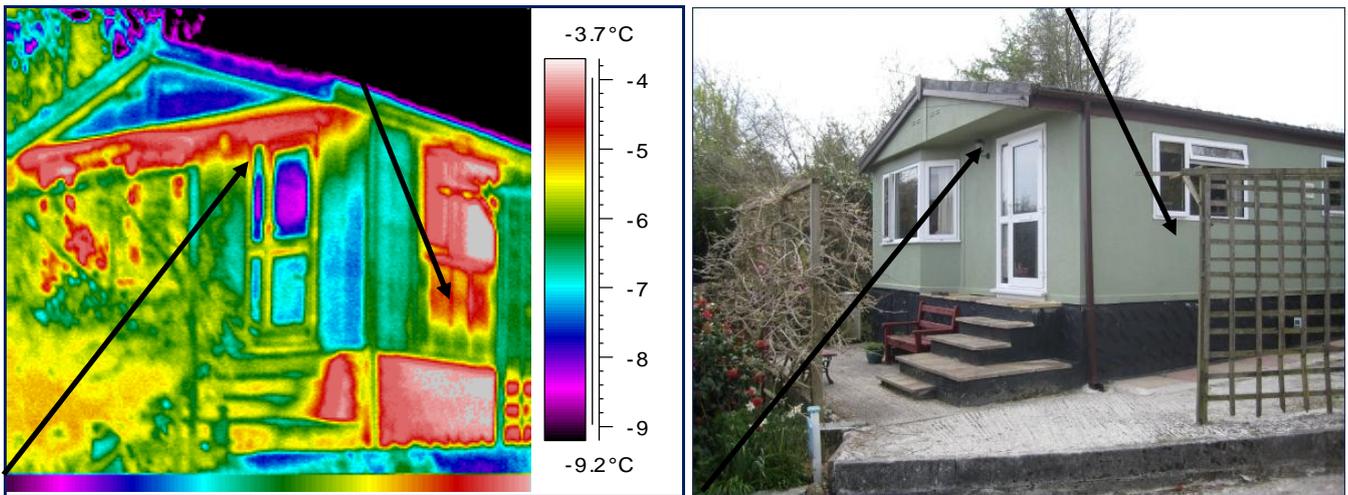
Pre-Improvement Inspection

In the thermal image “pre-improvement”, it is clear that significant heat loss is occurring across the building envelope and that this can be attributed to thermal bridging across the timber frame construction in addition to warm air leakage at critical junction details.

The thermographic inspection also identified a number of anomalies that were indicative of heat loss occurring across the floor construction.

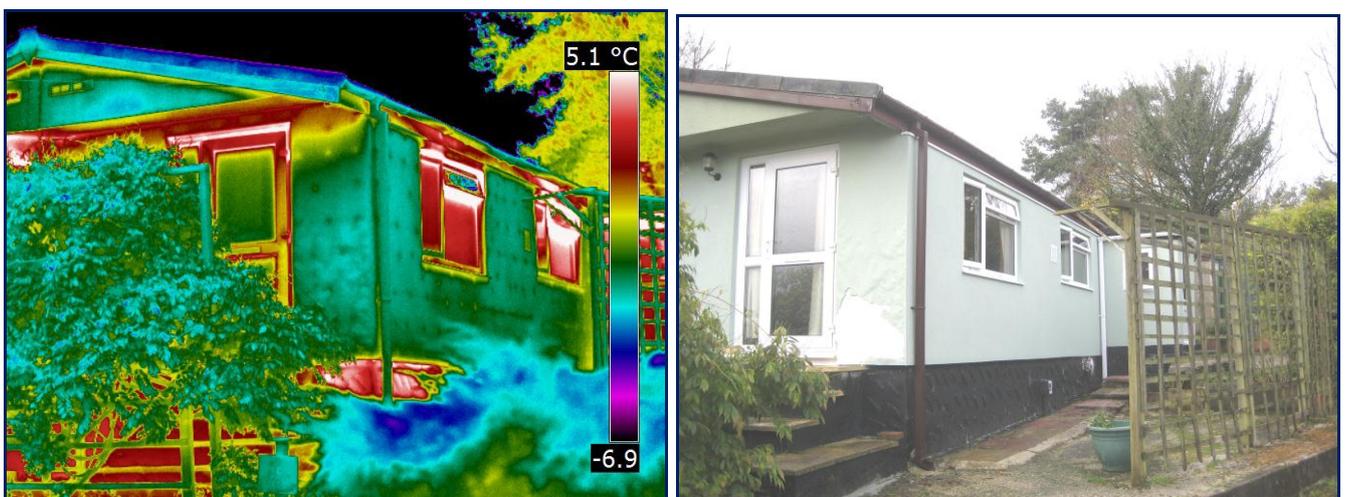
Post-Improvement Inspection

It can be seen in the above thermal image “post-improvement” that the number of heat-loss pathways across the building envelope have been significantly reduced (i.e. when compared to the “pre-improvement” image).

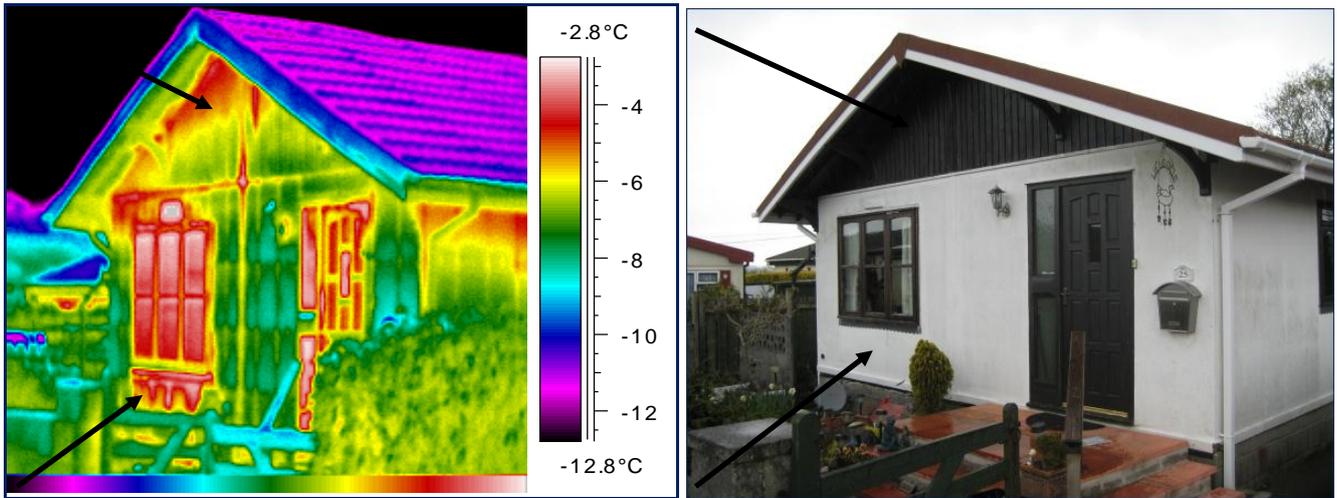
Pre-Improvement Inspection

In the thermal image “pre-improvement”, it is clear that significant heat loss is occurring across the building envelope and that this can be attributed to thermal bridging across the timber frame construction in addition to warm air leakage at critical junction details.

The thermographic inspection also identified a number of anomalies that were indicative of heat loss occurring across the floor construction.

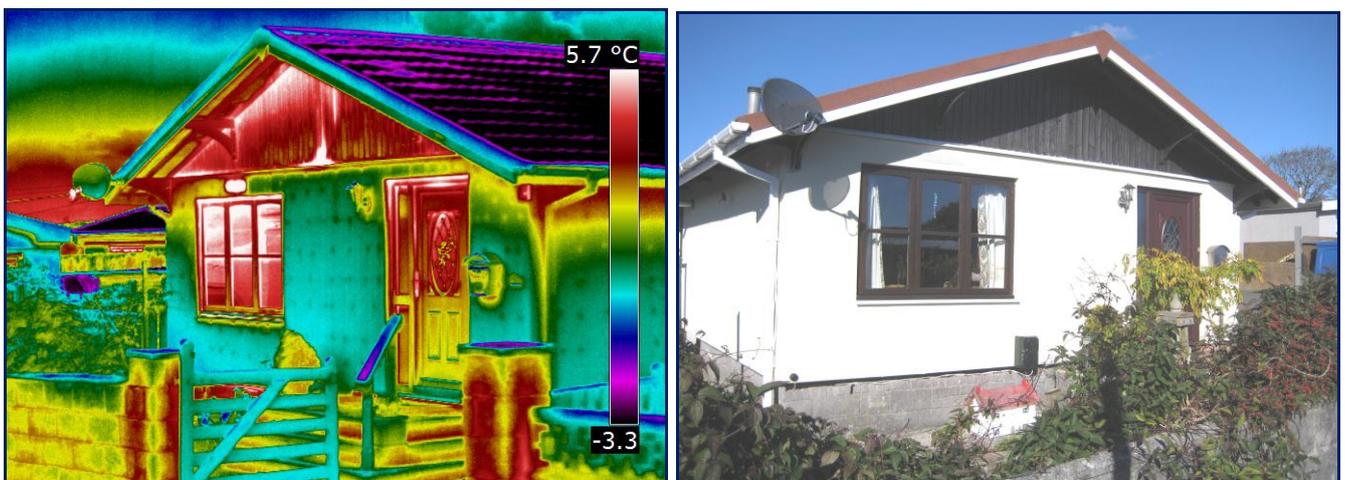
Post-Improvement Inspection

It can be seen in the above thermal image “post-improvement” that the number of heat-loss pathways across the building envelope have been significantly reduced (i.e. when compared to the “pre-improvement” image).

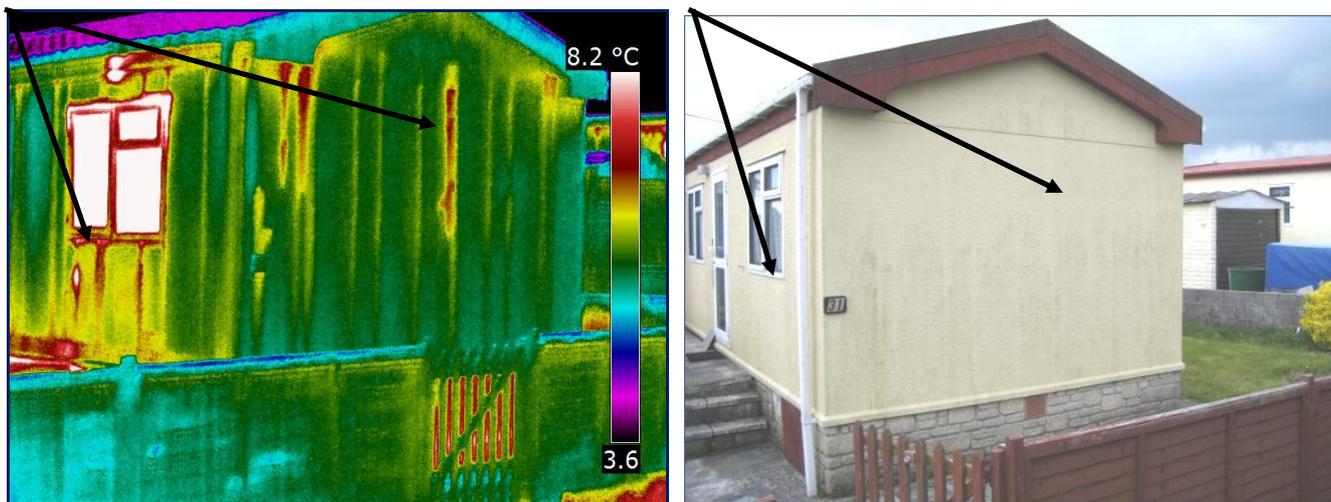
AP 38**Pre-Improvement Inspection**

In the thermal image “pre-improvement”, it is clear that significant heat loss is occurring across the building envelope and that this can be attributed to thermal bridging across the timber frame construction in addition to warm air leakage at critical junction details.

The thermographic inspection also identified a number of anomalies that were indicative of heat loss occurring across the floor construction.

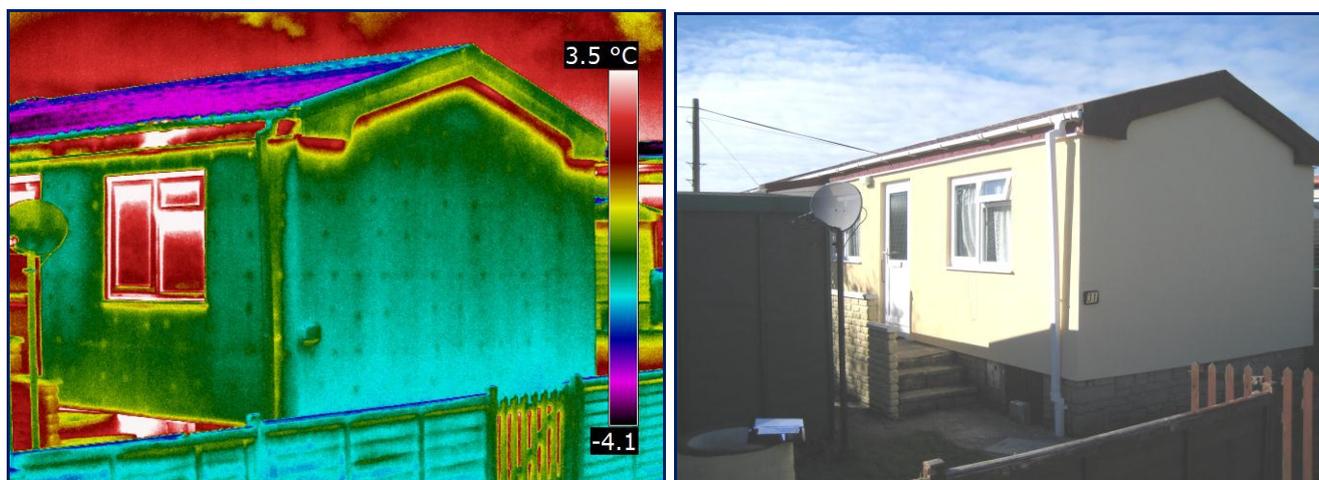
Post-Improvement Inspection

It can be seen in the above thermal image “post-improvement” that the number of heat-loss pathways across the building envelope have been significantly reduced (i.e. when compared to the “pre-improvement” image).

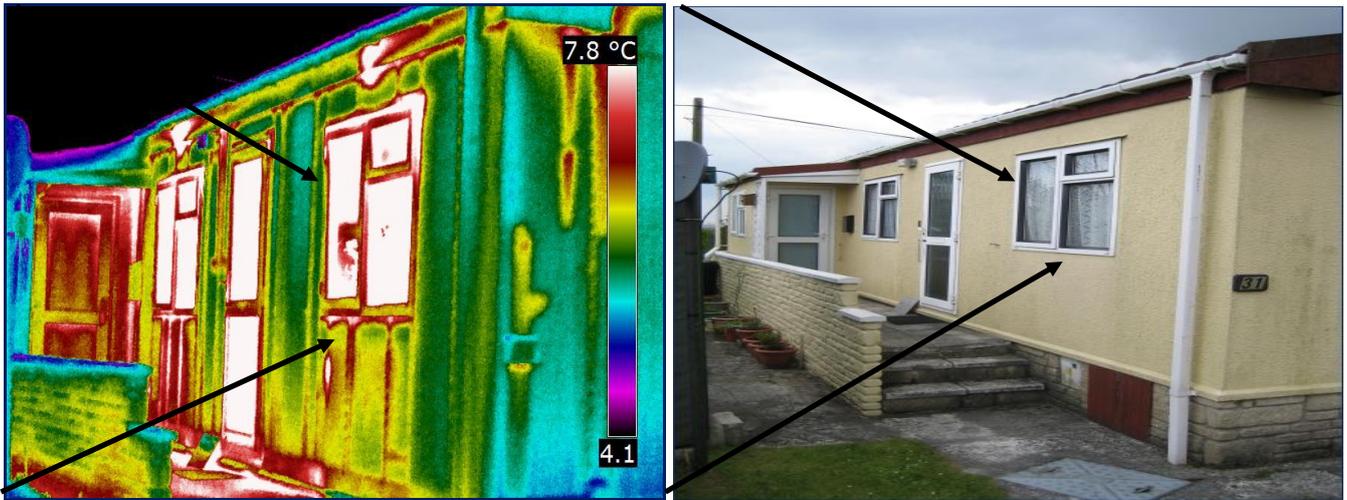
Pre-Improvement Inspection

In the thermal image “pre-improvement”, it is clear that significant heat loss is occurring across the building envelope and that this can be attributed to thermal bridging across the timber frame construction in addition to warm air leakage at critical junction details.

The thermographic inspection also identified a number of anomalies that were indicative of heat loss occurring across the floor construction.

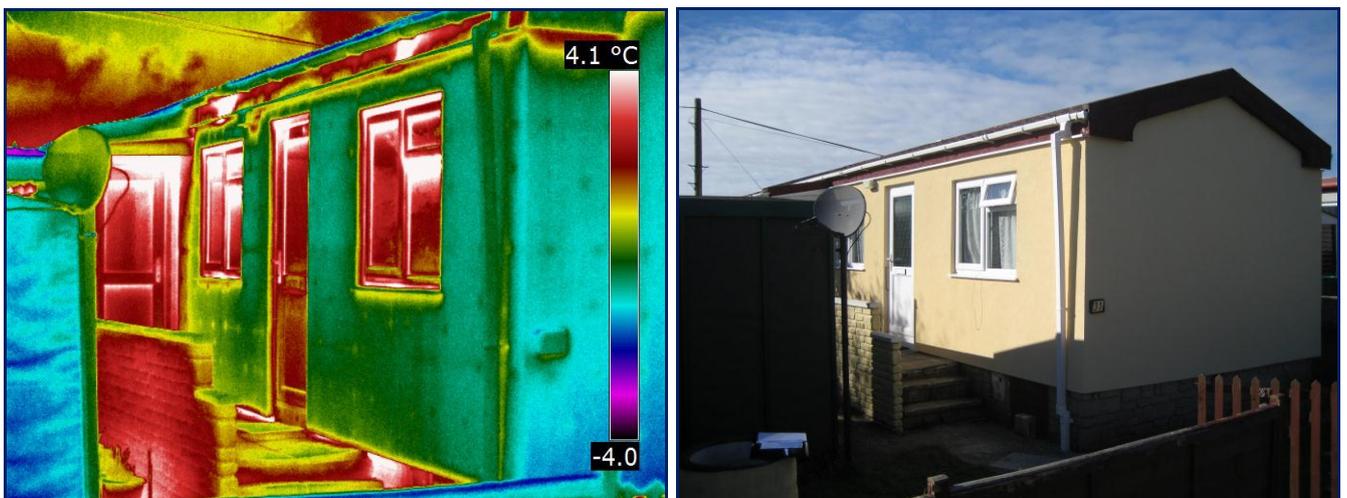
Post-Improvement Inspection

It can be seen in the above thermal image “post-improvement” that the number of heat-loss pathways across the building envelope have been significantly reduced (i.e. when compared to the “pre-improvement” image).

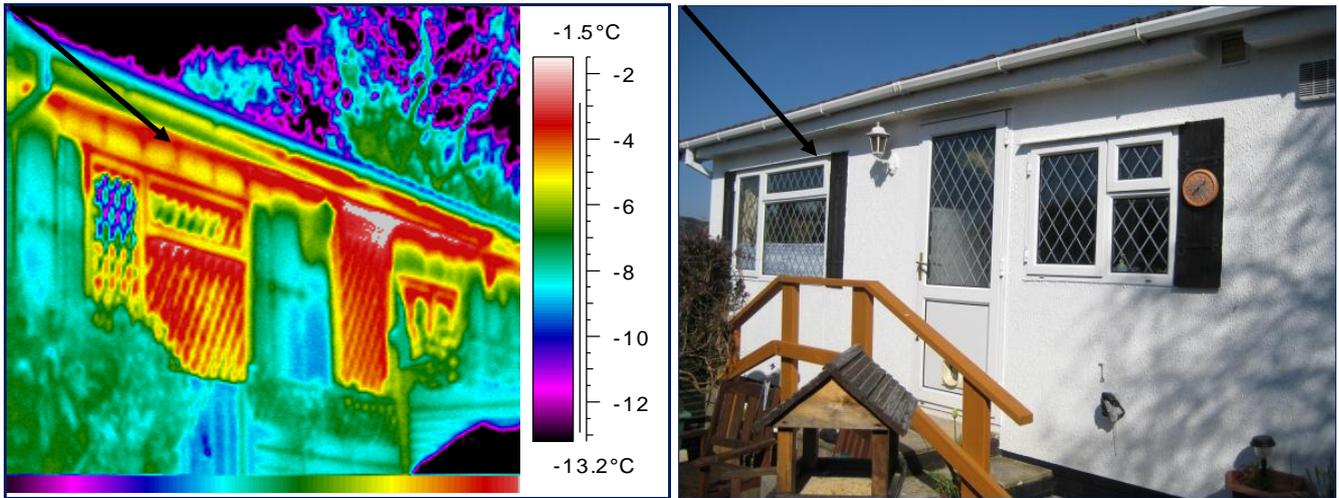
Pre-Improvement Inspection

In the thermal image “pre-improvement”, it is clear that significant heat loss is occurring across the building envelope and that this can be attributed to thermal bridging across the timber frame construction in addition to warm air leakage at critical junction details.

The thermographic inspection also identified a number of anomalies that were indicative of heat loss occurring across the floor construction.

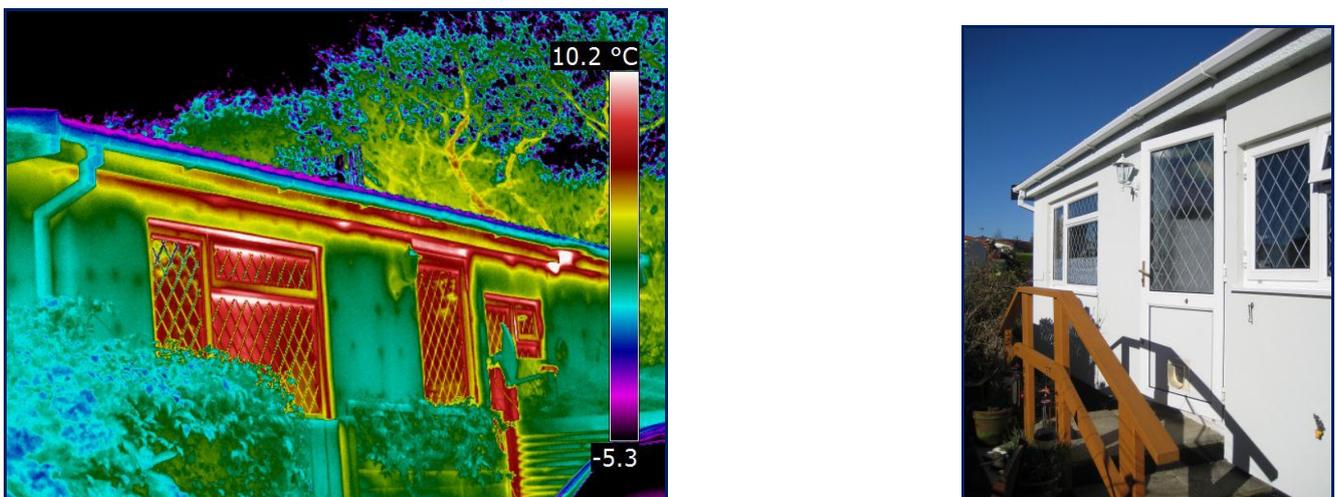
Post-Improvement Inspection

It can be seen in the above thermal image “post-improvement” that the number of heat-loss pathways across the building envelope have been significantly reduced (i.e. when compared to the “pre-improvement” image).

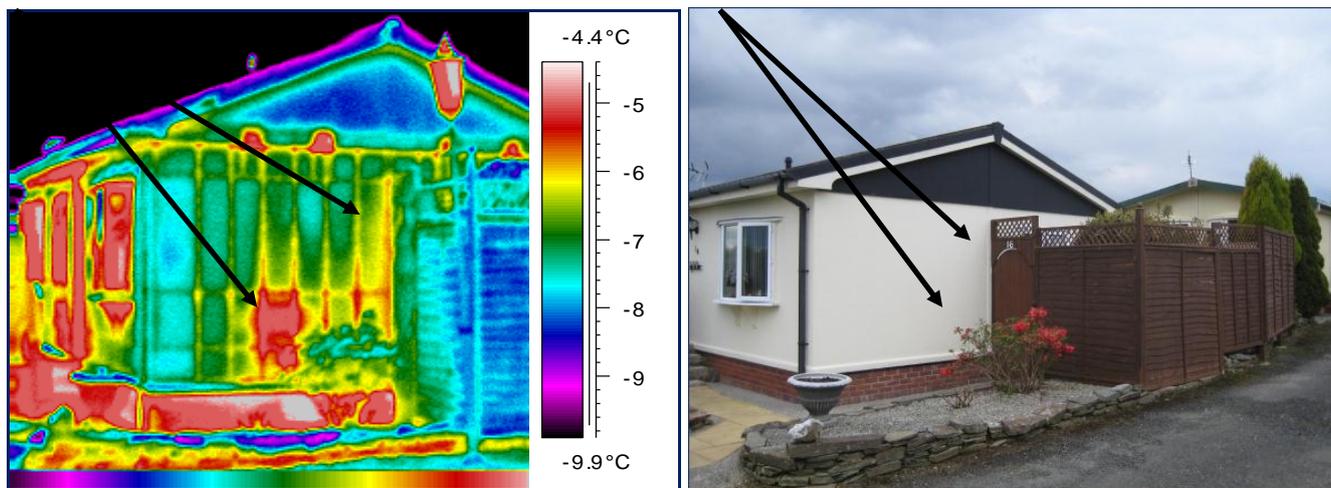
Pre-Improvement Inspection

In the thermal image “pre-improvement”, it is clear that significant heat loss is occurring across the building envelope and that this can be attributed to thermal bridging across the timber frame construction in addition to warm air leakage at critical junction details.

The thermographic inspection also identified a number of anomalies that were indicative of heat loss occurring across the floor construction.

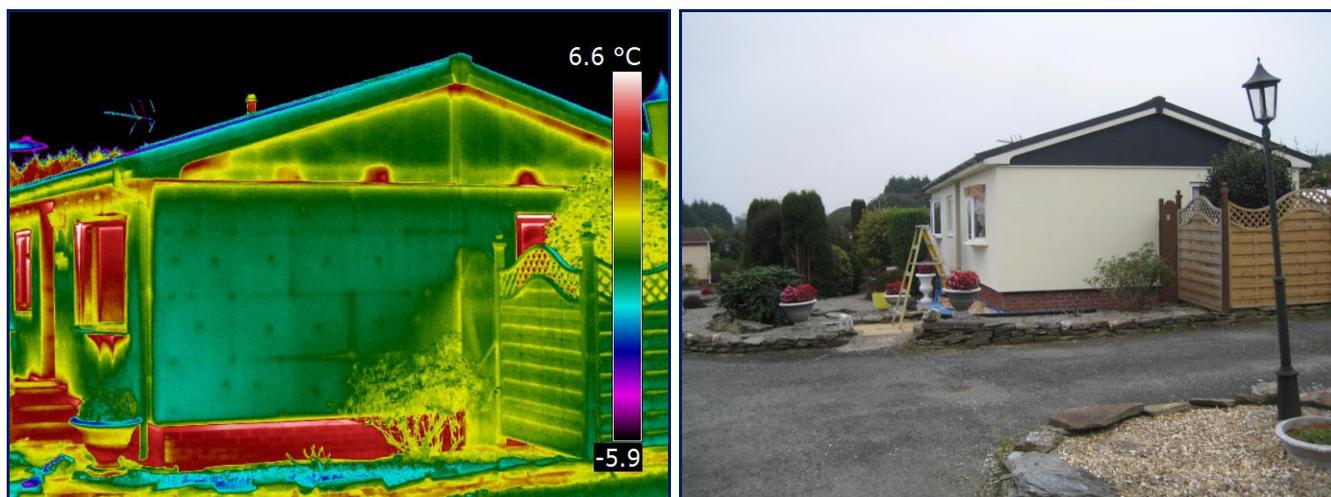
Post-Improvement Inspection

It can be seen in the above thermal image “post-improvement” that the number of heat-loss pathways across the building envelope have been significantly reduced (i.e. when compared to the “pre-improvement” image).

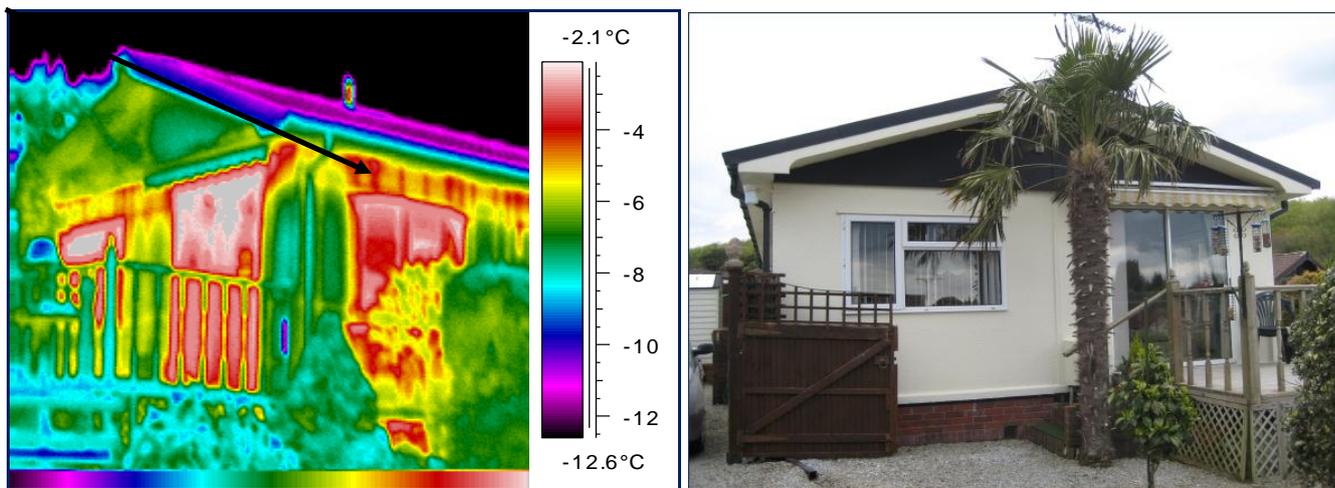
Pre-Improvement Inspection

In the thermal image “pre-improvement”, it is clear that significant heat loss is occurring across the building envelope and that this can be attributed to thermal bridging across the timber frame construction in addition to warm air leakage at critical junction details.

The thermographic inspection also identified a number of anomalies that were indicative of heat loss occurring across the floor construction.

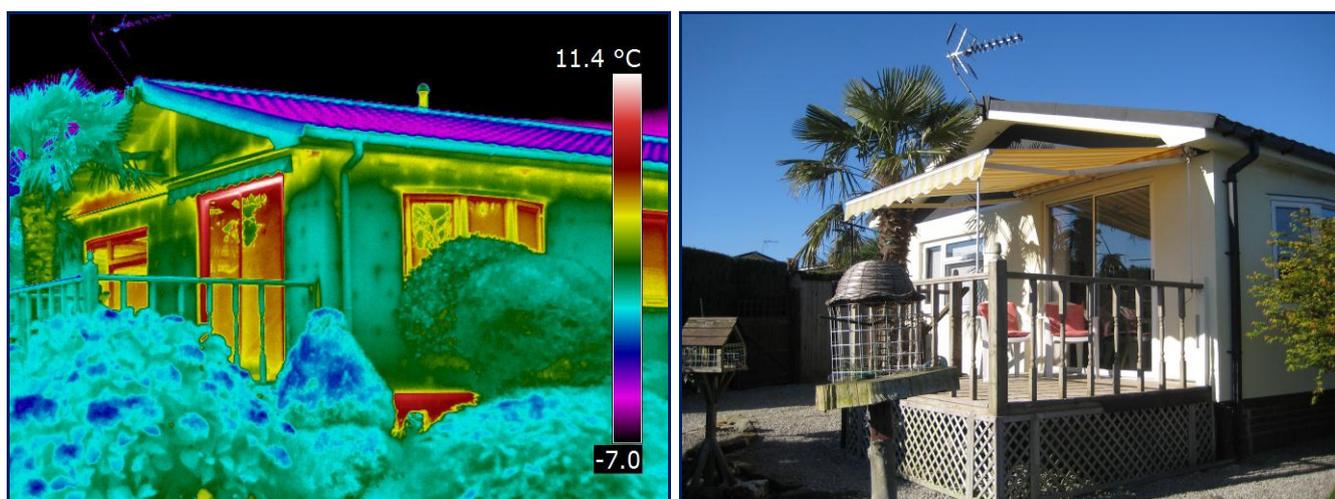
Post-Improvement Inspection

It can be seen in the above thermal image “post-improvement” that the number of heat-loss pathways across the building envelope have been significantly reduced (i.e. when compared to the “pre-improvement” image).
