Quality of Service Incentive Scheme – Exceptional Events

Appointed Examiner's Report	
Reporting year	2011/12
DNO	Western Power Distribution – East Midlands Licensed Area
Cause	Catastrophic failure of 33kV Switchgear
Date of event	12 October 2011

Title: Exceptional Events Report – WPD East Midlands – Winster BSP – catastrophic failure of 33kV switchgear – 12 October 2011

Reference: EE 2011/12 – WPD(EM)

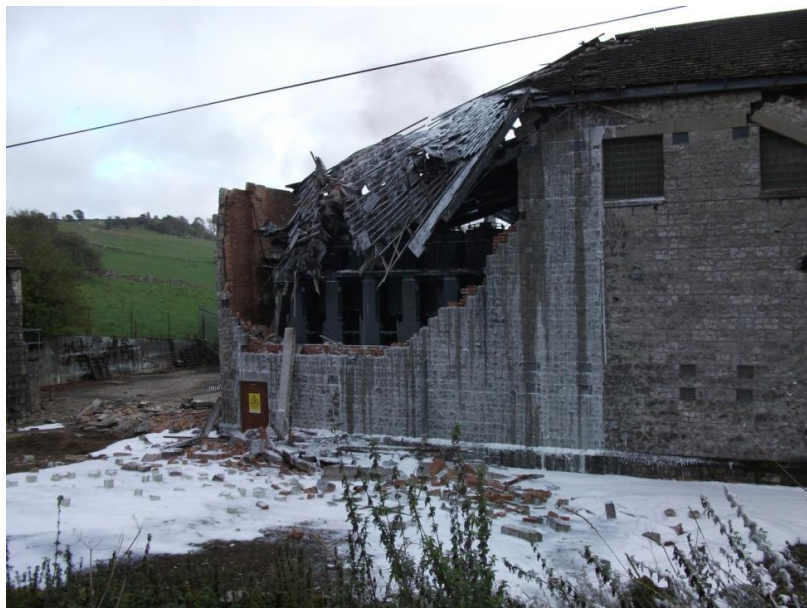
- 2.2 The AE has discussed WPD's policy on its preventative measures and studied WPD's records to ascertain if they were applied.
- 2.3 Photograph 1 shows the extensive damage to the 33kV switchhouse, making the building unsafe for access. **[AE's note: WPD subsequently employed a specialist demolition contractor to safely remove the remains of the switchhouse].**

Photograph 1 – The damage to the 33kV switchhouse

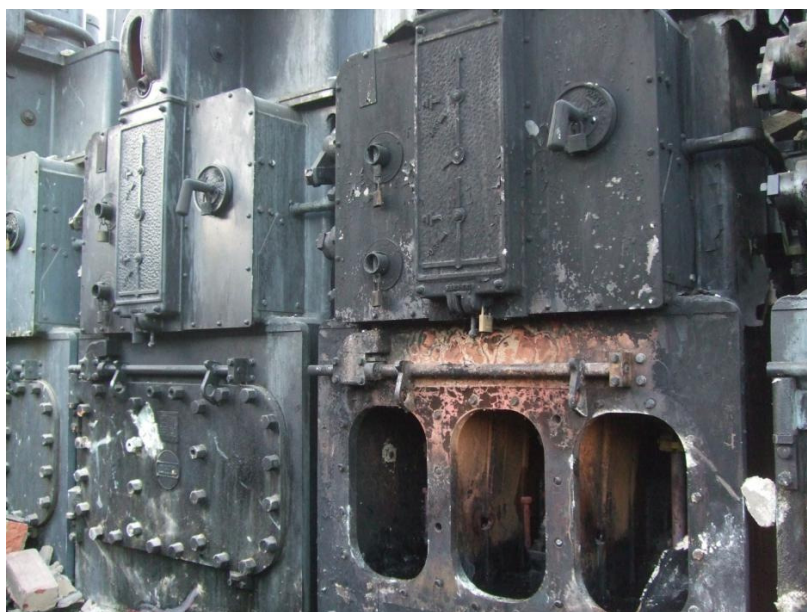
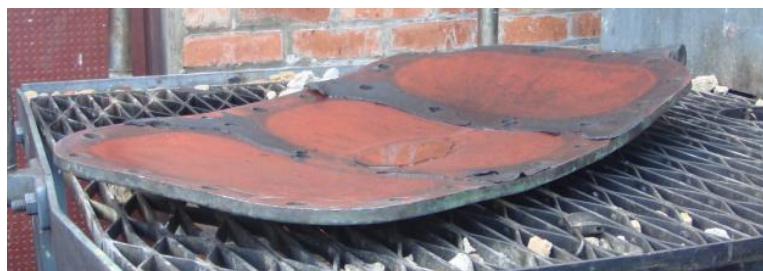
- 2.4 Photograph 2 shows the 33kV circuit-breaker that catastrophically failed. The force of the explosion can be gauged from the fact that the bolts securing the substantial metal door to the front of the circuit-breaker were sheared off and the whole door blasted off its hinges. The damage to the access door can be seen in the lower image of photograph 2. **[AE's note: the number of securing bolts that were sheared off during the incident can be judged from the undamaged circuit-breaker beyond that which failed].**

- 2.12 WPD's internal investigation concludes that the root cause of the incident is most likely to have been within the blue phase interrupter of the Longcliffe 'A' teed Ashbourne 'A' 33kV circuit-breaker. The failure of the circuit-breaker to fully clear a feeder fault led to the catastrophic failure of the circuit-breaker itself.

Photograph 2 – The damage to the Longcliffe 'A' teed Ashbourne 'A' 33kV circuit-breaker and the access door that was blasted off

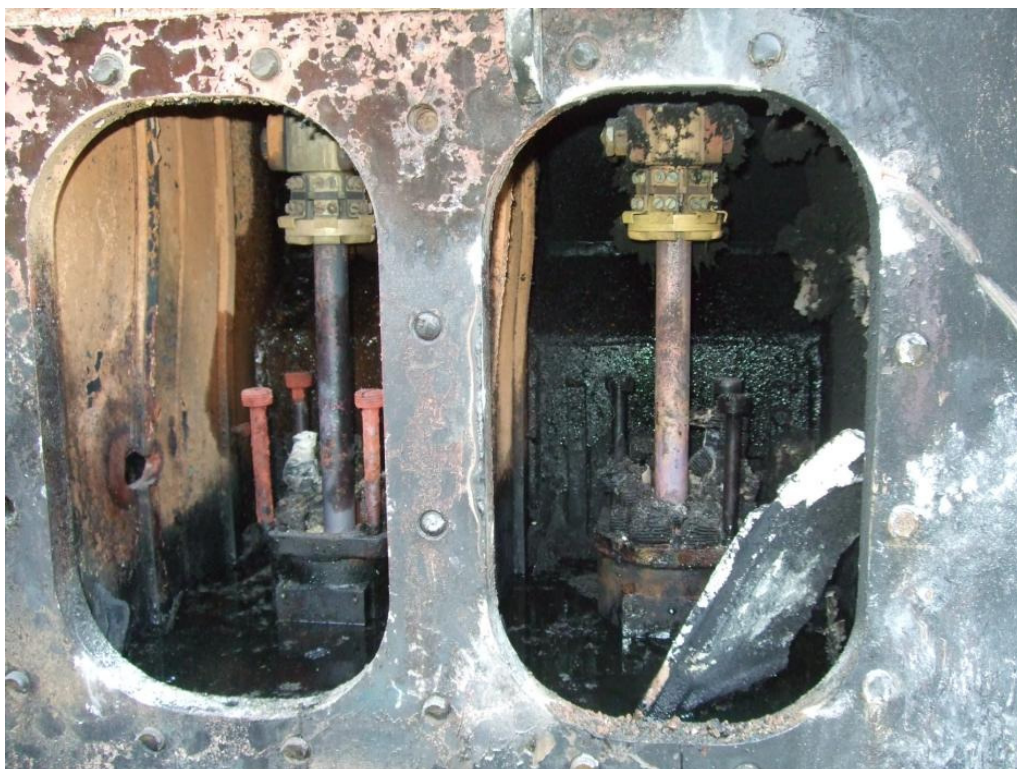
- 2.5 Photograph 3 shows the damaged interruption chamber of the failed circuit-breaker.
- 2.6 Photograph 4 shows the arc damage within the interruption chamber of the failed circuit-breaker.

Photograph 3 – View of the damaged interruption chambers

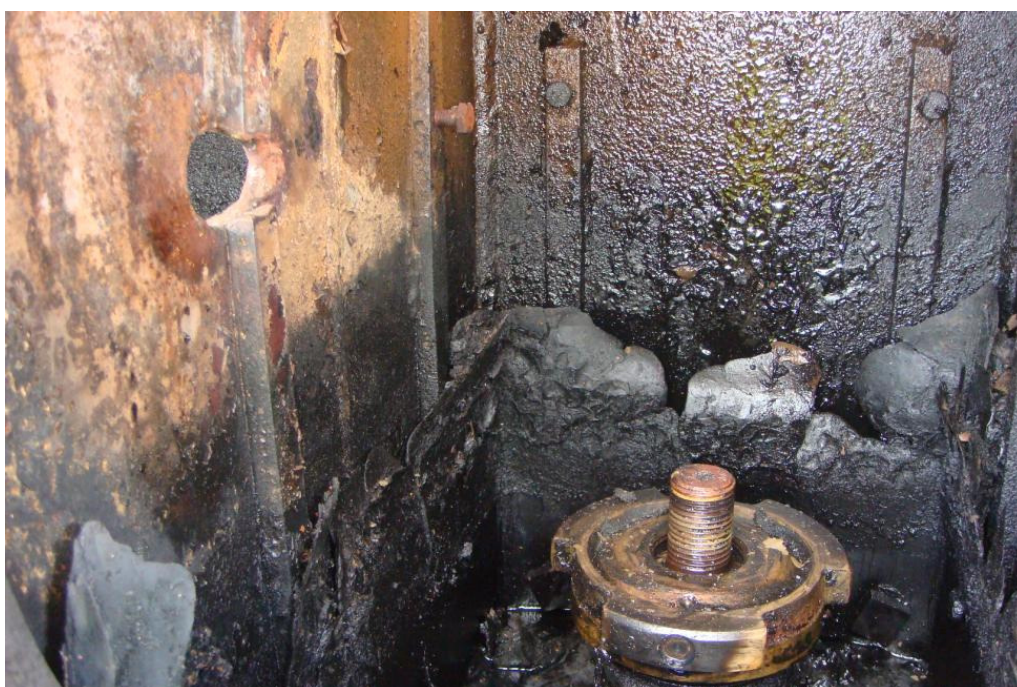
A4 WPD's confidential internal report was made available to the AE during the audit visit. The root cause of the incident was considered to be the failure of the blue phase circuit-breaking contact within the blue phase interruption chamber of the Longcliffe 'A' teed Ashbourne 'A' 33kV circuit-breaker during an operation to clear a fault on the outgoing feeder.

The arcing within the interruption chamber led to a flashover between the blue phase contacts and the switchgear metalwork, the ensuing pressure build-up resulting in an explosion, the catastrophic failure of the circuit-breaker and the devastation of the 33kV switchhouse.

Photograph 4 – The arc damage within the interruption chamber
