**Appointed examiner's audit of Exceptional Event Claim -
Scottish and Southern Energy Power Distribution
Damaged 132kV underground cable – 14 February 2012**

Title: SEPD – Audit of Exceptional Event Claim – SEPD – 14 February 2012

Issue: Final report v1.0

Date: 22 August 2012

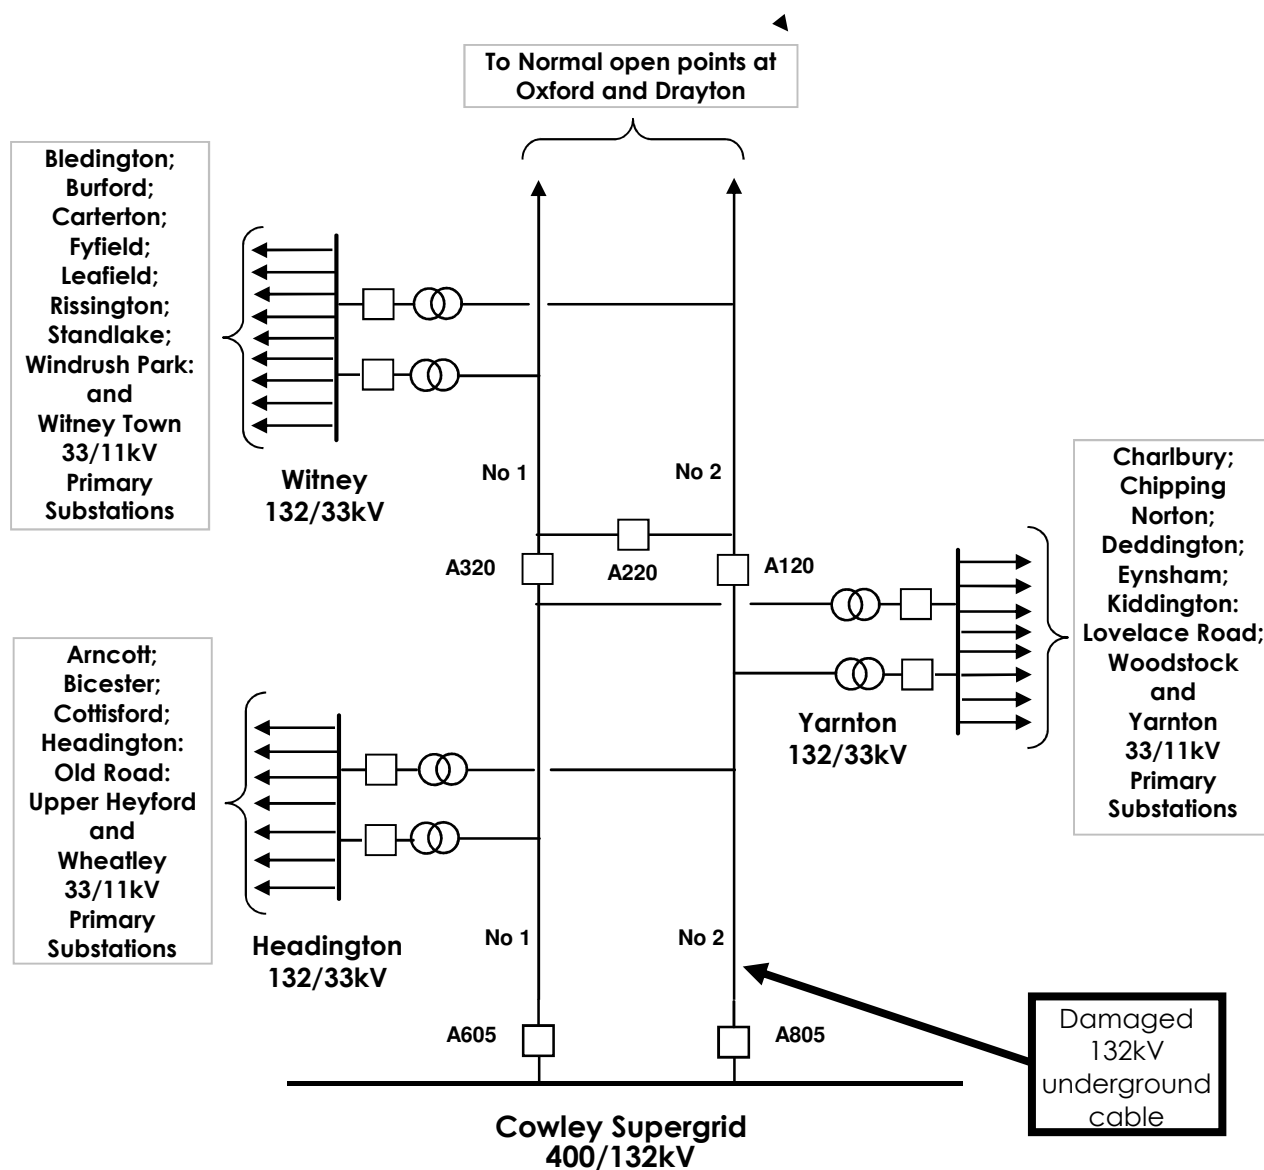
Figure 1 – Simplified Network Diagram of SEPD's 132/33kV distribution network affected by the incident

1. Only the salient items of switchgear are shown.
2. SEPD's network was running normally at the time of the incident.
3. CB A320 and auto-isolators at Yarnton operated correctly to isolate Yarnton and Witney to 'split' the network.
4. Following the successful auto-reclosure of the number 1 feeder, supplies to Headington 132/33kV Grid Substation and six of its 'satellite' Primary Substations were restored within one minute (<3 minutes and therefore a short interruption).
5. The seventh, Wheatley Primary Substation, is equipped with an auto-changeover which would normally have restored supplies within a short interruption. In this case, the multiple auto-reclosures on the 132kV system inhibited the operation of the auto changeover and supplies were restored by tele-controlled switching.
6. Supplies to Yarnton and to Witney were restored by tele-controlled switching.

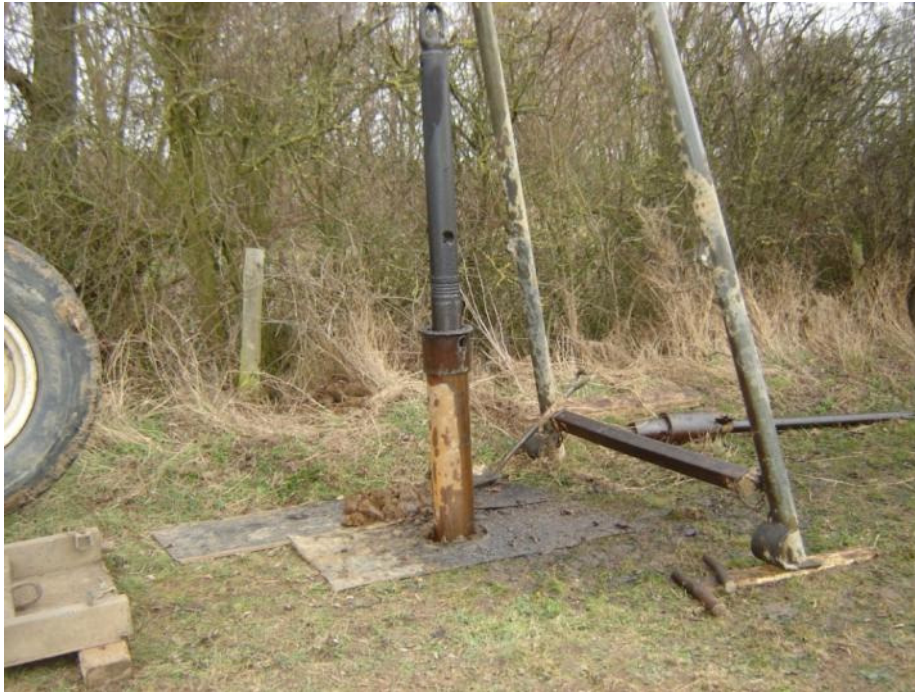
42. SEPD's photographs taken at the time of the incident clearly show the soil-sampling drilling rig in situ at the point of damage.
43. SEPD's photograph of the repair work clearly shows the concrete cable tiles protecting the underground cables at the point of damage.

51. The damage to the 132kV underground cable is consistent with it being struck by a soil-sampling drill, no prior notification of which had been received.
52. The resultant damage would have resulted in a permanent fault on the cable.

Photograph 1 – View looking eastwards of the soil-sampling drilling rig at the point of damage

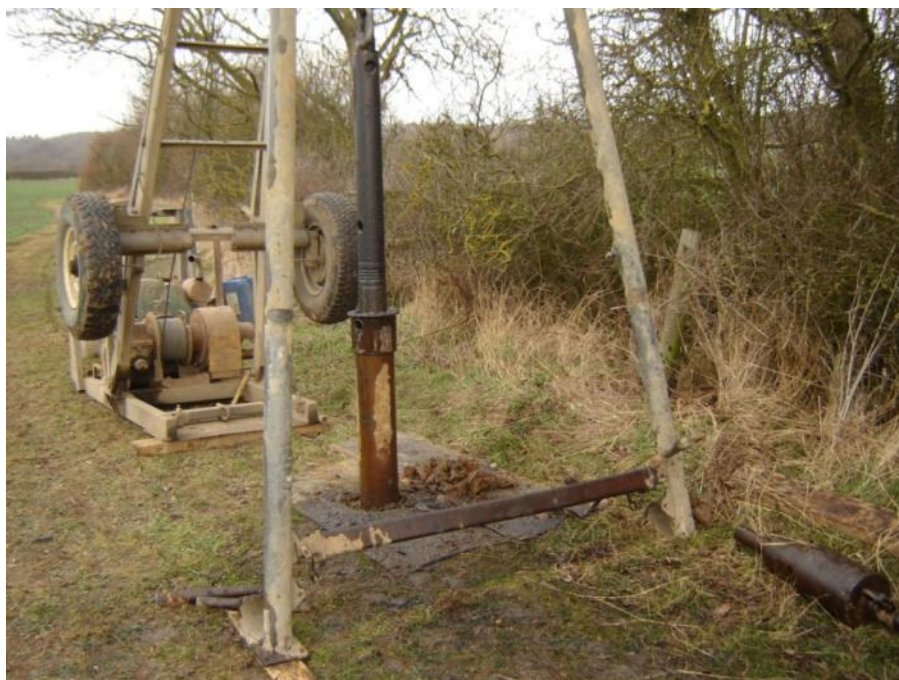
Photograph 2 – View looking northwards of the soil-sampling drilling rig at the point of damage

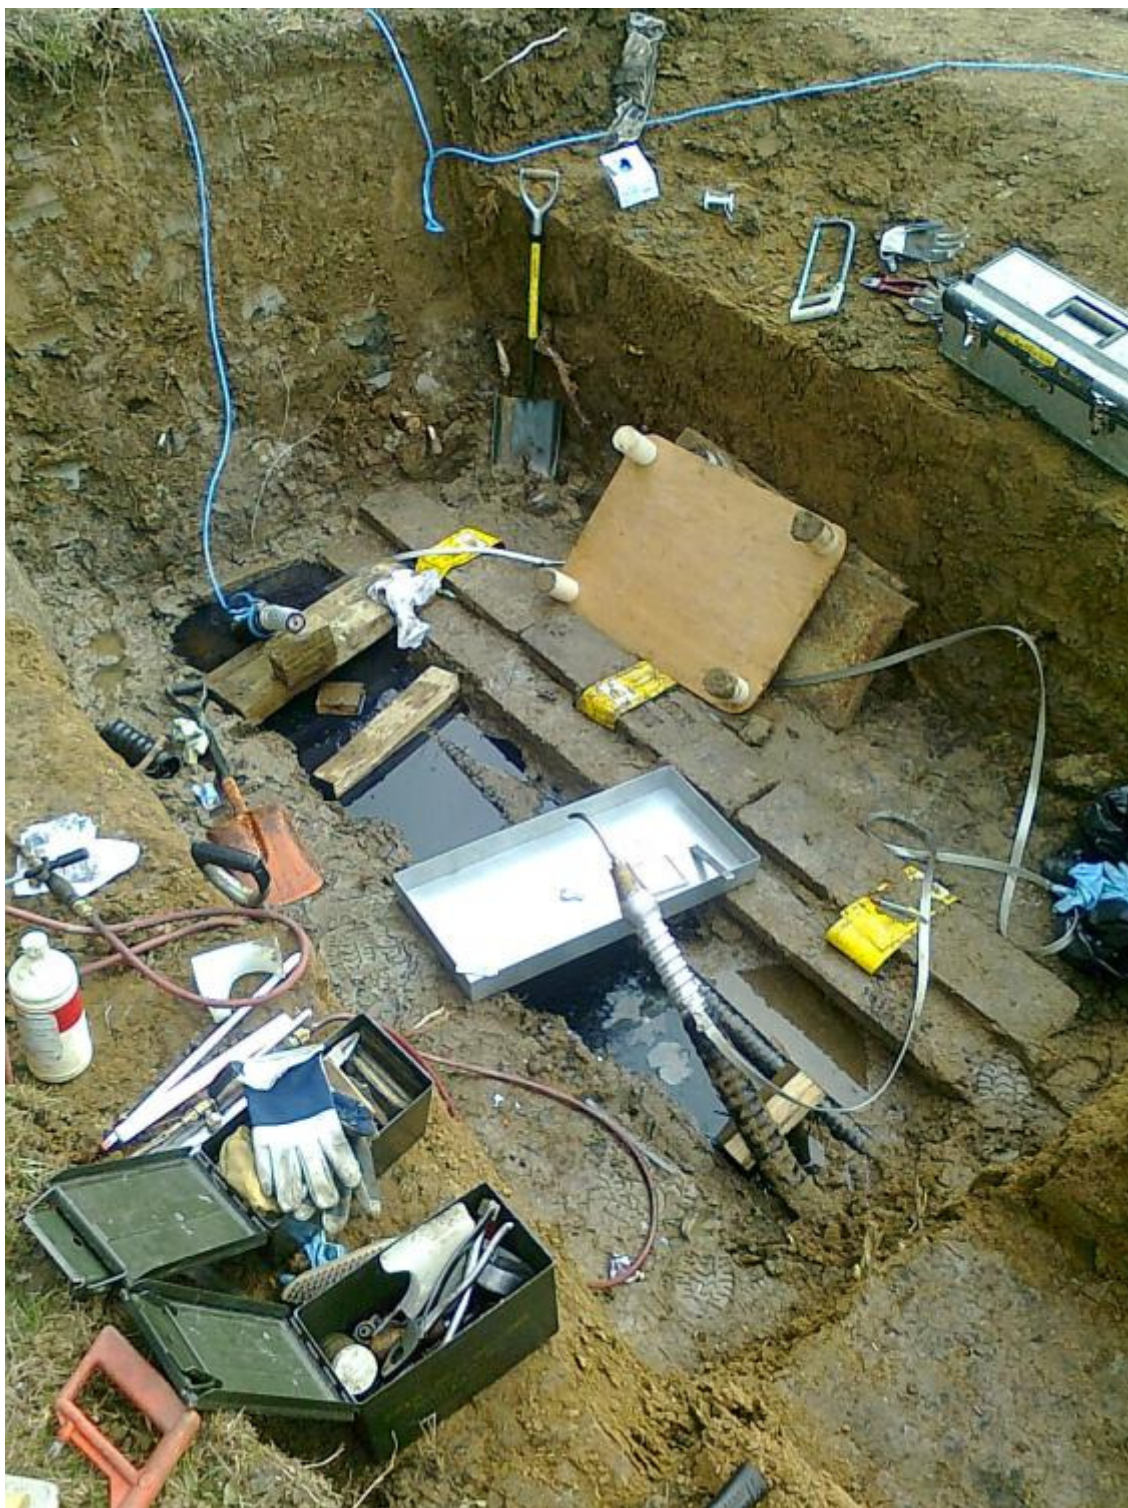
Photograph 3 – The repair work in progress – the concrete cable files protecting the cables are clearly visible

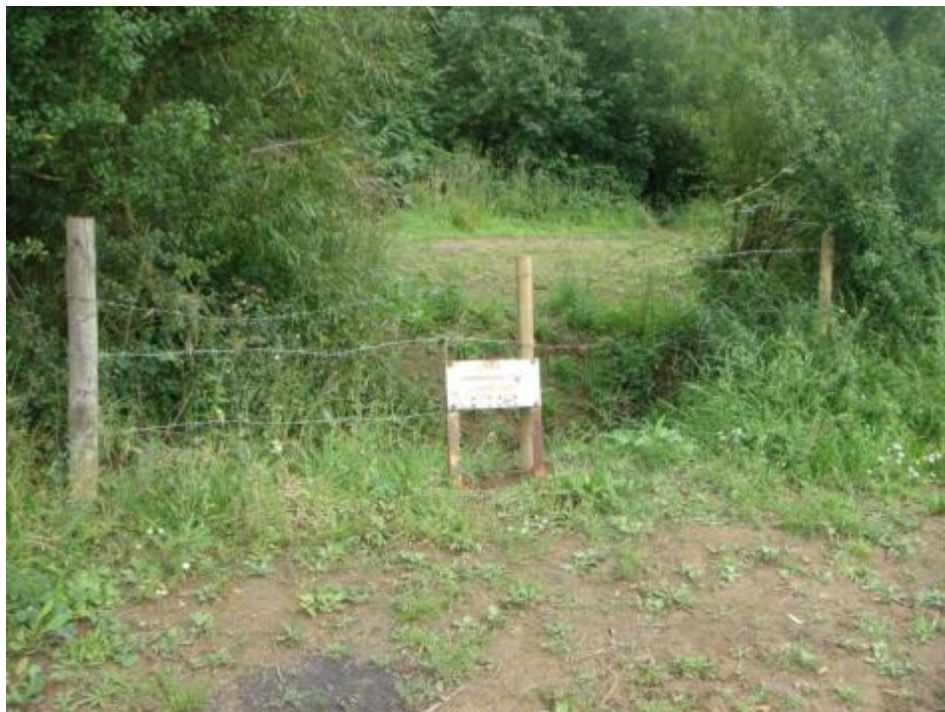
SSE does not have a consistent policy regarding the installation of above ground cable marker posts. An original CEGB sign is located close to the point of damage.

Photograph 4 – View looking east – the CEGB route-marking sign is clearly visible

40. The AE has discussed SEPD's policy on its deployment of cable route-markers and recommends that SEPD reviews its policy to ensure it is consistently applied throughout its distribution system, including replacing the older style CEGB metal plates with more modern concrete-type posts.

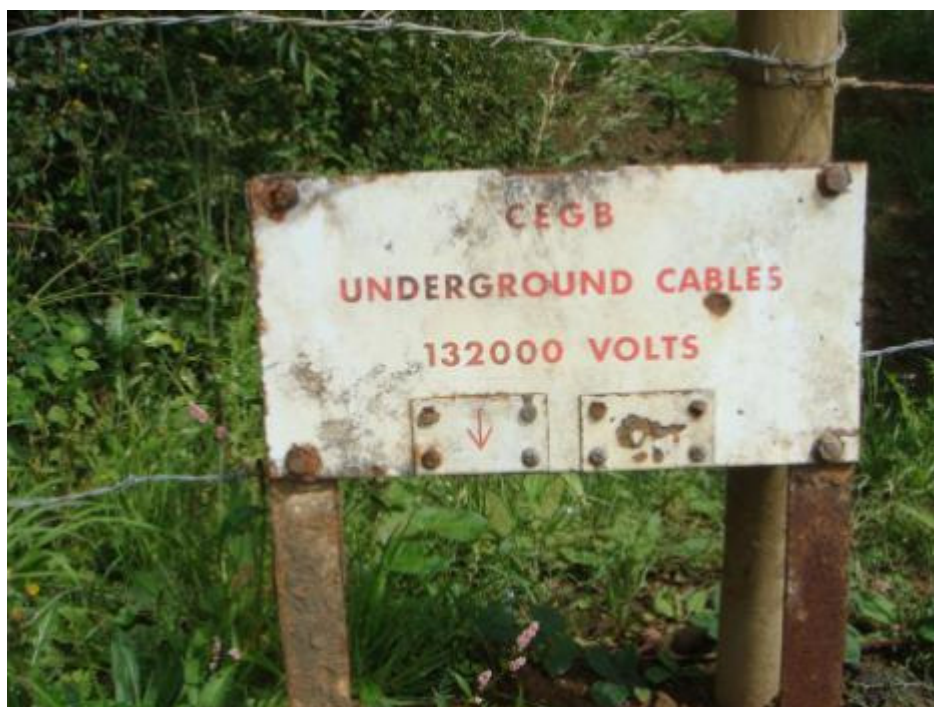
Photograph 5 – Close-up of the CEGB route-marking sign
