## Quality of Service Incentive Scheme – Exceptional Events

Appointed Examiner's Report	
Reporting year	2011/12
DNO	Northern Powergrid – Yorkshire Licensed Area
Cause	Failure of two 33kV surge diverters and a 33kV busbar fault
Date of event	24 June 2011

Title: Exceptional Events Report – Northern Powergrid (Yorkshire) – failure of two 33kV surge diverters and a 33kV busbar fault – 24 June 2011

Reference: EE 2011/12 – NPG(Y)

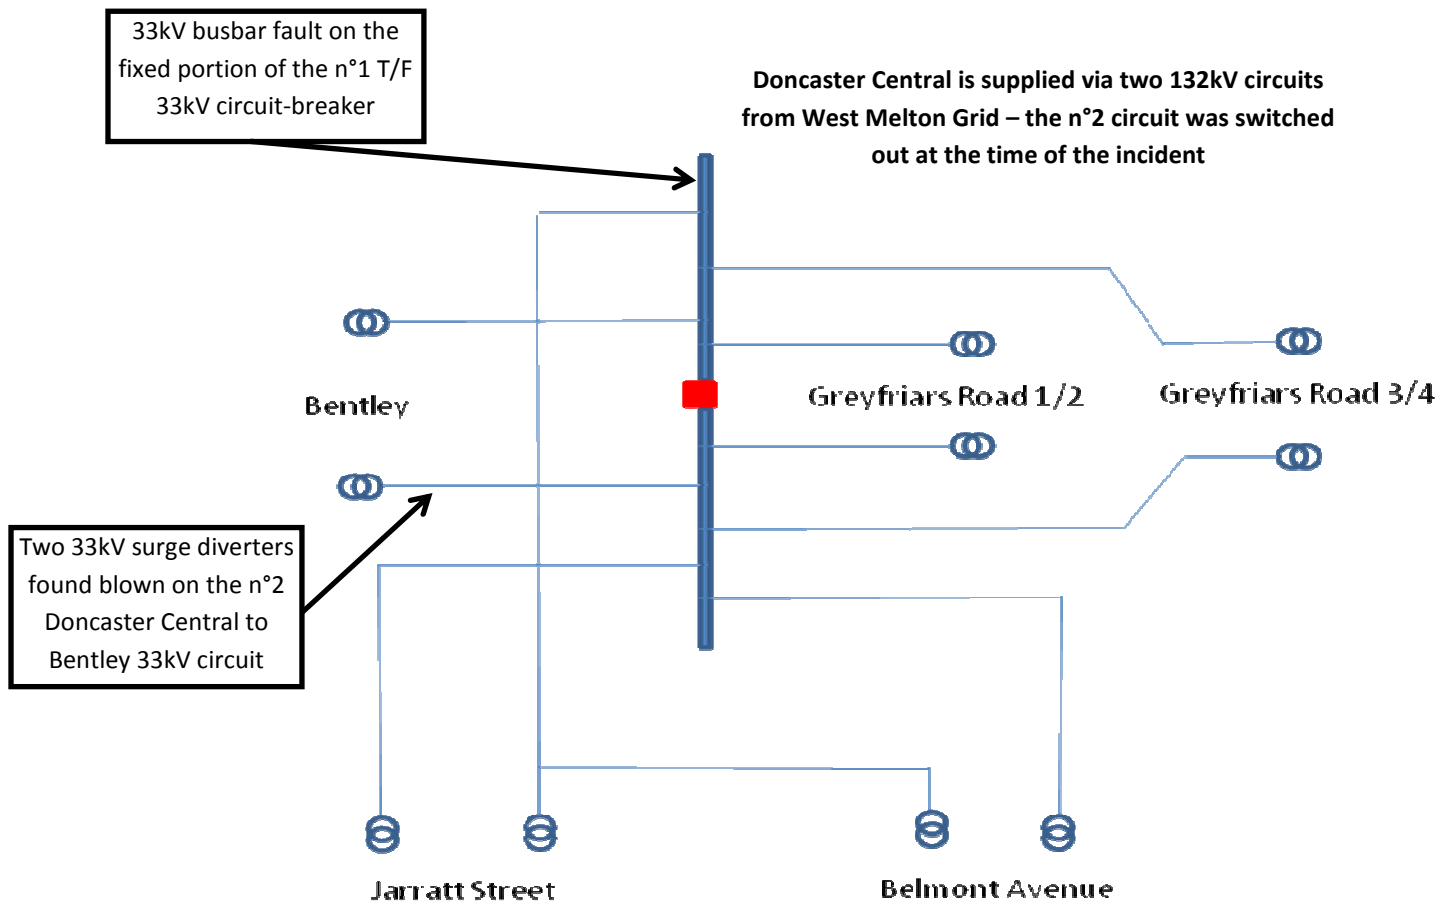
- 1.9 The work on the n°2 circuit was stopped and the circuit returned to service at 10:21 on 24 June 2011.
- 1.10 A simplified view of the section of Northern Powergrid's 33kV network affected by this event is shown in Figure 1.

**Figure 1 – Simplified Network Diagram of Northern Powergrid's 33kV distribution network affected by the incident**

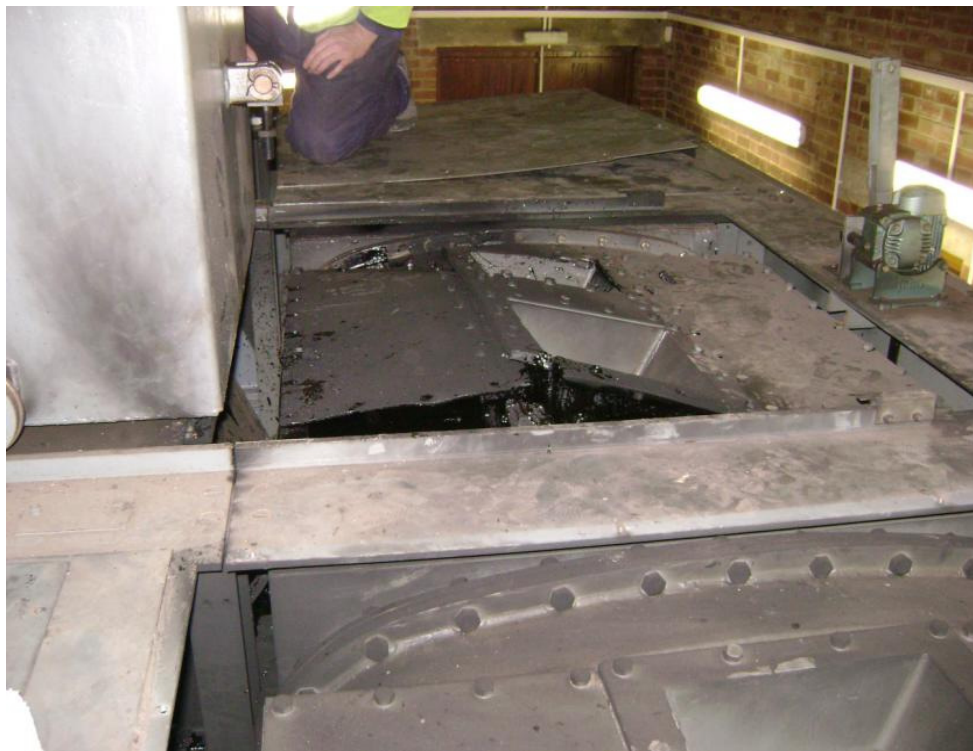
- 2.5 Photograph 1, copied from Northern Powergrid's SoF shows the damage to the busbar cover plates above the faulted fixed portion of 33kV busbars at Doncaster Central Grid Substation.

**Photograph 1 – The cover plates above the faulted busbar**

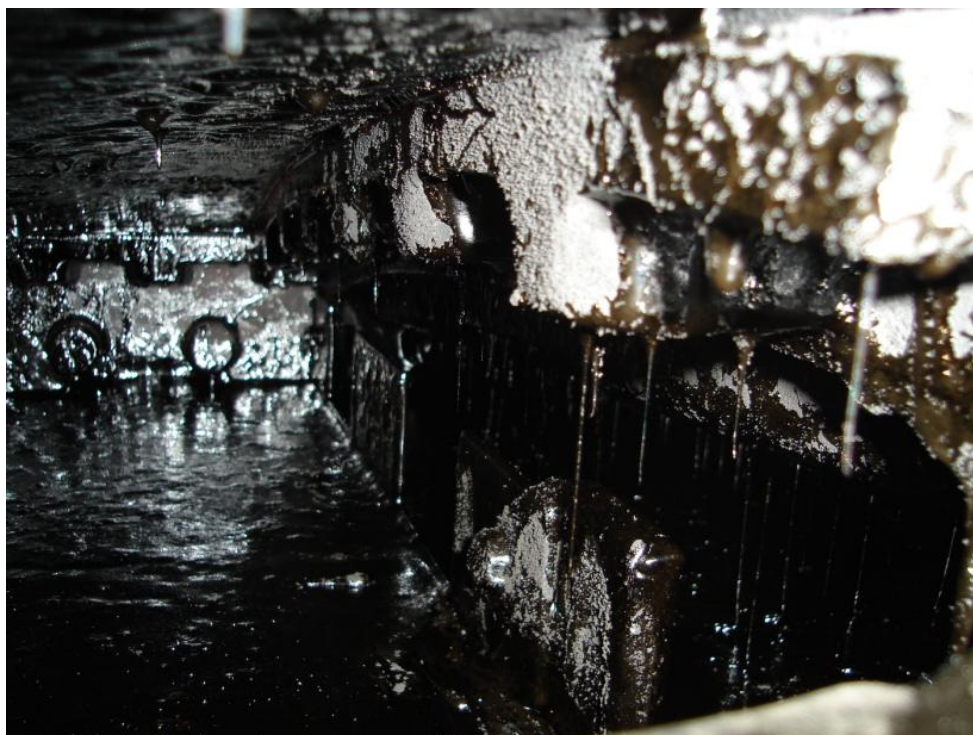
**Photograph 2 – The faulted busbar chamber**

- a discussion regarding the replacement of the faulted fixed portion of compound-filled busbars, the first Permit to Work for which was issued at 09:29 on 26 June 2011.
