Quality of Service Incentive Scheme – Exceptional Events

Appointed Examiner's Report	
Reporting year	2011/12
DNO	Northern Powergrid – Yorkshire Licensed Area
Cause	Failure of jumper connection to 132kV cable sealing end
Date of event	09 August 2011

Title: Exceptional Events Report – Northern Powergrid (Yorkshire) – failure of jumper connection to 132kV sealing end – 09 August 2011

Reference: EE 2011/12 – NPG(Y)

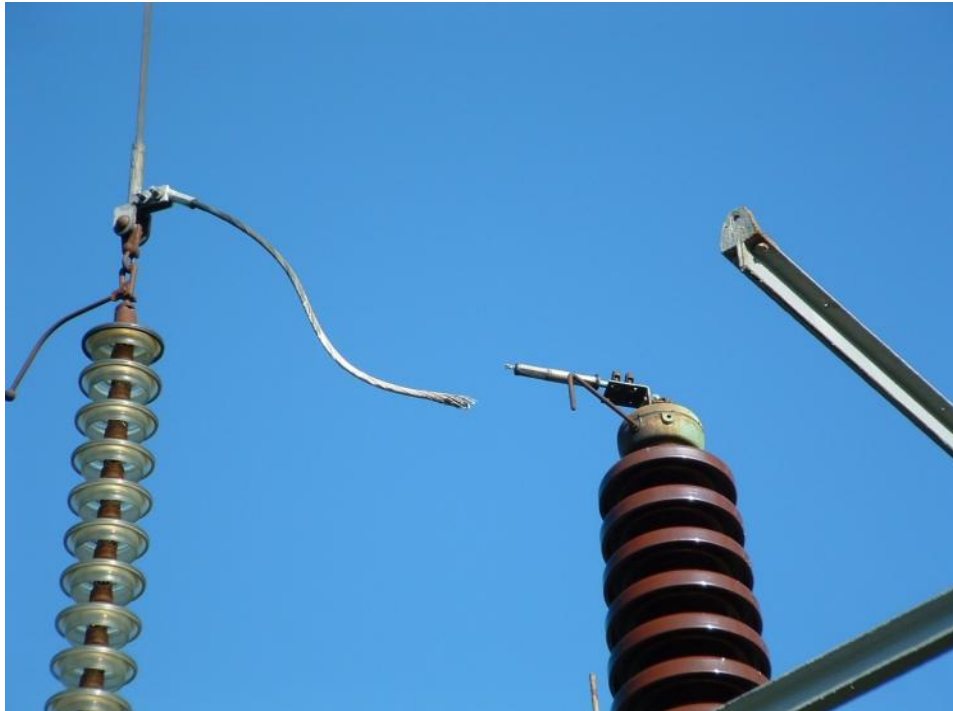
- 2.5 Photograph 1, copied from Northern Powergrid's SoF, shows the failed jumper in situ at tower PHO1. *[AE's note: Discussions with Northern Powergrid's Bradford repairs engineer confirm that the jumper failed at a point where the conductor enters the crimped lug, making visible detection of any weakness virtually impossible].*

Photograph 1 – The failed jumper in situ at tower PHO1

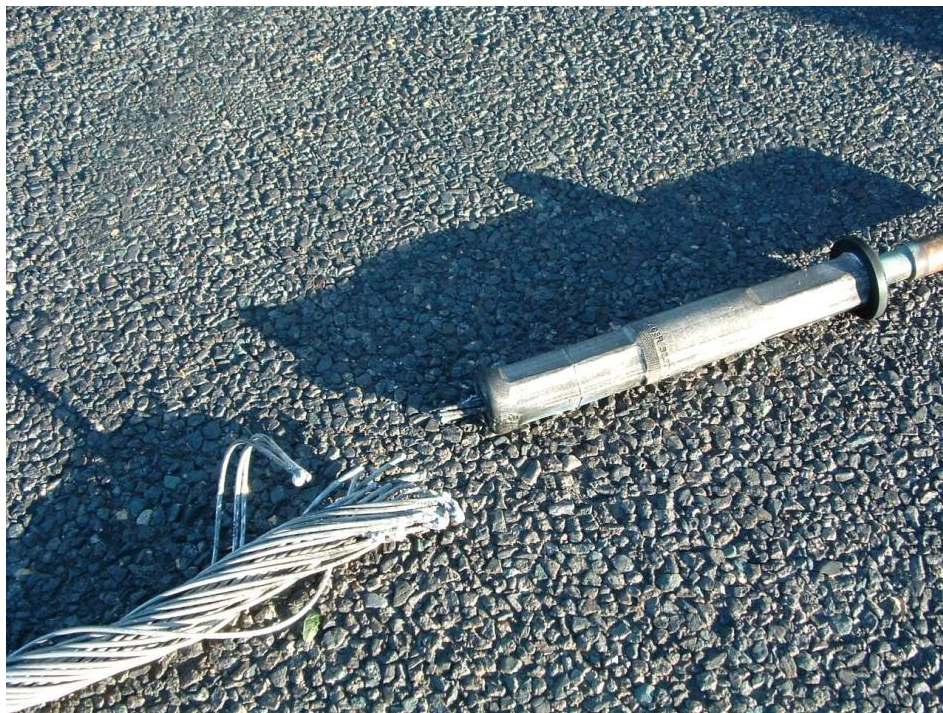
- 2.6 Photograph 2, taken after the failed components had been removed, shows the failed jumper connection in relation to the crimped lug.
- 2.7 Photograph 3 shows the jumper connections to the 132kV cable sealing ends of the other two phases on the n°2 circuit at tower PHO1.

Photograph 2 The failed jumper connection in relation to the crimped lug

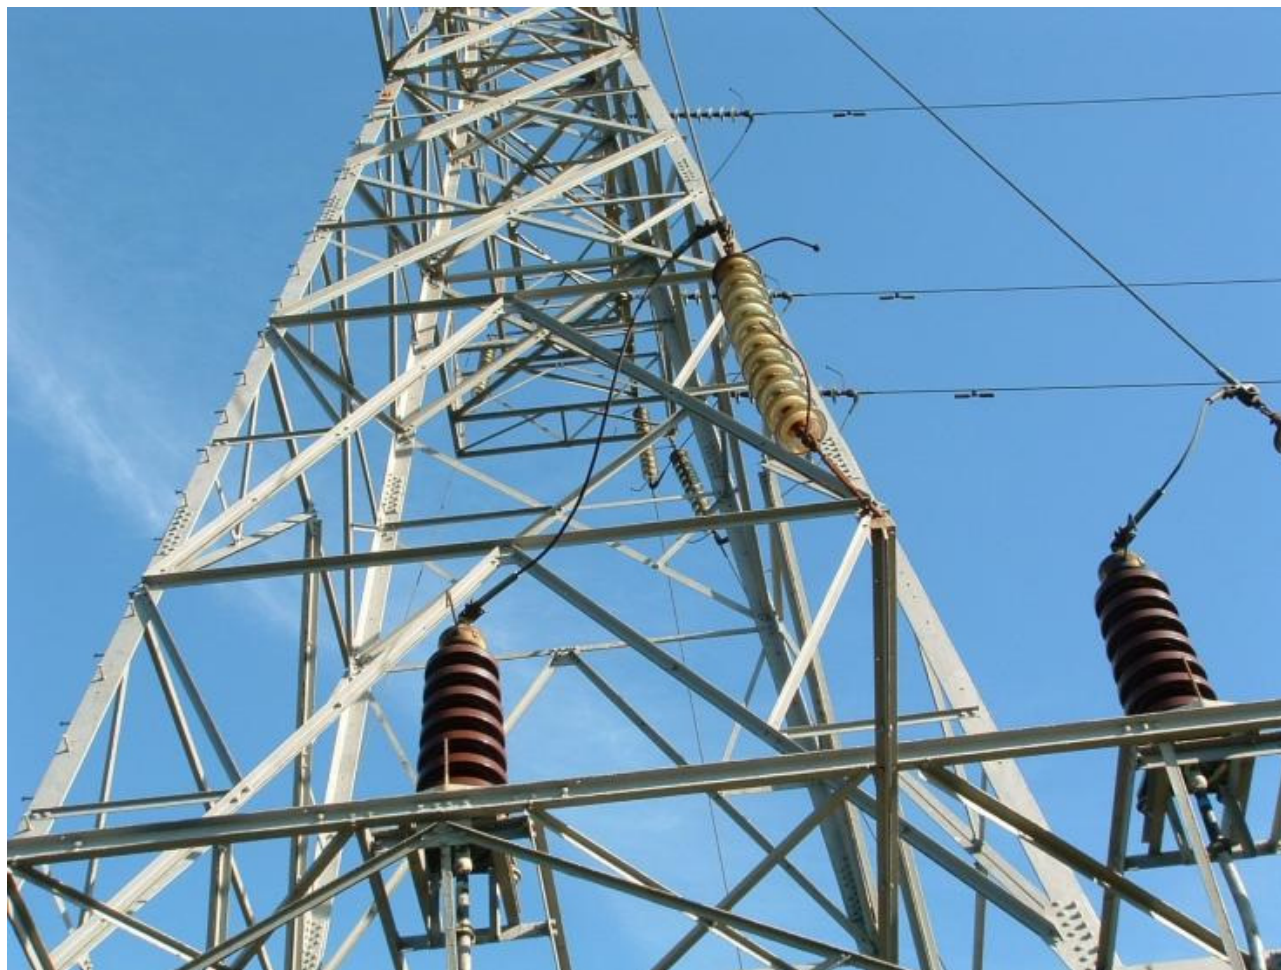
Photograph 3 –The jumpers of the other two phases on the n°2 circuit at tower PHO1
