Quality of Service Incentive Scheme – Exceptional Events

Appointed Examiner's Report	
Reporting year	2011/12
DNO	Southern Electric Power Distribution
Cause	Windborne material damaging 33kV switchgear
Date of event	18 July 2011

Title: Exceptional Events Report – SEPD – Norrington Grid Substation – damage to 33kV switchgear – 18 July 2011

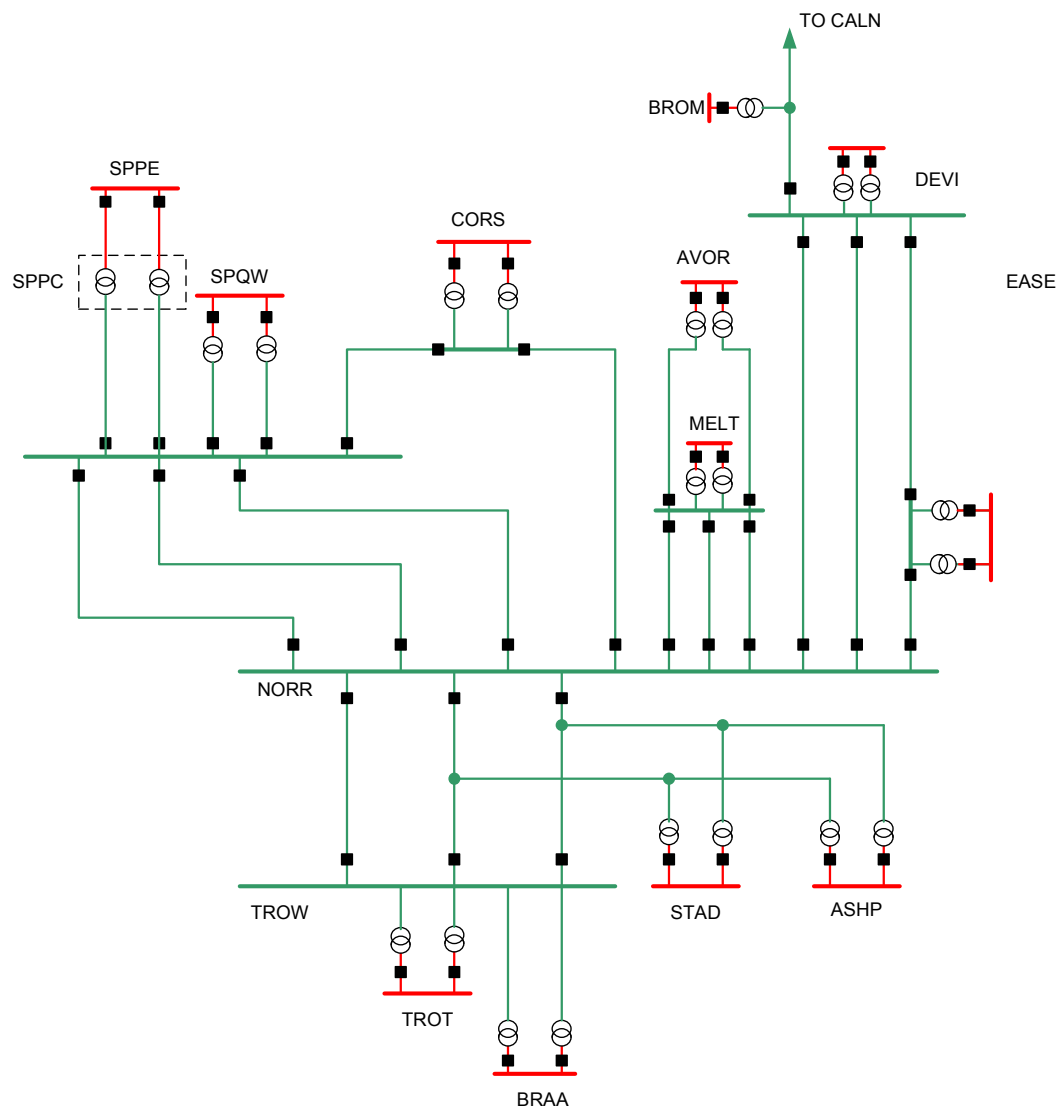
Figure 1-1 – Simplified Network Diagram of SEPD's 132/33kV distribution network affected by the incident

- 1.9 The final customer was restored via manual switching at 05:48.
- 1.10 A simplified view of the section of SEPD's 33kV network affected by this event is shown in Figure 1.

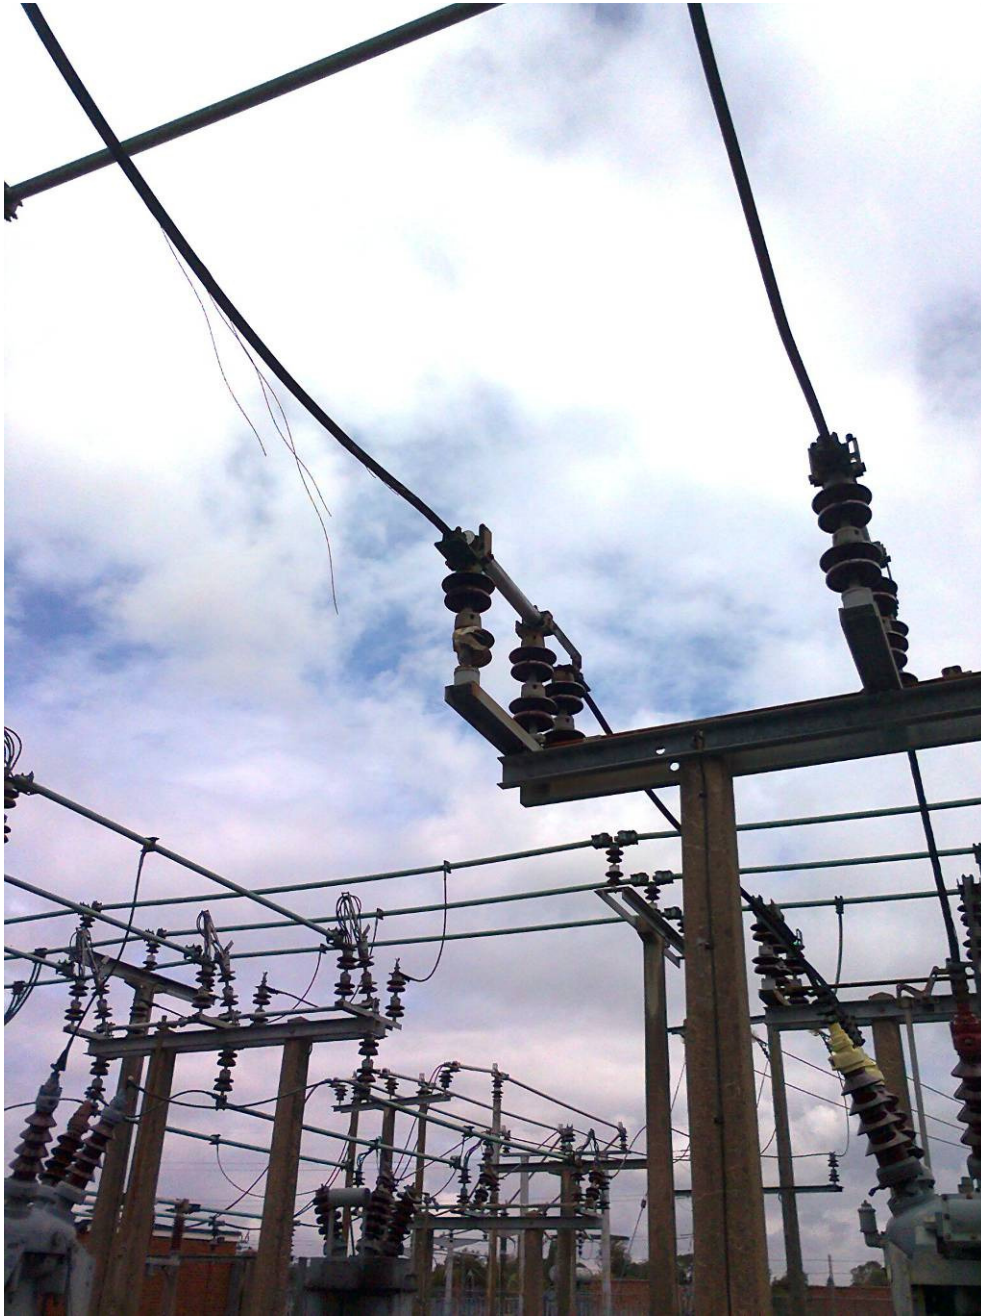
- 2.4 Photographs taken at the time of the incident show the remains of the metallised balloon, the damaged 33kV overhead connection and the irreparable damage to the post-type insulator at 33kV busbar isolator C1W6.

- 2.5 The remains of the metallised tail dangling from the 33kV overhead connection are readily visible in photograph 1.
- 2.6 The irreparable damage to the post-type insulator is obvious from photograph 2.

- 2.16 The damage to the 33kV overhead connection and the irreparable damage to the 33kV post-type insulator are consistent with a metallised object coming into contact with them.

Photograph 1 – View of 33kV isolator C1W6 showing the remnants of the metallised tail of the balloon dangling from the overhead connection and the in-situ irreparably damaged post-type insulator

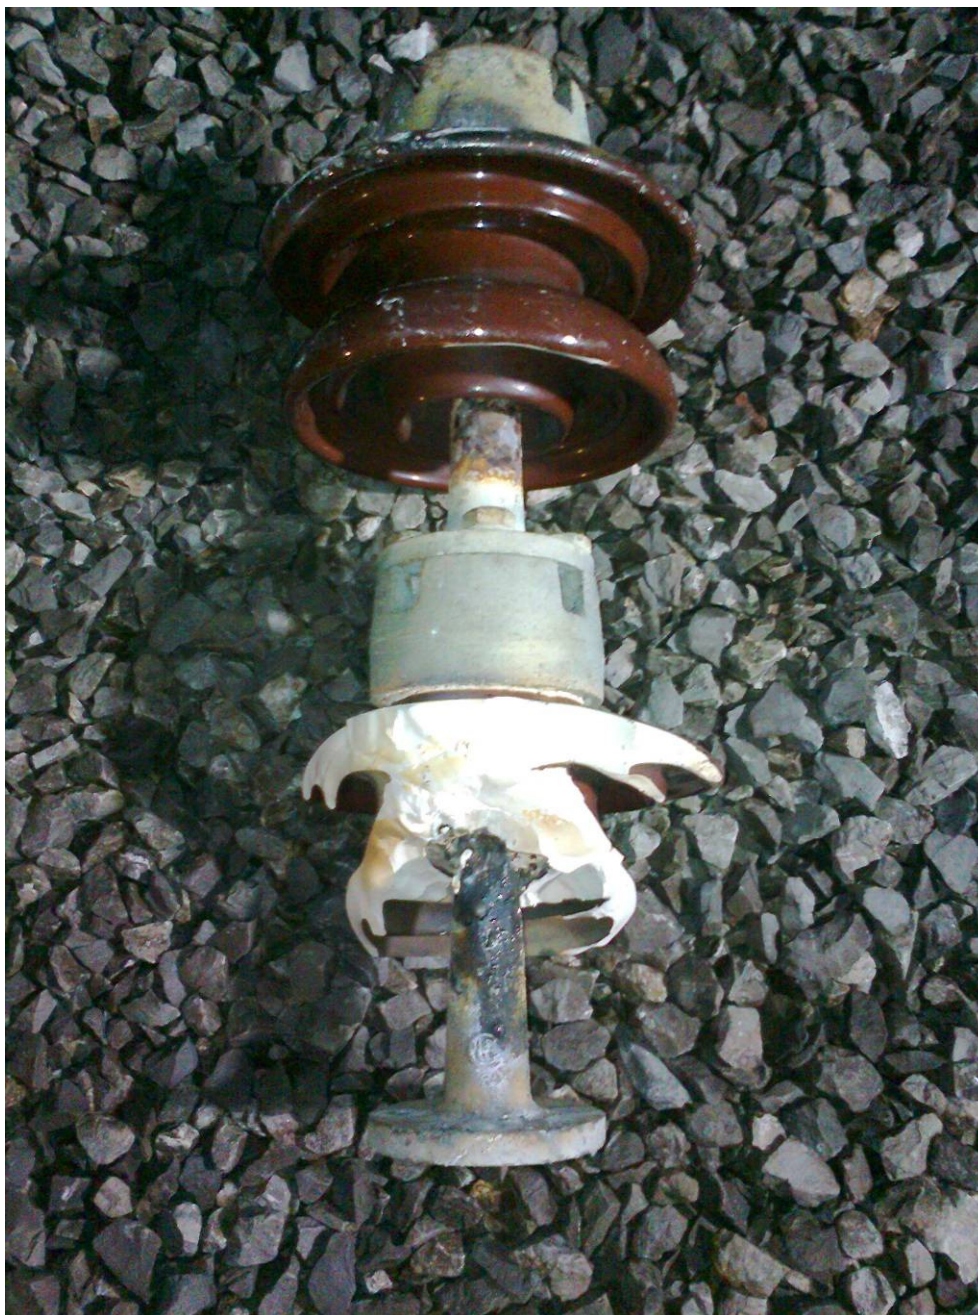
Photograph 2 – The irreparably damaged 33kV post-type insulator

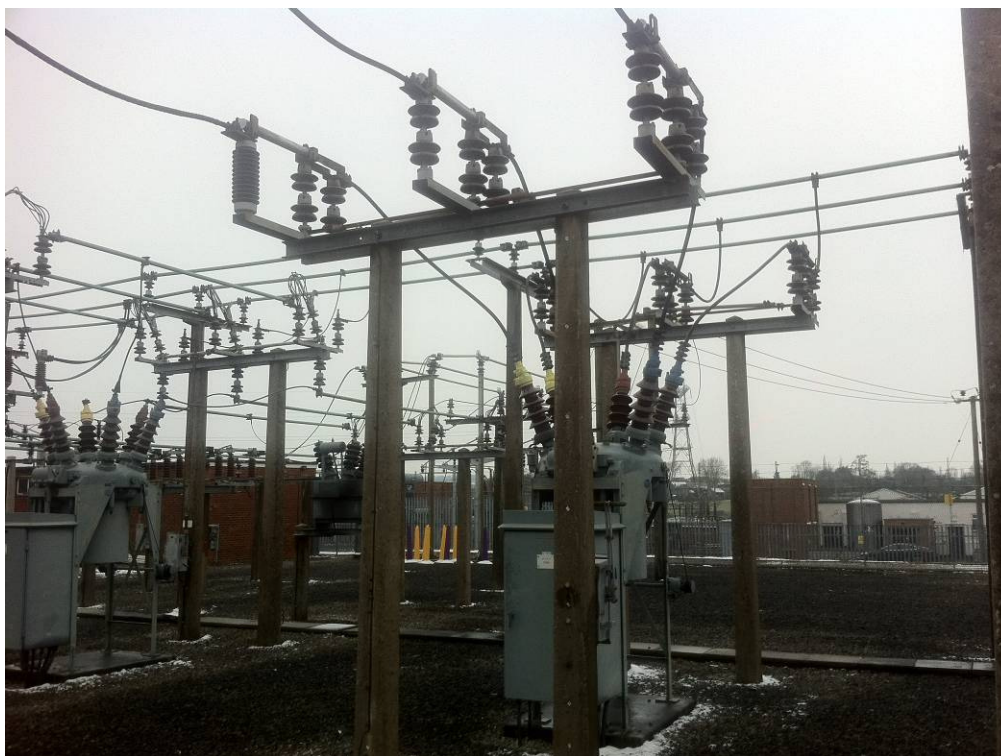
Photograph 3 – View of 33kV isolator C1W6 following replacement of the irreparably damaged post-type insulator

- 2.7 A comparison with the replacement post-type insulator can be gauged from photograph 3 which shows the equipment after repairs had been completed.
