Quality of Service Incentive Scheme – Exceptional Events

Appointed Examiner's Report	
Reporting year	2011/12
DNO	Northern Powergrid – Northeast Licensed Area
Cause	The disruptive failure of an 11kV circuit-breaker during the clearance of an 11kV cable fault
Date of event	17 December 2011

Title: Exceptional Events Report – Northern Powergrid (Northeast) – Harrogate 132/11kV Primary Substation – disruptive failure of an 11kV circuit-breaker during the clearance of an 11kV cable fault – 17 December 2011
Reference: EE 2011/12 – NPG(NE)
Issue: Final Version 1.0
Date: 26 March 2012
Electronic Doc Ref: M:\BPIUSER\Projects\Current\UK Ofgem - EE one-offs for 2011/12/NPG(NE)/Reports

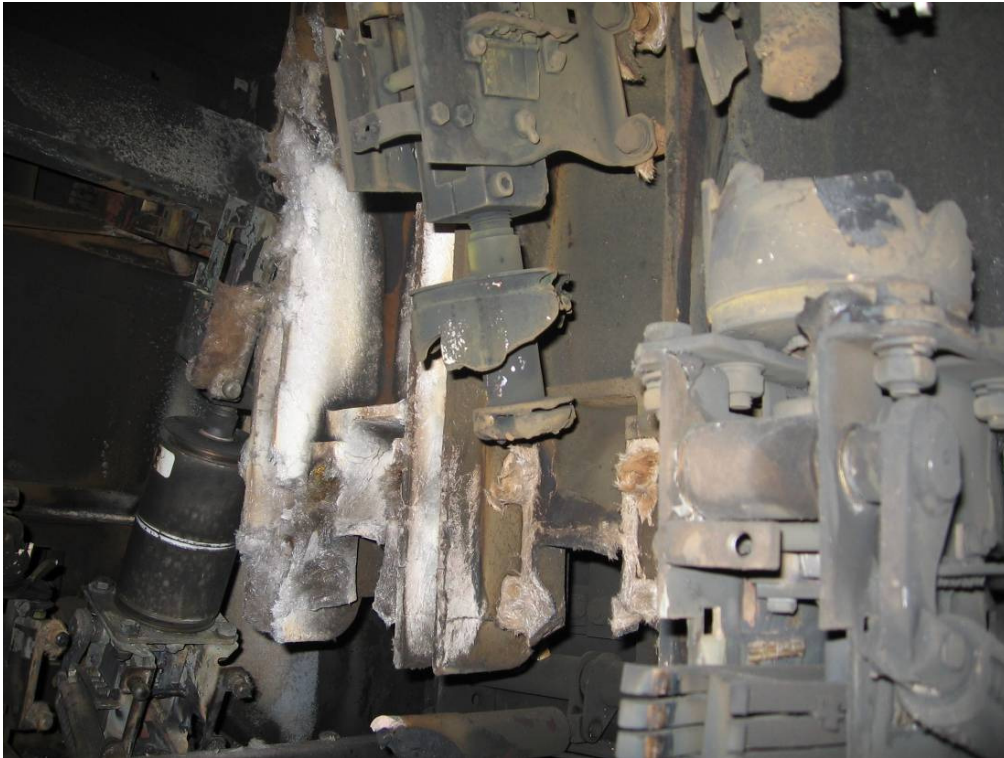
- 1.5 The arc products from the failed vacuum interrupter melted the components of the cast resin assembly and the inter-phase barriers of the circuit-breaker, catching them alight, the smoke from which filled the 11kV switchroom.

- 2.6 Photograph 1 shows the damage to the Parliament Street 11kV vacuum circuit-breaker. *[AE's note: the cast resin assembly and plastic phase dividers have been burnt away during the incident. The blue-phase vacuum interrupter is 'stuck' in the fixed portion of the switchgear whereas it should be fastened to the hinged panel of the circuit-breaker].*

Photograph 1 – The damaged 11kV vacuum circuit-breaker

- 1.30 Northern Powergrid considers that its engineering team did well in replacing the damaged 11kV vacuum circuit-breaker and in repairing the minor damage to the fixed portion of the switchboard.

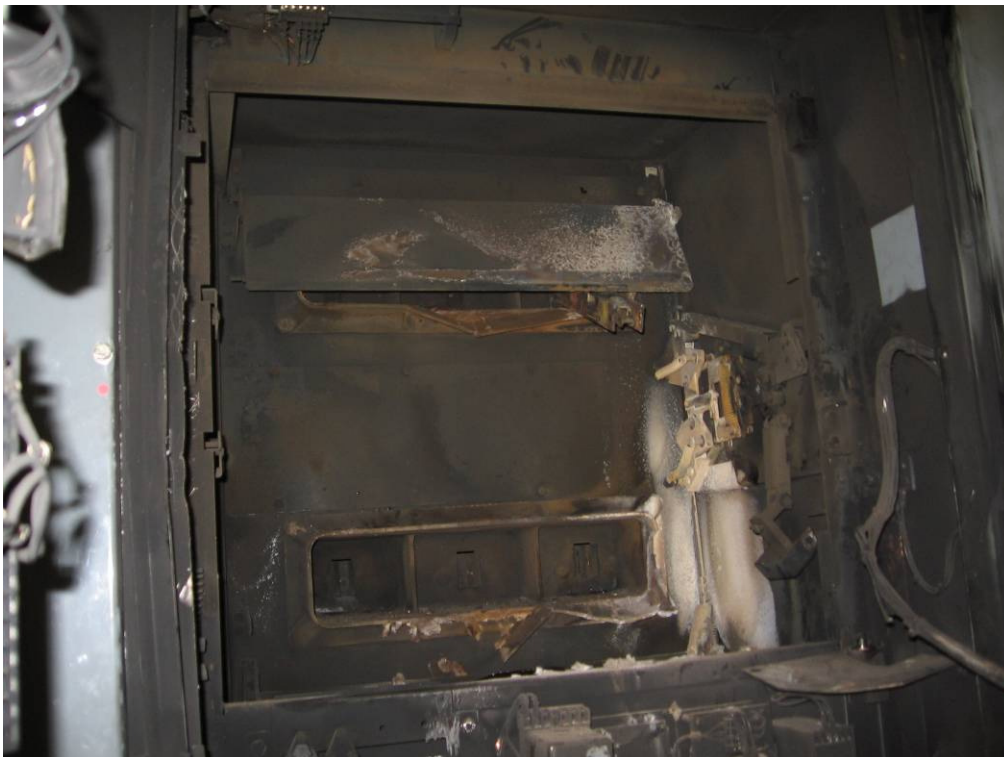
- 2.7 Photograph 2 shows the damage to the fixed portion of the Parliament Street 11kV vacuum circuit-breaker housing. *[AE's note: the feeder spouts are the upper set of fixed contacts and the busbar spouts the lower set. The blue phase isolating contact from the vacuum interrupter is still attached to the fixed portion of the switchgear housing].*

Photograph 2 – The damage to the fixed portion of the Parliament Street 11kV circuit-breaker housing

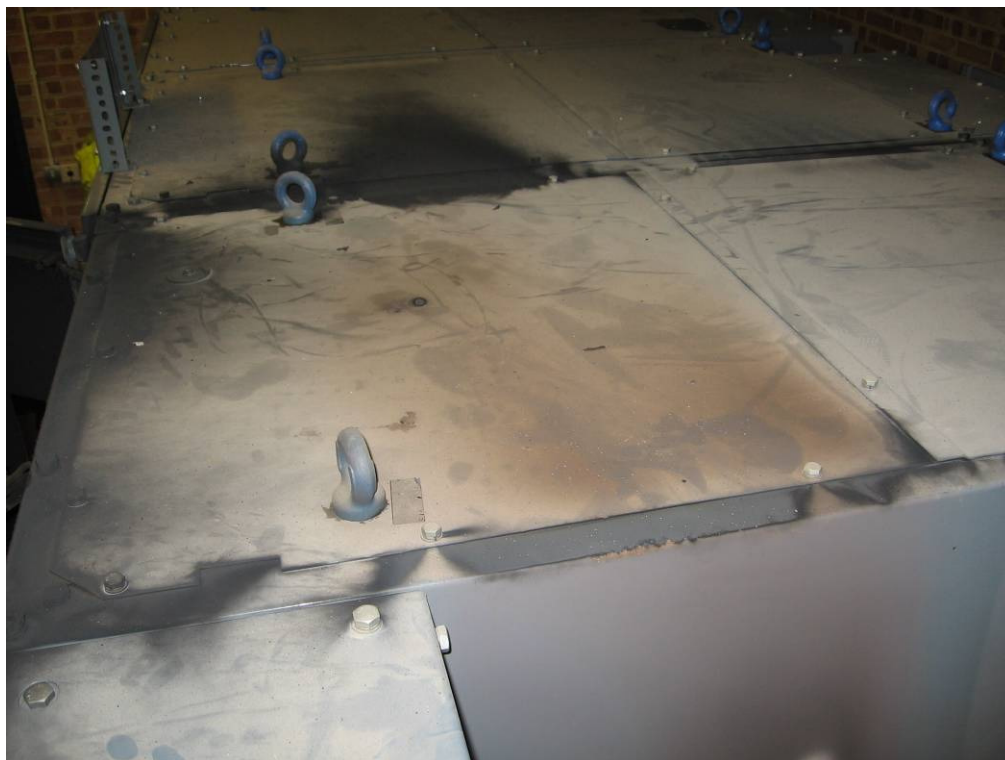
- 2.8 Photograph 3 shows the damage to the cover plates on the top of the fixed portion of the 11kV switchboard.
- 2.9 Northern Powergrid's measurement systems confirm the tripping of the Parliament Street 11kV circuit-breaker at 13:23 on 17 December 2011 in response to the 11kV feeder fault.

Photograph 3 – The damage to the cover plates on the top of the 11kV switchboard
