**Appointed examiner's audit of Exceptional Event Claim -
Scottish and Southern Energy Power Distribution
33kV bus-bar Incident at Chippenham Grid Substation
14 January 2013**

Title: SSEPD – Audit of Exceptional Event Claim – SEPD – Chippenham
Grid Substation - 14 January 2013

Issue: Final report v2.0

Date: 31 May 2013

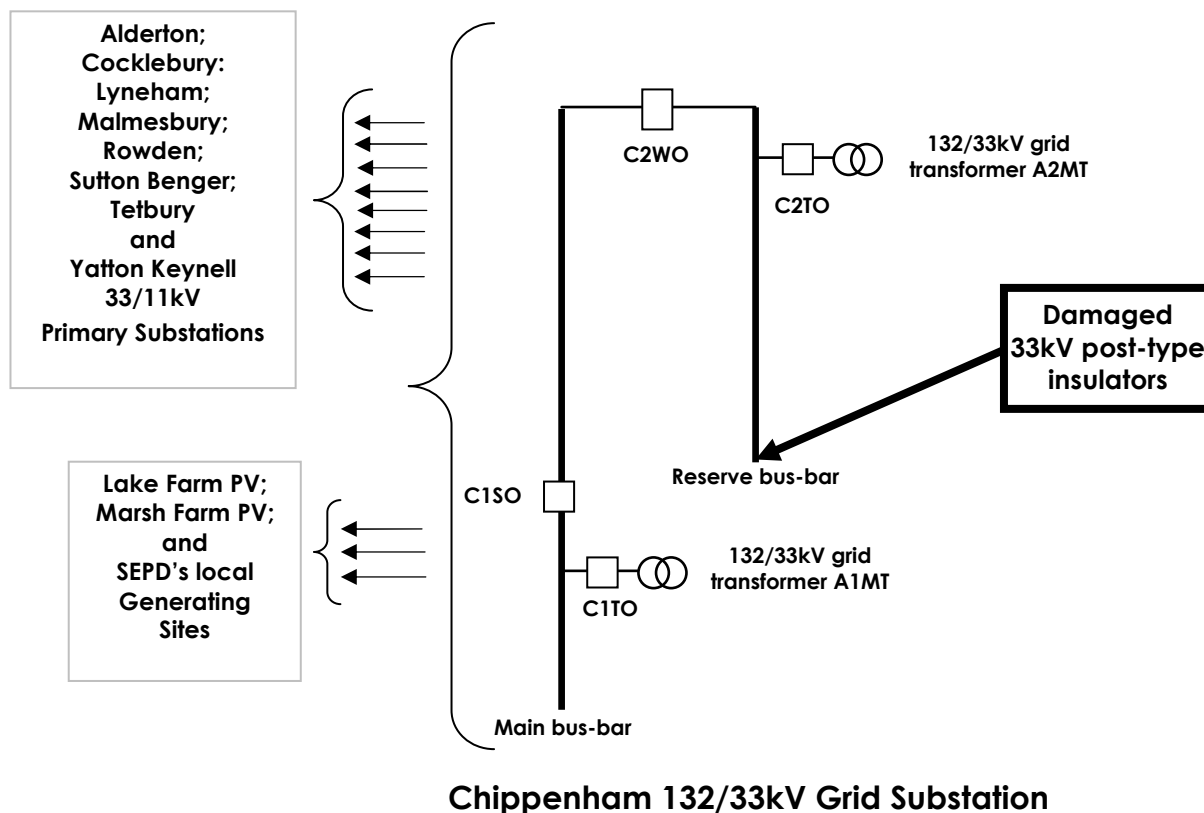
Figure 1 – Simplified Network Diagram of SEPD's 33kV distribution network affected by the incident

20. A simplified view of the sections of SEPD's 33kV network affected by this event is shown in Figure 1.

31. At 09:47 on 14 January 2013, a three-phase flashover on the 33kV reserve bus-bar caused the circuit-breakers on the 33kV sides of the two 132/33kV transformers to trip on overcurrent protection, thus losing all supplies to SEPD's customers fed from Chippenham Grid Substation.

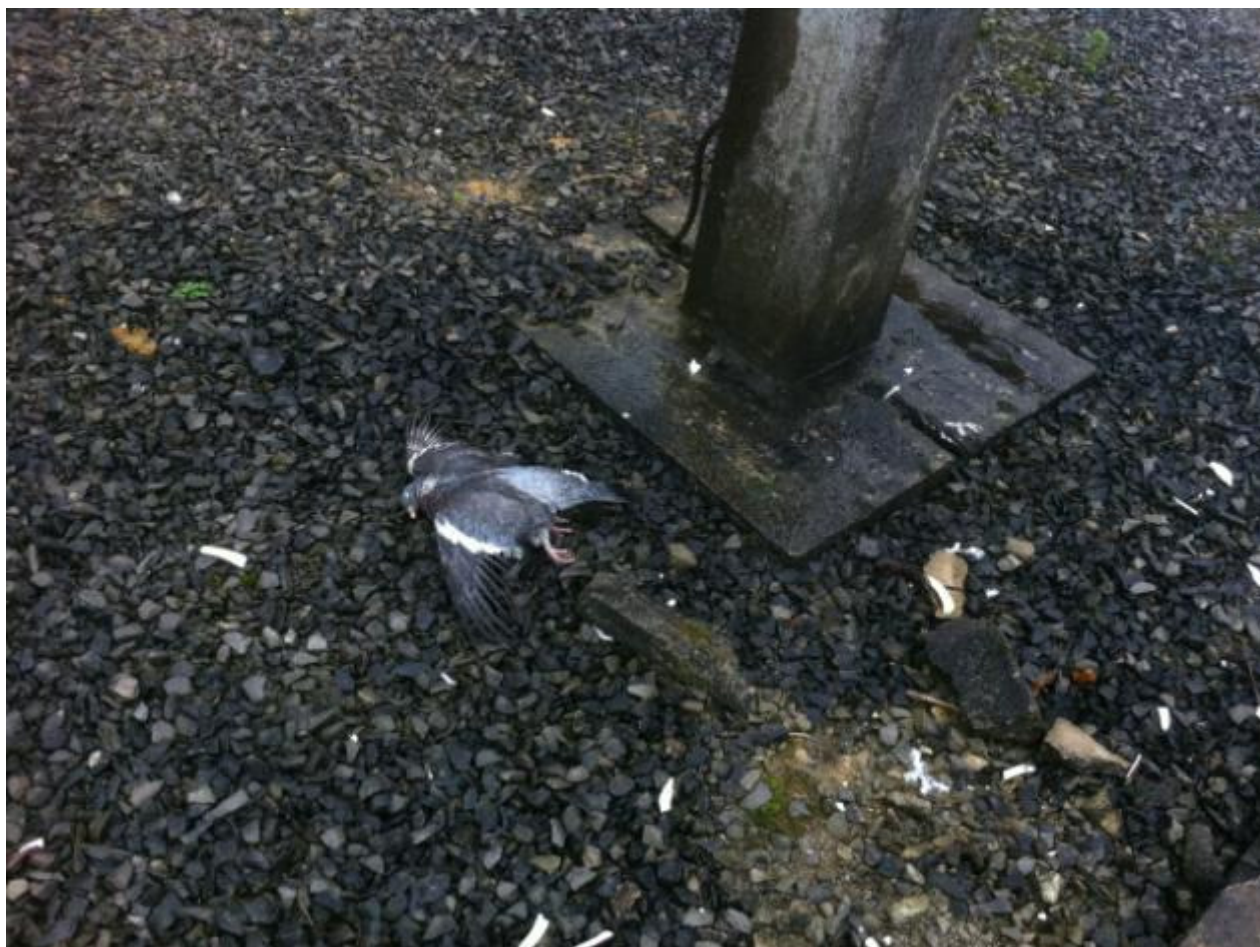
- A2. Three pieces of photographic evidence, captured shortly after the incident are available for the Appointed Examiner to view. One photograph shows pieces of freshly damaged porcelain insulator together with the pigeon at the base of the reserve bus-bar support.

47. SEPD's photograph 1, taken at the time of the incident shows the dead pigeon below the 33kV bus-bar support and the shattered porcelain fragments referred to in SEPD's answer to the AE's question number 2.

Photograph 1 – The dead pigeon and porcelain fragments at the foot of the support carrying the reserve 33kV bus-bar

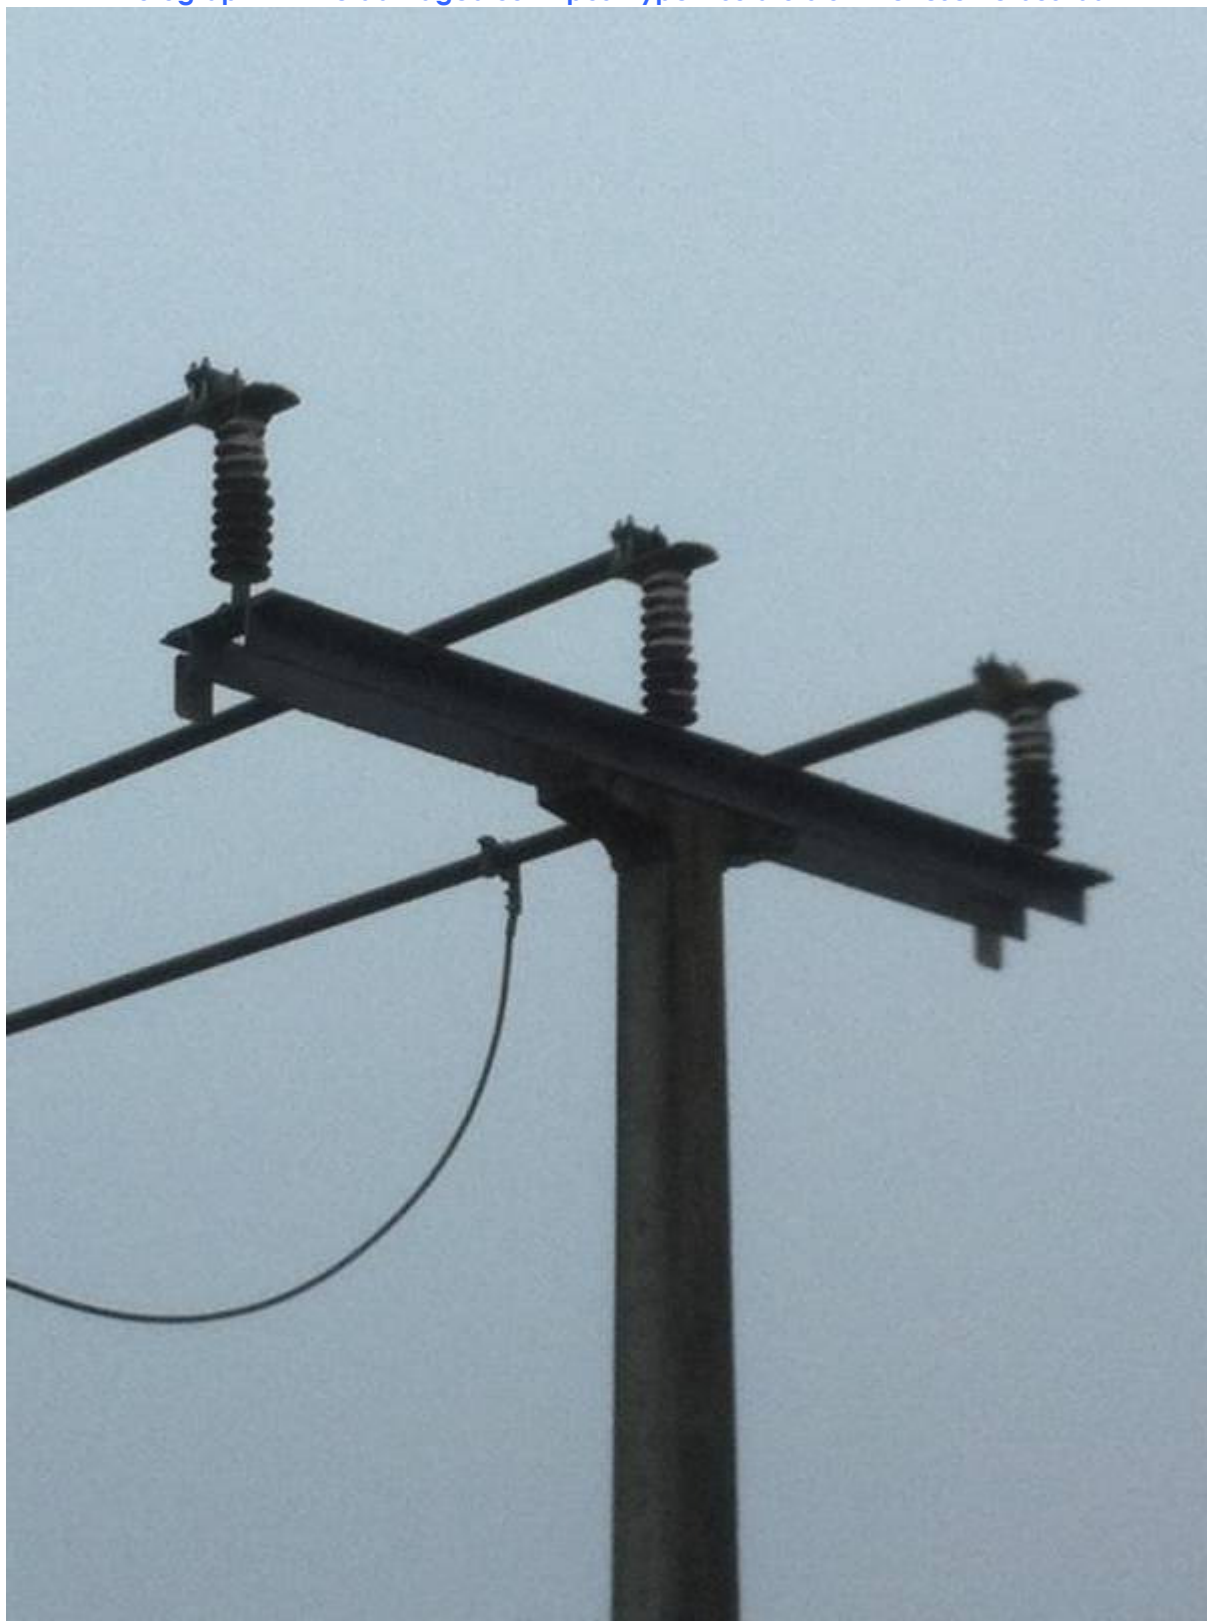
48. SEPD's photograph 2, taken shortly after the incident and before permanent repairs were effected, shows the damage to the three 33kV post-type insulators below which the dead pigeon was found.

57. The irreparable damage to the three 33kV post-type insulators is consistent with an electric arc having occurred between the energised 33kV bus-bars and with the operation of overcurrent protection to clear the incident from SEPD's distribution system.

Photograph 2 – The damaged 33kV post-type insulators on the reserve bus-bar

36. SEPD also considers that its engineering team did well in replacing the three damaged 33kV post-type insulators by 17:25 on the day of the incident, thereby restoring the security of supplies to its customers.

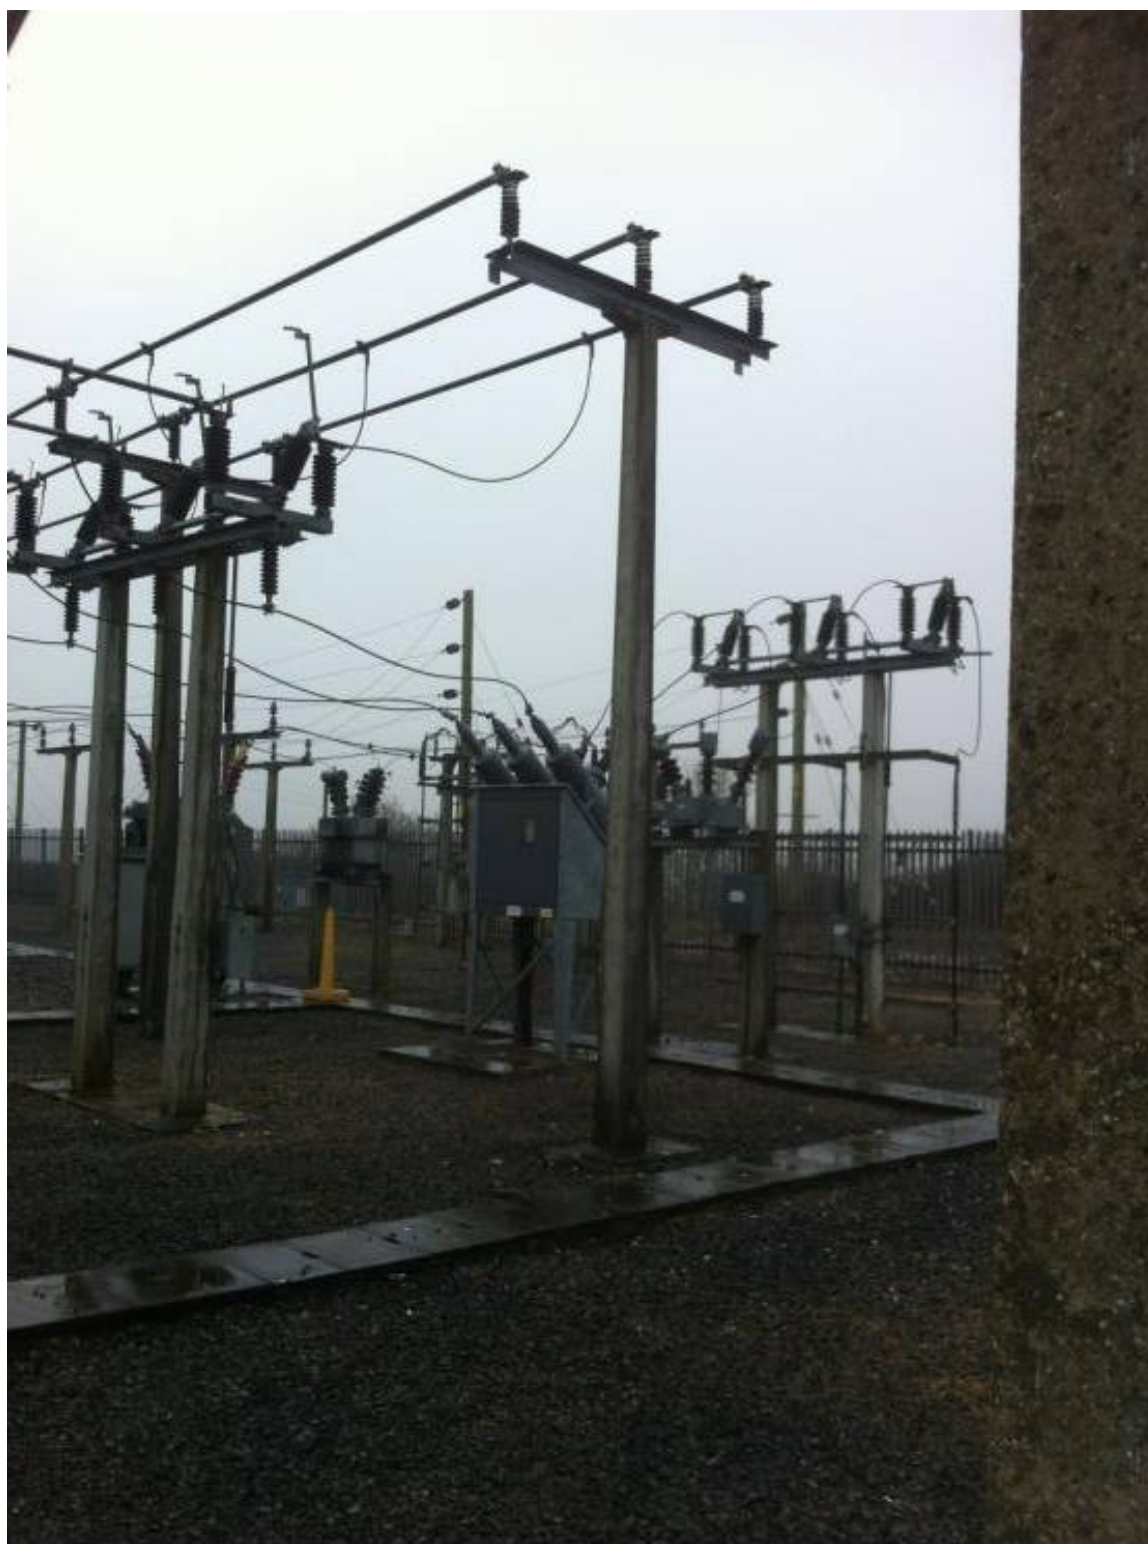
49. A general view of the area surrounding the damaged 33kV post-type insulators can be gauged from SEPD's photograph 3.
50. It is practically impossible to insulate all the live exposed conductors in 33kV compounds such as at SEPD's Chippenham Grid Substation and SEPD is working to retro-fit bus-bar reclosing schemes at its Substations that are equipped with outdoor 33kV switchgear as at its Chippenham Grid Substation.

Photograph 3 – General view of the 33kV compound at the point of damage
