**Appointed examiner's audit of Exceptional Event Claim -
UK Power Networks (Eastern)
132kV incident – Rayleigh Main to Fleethall Grid Substation
11 October 2014**

Title: UK Power Networks (Eastern) – Audit of Exceptional Event Claim
– UKPN (EPN) – 132kV Rayleigh main to Fleethall Grid Substation
– 11 October 2014

Reference: ep/Ofgem/EPN/11 Oct '14

Date: 16 December 2015

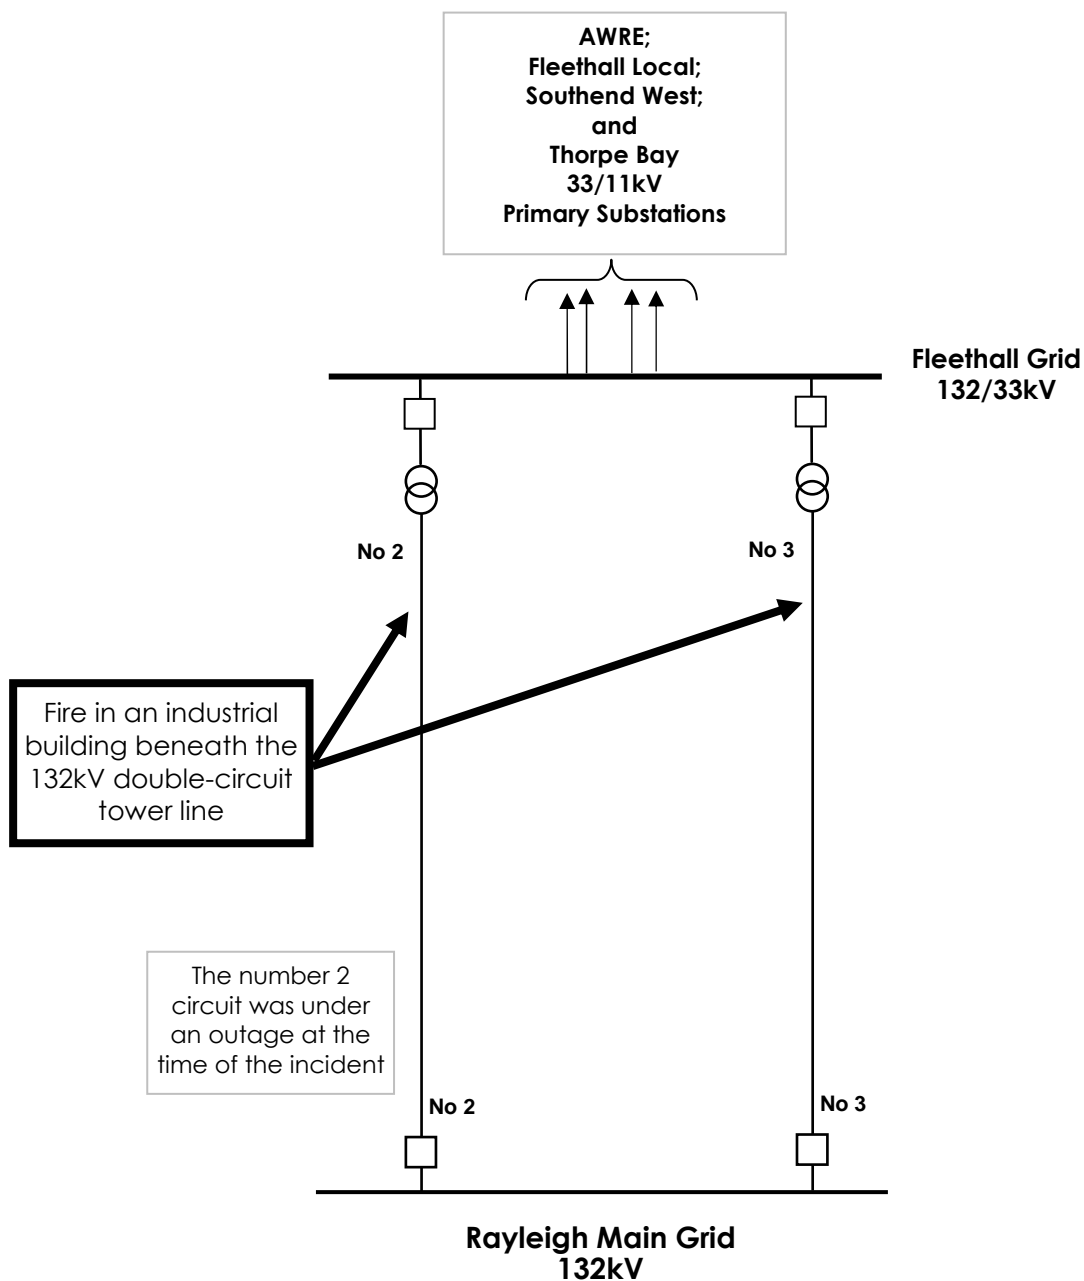
14. As a result of the loss of 132kV infeeds to Fleethall 132/33kV Grid Substation the 33kV infeeds to four of UKPN's 33/11kV Primary Substations were interrupted and the loss of supply to 37,718 of EPN's customers for longer than three minutes.

Figure 1 – Simplified Network Diagram of EPN's 132/33kV distribution system affected by the incident

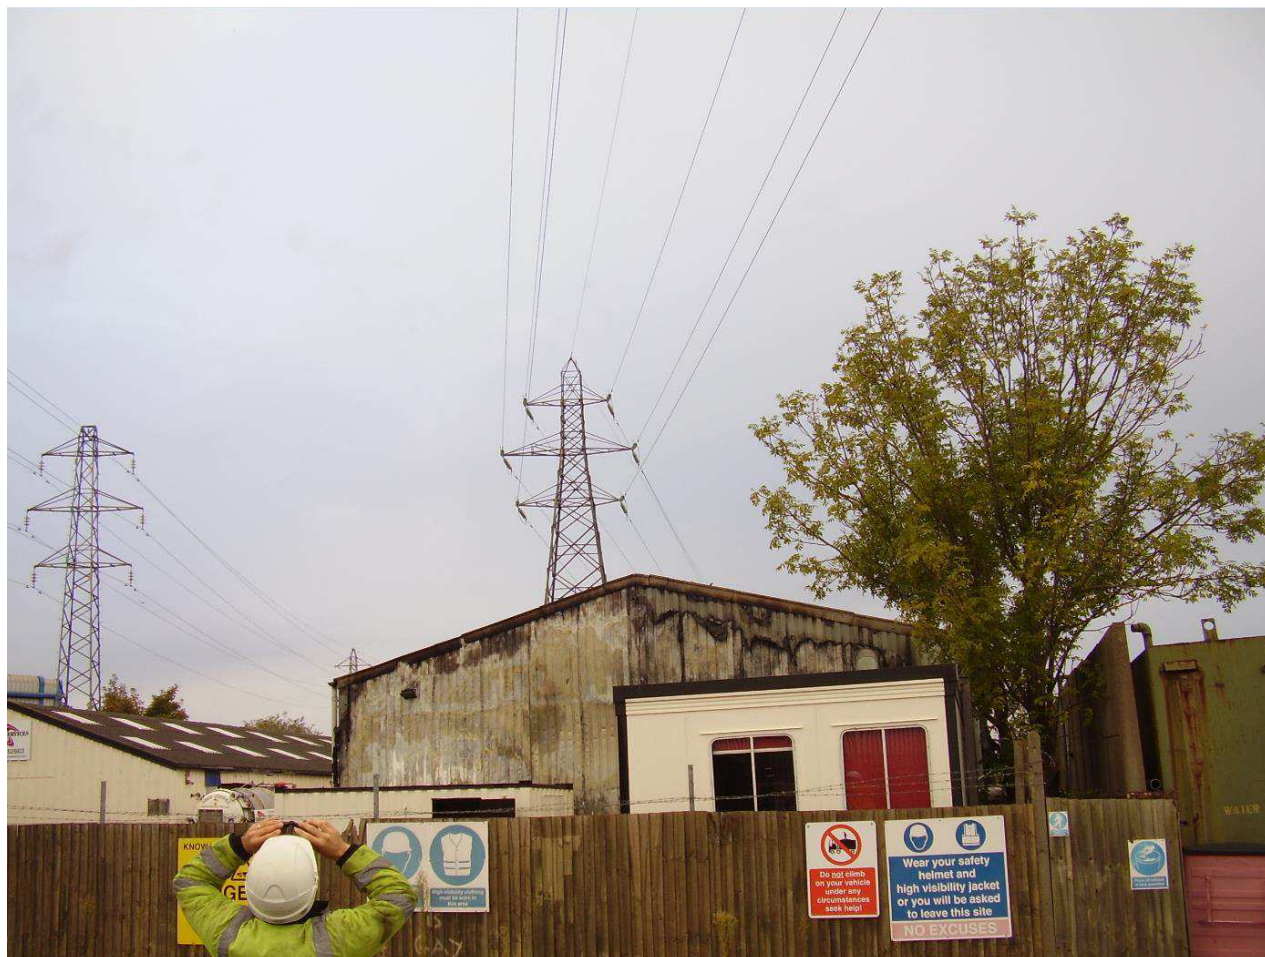
19. EPN measured the clearance between the fire-damaged building and the lowest part of the affected span to exceed 3.6 metres. This exceeds the minimum safety clearance of 2.9 metres.

32. The cause of the incident was confirmed to be a fire in an industrial building beneath the tower line, ionising the air and causing the circuit to flash-over.

Photograph 1 – 'End-on' view of the 132kV double-circuit overhead tower line and the fire-damaged building below

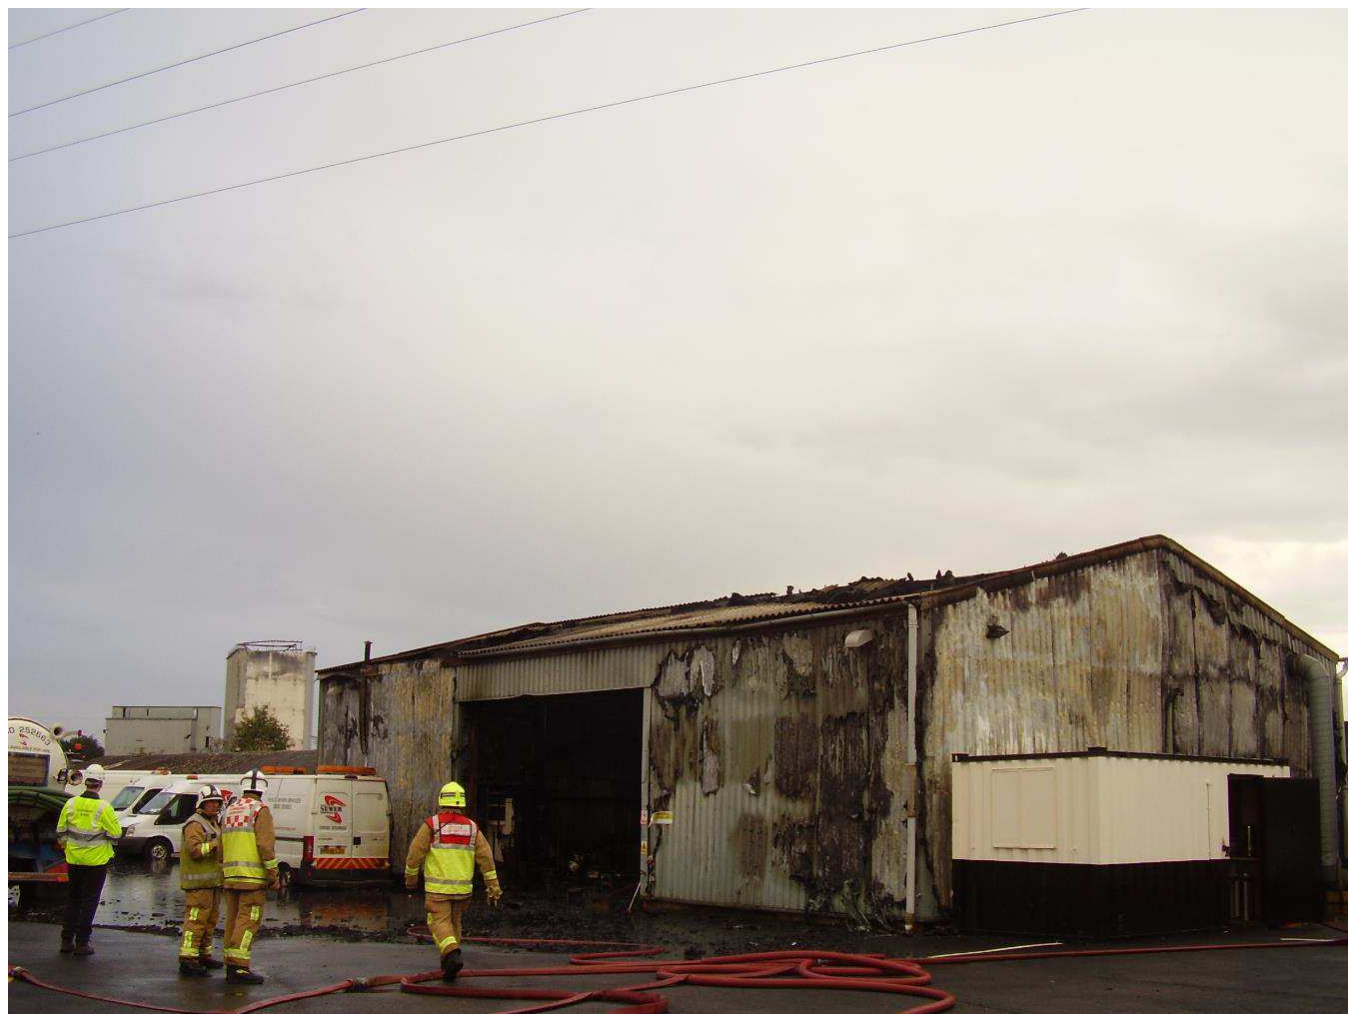
Photograph 2 – 'Side view' of the 132kV double-circuit overhead tower line and the fire-damaged building below
