**Appointed examiner's audit of One-Off Exceptional Event Claim
Western Power Distribution (West Midlands)
66kV incident - Evesham to Broadway
16 July 2014**

Title: Western Power Distribution (West Midlands) – Audit of One-Off Exceptional Event Claim – 66kV incident - Evesham to Broadway – 16 July 2014

Reference: ep/Ofgem/WPD(WM)/16 Jul '14

Date: 15 September 2015

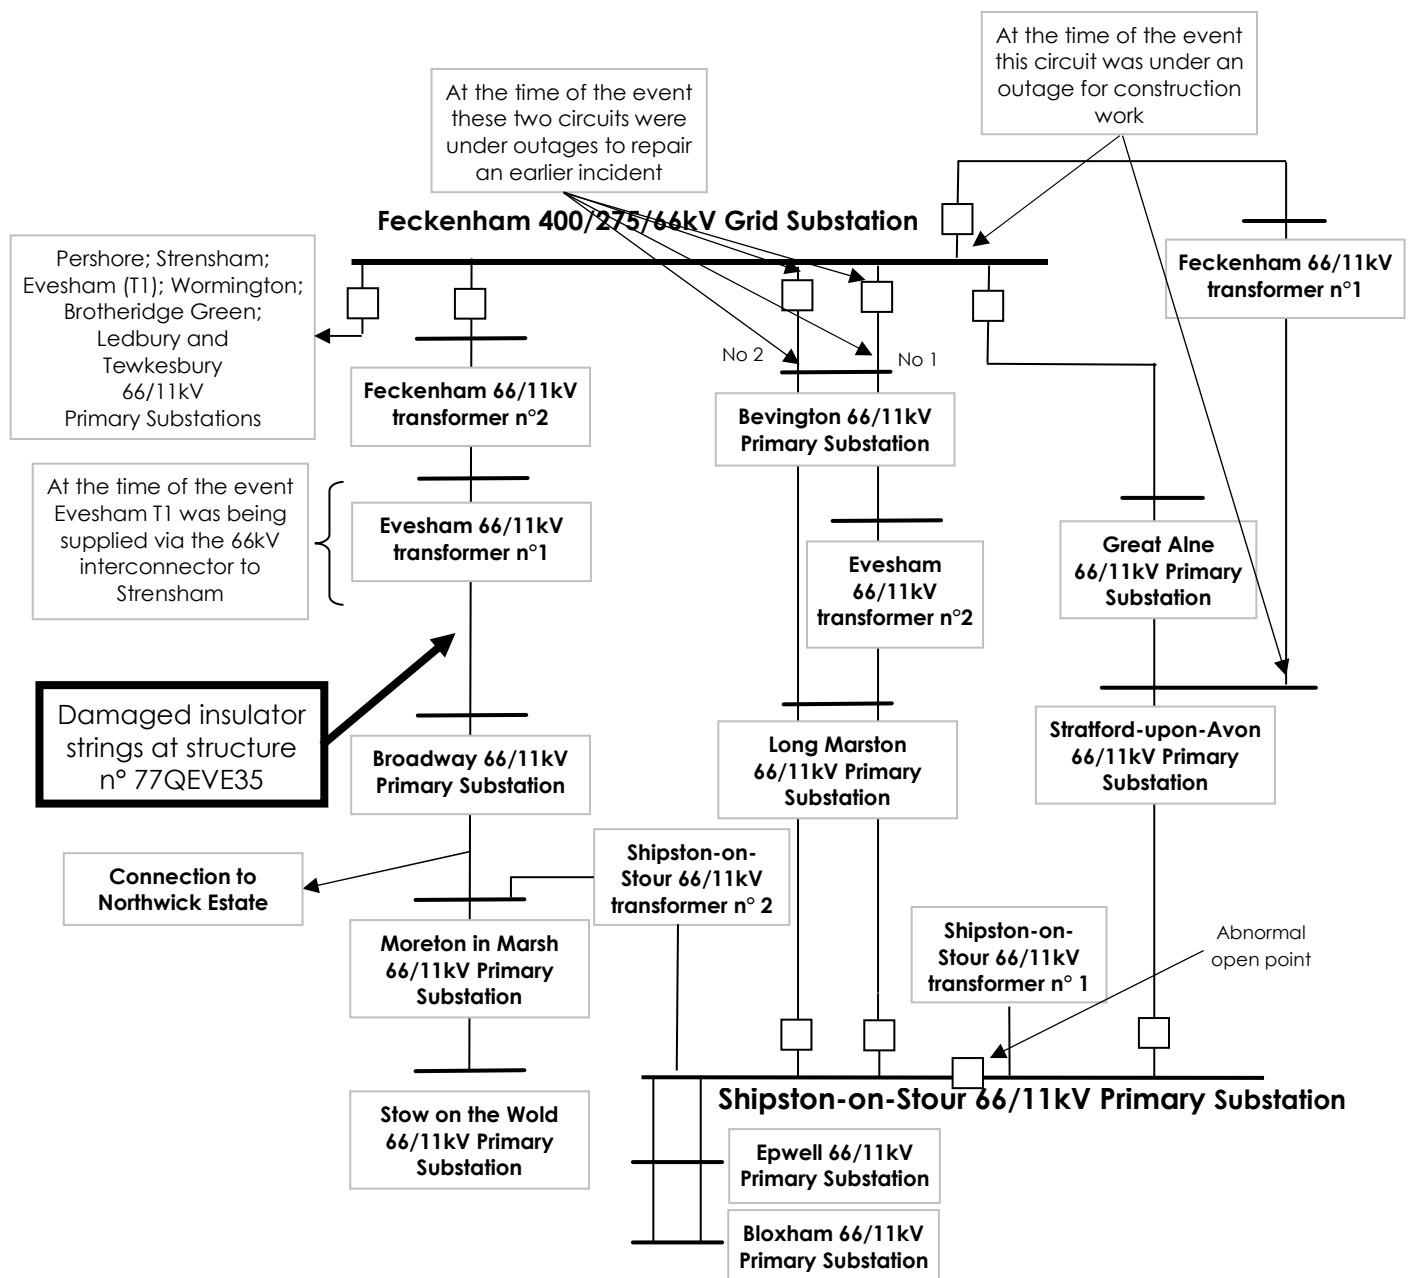
Figure 1 – Simplified Network Diagram of WPD's 66/11kV distribution system affected by the incident

31. A simplified view of the sections of WPD's 66/11kV network affected by this event is shown in Figure 1.

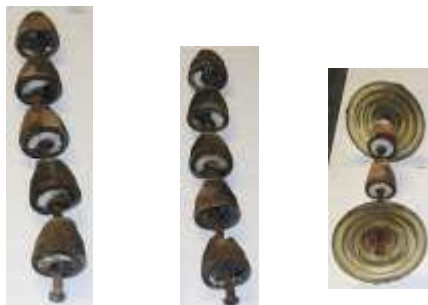
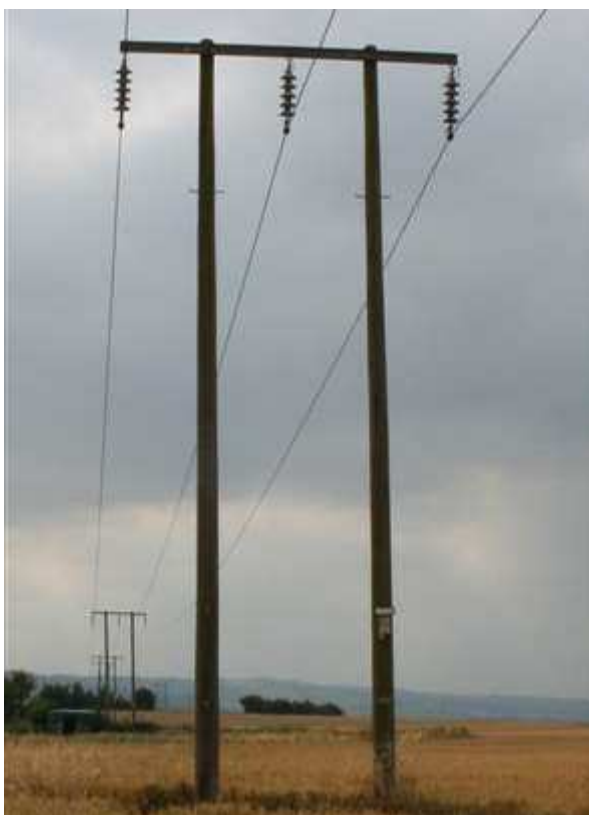
Photograph 1 – The severely damaged insulator strings in relation to structure 77QEVE35

12. WPD has provided photographic evidence to support its claim that, in the village of Badsey, Worcestershire, the glass insulator strings supporting the 66kV overhead line conductors at structure number 77QEVE35 between WPD's Evesham and Broadway 66/11kV Primary Substations had been irreparably damaged by an unknown third-party.

13. Consequently, during a period of heavy rain, a short-circuit was created between two of the phase conductors via the metal cross-arm on structure number 77QEVE35, causing the controlling circuit-breaker at Feckenham 400/275/66kV Grid Substation to trip, resulting in the loss of supplies to 41,405 of WPD's customers, 36,615 of whom were off supply for longer than three minutes.

14. One of the affected 66kV conductors dropped from the damaged suspension insulator string and came into contact with an under-running 11kV overhead line.

60. Photograph 1, copied from WPD's investigation report, shows the severely damaged insulator strings in relation to their original location on structure number 77QEVE35.

75. In the AE's experience, damage such as that which occurred to the glass insulators at structure number 77QEVE35 could only be caused by third-party interference.

76. Furthermore, the AE is of the opinion that the damage is consistent with the insulators having been systematically targeted and shattered by either rifle fire or shotgun pellets.

This photo-montage is taken from WPD's report following the company's investigation into the cause of the incident.

The damaged insulator strings are depicted above their original locations on structure 77QEVE35.

Structure 77QEVE35 is shown with the replacement insulator strings which are made from high-impact porcelain to legislate against similar third-party damage in the future.

29. As a result of this incident and to prevent a re-occurrence, WPD has fitted high-impact resistant porcelain insulators to both structure number 77QEVE35 and the next structure along the line; 77QEVE34.

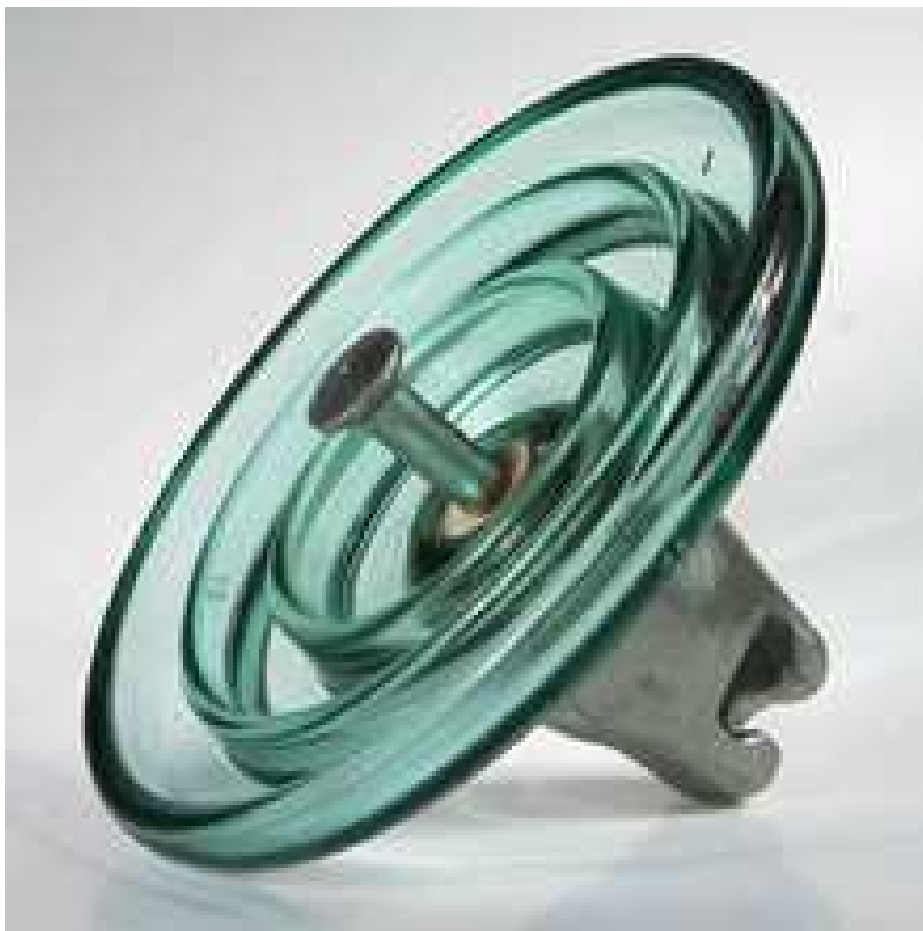
Photograph 2 – A new glass disc insulator

Five glass disc insulators like this made up each suspension string on WPD's 66kV structure 77QEVE35.

Thus, in the absence of the glass section due to, say, third-party damage, the electrical path between the two metal pieces is very short and, with pollution and rain, a flashover is likely to occur.

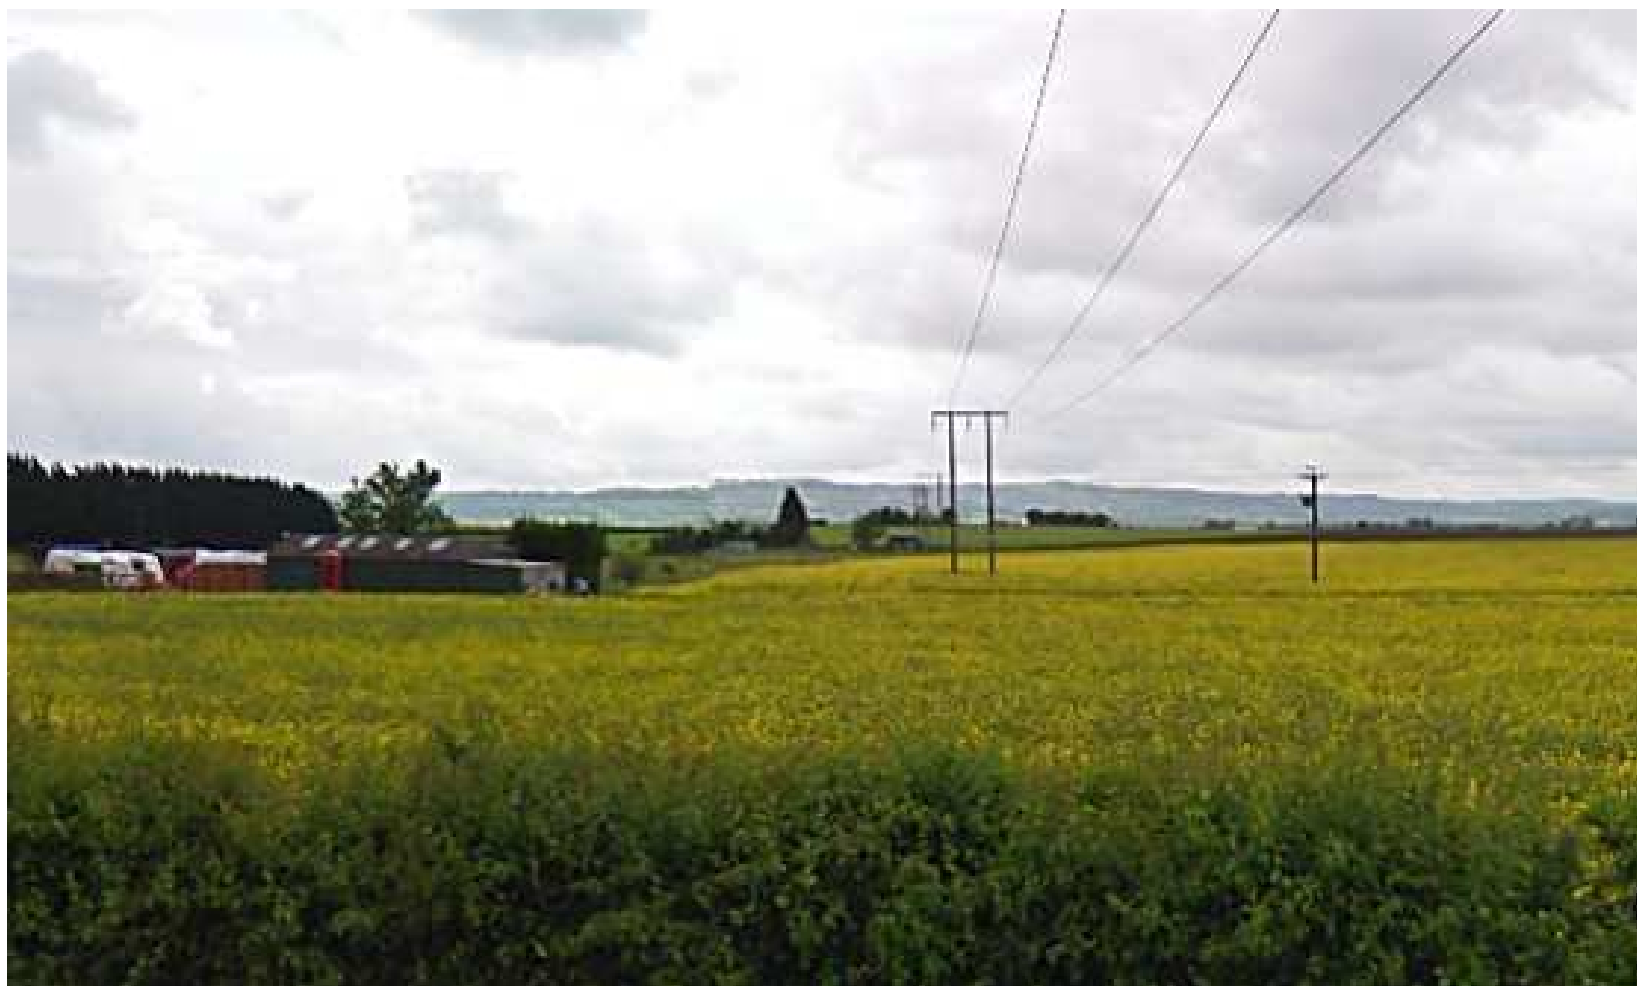
Photograph 3 – A view of structure 77QEVE35 taken from “Google Maps”

The rural setting is apparent from this photograph

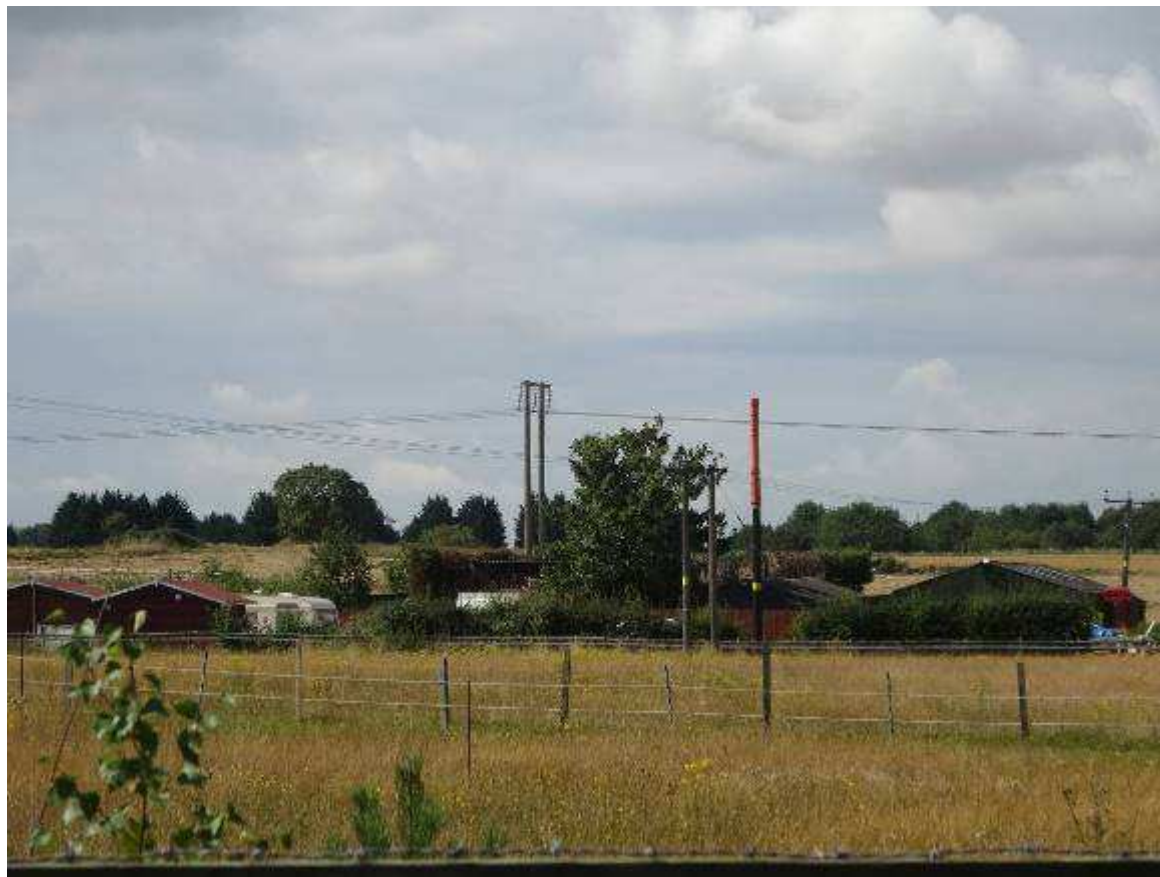
Photograph 4 – Structure 77QEVE35 in relation to the farm outbuildings and WPD's under-running 11kV overhead line

30. Coincidentally, the section of 11kV overhead line over which the 66kV overhead line crossed was due to be undergrounded at the request of the local farmer. One of the newly erected poles for this purpose is visible in Photograph 4 - the top of this pole is wrapped in red insulating material.

This photograph was taken after the incident. In addition to the 66kV and 11kV overhead lines it shows the farm outbuildings and a newly erected terminal pole for the undergrounding of two spans of the 11kV overhead line at the request of the farmer. The pole with red-coloured insulation wrapping will be a new terminal pole for this undergrounding job.
