**Appointed examiner's audit of Exceptional Event Claim -
UK Power Networks (Eastern)
132kV Incident – Norwich Trowse
to Gorleston and Great Yarmouth Grid Substations
01 January 2014**

Title: UK Power Networks (Eastern) – Audit of Exceptional Event Claim – UKPN (EPN) – 132kV Norwich Trowse to Gorleston and G⁺ Yarmouth Grid Substations – 01 January 2014

Reference: ep/Ofgem/EPN/01 Jan '14

Date: 26 May 2015

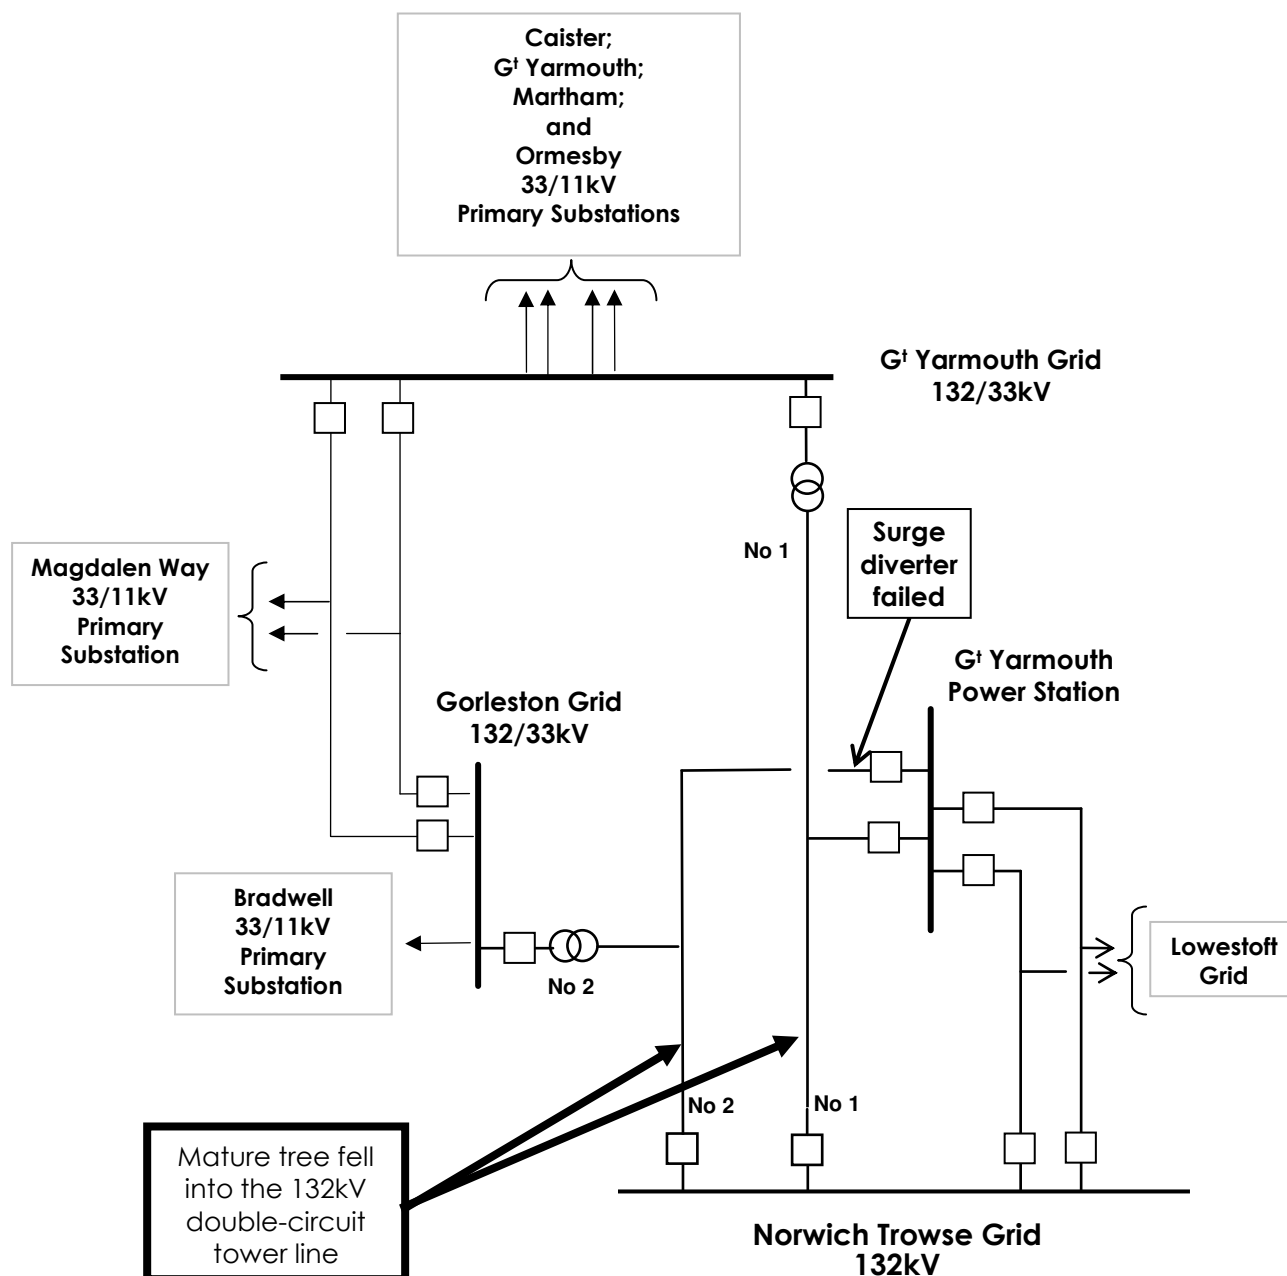
Figure 1 – Simplified Network Diagram of UKPN's 132/33kV distribution system affected by the incident

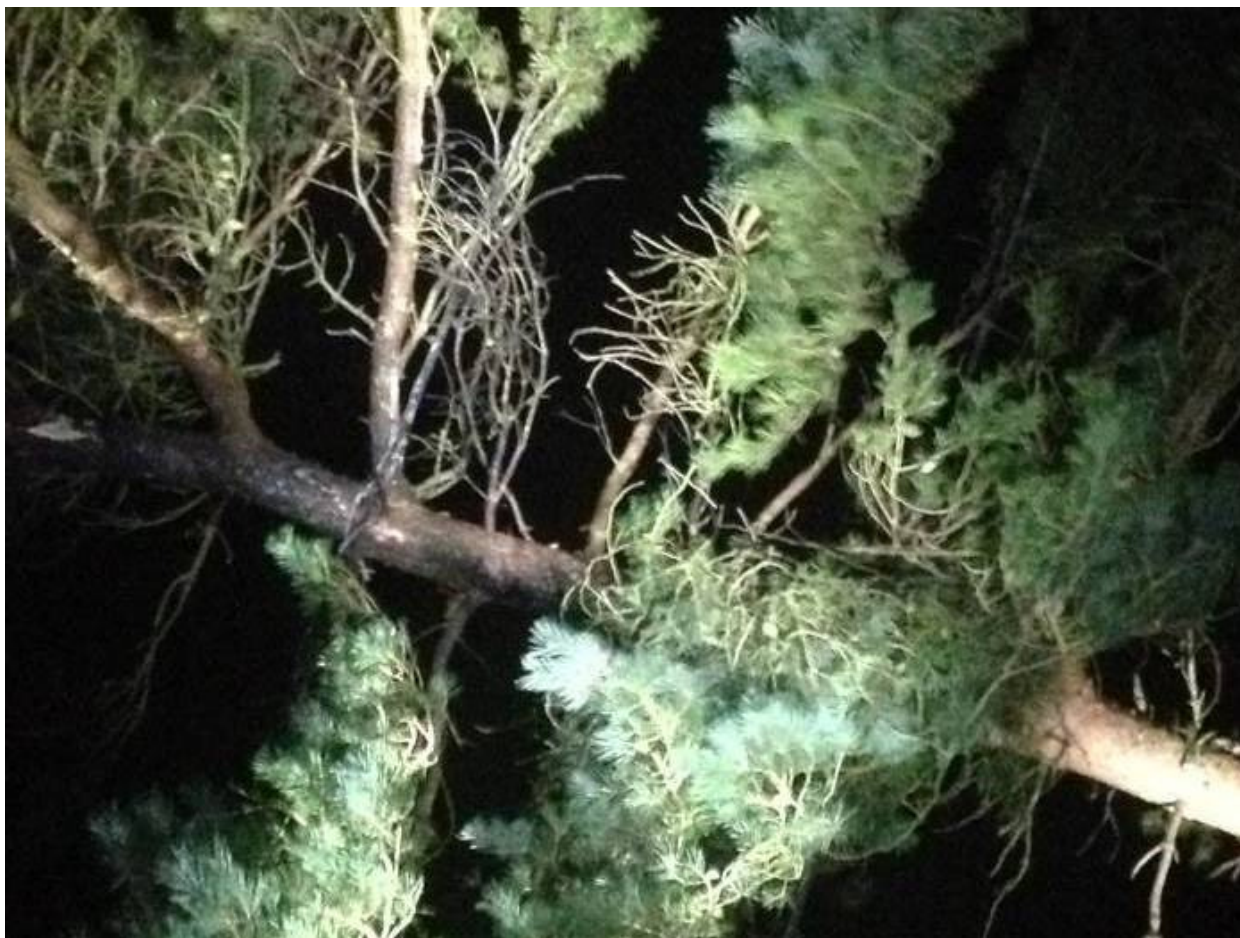
A5(d). The tree in question fell from outside the agreed 20m cut swathe as confirmed on the Clearance Consent Form. It should be noted that the tree did not break but was up-rooted as a result of strong winds and saturated ground conditions.

Photograph 1 – The fallen tree as found at the time of the incident

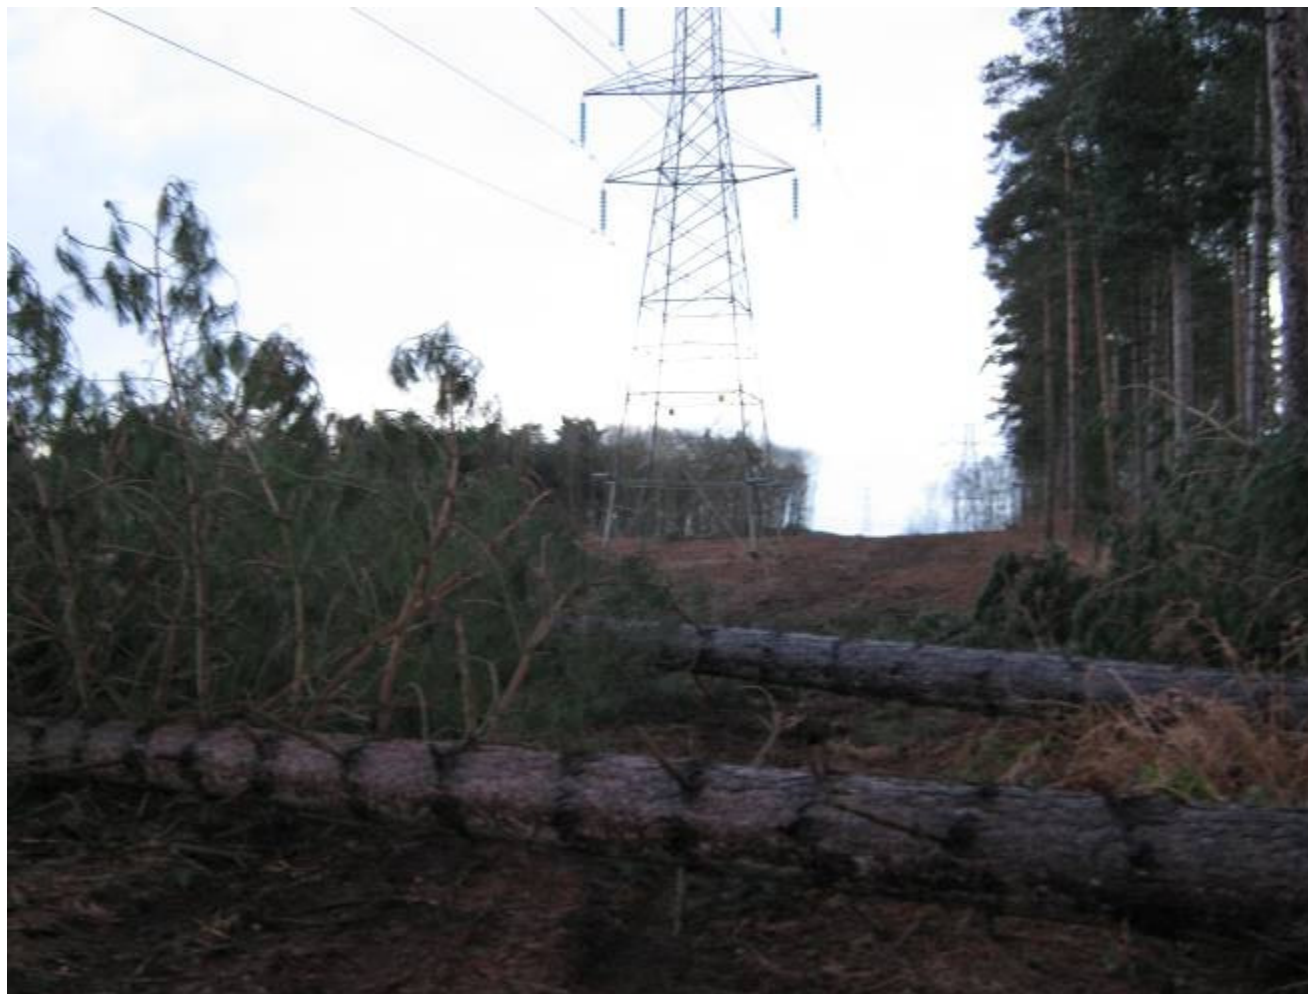
A3(d). The clearance at the site of the incident is restricted by the landowner to 20m, with dead or diseased trees outside the restricted cut cleared if at risk of falling onto the double-circuit.

Photograph 2 – The cut swathe and the fallen tree

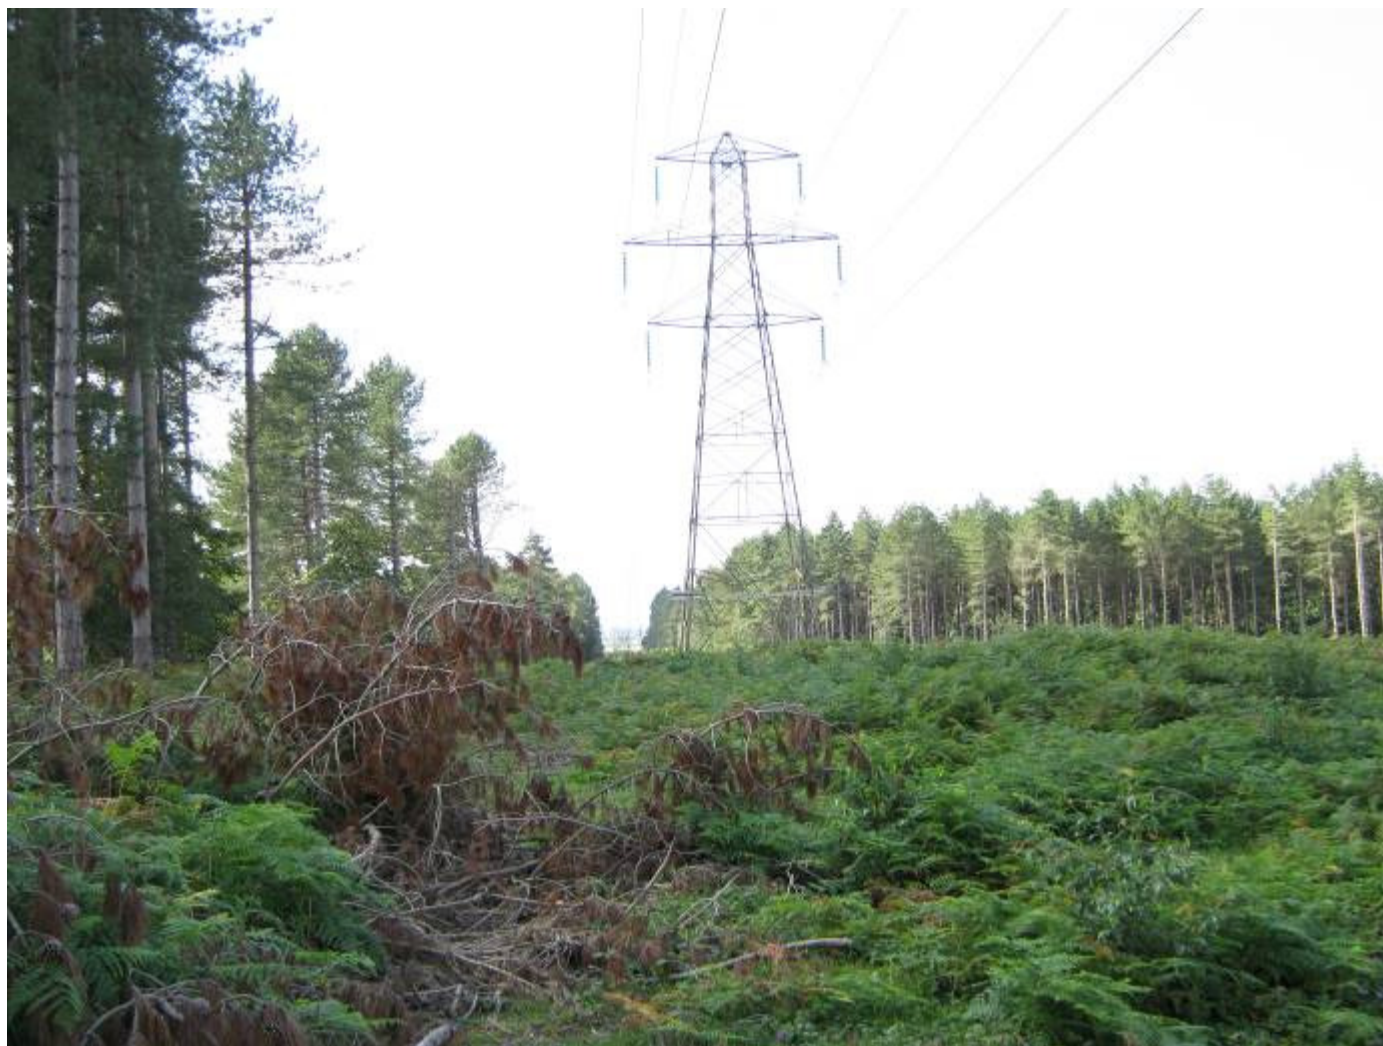
Photograph 3 – The cut swathe in September 2014 – taken just prior to the audit visit

A7. UK Power Networks' tree manager is in regular contact with the landowner and continues to work with the landowner to improve tree clearance in this area. Since this incident additional tree clearance has been agreed with the landowner and work started on 15 September 2014 to clear the trees in the area to the north of the double-circuit tower line from which the tree fell that caused this incident.

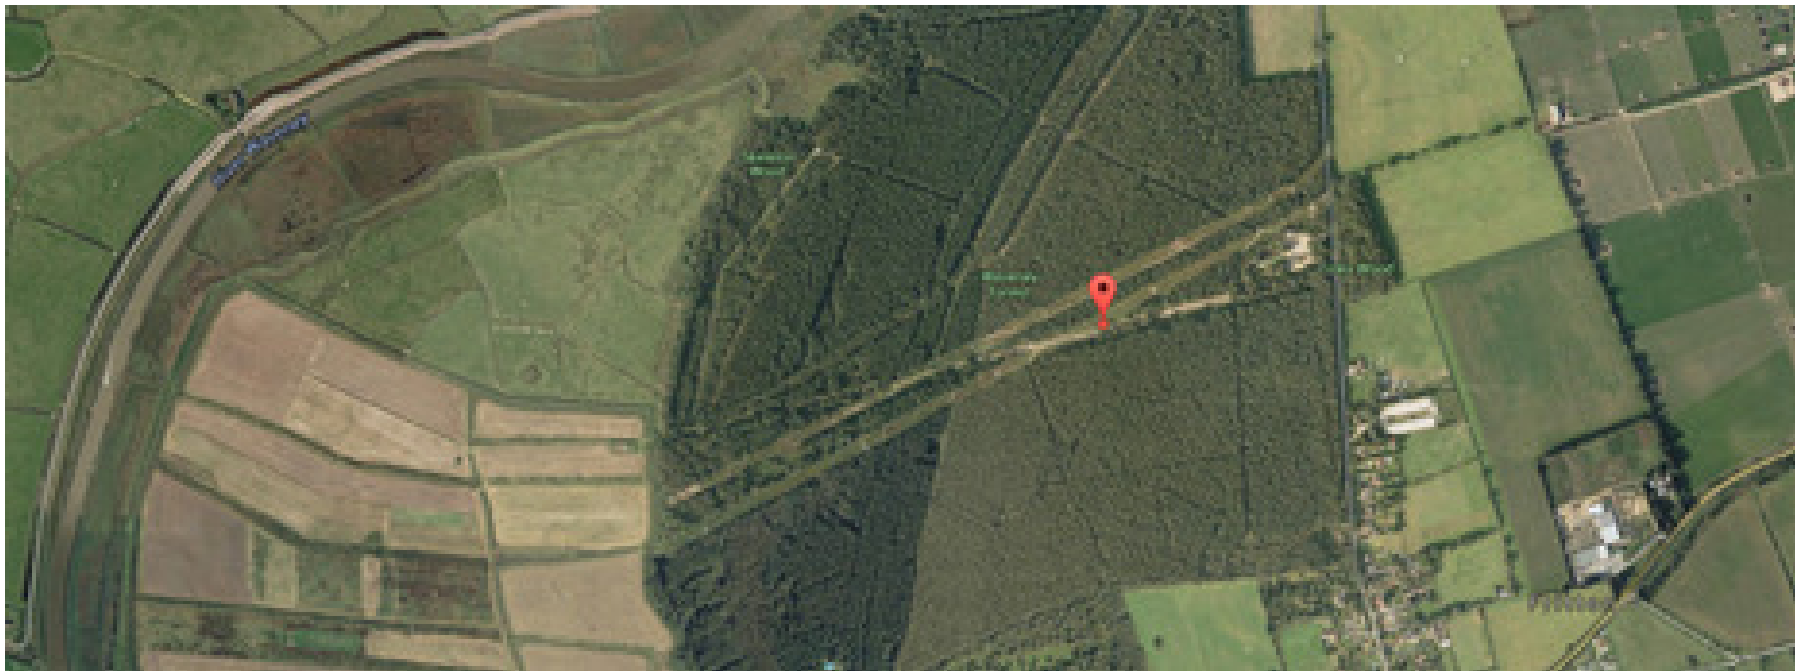
Photograph 4 – The cut swathe taken from “Google Earth”

Note: The photograph shows two parallel cut swaths; both are for UKPN's 132kV tower lines.

The one relevant to this event is the northerly one.

A5(b). UK Power Networks is in regular contact with the landowner and continues to negotiate with the landowner to gain increased clearances. On 15 September 2014 work started to clear the trees between the PPA tower line and the PAC tower line following further negotiations with the landowner. *[AE's note: this is the belt of trees between the two cut swathes which are clearly visible from "Google Earth" as shown in photograph number 4].*
