**Appointed examiner's audit of Exceptional Event Claim -
Northern Powergrid (Northeast)
33kV Incident at Scarborough Grid Substation
11 April 2013**

Title: Northern Powergrid – Audit of Exceptional Event Claim – Northern Powergrid (Northeast) – Scarborough Grid Substation – 11 April 2013

Reference: ep/Ofgem/NPG/11 Apr '13

Date: 18 October 2014

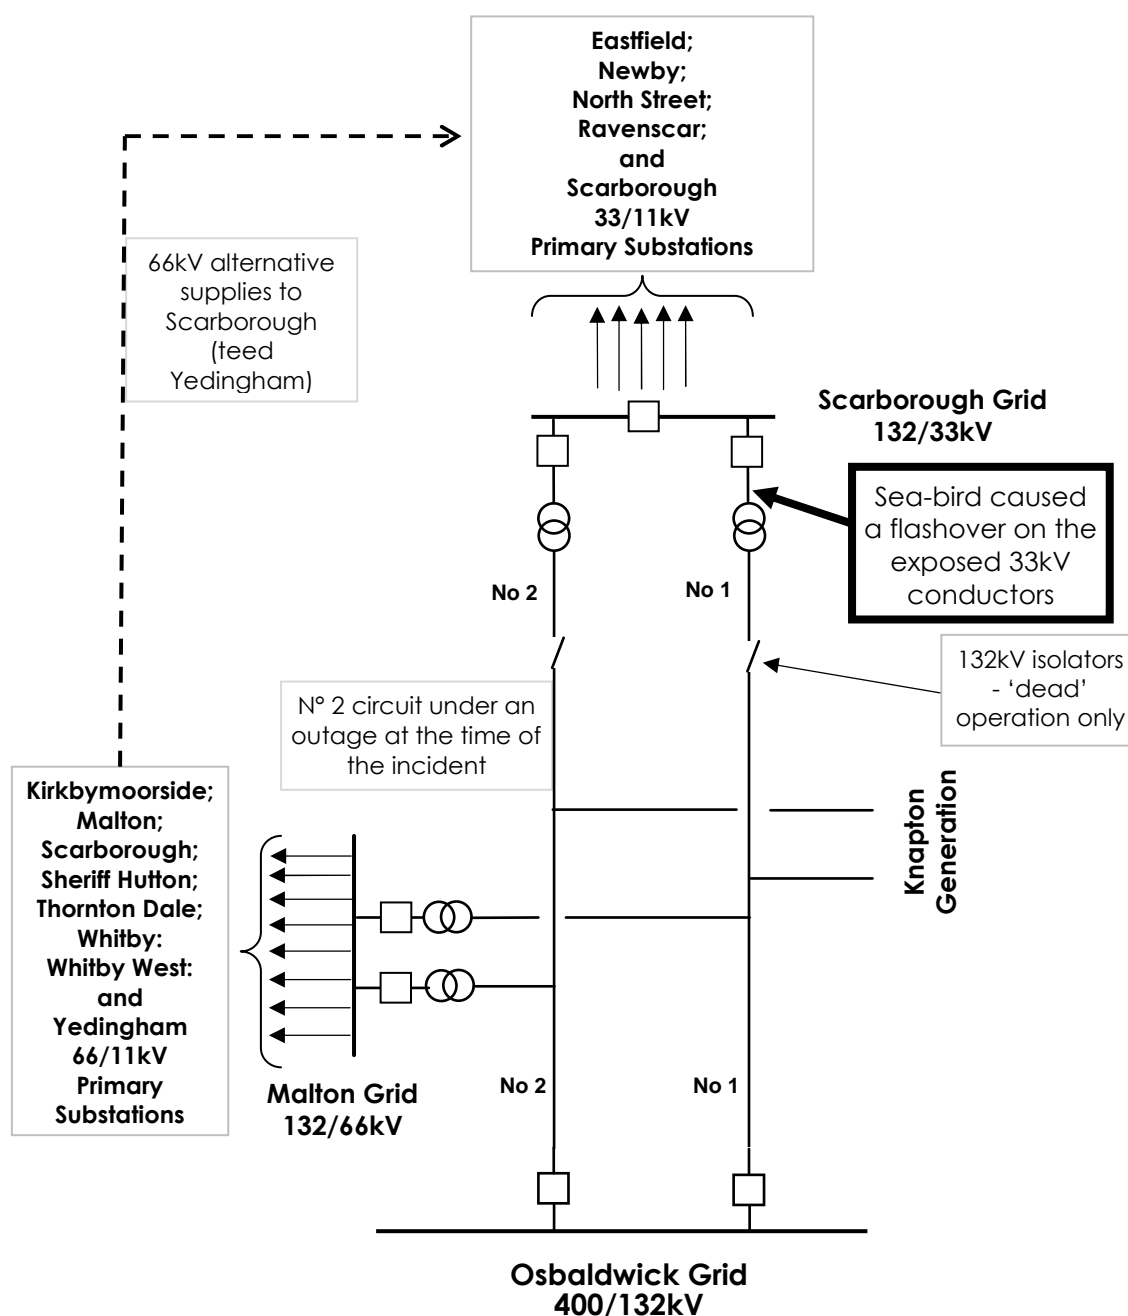
Figure 1 – Simplified Network Diagram of NPG's 132/66/33kV distribution networks affected by the incident

1. Only the salient items of switchgear are shown.
2. NPG's network was running abnormally at the time of the incident, the number 2 132kV infeed to Scarborough Grid Substation was under an outage.
3. The outgoing 33kV feeders from Scarborough Grid Substation are shown schematically.
4. Following inspection of the exposed 33kV conductors by NPG's personnel, supplies were restored by tele-controlled switching.

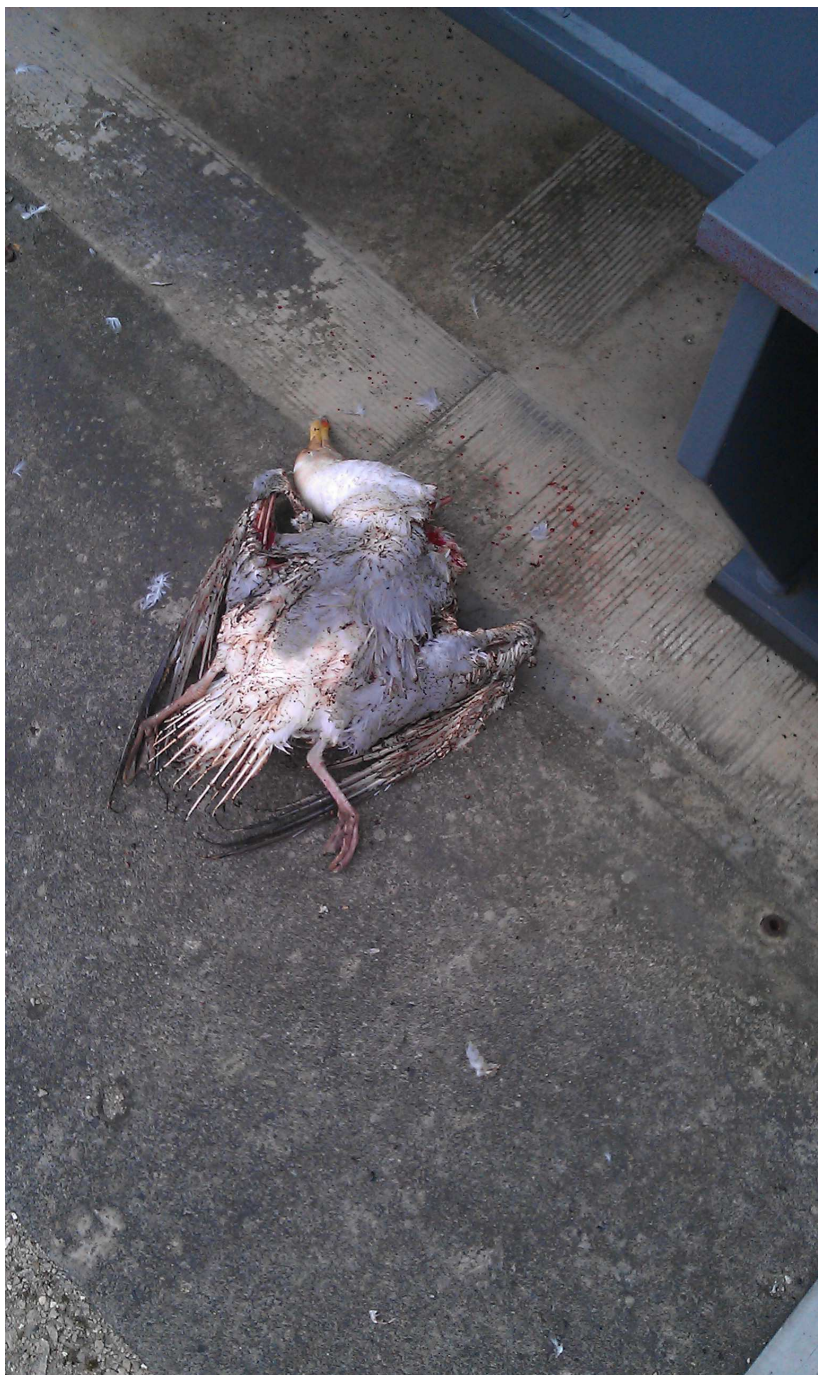
A14. NPG's photographs show the gull at the base of Grid Transformer No.1 directly below the exposed 33kV bus bars which are situated above labels 'a' and 'b'. From the available evidence it was surmised that the gull bridged the two 33kV busbars with no resultant traces of flash-marks caused by electromagnetic arcing. *[AE's note: The sequence of events is consistent with the sea-bird having caused a flash-over – the lack of charring on the carcass tends to indicate that the bird had only slight contact with the exposed conductors before NPG's protection operated to clear the incident from its distribution system].*

87. The dead sea-bird found below the exposed 33kV conductors is consistent with an electric arc having occurred and with the operation of overcurrent relays that detected a flashover of the 33kV conductors within the protection zone of the 132/33kV Grid Transformer.

Photograph 1 – The dead sea-bird at the foot of the 33kV side of the number 1 132/33kV Grid Transformer

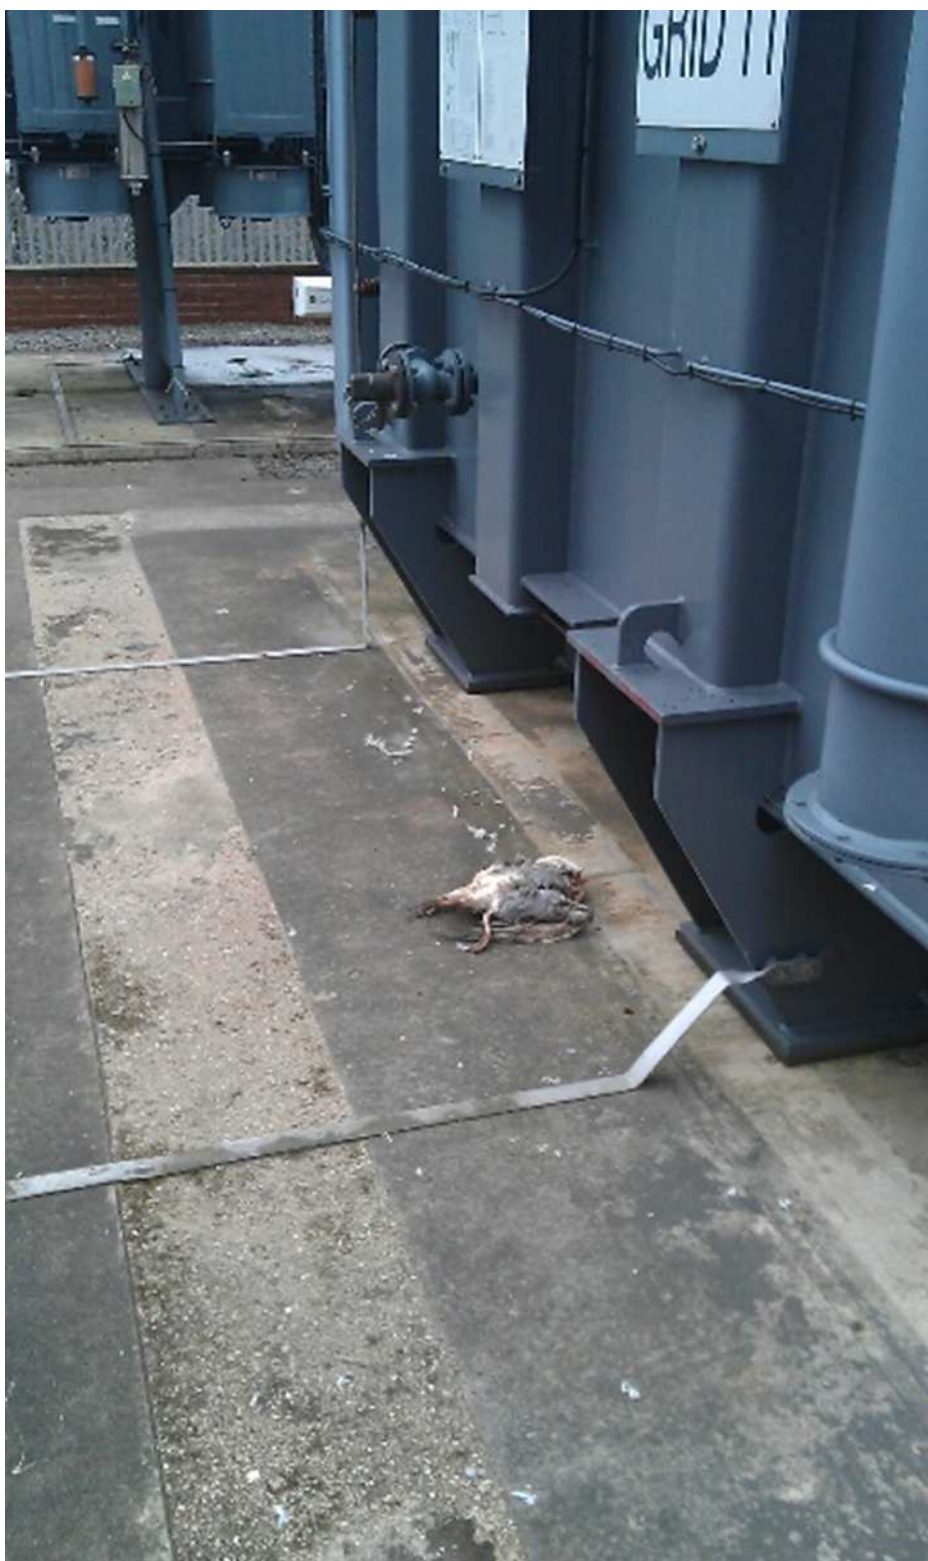
Photograph 2 – The dead sea-bird in relation to the number 1 132/33kV Grid Transformer

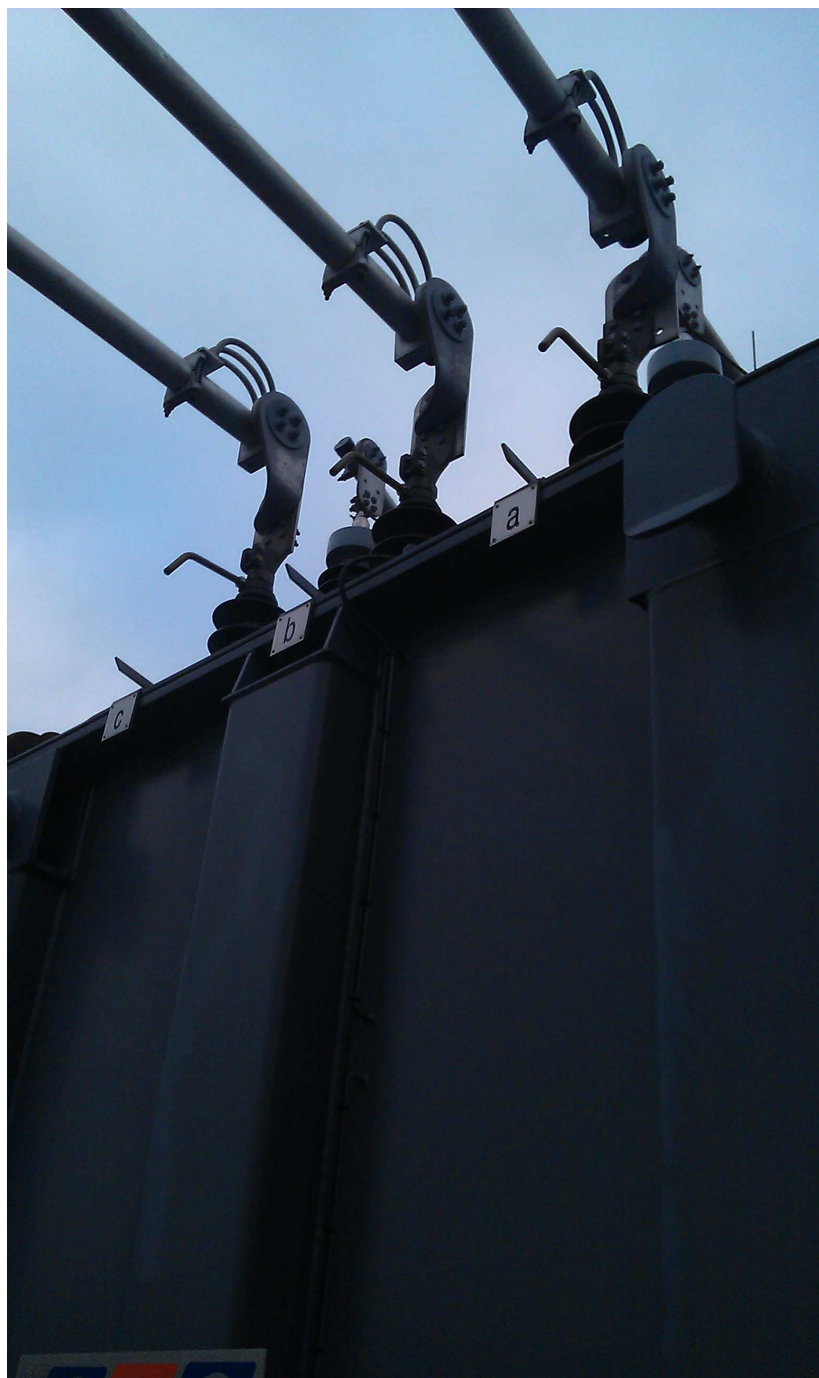
59. Upon investigating at Scarborough Grid Substation, NPG personnel reported the cause of the incident to be a sea-bird precipitating a flashover on the exposed 33kV connections of the number 1 132/33kV Grid Transformer and that there was no permanent damage to NPG's equipment.

A4. Following the bridging of two exposed 33kV busbars on the top of Grid Transformer No. 1 at Scarborough Grid substation, creating a phase to phase fault, 33kV overcurrent protection operated at Scarborough Grid (as noted in items 33 and 68 in the associated NMS Fault Log), initiating both an auto-reclose sequence of the 132kV feeder at Osbaldwick and auto-isolation of Grid Transformer No. 1 at Scarborough Grid. *[AE's note: NPG has provided a copy of its NMS fault log which confirms the above sequence of events].*

Photograph 3 – The exposed 33kV connections of the number 1 132/33kV Grid Transformer at the time of the incident

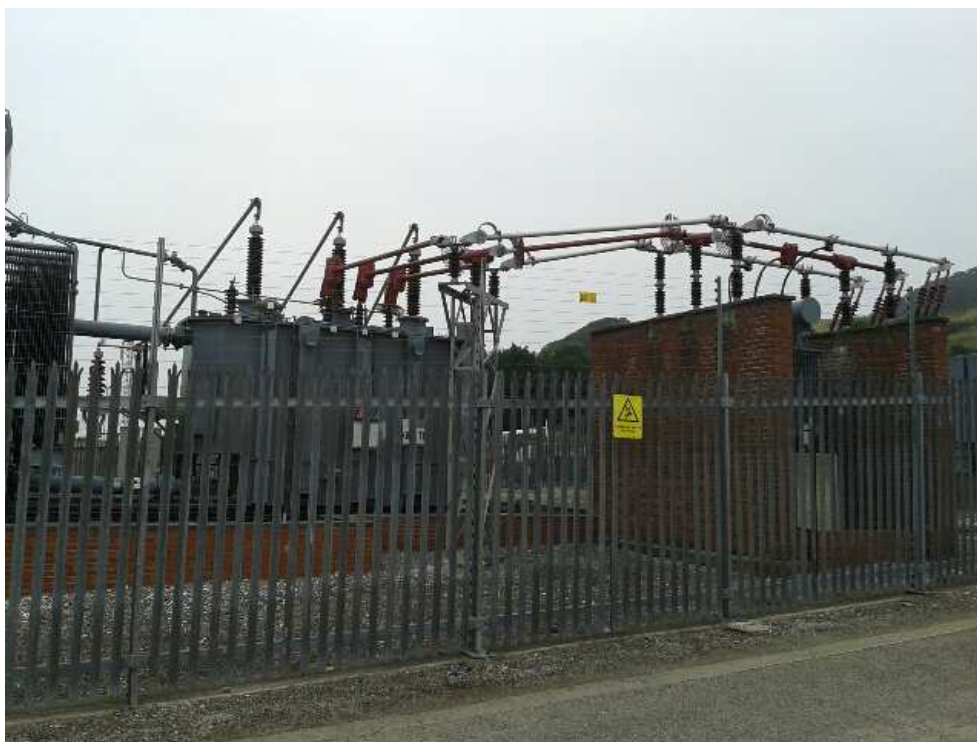
Photograph 4 – A recent view of the number 1 132/33kV Grid Transformer at NPG's Scarborough Grid Substation showing the additional shrouding of the 33kV bushings and overhead conductors

A11. Following the incident, insulated shrouds were fitted to Grid Transformer No. 2 33kV bus bars and bushings on April 25, 2013 and to Grid Transformer No. 1 on July 5, 2013 to minimise the risk of flashover causing either a non-damage or a damage fault at this substation. *[AE's note: See NPG's photographs 4 and 5].*

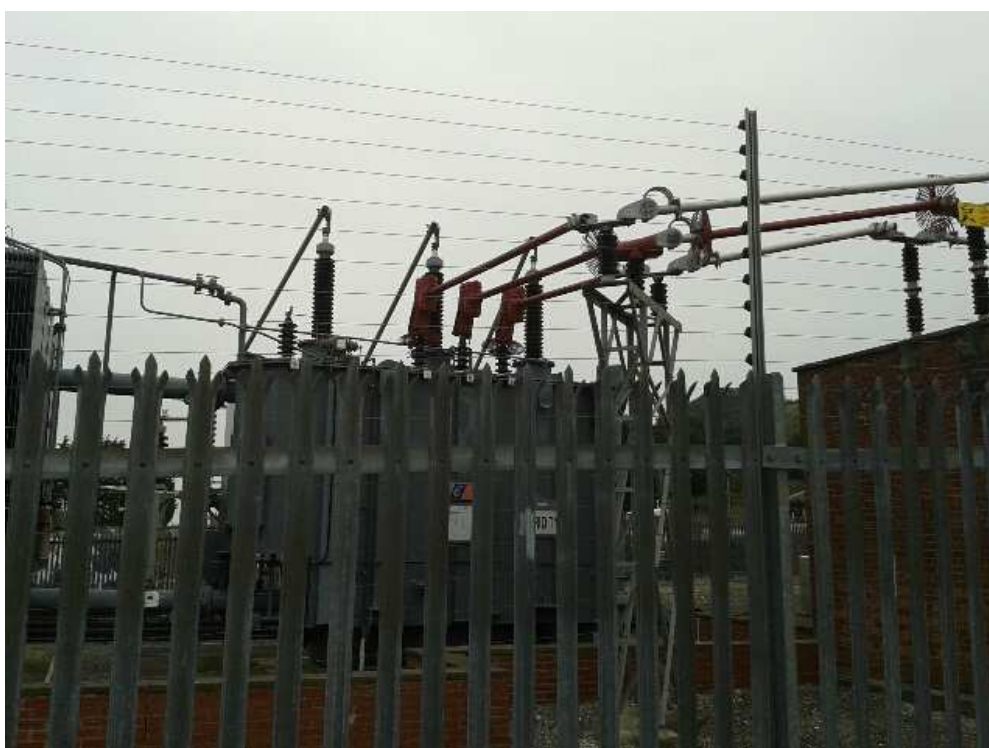
73. Subsequent to the incident, NPG has taken additional measures to prevent a reoccurrence,
74. Images from "Google Maps" dating before the incident show NPG's Scarborough Grid Substation to be surrounded by an 'unclimbable' palisade fence in accordance with accepted UK practice for this type of substation. The fence is in good condition and carries statutory warning notices.

Photograph 5 - A close-up of the fence surrounding NPG's 132/33kV Scarborough Grid Substation showing the electrified wire extension above the 2.4 metre-high 'unclimbable' palisade palings
