**Appointed examiner's audit of Exceptional Event Claim -  
Electricity Northwest Limited - Blackburn Group  
30 April 2013**

Title: ENWL – Audit of Exceptional Event Claim – Blackburn Group – 30 April 2013

Reference: ep/Ofgem/ENWL/30 Apr '13

Date: 29 November 2014

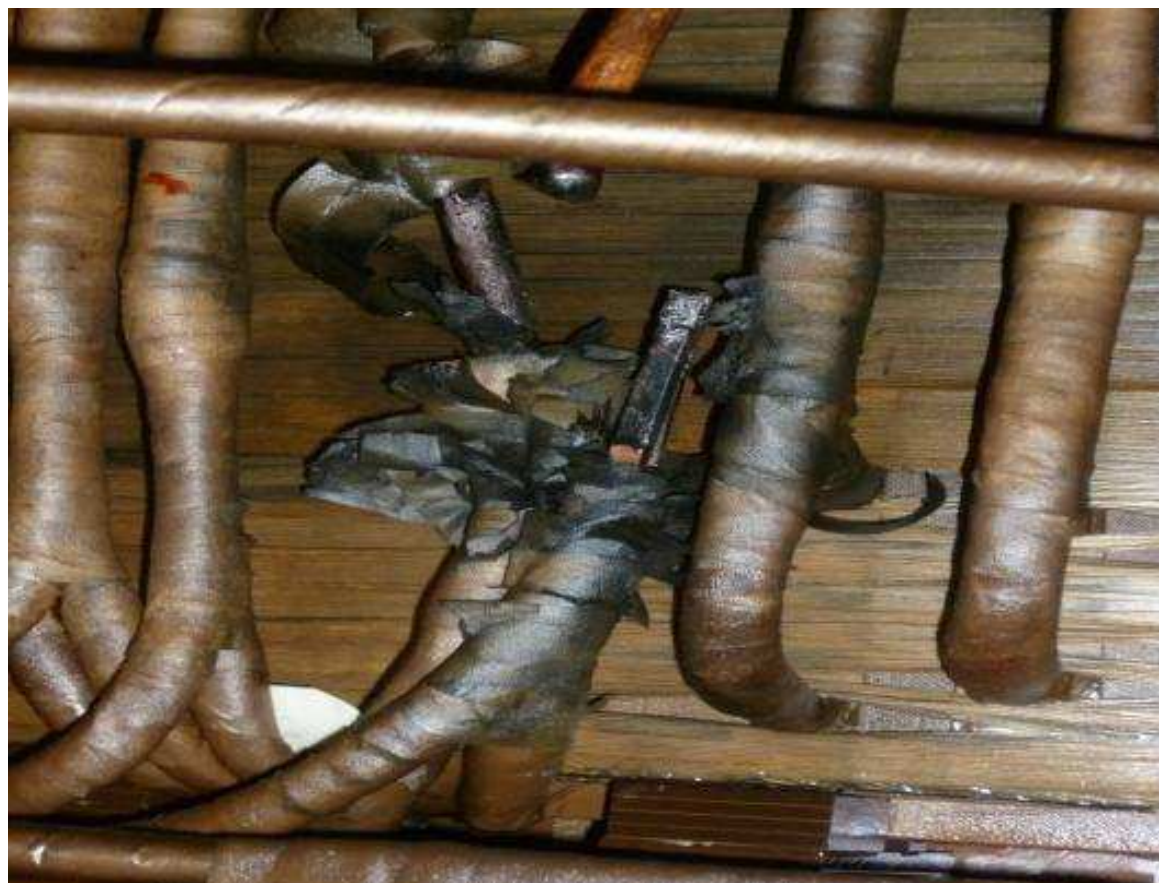
30. Meanwhile, ENWL's engineering team replaced the faulted unit with the unit intended to become the uprated number 2 Grid Transformer.
31. After extensive investigation by the manufacturers, the cause of the failure of the number 1 132/33kV Grid Transformer was found to be a "one-off" manufacturing defect within the tap-changer.

A23. The tap changer is of an identical type and we have included details of similar units on our system in Appendix 11 of our SoF. As per the report submitted from the manufacturer the fault was due to an incorrectly tightened connection. All other units have been inspected via endoscope to confirm there are no defects. No other defects of this type have been found in ENWL.

78. ENWL's sequence of photographs taken during the investigation at the manufacturer's works and included with its SoF show the internal damage caused to the Grid Transformer by the manufacturing defect. As an example, Photograph 1 of this report shows the damage to the internal connections of the failed Grid Transformer.

Photograph 1 – The failed tapping lead weld resulting from the manufacturing defect within the tap-changer of GT1 at Blackburn Grid

**AE's note (continued):** ENWL is commended for having devised and used a method whereby the potentially suspect connections can be reliably inspected within a relatively short period of time; hence safeguarding its customers from incidents due to the identified cause of the failure of GT1 at Blackburn Grid Substation].

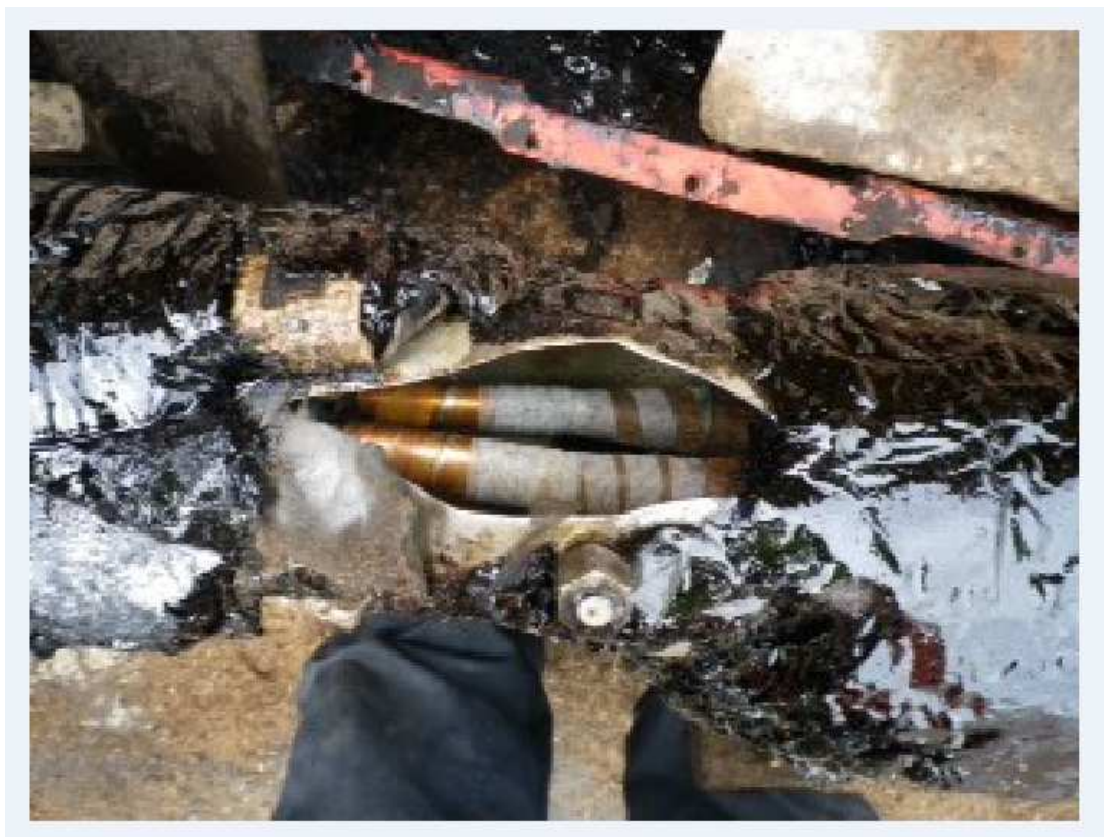
32. The cause of the failure of the 33kV fluid-filled underground cable joint was found to be the rupturing of the conical 'end-piece' of the metal sleeve surrounding the conductors of the joint itself.

79. ENWL's photograph 2 of the ruptured outer casing of the 33kV joint sleeve that failed demonstrates how much fluid must have been lost from the pressurised system at the time of the failure. The AE notes from the circuit records that the failed joint was at a pressurised tank position within the Griffin section of the cable route. This section is pressurised by three tanks with a total capacity of 735 litres which would have 'fed' the leak before the circuit faulted.

Photograph 2 – The ruptured casing of the failed joint of the 33kV fluid-filled cable

28. Once energised, this temporary arrangement enabled ENWL to de-energise the faulted 33kV underground cable, locate and repair the fluid leak and return the cable to service, thus maximising the security of supply to its customers in the Blackburn Group.
