**Appointed examiner's audit of Exceptional Event Claim -
UK Power Networks (Eastern)
33kV Incident at Barnet Grid Substation
03 November 2013**

Title: UK Power Networks (Eastern) – Audit of Exceptional Event Claim
– UKPN (EPN) – Barnet Grid Substation – 03 November 2013

Reference: ep/Ofgem/EPN/03 Nov '13

Date: 25 May 2015

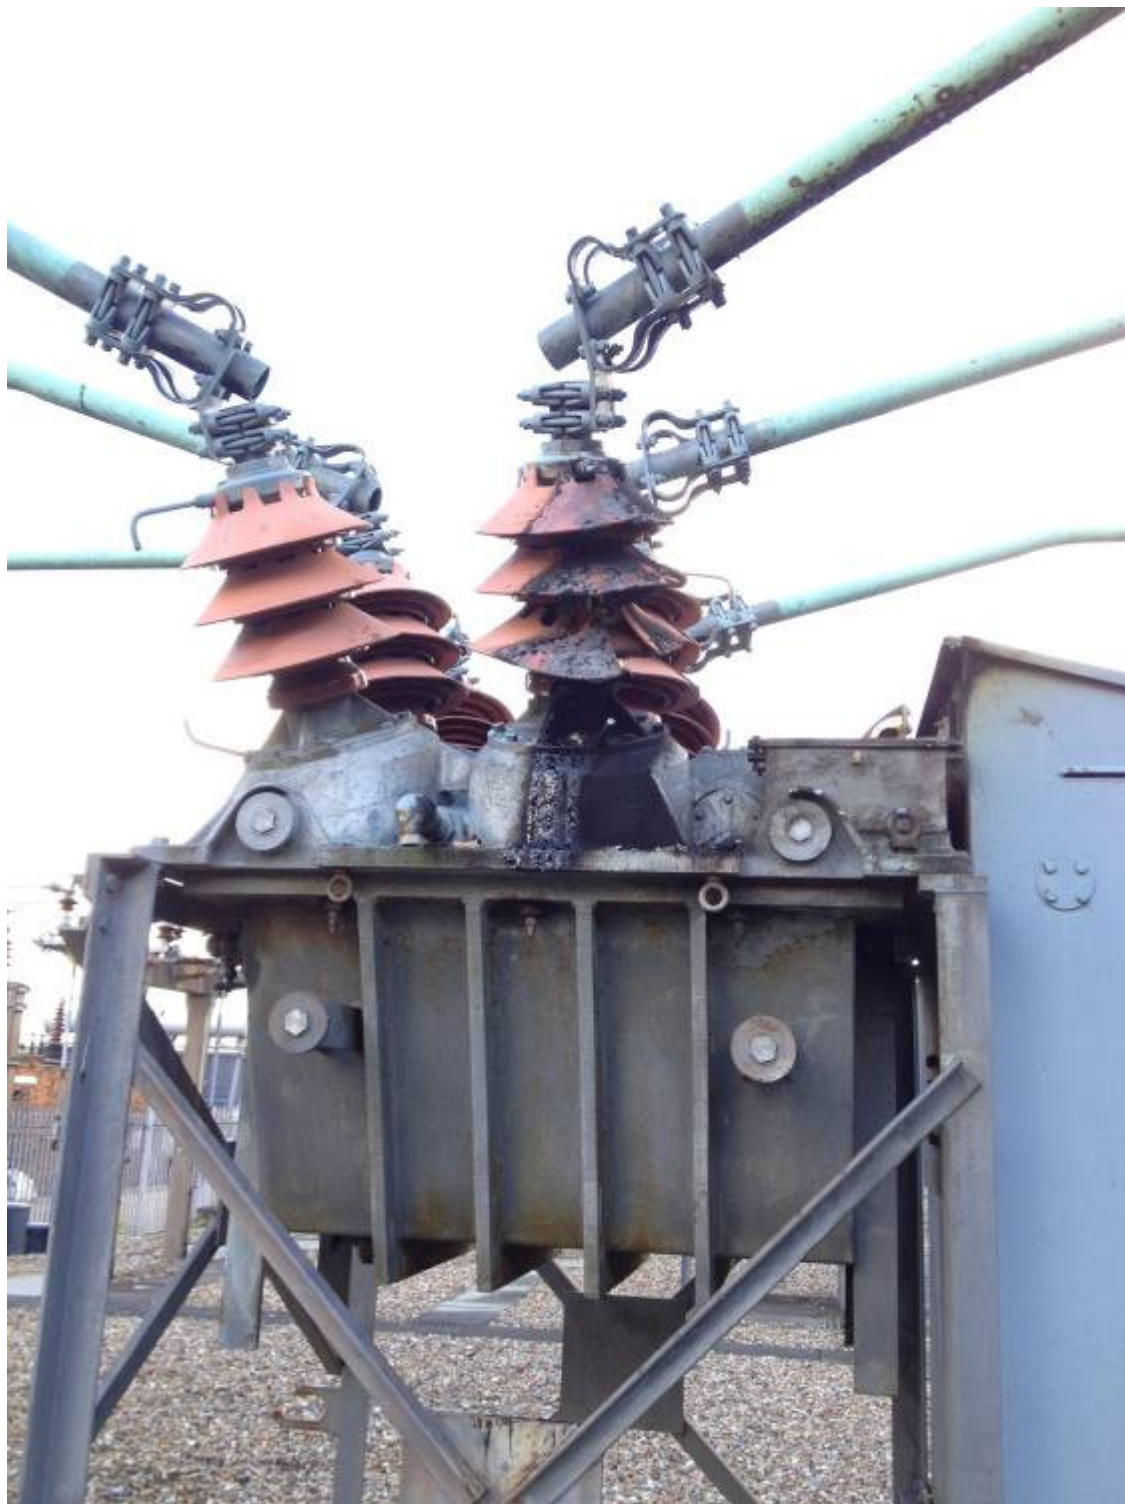
37. UKPN's photograph 1, taken at the time of the incident shows 33kV circuit-breaker 1TO and the irreparably damaged bushing.
38. UKPN's photograph 2 shows a close-up of the irreparably damaged bushing.

39. The damage to the porcelain bushing is clearly seen in both photographs, as are the additional rubber shields fitted to the 'sheds' of the bushing in order to protect it from such things as vandal damage, (stone throwing and shotgun pellets).

46. The irreparably damaged 33kV bushing is consistent with an internal fault developing that would not be detected despite UKPN's comprehensive non-invasive routine inspection and preventative maintenance measures.
47. The AE has studied the running arrangements of UKPN's 132/33kV distribution network supplying its Barnet Grid Substation and concludes that UKPN's protection systems worked correctly to clear the incident from UKPN's distribution system.
48. The AE commends UKPN's control engineers for analysing the situation, and for restoring supplies as rapidly as possible, thereby minimising the duration of the interruption.

Photograph 1 – The irreparably damaged bushing and its associated 33kV circuit-breaker

A16. A replacement vacuum circuit-breaker has been installed and is in the process of being commissioned.

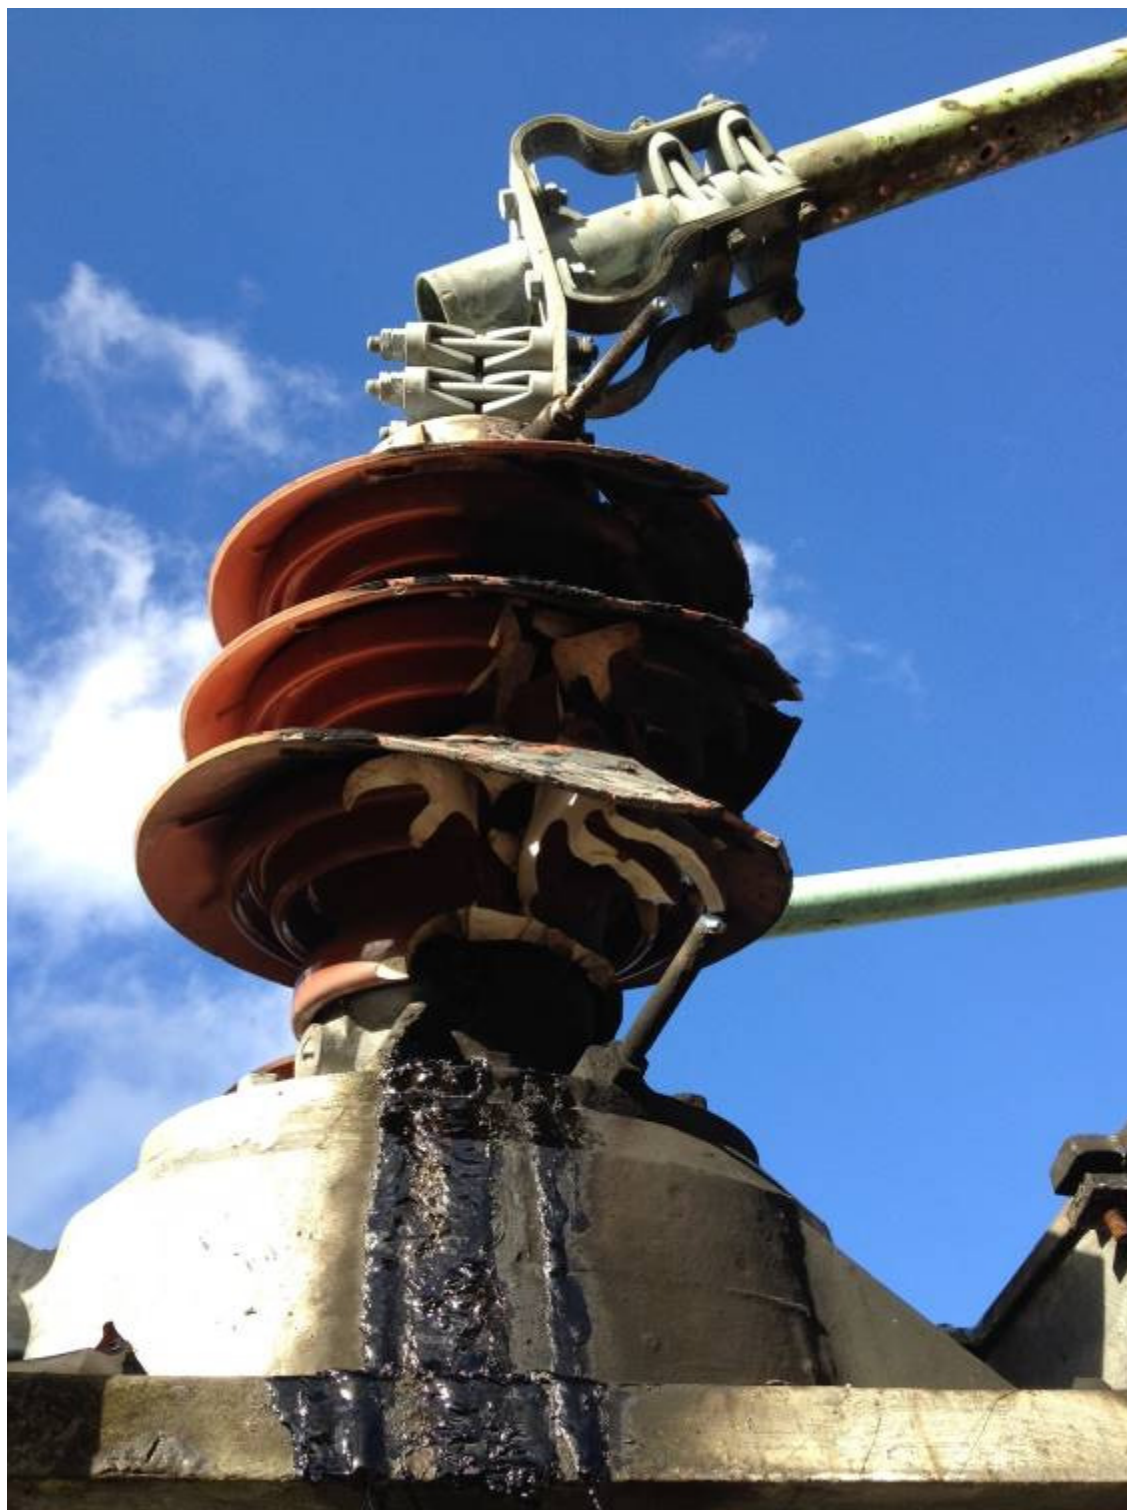
Photograph 2 – Close-up of the irreparably damaged bushing
