**Appointed examiner's audit of Exceptional Event Claim -
UK Power Networks (Eastern)
132kV incident – Warley Grid
21 July 2015**

Title: UK Power Networks (London) – Audit of Exceptional Event Claim – UKPN (EPN) – 11kV incident - Bengeworth Road – 21 July 2015

Reference: ep/Ofgem/EPN/21 Jul '15

Date: 20 October 2016

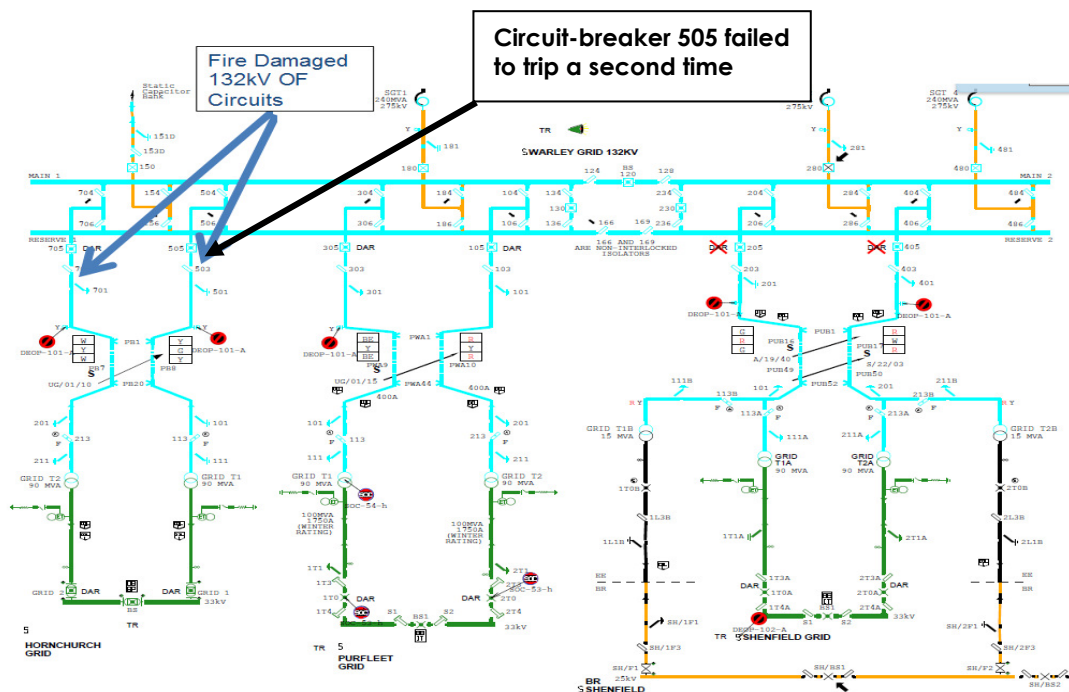
Figure 1 – Simplified Network Diagram of EPN's 132/33kV distribution system affected by the incident

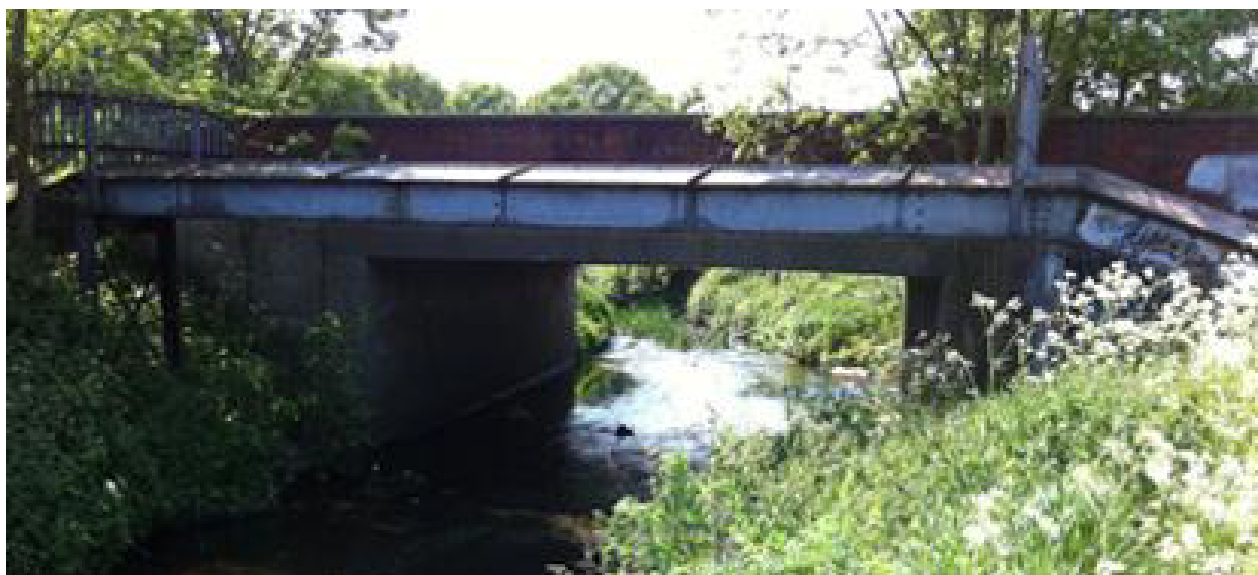
Photograph 1 - the steel-clad cable support structure adjacent to Hacton Lane

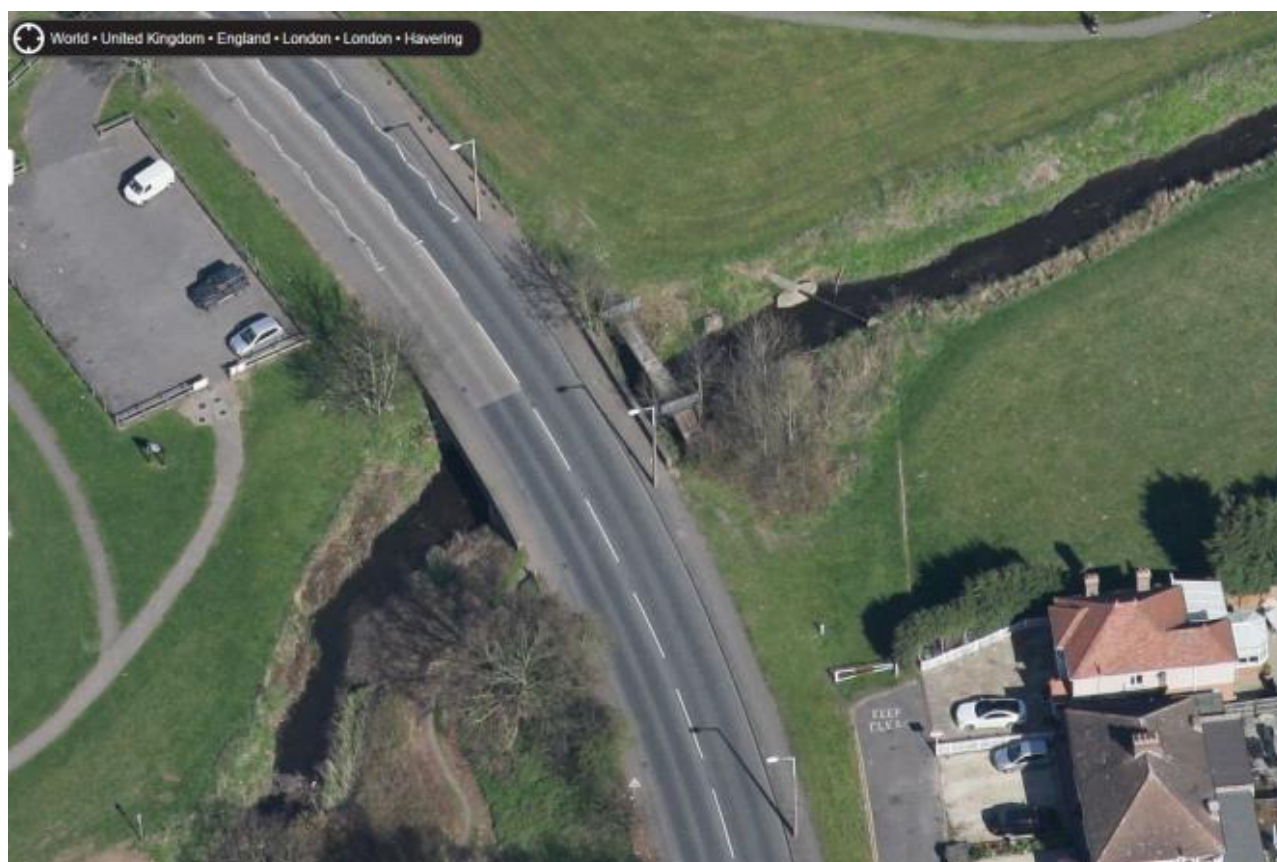
Photograph 2 – an aerial view of the cable support structure at Hacton lane

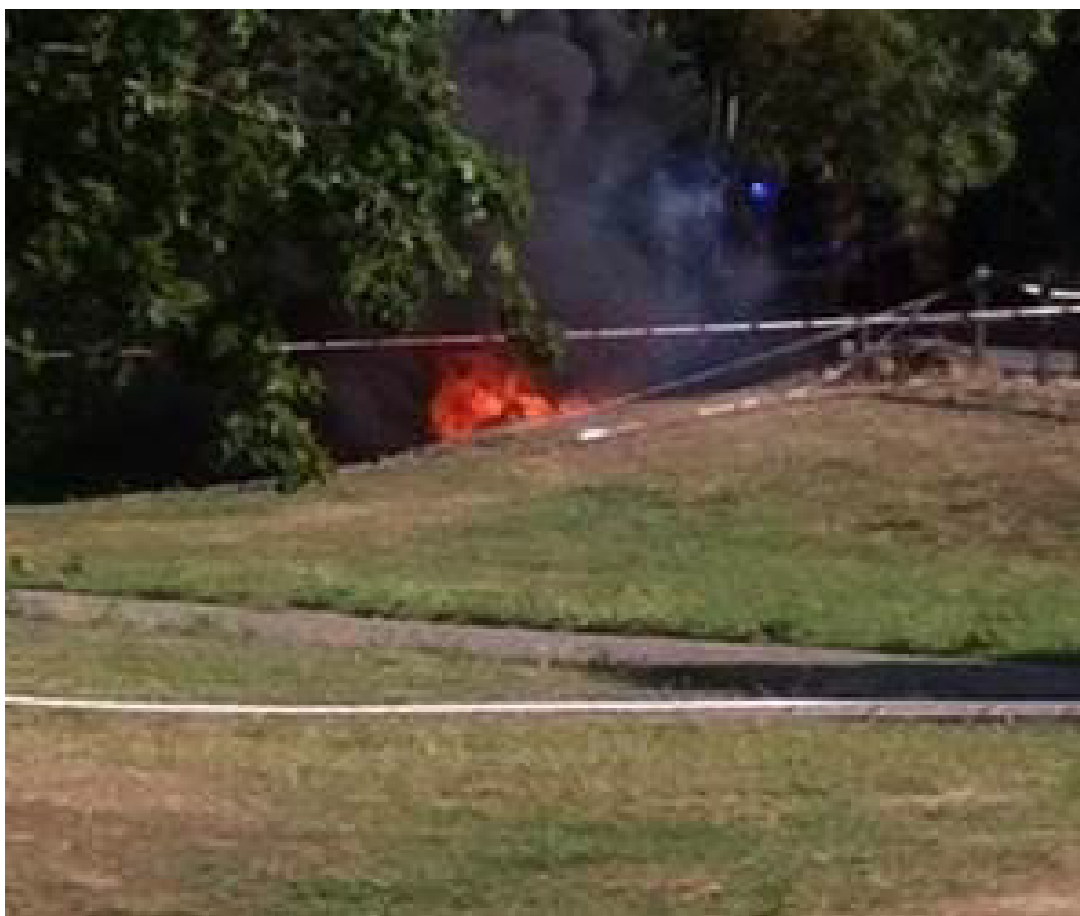
50. Following a call from the London Fire Brigade, the cause of the incident was confirmed to be due to a fire having been started in the confined space below the cable support structure in Hacton lane, Upminster, catching the undergrowth alight and resulting in the damage to the two fluid-filled cables.

A14. In the confined space under the north slope of the structure as shown to the AE during the audit visit. *[AE's note: the AE can confirm that the damage to the two fluid-assisted cables is consistent with a fire having been started in the confined space below the northern ramp of the cable support structure].*

Photograph 3 - the seat of the fire below the cable support structure

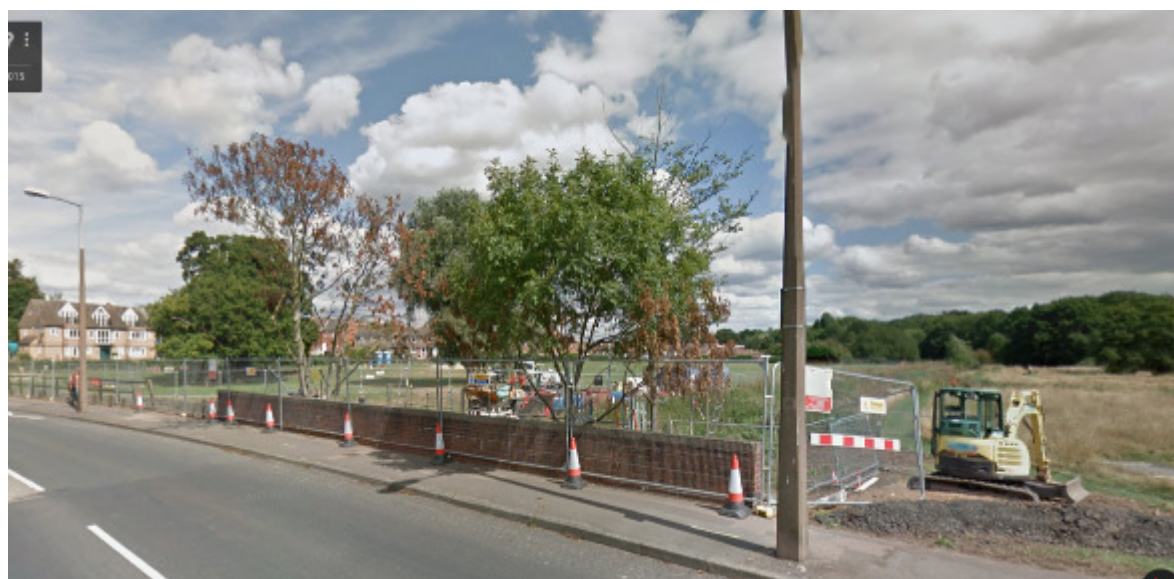
65. Photograph 4, copied from "Google Earth" shows the scene during August 2015 when EPN was working to repair the damaged cables and to improve the measures put in place to prevent third-party interference. The intensity of the fire can be gauged by the damage to the trees.

Photograph 4 - the scene of the incident in August 2015

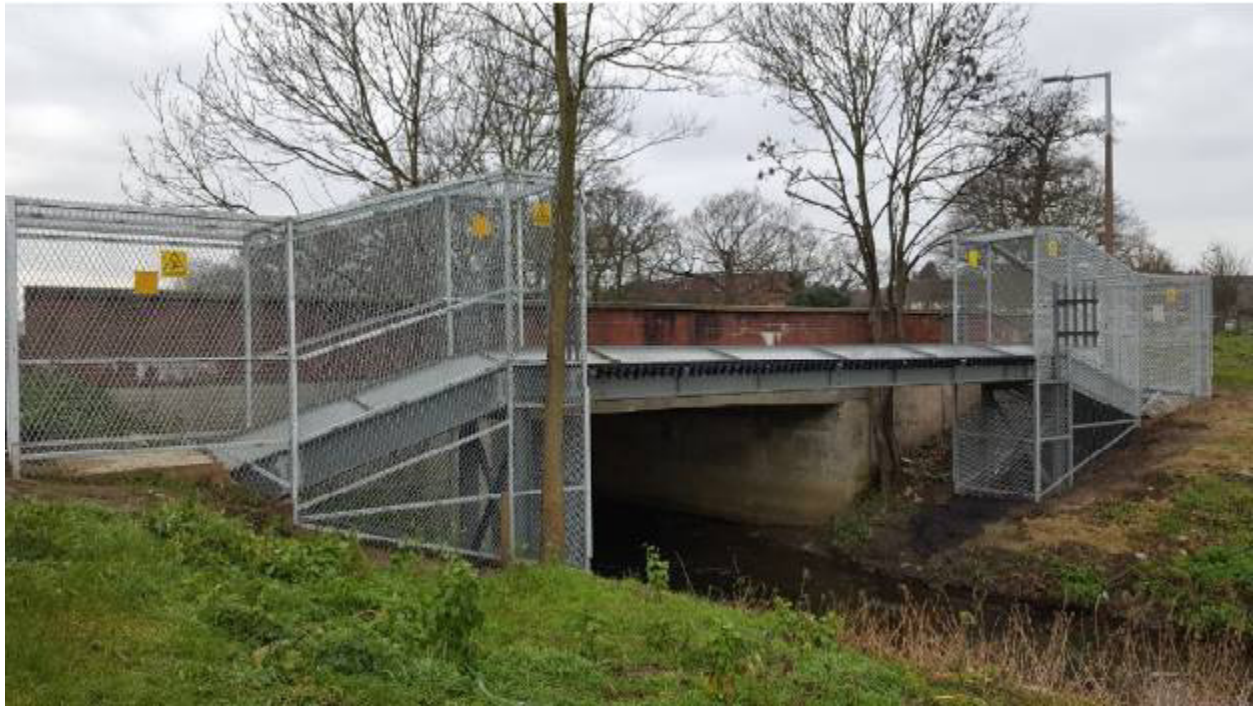
66. Photograph 5, specifically requested by the AE during the audit visit, shows the cable support structure after EPN had completed its repair work. As can be seen, new metal fences have been installed to prevent third-party access to the areas beneath the ramps of the cable support structure.

Photograph 5 - the support structure following the additional preventative measures

A28. As noted above, additional mechanical protection has been added to the cable support structure at Hacton Lane, Upminster and a review is underway to determine whether there are any other outstanding structures that need risk assessing.
