**Appointed examiner's audit of One-Off Exceptional Event Claim  
Western Power Distribution (South Wales)  
132kV incident – Swansea North to Ammanford  
07 November 2015**

Title: Western Power Distribution (South Wales) - Audit of One-Off Exceptional Event Claim - 132kV incident - Swansea North to Ammanford - 07 Nov 2015

Reference: ep/Ofgem/WPD(SWa)/07 Nov '15

Date: 28 October 2016

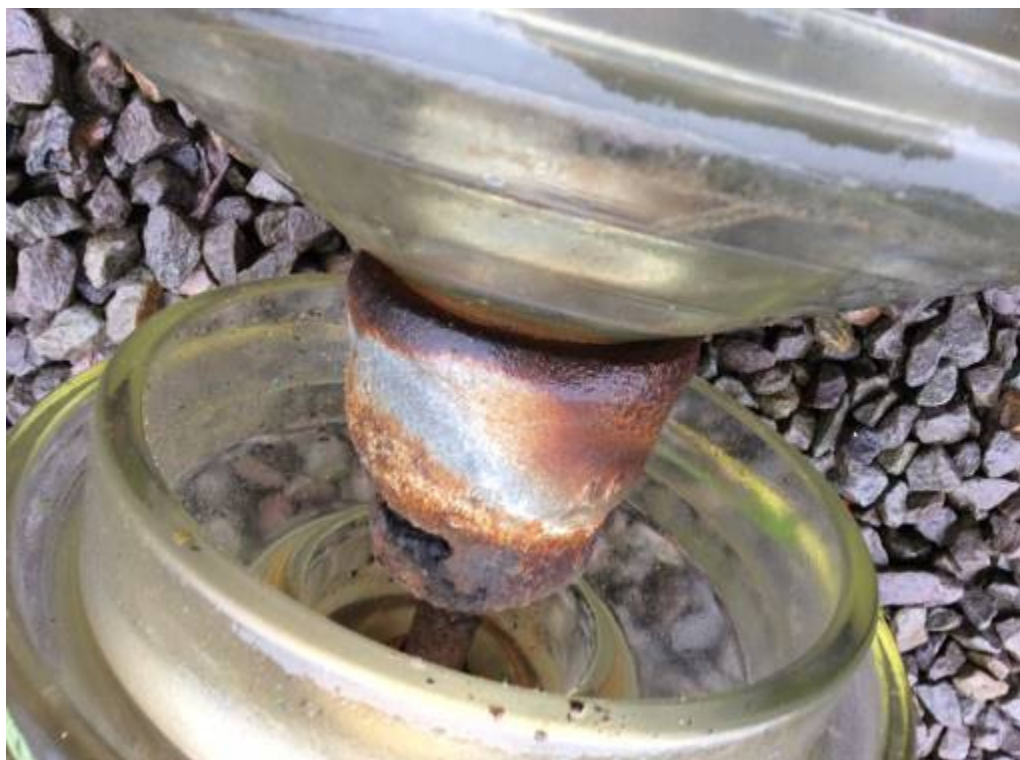
40. Following the incident, WPD carried-out a detailed examination of the failed insulator string, concluding that the failure was due to undetected corrosion of the pin which engages with the cap of the adjacent insulator.

53. WPD's examination of the mode of failure of the insulator string concluded that undetected corrosion between the metal parts of adjacent glass insulators within the string had sufficiently weakened the pin so that it pulled out of the metal cap of the insulator immediately below it.

Photograph 1 - the metal cap of the glass insulator at the point of failure

43. WPD has replaced all the insulator strings on the affected section of its 132kV double-circuit tower line and found no other instances of the type of corrosion seen at the point of failure on tower C67.

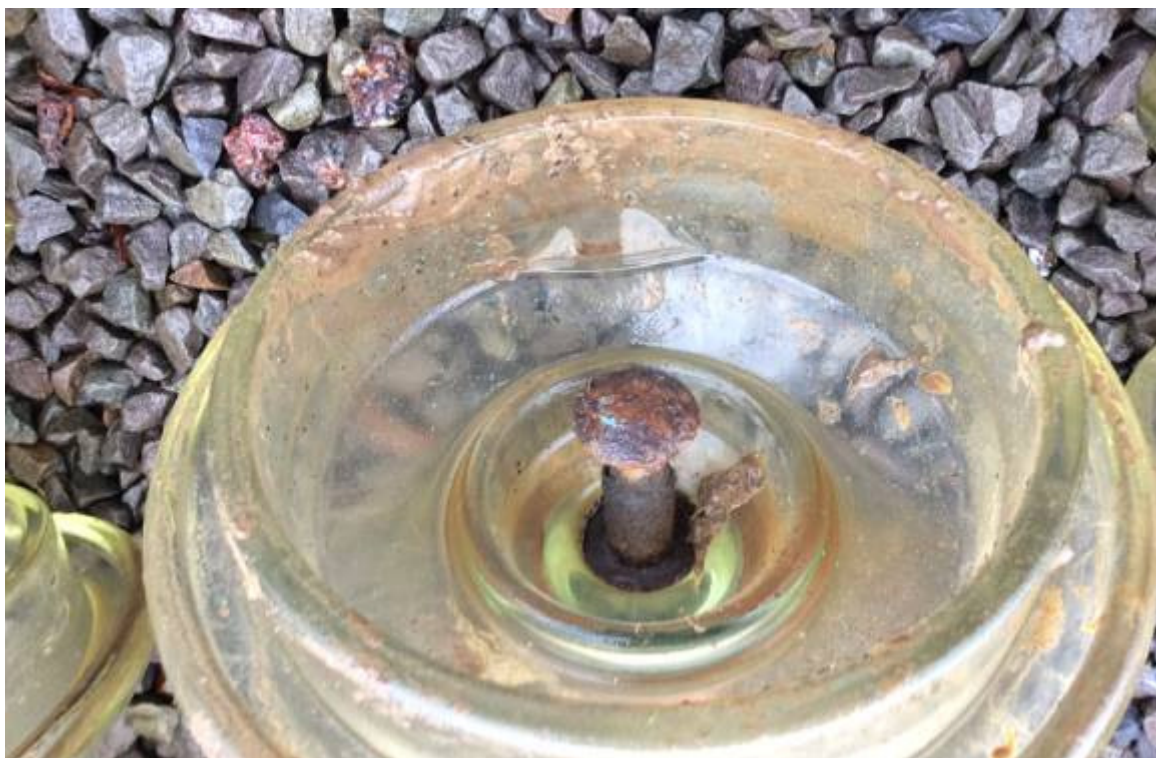
A3. The glass insulator set when lowered was examined and was "rigid" and non-flexible across a number of its connection points where cap meets pin, indicating seated corrosion. Local disassembly confirmed this.

Photograph 2 - the metal pin of the glass insulator at the point of failure

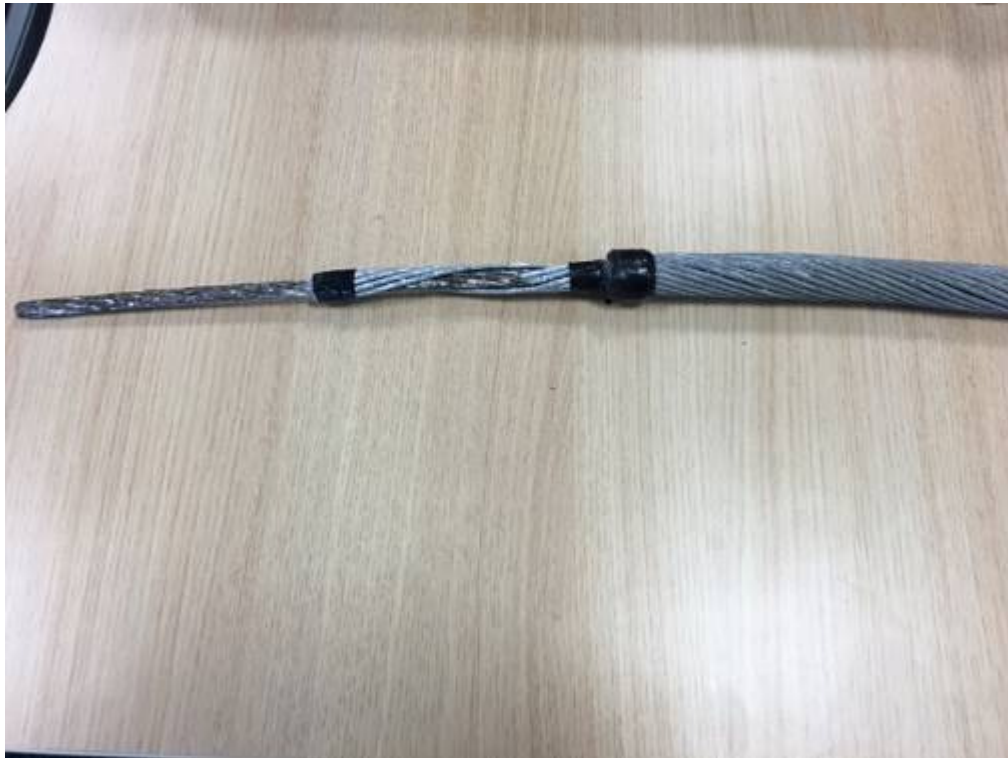
42. The actual cause of the failure was found to be undetected galvanic corrosion between the inner aluminium strands and the central steel core; the passage of the earth fault current being considered the reason it failed during the incident.

56. Photograph 3, specifically requested by the AE during the audit visit, shows the stripped-back earth wire, revealing the corrosion within the inner aluminium strands. The integrity of the outer aluminium strands is clearly seen in this photograph.

Photograph 3 - the corrosion within the failed earth wire

44. Similarly, WPD has replaced the tower-to-tower earth wire along the affected section of its double-circuit 132kV tower line and has found no other instances of galvanic corrosion.

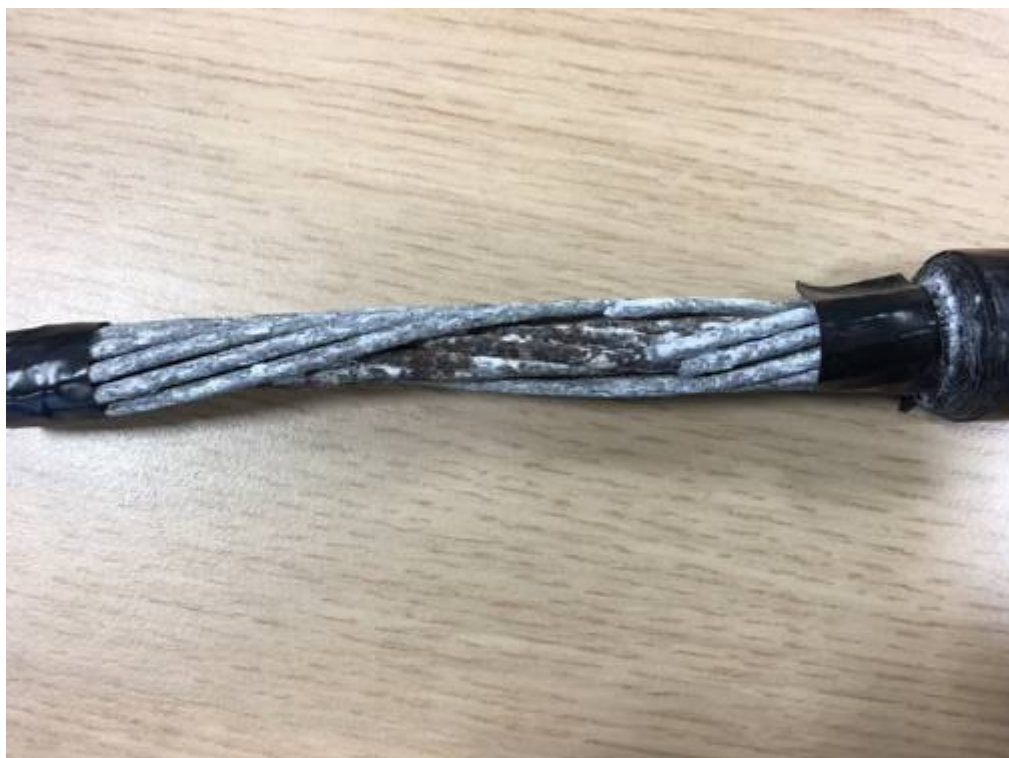
57. Photograph 4, also specifically requested by the AE during the audit visit, shows a close-up of the corrosion affecting the inner aluminium strands of the failed earth wire.

Photograph 4 - a close-up of the corrosion within the earth wire

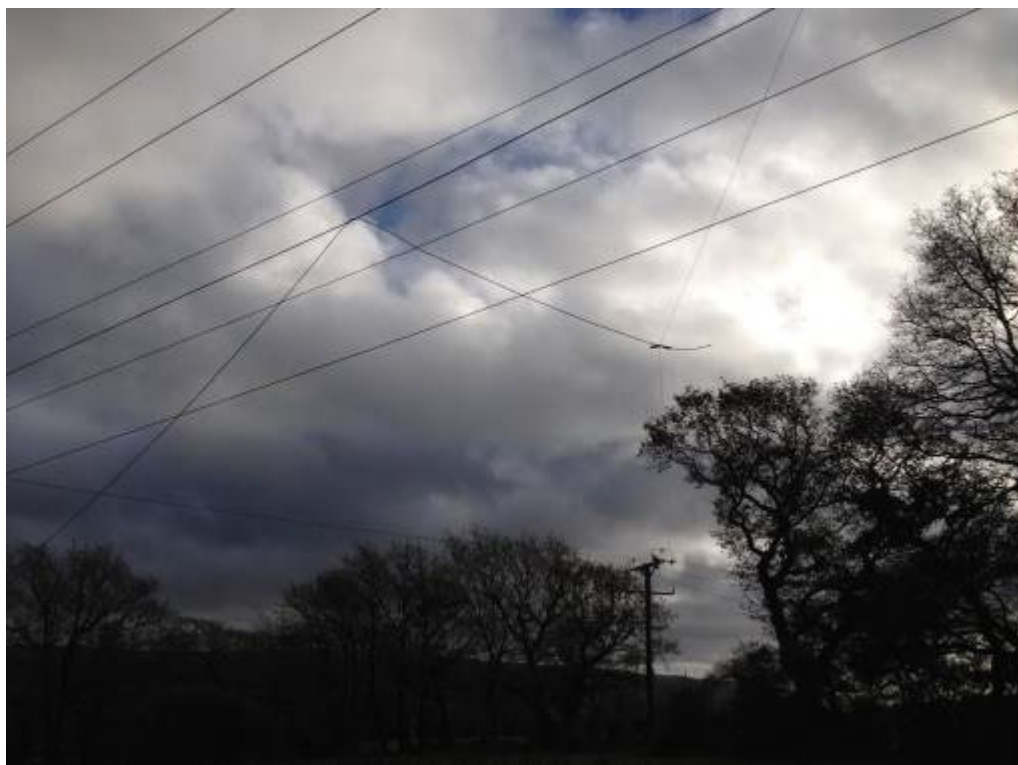
18. The failed earth wire also fell across an under-running 11kV overhead line, bringing down two of its three conductors and causing its controlling circuit-breaker to trip.

33. The virtually simultaneous failure of the tower-to-tower earth wire caused it to fall onto the number one 132kV circuit and the under-running 11kV overhead line.

**Photograph 5 - the failed earth wire lying on the number one 132kV circuit and on the under-running 11kV overhead line**

23. The customers supplied from the damaged 11kV overhead line were restored using mobile generators.
24. WPD removed the failed tower-to-tower earth wire, replacing it with a temporary over-ground arrangement until a permanent re-string was completed during week commencing 09 November 2015. At that time all suspension insulators were also replaced as a precaution against further failure.

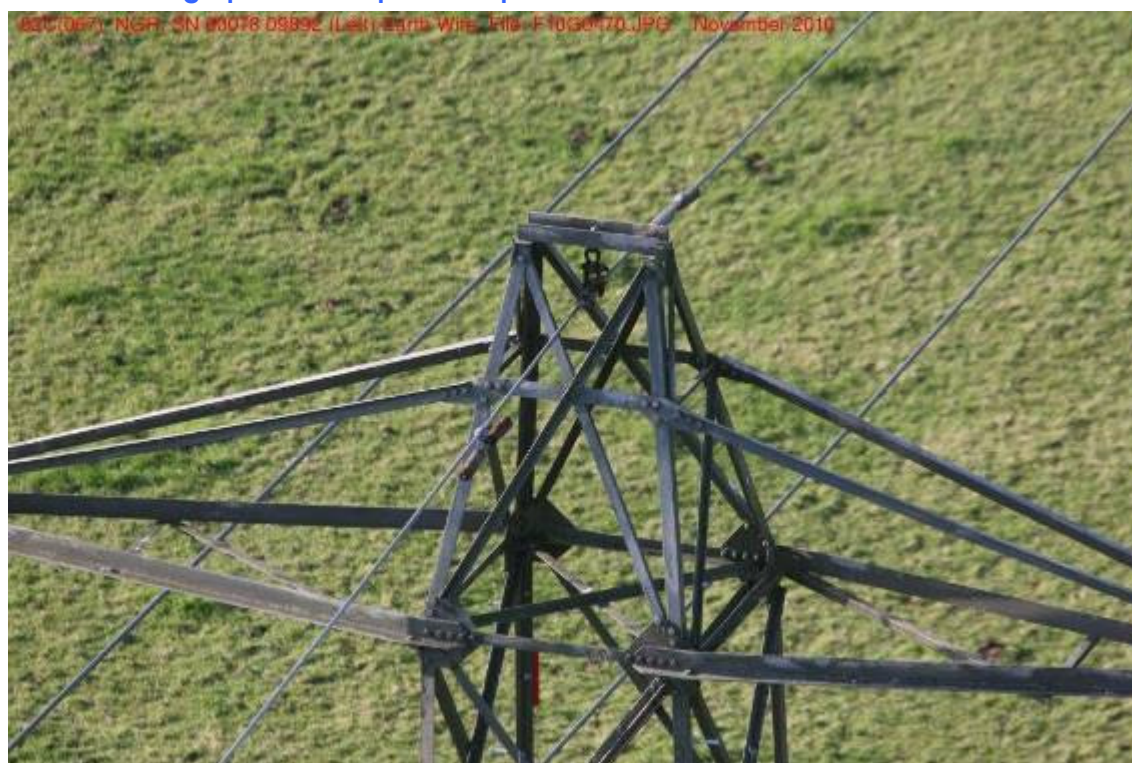
It should be noted that this was not externally visible and readily apparent to any visual check. *[AE's note: WPD has provided a high-resolution image of the clamp and apex at tower C67].*

**Photograph 6 – the apex clamp at tower C67 as seen in November 2010**

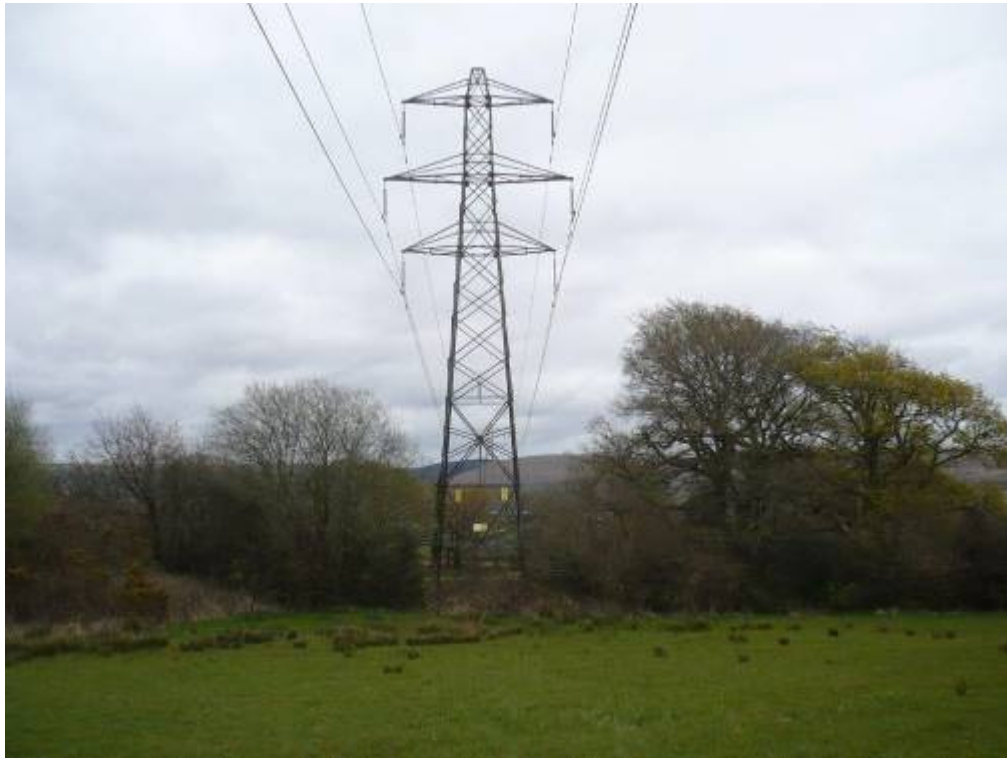
60. Photograph 7, again specifically requested by the AE, shows the disposition of the conductors and cross-arms at tower C67. It can be seen that the failure of the insulator string supporting an upper conductor would cause that conductor to fall onto the central cross-arm below.

Photograph 7 - a view of tower C67 showing the disposition of the cross arms

**AE's note:** from the photograph it is clear that the failure of the suspension insulator on an upper conductor would cause that conductor to fall onto the cross-arm below
