# **Culligran GT1 132/11kV Transformer**

**Level 1 Condition  
Assessment Report  
16th July 2020  
Report:  
CULLGT1SHET200629  
FINAL**

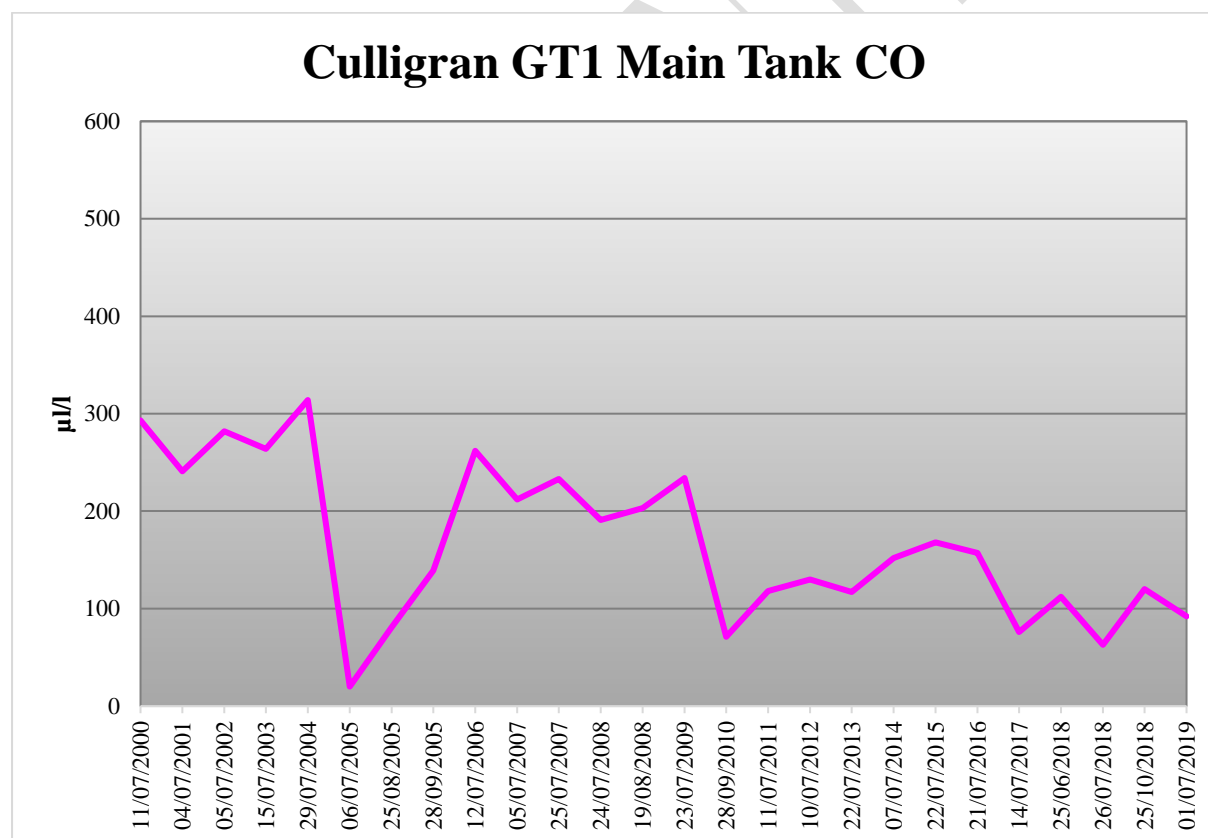
The CO characteristic is dynamic and has spikes, indicating periods of ageing but overall, exhibits a decreasing trend. All values remain below “typical values” specified in IEC 60599 over the sample period, peaking at 314 $\mu$ l/l in 2002. The paper insulation is likely in reasonable condition for its age.

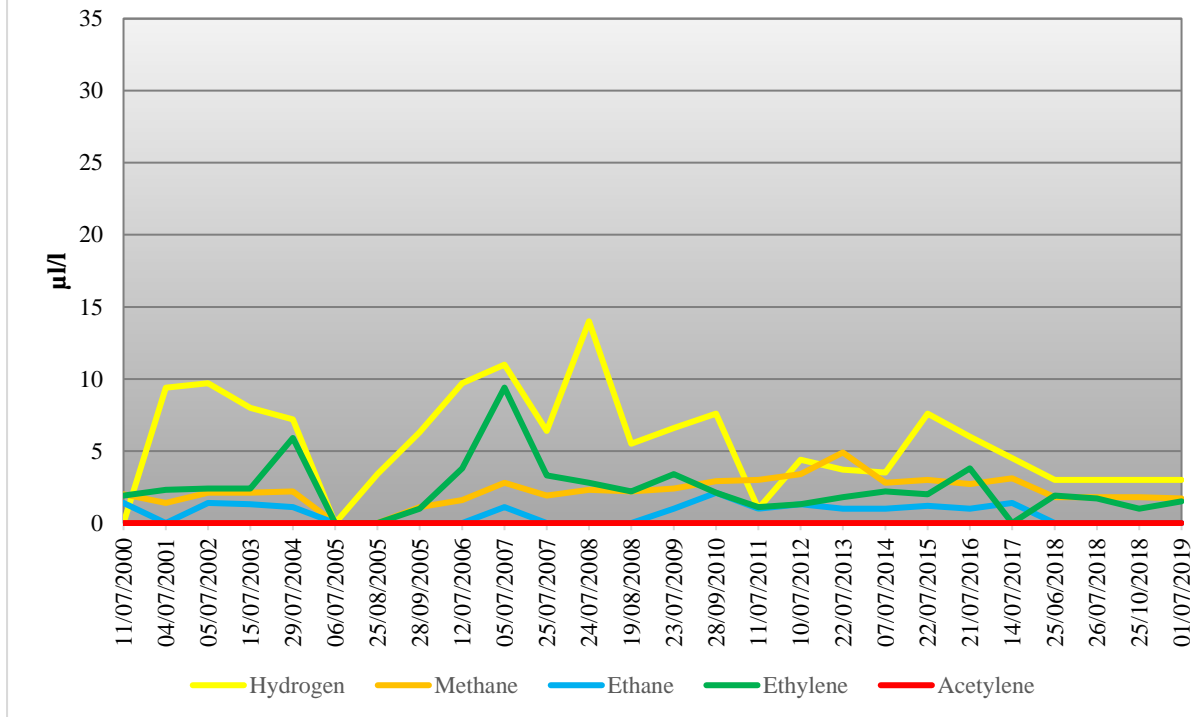
## Culligran GT1 Main Tank DGA

Thermal gases Methane, Ethane & Ethylene are present throughout the DGA history however, all remain at levels well below “typical values” specified in IEC 60599. There are two identifiable peaks in dissolved ethylene which have not manifested into a more serious underlying thermal condition.

Application of the gas ratios, as defined in IEC 60599, [0,0.66,undefined] fails to highlight a fault condition through a diagnosis of non-classification. Using the Duval’s triangle method of DGA interpretation, the same gas ratios define a “T2” condition, “Thermal faults, 300°C < T < 700°C”, however, it should be noted that the Duval method, being a closed system, will always result in a condition being identified. The magnitudes of dissolved gas levels are presently considered to be too low to accurately diagnose and in this case the DGA would be considered benign.

The DGA does not presently exhibit any evidence of partial discharge, discharge, or thermal abnormality. The DGA history can be described as benign.

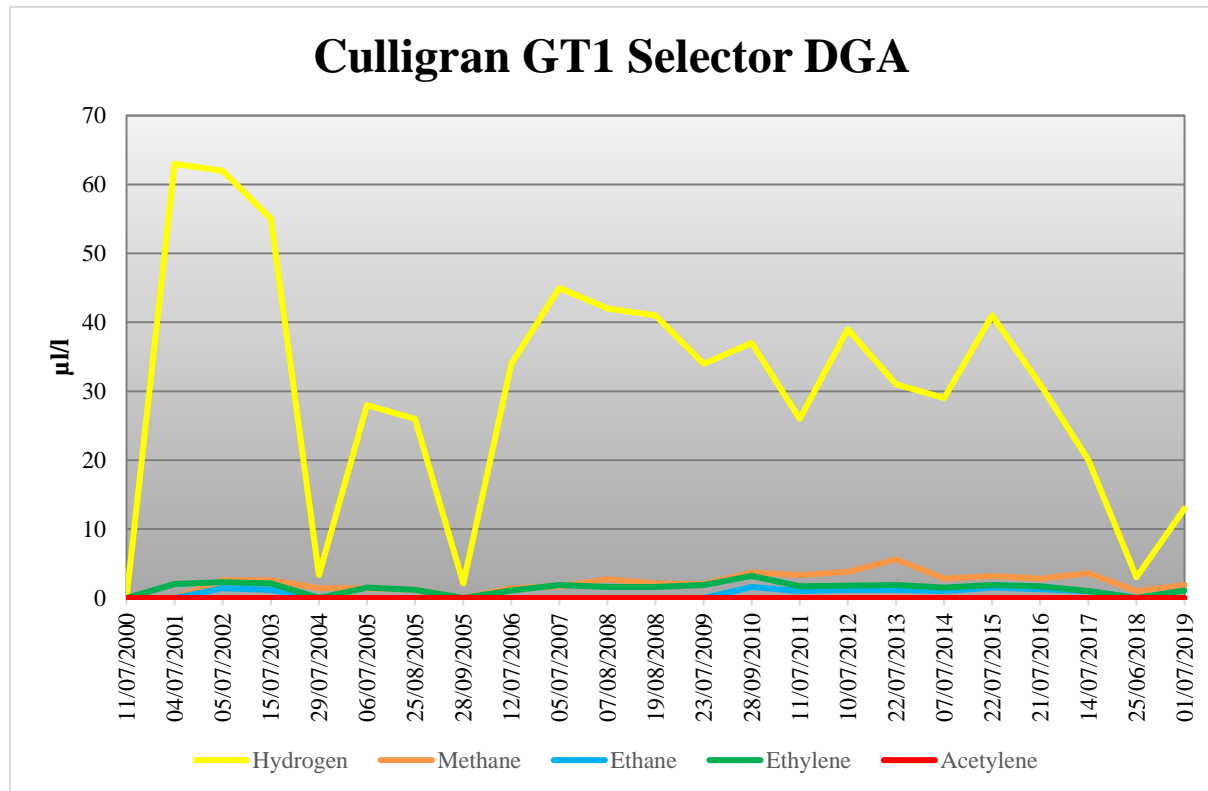
Thermal gases Methane, Ethane & Ethylene are present throughout the DGA history however, all remain at levels well below “typical values” specified in IEC 60599. The key gas present is Hydrogen which is still at low level.

Application of the gas ratios, as defined in IEC 60599, [0,0.15,undefined] fails to highlight a fault condition through a diagnosis of non-classification diagnosis. Using the Duval’s triangle method of DGA interpretation, the same gas ratios define a “T2” condition, “Thermal faults,  $300^{\circ}\text{C} < T < 700^{\circ}\text{C}$ ”, however, it should be noted that the Duval method, which is closed system, will always result in a condition being identified. The magnitudes of dissolved gas levels are considered to be too low to accurately diagnose and in this case the DGA would be considered benign.

The DGA does not presently exhibit any evidence of partial discharge, discharge, or thermal abnormality. The DGA history can be described as benign.

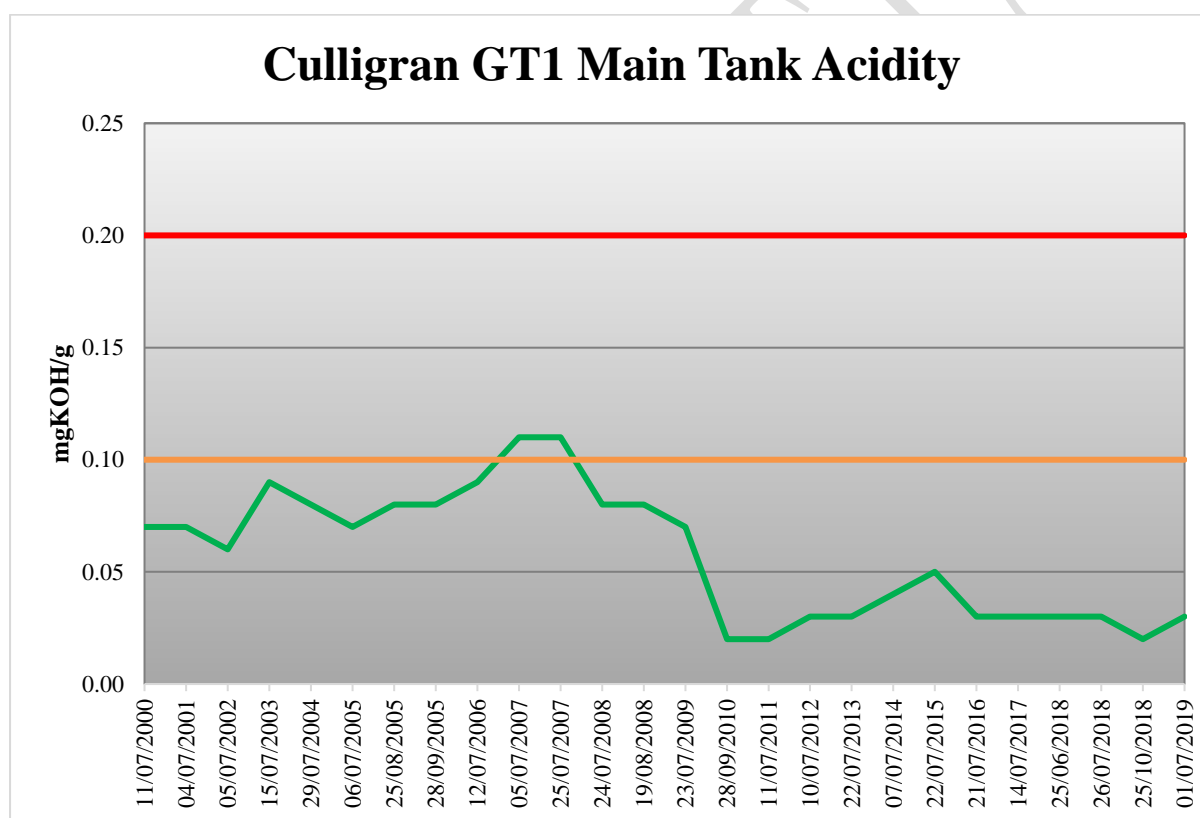
The historical acidity record has 26 samples taken in the period of 2000 to 2019. The acidity levels between July 2000 & July 2007 clearly indicate an increasing trend indicative of oxidation of the oil. From 2007 onwards an overall decreasing trend is observed most likely the result of top ups to the main tank oil or an intervention in the oil system. Except for two sample from July 2007 which are categorised as “Fair” by IEC 60422, all samples are categorised as “Good”. The most recent acidity result of 0.03 which is satisfactory and considered representative of recent historical results.

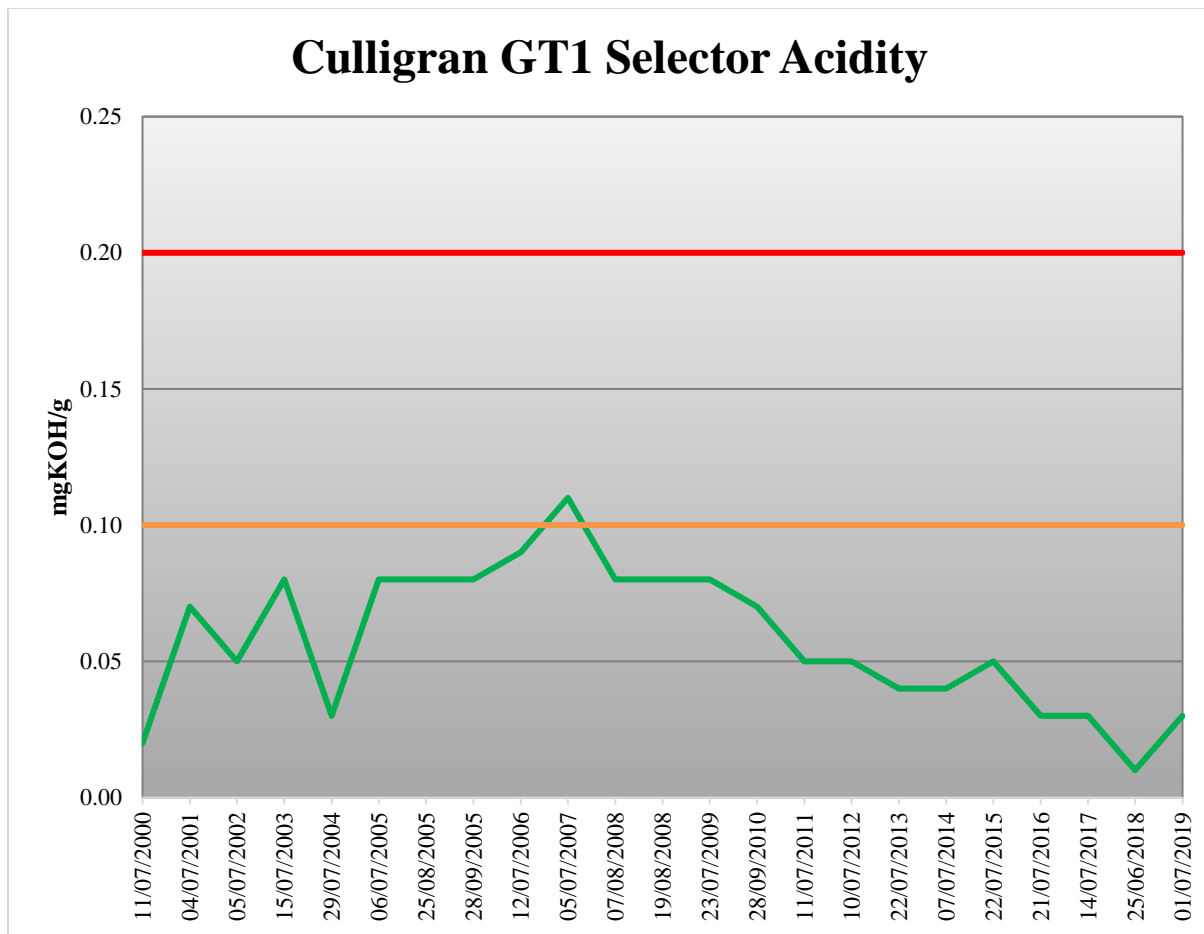
The historical acidity record spans the period of 2000 to 2019 and includes 23 samples. The acidity levels are observed to from 2007 onwards indicative of a dilution effect to the main tank oil by means of oil top ups or an intervention been carried out on the oils system. Being a tap changer this may be due to sympathetic communication from the main tank oil. Acidity levels are consistently categorised as “Good” as defined by IEC 60422, with the exception of one sample from July 2007 (0.11) which is categorised as “Fair”. The most recent acidity result of 0.03 is classified as “Good” and considered to be satisfactory representative of recent historical results.

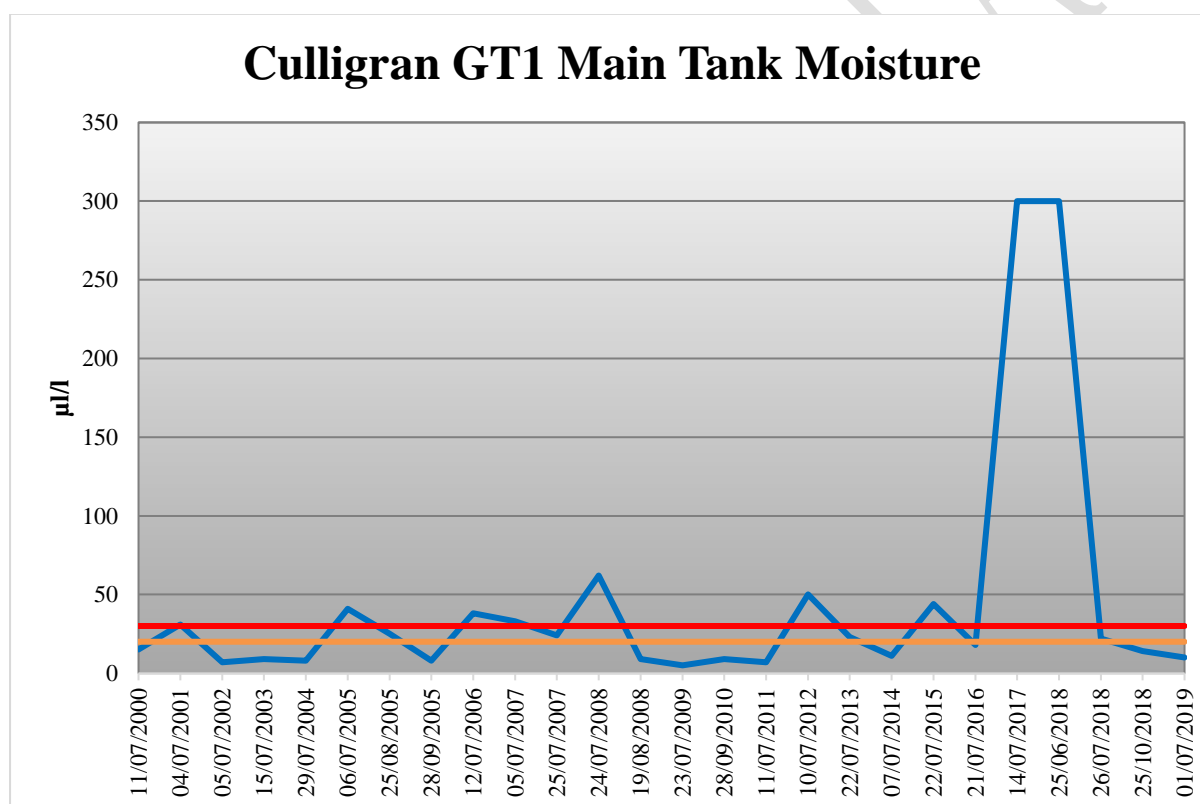
The historical moisture records contain two samples dated July 2017 & June 2018 where moisture levels are recorded as 300 $\mu\text{l/l}$ . Report T2BP-ACR-0024 states remedial works were conducted on GT1 to address oil leak issues. The high moisture content is believed to have been caused by voids in steelwork and seals of the transformer.

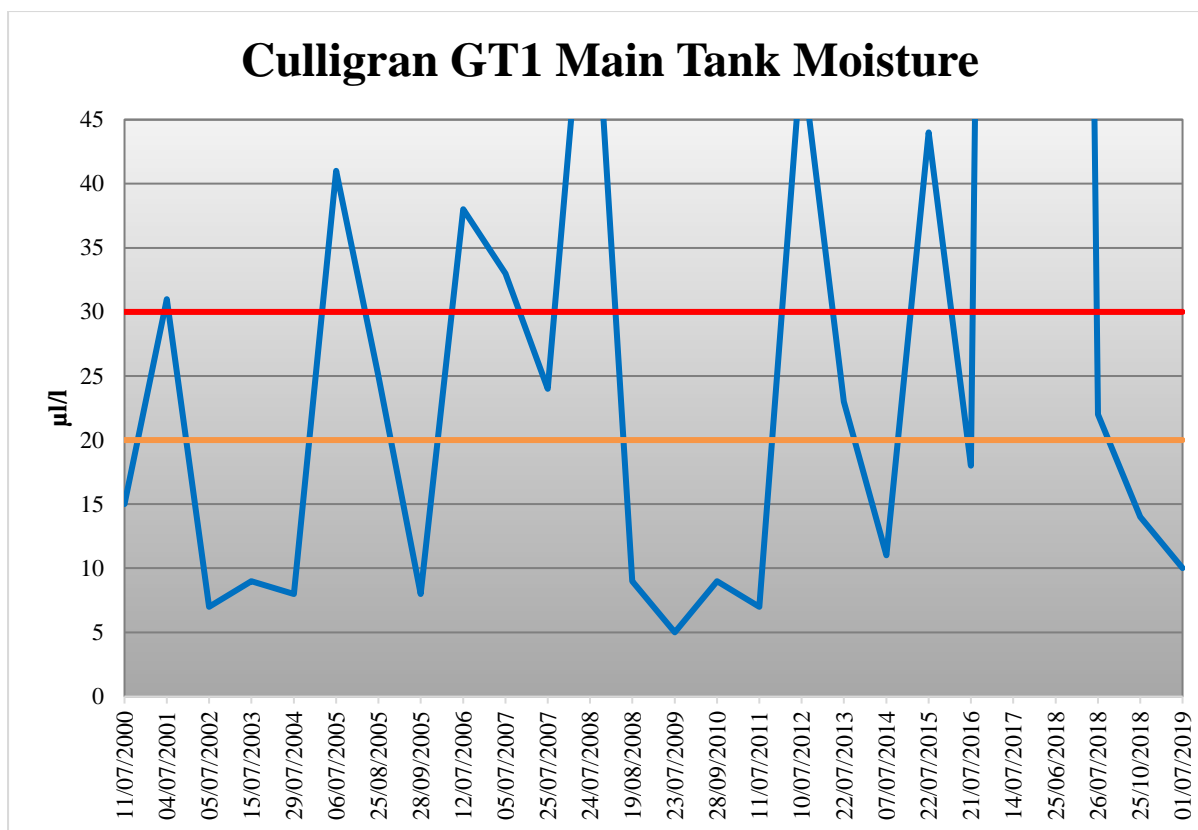
The historical moisture data spans 26 samples taken in the period of 2000 to 2019. Over the sample range the moisture levels have exhibited an erratic characteristic, likely due to the oil leak issues. Report T2BP-ACR-0024 states “Oil was reconditioned in February 2010”, if this is accurate it appears to have made no respectable difference to moisture content of GT1 as moisture levels continue to rise post – reconditioning. Moisture content consistently fluctuates between values categorised as “Good”; “Fair” & “Poor” as defined by IEC 60422 for category B apparatus. The most recent moisture result of 10µl/l is categorised as “Good” but is not considered representative of historical moisture results.

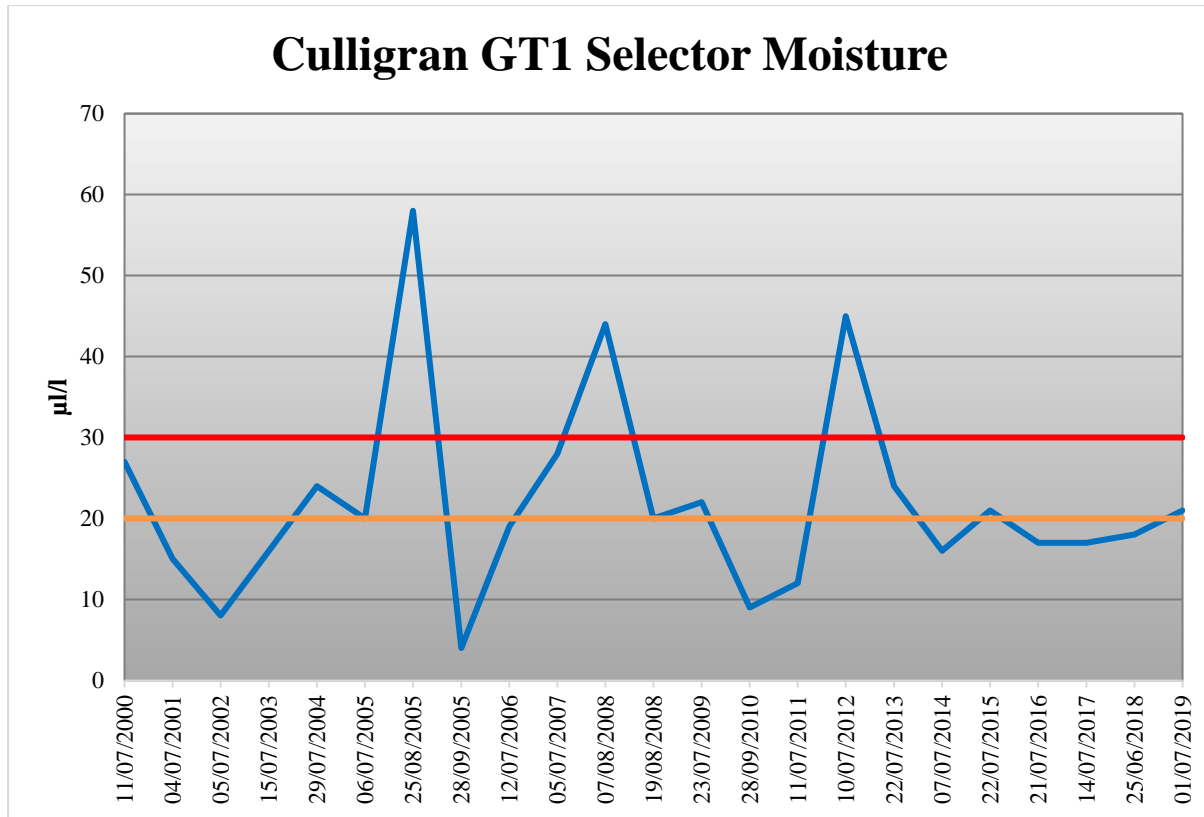
The historical selector moisture data spans 23 samples over the period of 2000 to 2019. Over the operational life of the selector moisture levels have been dynamic, this has resulted in a fluctuation between a categorisation of “Good”, “Fair” & “Poor”, as defined by IEC 60422. Correlation in increased moisture in the selector & the main tank are observed in August 2005, August 2008 & July 2012. This would suggest that moisture management of the main tank should be improved and because of this action, selector moisture levels should also reduce. Communication between the main tank and selector moisture levels is evident. Peak moisture value in the selector is recorded as 58µl/l in August 2005. The moisture trend is not satisfactory.

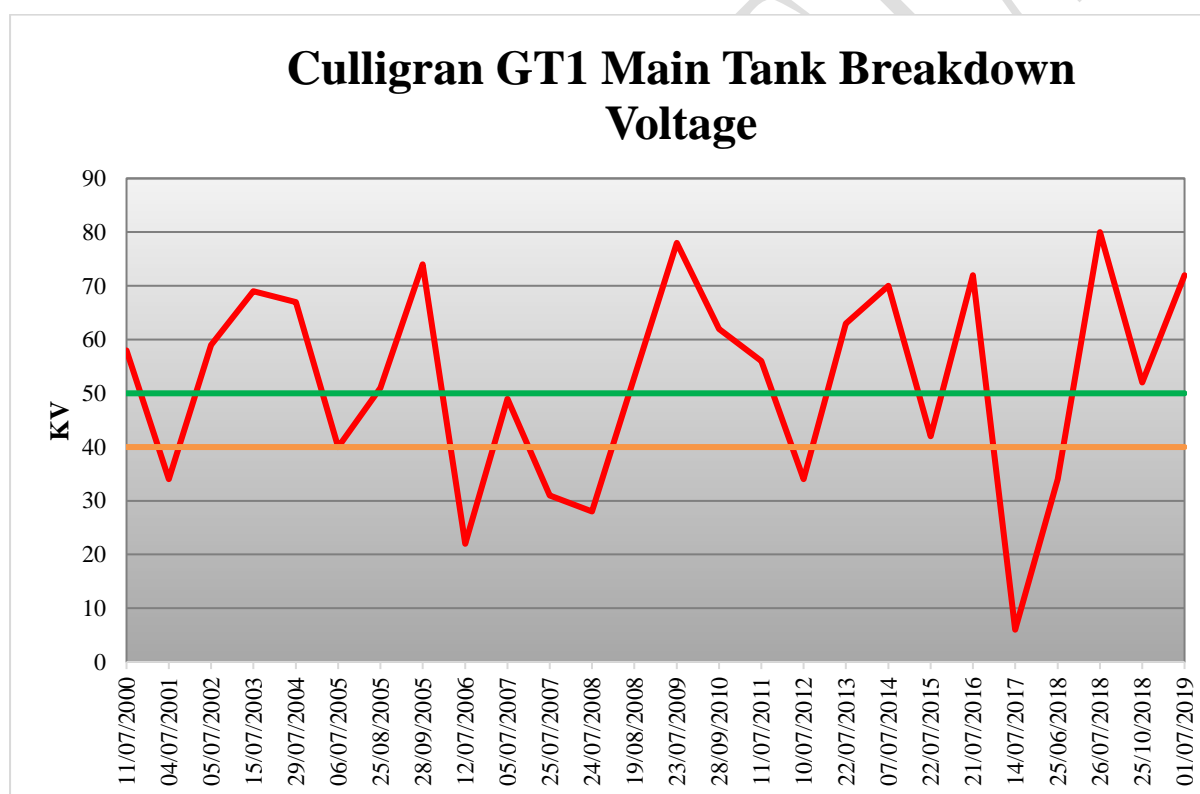
The historical breakdown voltage record spans the period of 2000 to 2019 and is inclusive of 26 samples. The breakdown voltage levels present an erratic trend which can be categorised as “Good”, “Fair” and “Poor” as defined by IEC 60422 throughout the historical range. All major reductions in breakdown voltage levels correlate with increased moisture content in the main tank. The most recent result from July 2019 (72kV) is categorised as “Good” but is not representative of the historical sample range. Remedial actions are clearly required to improve moisture management of GT1.

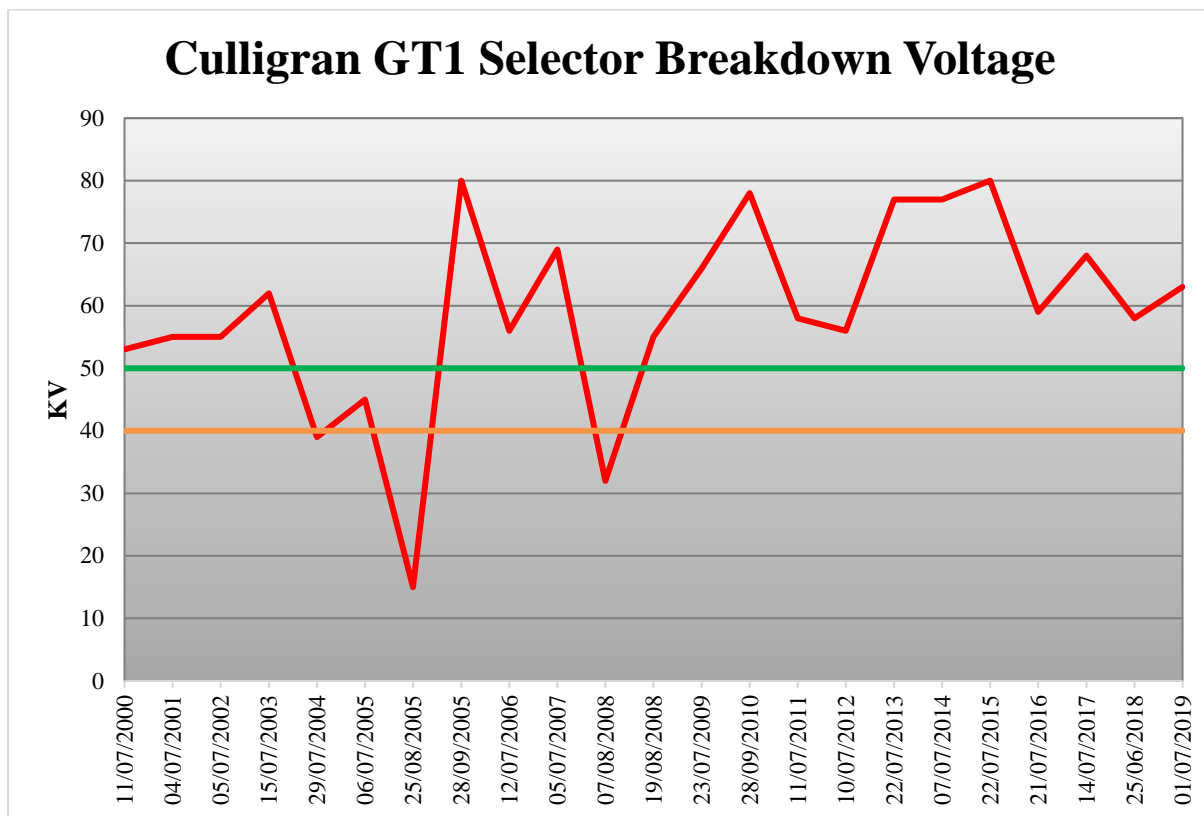
The selector historical breakdown voltage record spans the period of 2000 to 2010 and is inclusive of 23 samples. The breakdown voltage levels present an erratic trend which can be categorised as “Good”, “Fair” and “Poor” as defined by IEC 60422 throughout the historical range. A clear correlation exists between reduced breakdown voltage results and an increased moisture content within the selector in July 2005, August 2008 & July 2012. Present breakdown voltage results are satisfactory however, historical fluctuations in results suggest moisture management issues must be addressed.

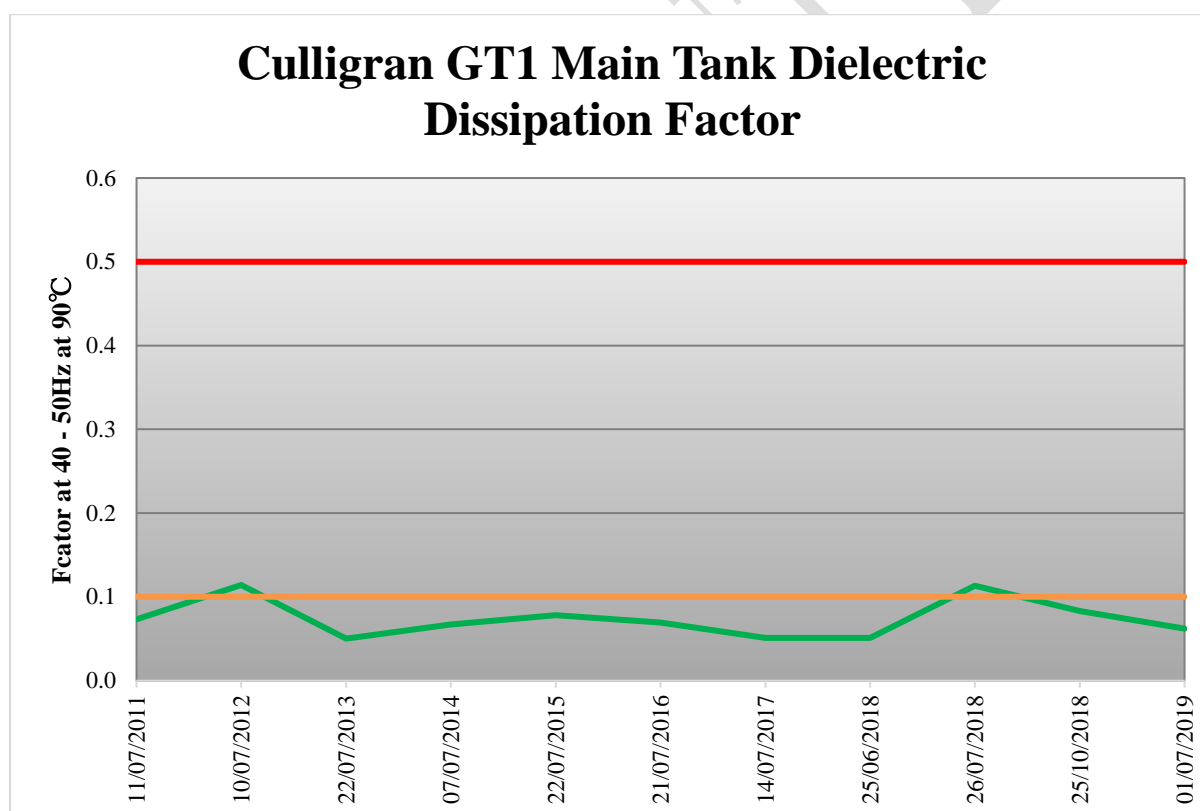
The Dielectric dissipation factor historical results contain 11 results in the period of 2011 to 2019. With the exception of samples taken in July 2012 (0.114) & July 2018 (0.113) both categorised as “Fair” by IEC 60422, all results are categorised as “Good”. A trend is observed which suggests dilution of the main tank oil by means of top ups or oil interventions. The present results are considered satisfactory and fairly representative of the DDF history.

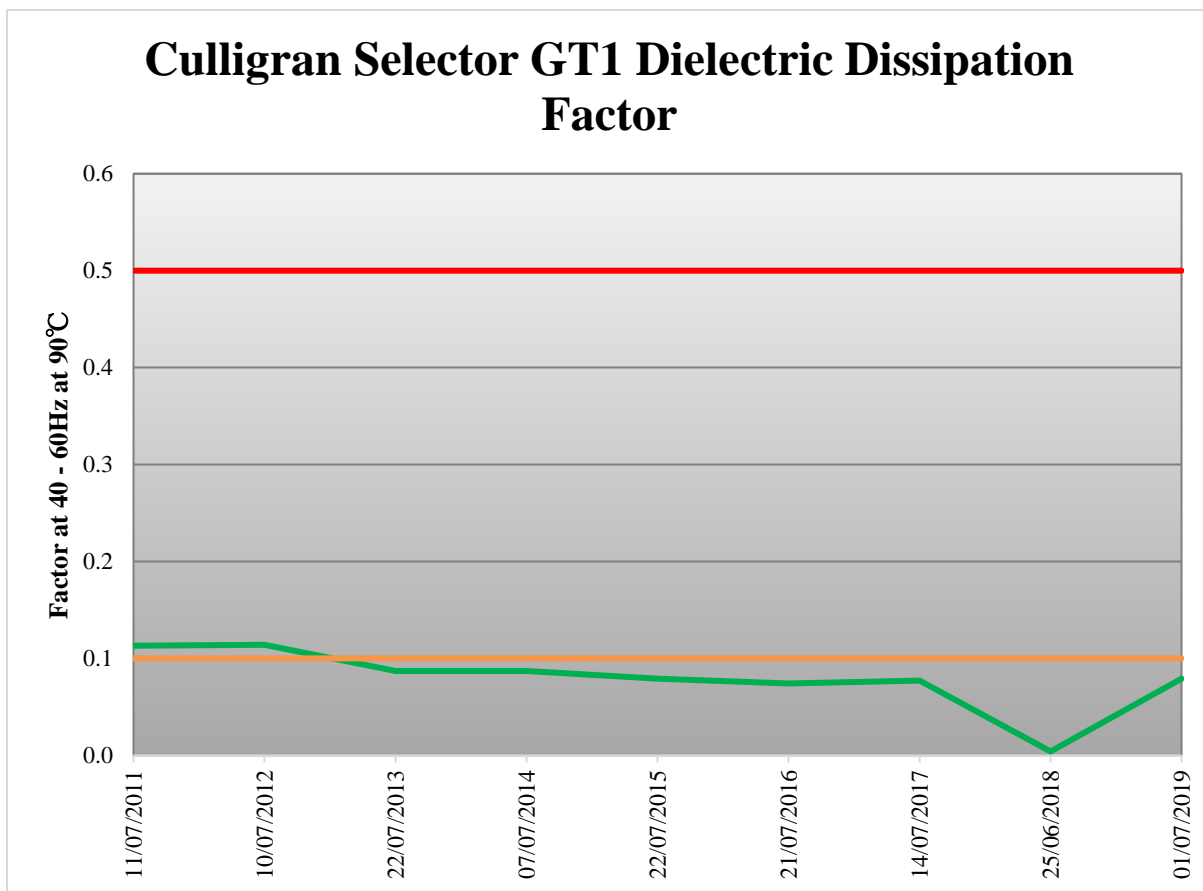
The dielectric dissipation factor is predominantly categorised as “Good” as defined by IEC 60422. Reductions in dielectric dissipation factor results are indicative of a dilution effect by means of top ups with new or reclaimed oil or an intervention in the oil system has taken place. Results are satisfactory.

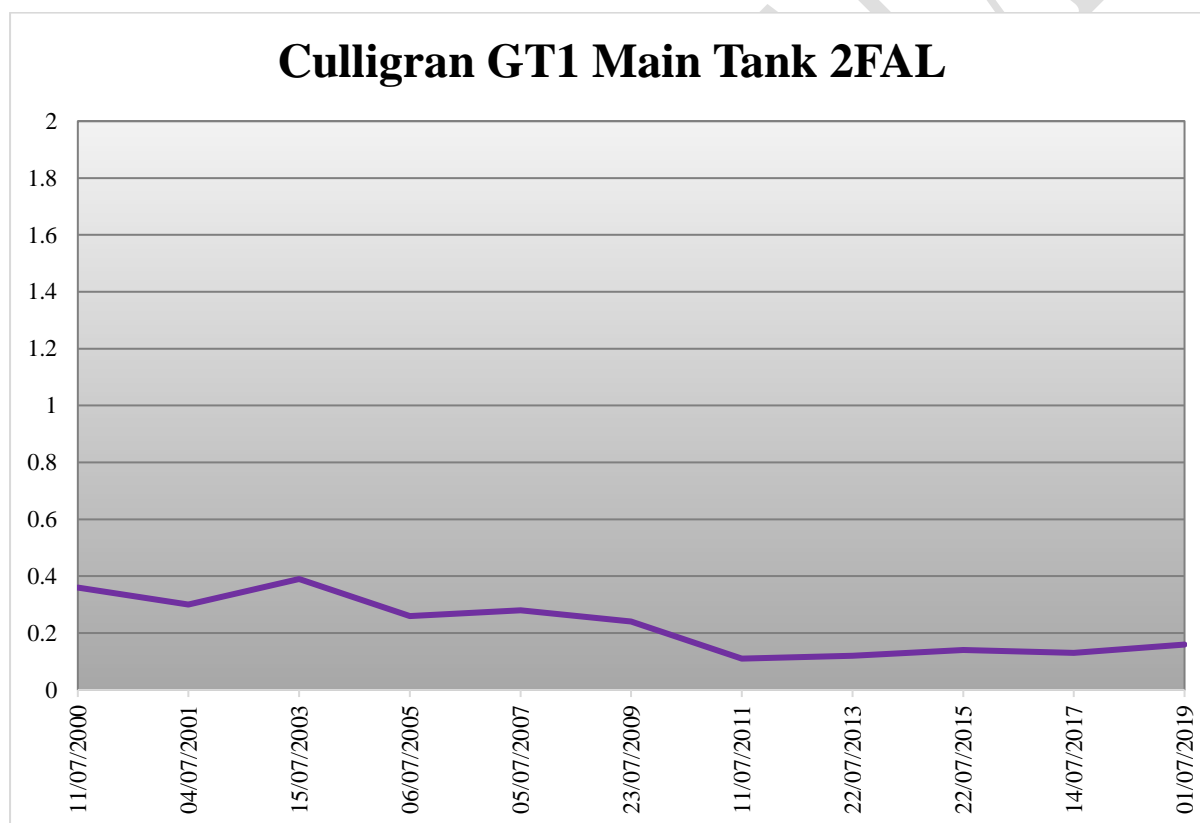
The 2FAL record spans from 2000 until the most recent sample, which was taken in July 2017. The 2FAL levels show an overall decreasing trend between July 2000 & July 2011. This is indicative of a dilution of 2FAL levels by means of top ups with new or reclaimed oil, or an intervention having taken place in the oil system. The final value recorded was 0.16 (Est DP 656), compared to the highest value recorded in the sampling period of 0.39 (Est DP 545). The link between measured 2FAL and estimated DP is reliant on an algorithmic relationship, of which there are five different variants. The Chengdong algorithm has been used to relate measured 2FAL to estimated DP. In order to estimate the DP of the insulation system, the highest value of measured 2FAL shall be used (From July 2003). Measured 2FAL

of 0.39 gives an estimated DP of 545. The insulation within a new transformer has typically a DP value of 1000. It is generally accepted within the industry that an estimated DP value of 200 is “end of life”. Application of this criteria, results in the transformer having an estimated 43% residual life remaining in the paper insulation. This suggests that the paper insulation is in a good condition given its age.

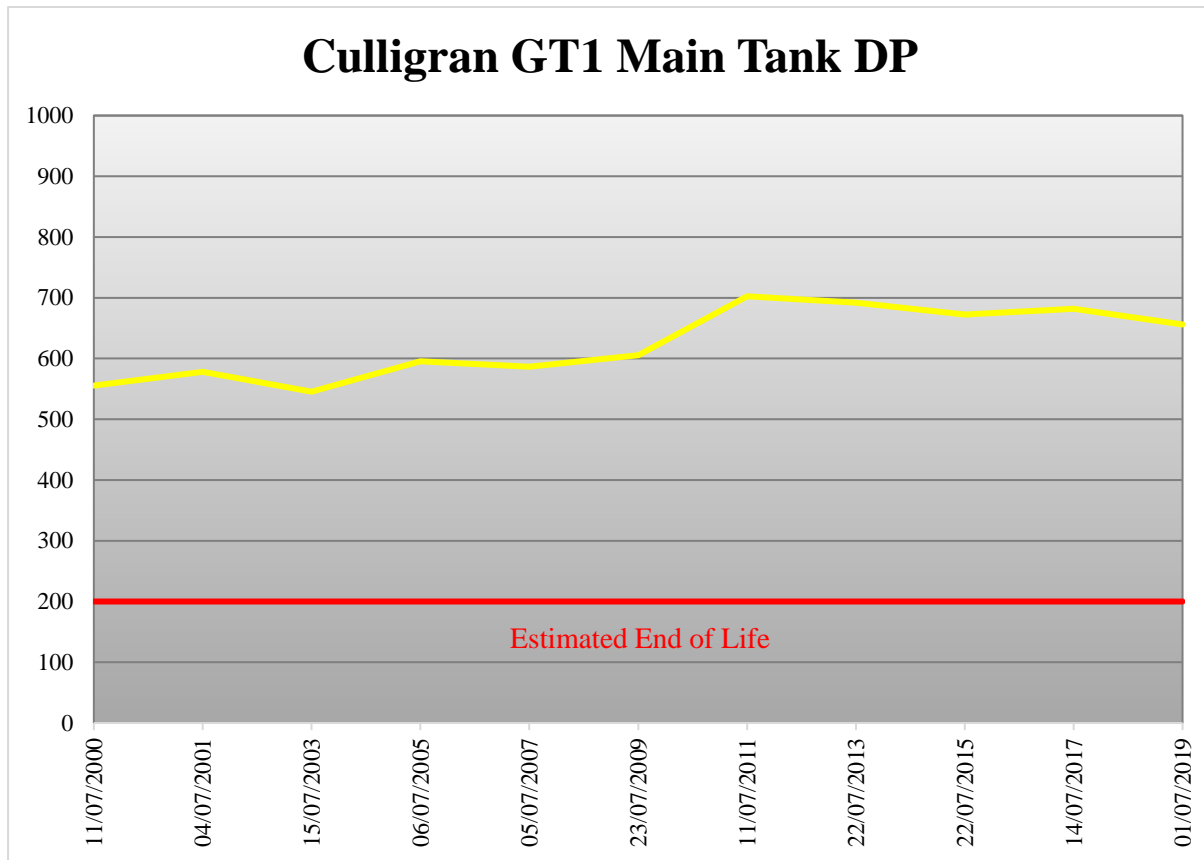
This figure is considered to be optimistic as the 2FAL has been diluted and with the 2FAL level being used to estimate the DP of the paper insulation, the estimated DP is most likely lower than the predicted figure.
