# **Sloy GT4 132/11kV Transformer**

**Level 1 Condition  
Assessment Report  
15th July 2020  
Report:  
SLOYGT4SHET200626  
FINAL**

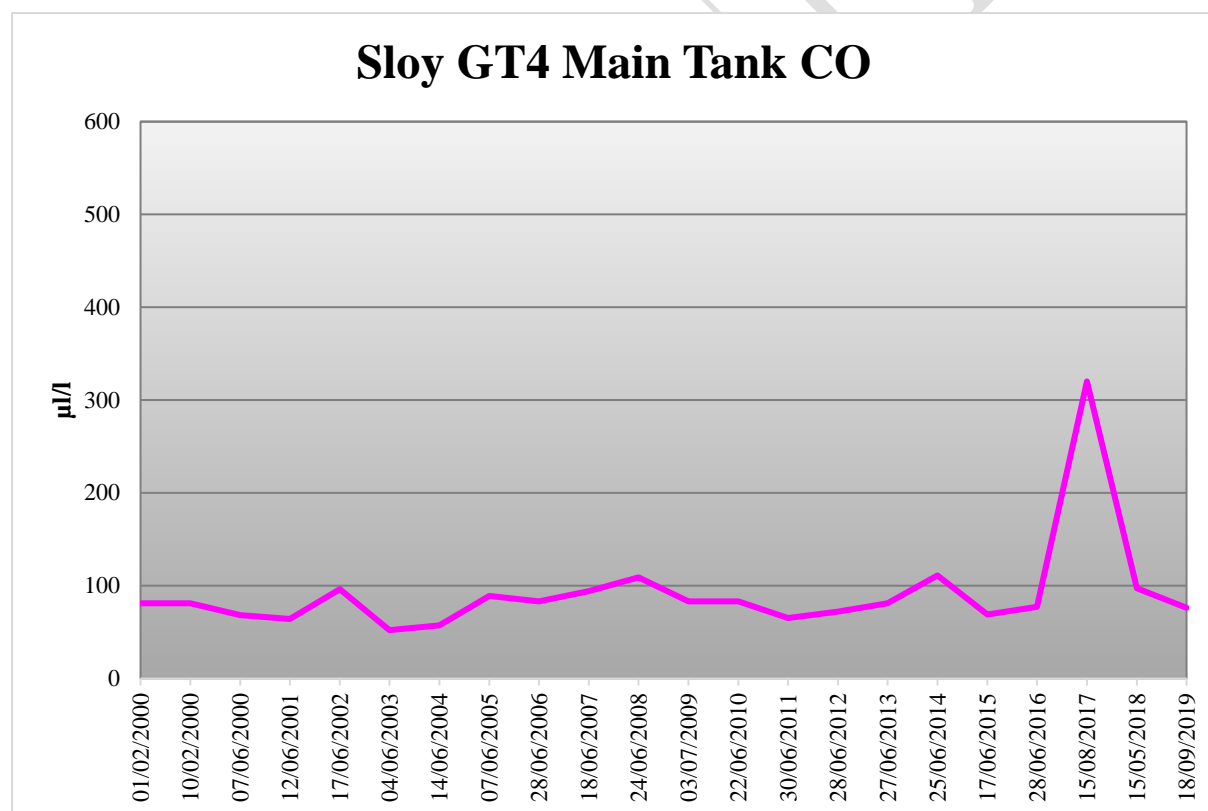
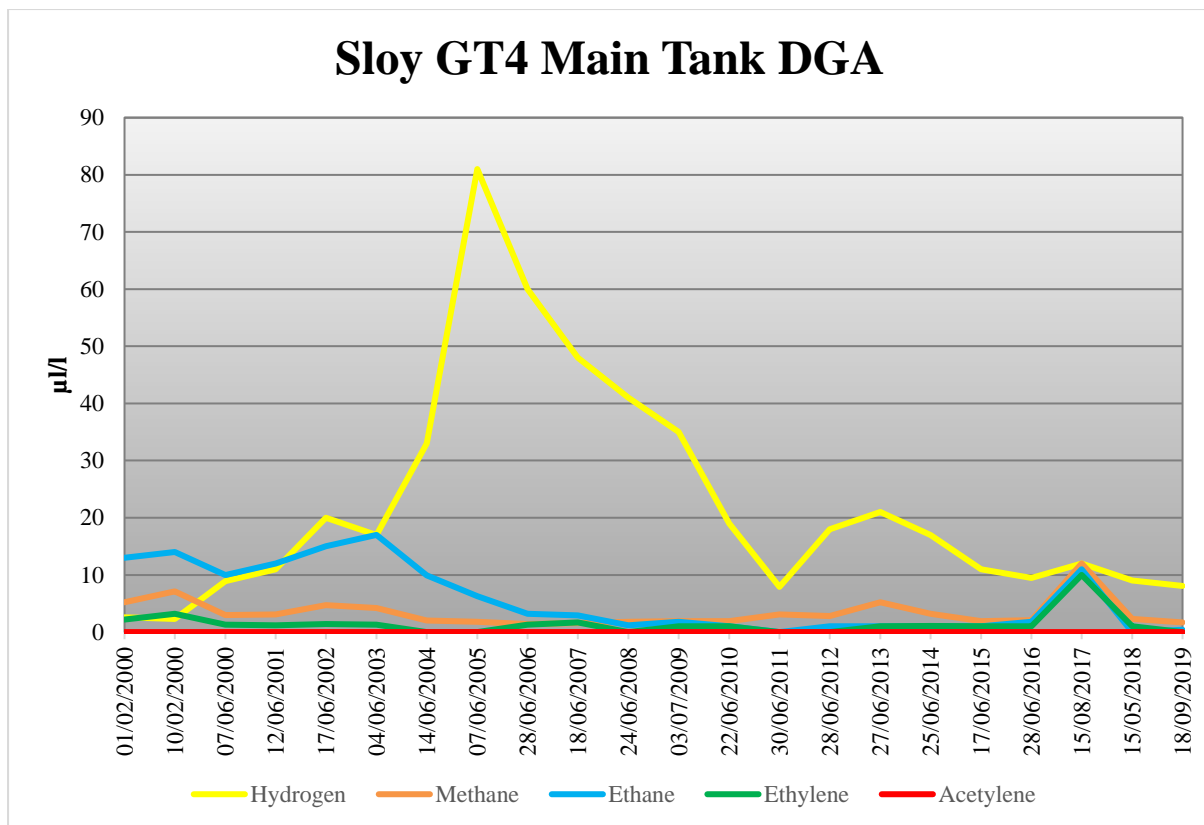
The CO characteristic is, overall, relatively stable over the sample period. One spike in generated CO is present in August 2017 which is indicative of a period where there is accelerated ageing of the cellulose insulation. This spike in CO also represents the peak value over the sample period of 320 $\mu$ l/l. CO remains well below “typical values” specified in IEC 60599 over the sample period.

Hydrogen, Methane, Ethane and Ethylene are all present throughout the historical DGA sample range. The dissolved diagnostic gas values measured in the final sample are all below the “typical concentration values” stated within IEC 60599.

Application of the gas ratios, as defined in IEC 60599,  $[0, 0.25, 0]$  fails to highlight any abnormality through a diagnosis of non-classification diagnosis. Using the Duval’s triangle method of DGA interpretation, the same gas ratios define a “PD” condition, “Corona partial discharges”, however, it should be noted that the Duval method being a closed system will always result in a condition being diagnosed. The magnitudes of dissolved gas levels are considered to be too low to accurately diagnose and in this case the DGA would be considered benign.

The DGA does not exhibit any evidence of partial discharge, discharge, or thermal abnormality. The DGA history can be described as benign.

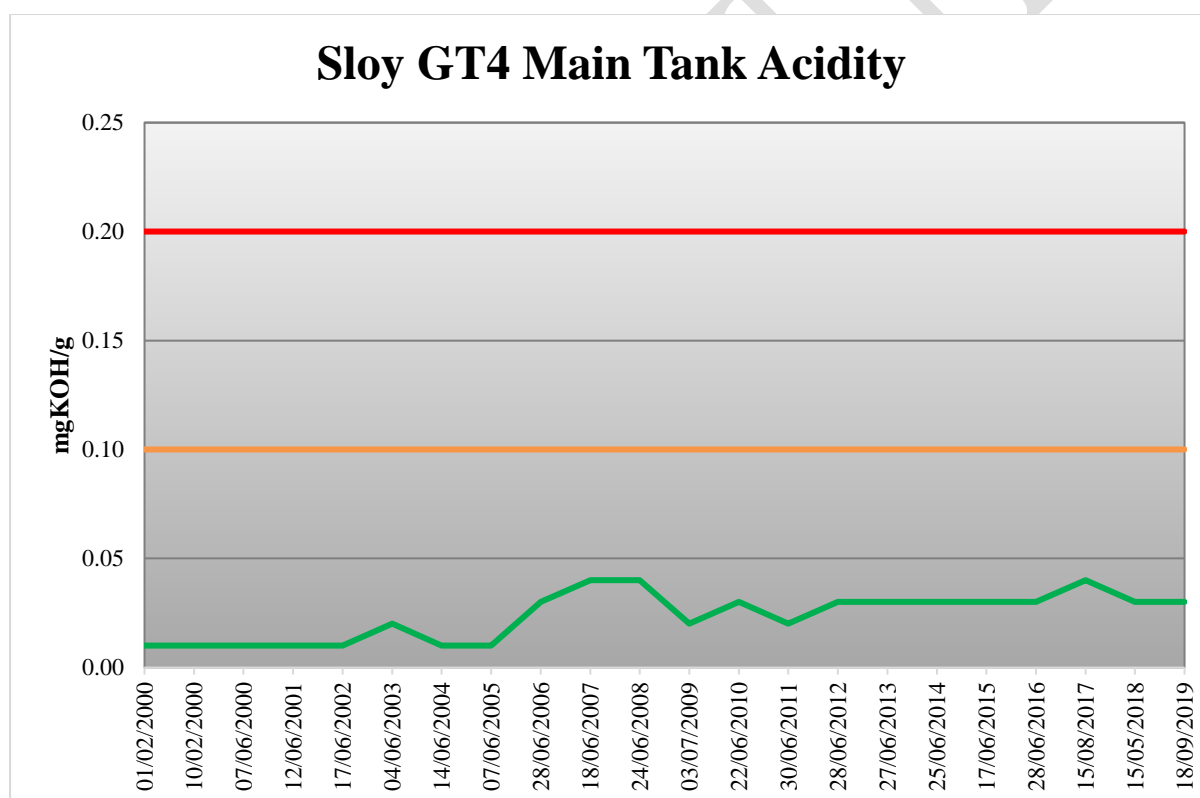
The historical acidity record has 22 samples taken in the period of 2000 to 2019. The acidity levels are found to exhibit a very minor increasing trend over the sample period. Over the entire historical sample range all results can be categorised as “Good” as defined by IEC 60422 for category B apparatus. The acidity is considered satisfactory.

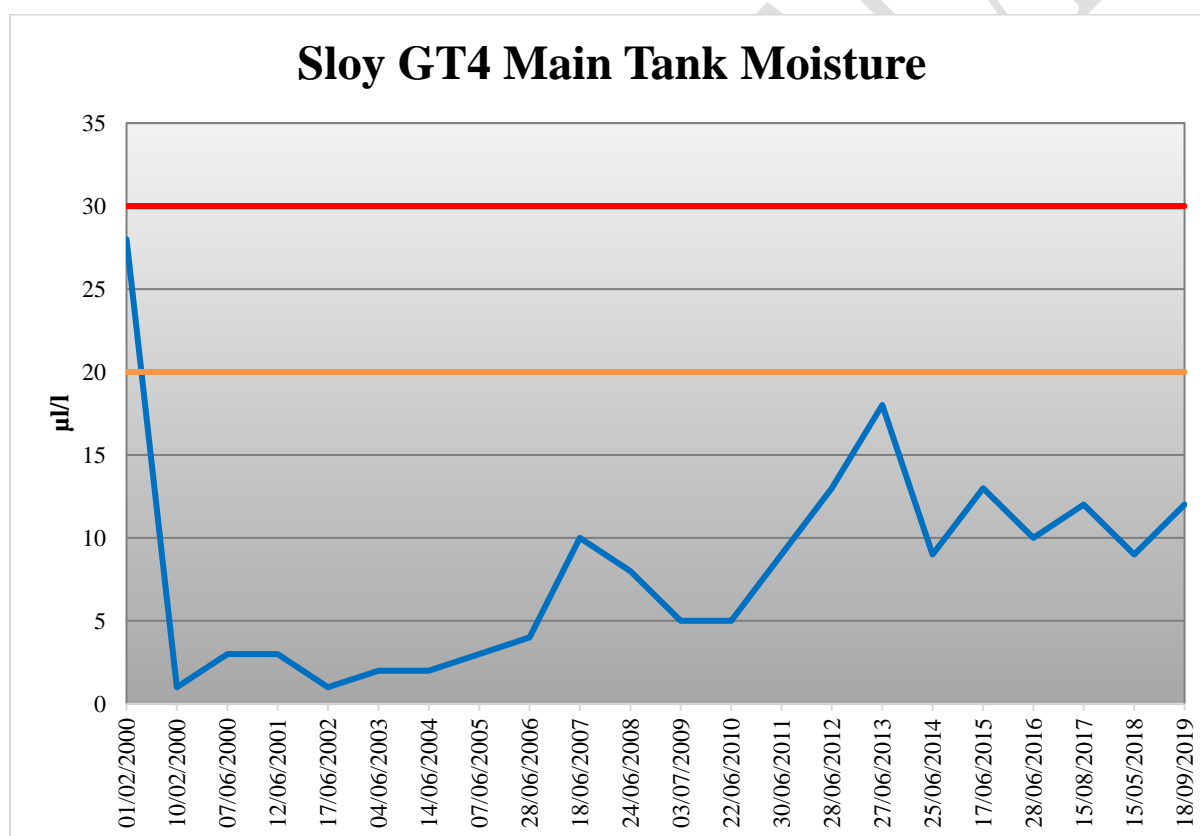
The historical moisture data span the period 2000 to 2019 and includes 22 samples. Over the operational life of the transformer the moisture levels are observed to be dynamic and, overall, exhibit an increasing trend. Moisture levels have predominantly been categorised as “Good”, as defined in IEC 60422 for category B apparatus, despite the overall increasing trend displayed. A substantial reduction in moisture levels between the first two samples in the range suggests re-conditioning of the main tank oil or poor sampling technique in the sample dated 1<sup>st</sup> of February 2000. The overall moisture trend is satisfactory.

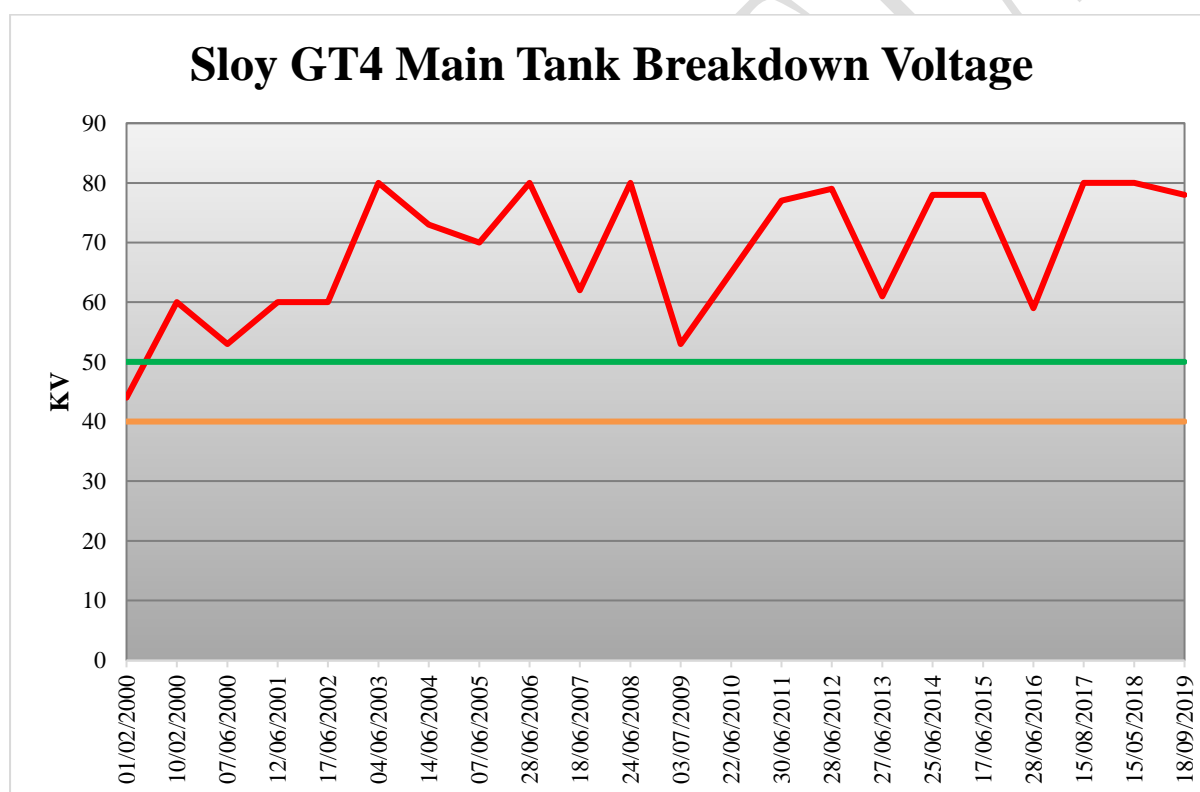
The historical breakdown voltage spans the period 2000 to 2019 and includes 22 samples. Over the sample period, the breakdown voltage is predominantly categorised as “Good”, as defined by IEC 60422. The overall trend exhibited is erratic however, a correlation between reduced breakdown voltage level and increased moisture levels are apparent in February 2000, June 2007, and June 2013. The most recent breakdown voltage is “Good” and is considered representative of the breakdown voltage history.

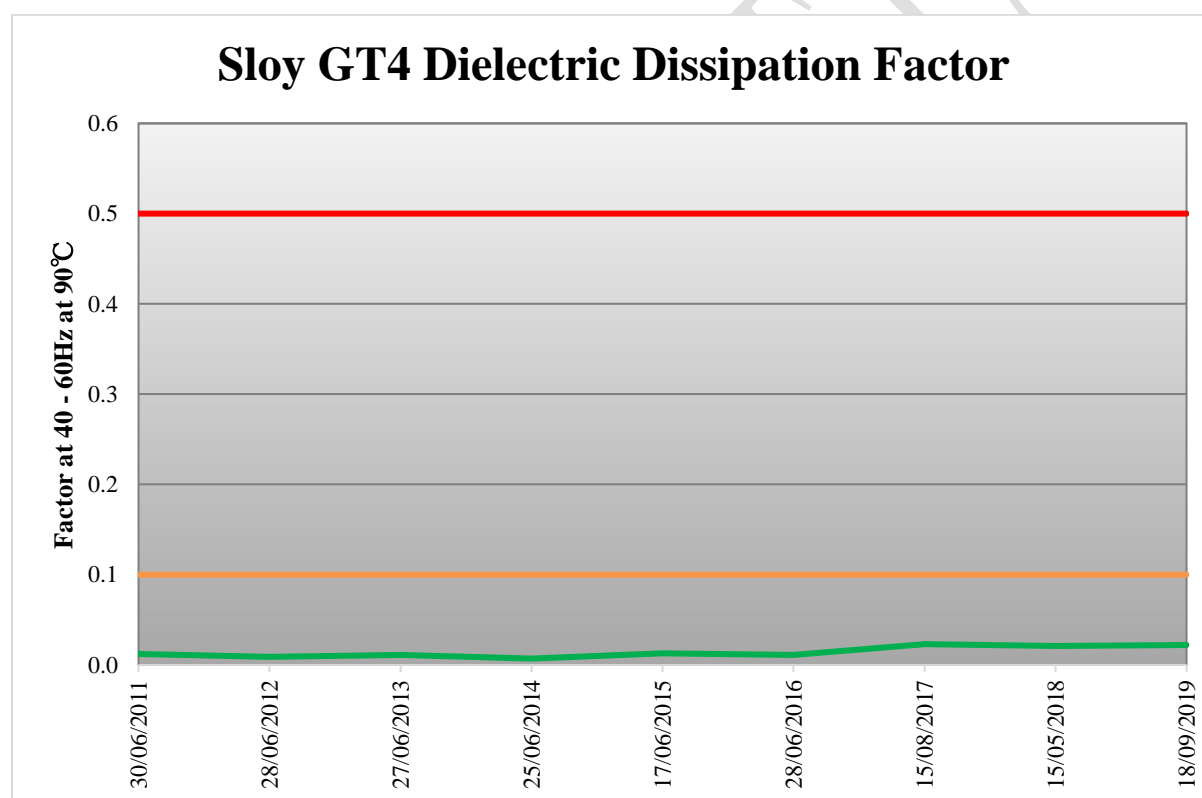
The Dielectric Dissipation Factor level, as defined by IEC 60422, as “Good” and is satisfactory.

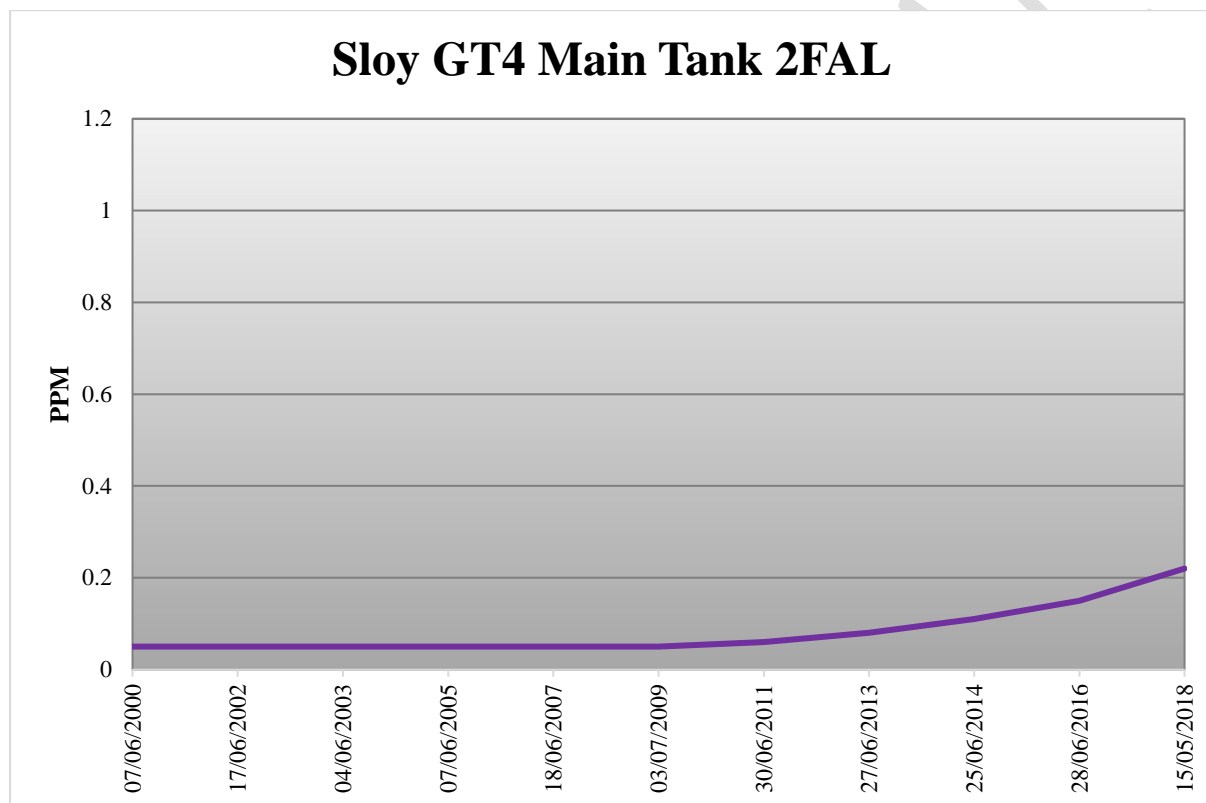
It is likely that there is a type defect manifesting in this transformer, as characterised by accelerated ageing of the paper insulation, which is detected by increasing levels of 2FAL in all 132/11kV transformers at Sloy substation. The root cause of this has not yet been determined and will require further investigation.

The 2FAL record spans from 2000 until the most recent sample, which was taken in May 2018. The 2FAL level remains in a steady state until June 2011 where an increasing trend is exhibited over the remaining sample range. This increasing trend is indicative of increasing or accelerated insulation ageing. The final value recorded was 0.22 (Est DP 616), which also represents the highest value recorded throughout the historical sample range. The link between measured 2FAL and estimated DP is reliant on an algorithmic relationship, of which there are five different variants. The Chengdong algorithm has been used to relate measured 2FAL to estimated DP. In order to estimate the DP of the insulation system, the highest value of measured 2FAL shall be used (From May 2018). Measured 2FAL of 0.22 gives an estimated DP of 616. The insulation within a new transformer has typically a DP value of 1000. It is generally accepted within the industry that an estimated DP value of 200 is “end of life”. Application of this criteria, results in the transformer having an estimated 52% residual life remaining in the paper insulation. This suggests that the paper insulation is in a reasonable condition.

- Main tank oil should be sampled at 6 monthly intervals, in order to keep the levels of 2FAL under surveillance and to assess the ageing rate. This is in addition to routine sampling. On line monitoring of 2FAL is not presently an option as the technology is not mature.
- Electrical diagnostic testing. This is to assess the mechanical condition of the active part by Sweep Frequency Response Analysis (SFRA) and the condition of the insulation system by means of dielectric frequency response (DFR), 10kV Power Factor and 5kV Insulation

The main tank oil should not be reconditioned, reclaimed, regenerated or topped up as this will affect the 2FAL concentrations, which is the primary method of surveillance used to monitor the ageing rate of the paper insulation. These interventions will mask any underlying ageing profile. This of course should be reviewed, by Transmission Operations in the case where the dielectric properties of the main tank oil are deteriorating and presenting a risk of dielectric failure of the liquid insulation.

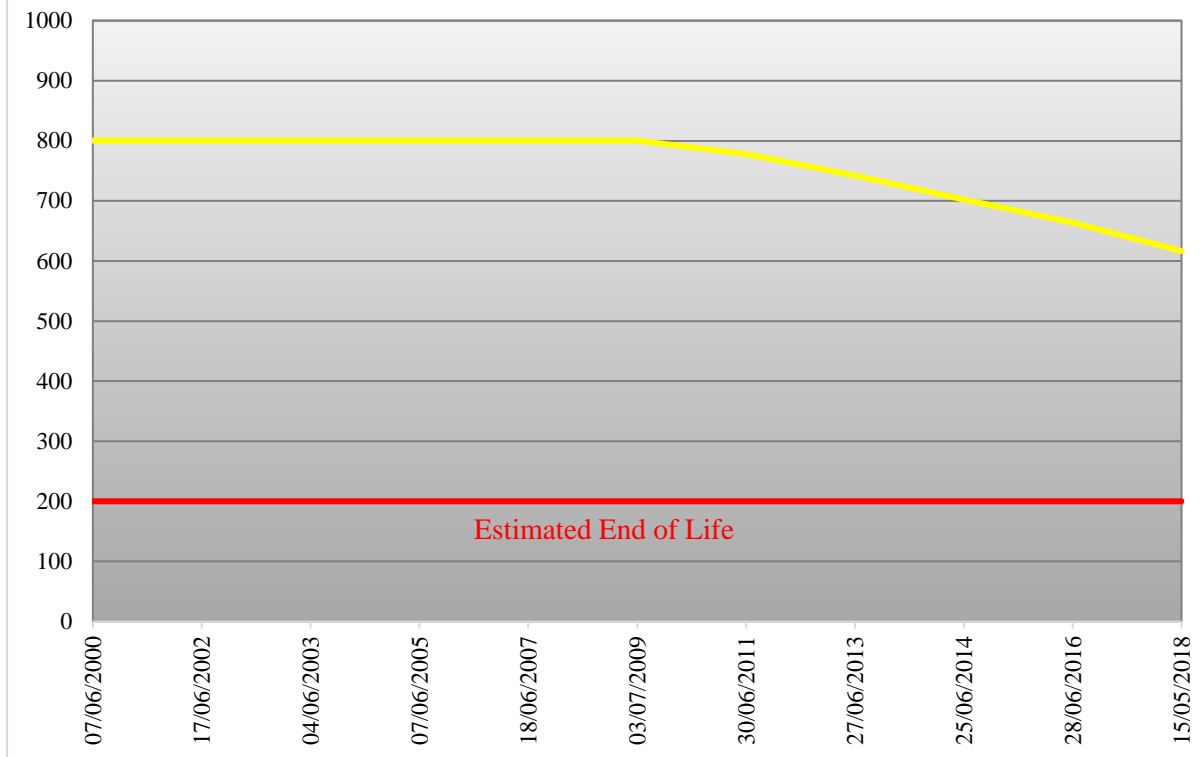
## Sloy GT4 Main Tank Estimated DP

Between 2009 and 2018 there is an almost linear and sustained ageing rate. Extrapolation of the estimated DP, based on the overall rate of ageing, and assuming that there is no deviation in that rate, or that the transformer is not subjected to external failure mechanism, would predict that “end of life” would be reached in the year 2030, and has 10 years of operational service life remaining, which is beyond the RIIO T2 period.

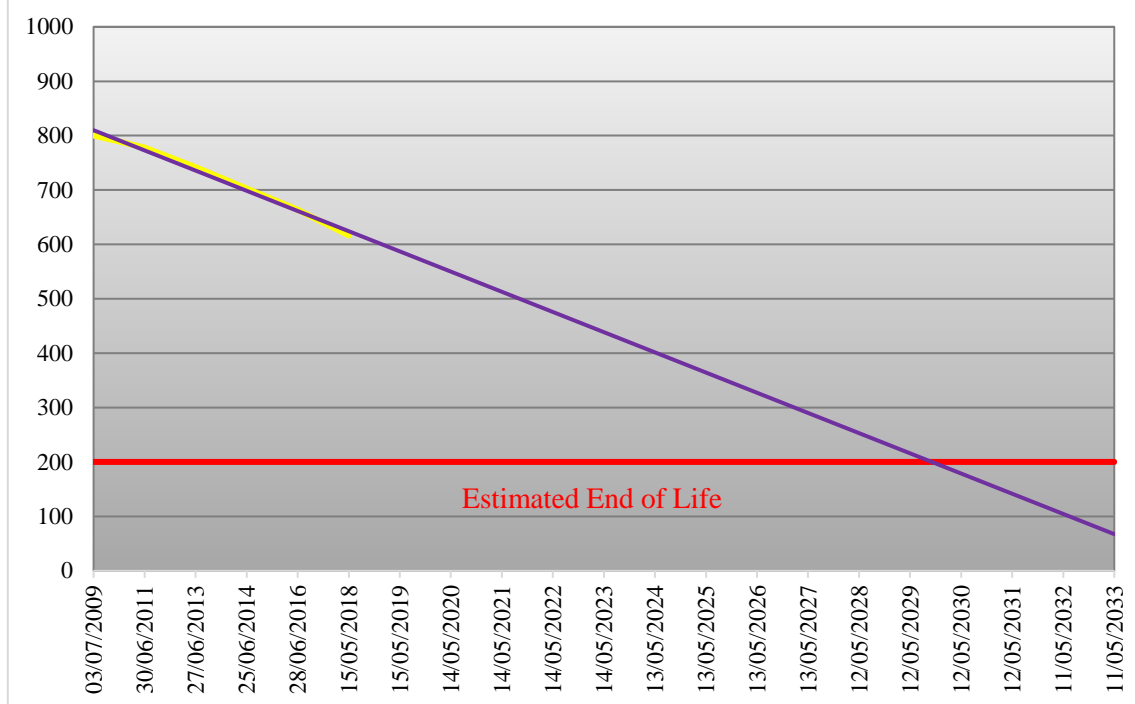
## Sloy GT4 Main Tank Estimated DP Projected

Measured 2FAL of 0.22 gives an estimated DP of 616. The insulation within a new transformer has typically a DP value of 1000. It is generally accepted within the industry that an estimated DP value of 200 is “end of life”. Application of this criteria, results in the transformer having an estimated 52% residual life remaining in the paper insulation. This suggests that the paper insulation is currently in a reasonable condition. There is however an observable deterioration. Between 2009 and 2018 there is an almost linear and sustained ageing rate. Extrapolation of the estimated DP from that period, based on the overall rate of ageing, and assuming that there is no deviation in that rate, or that the transformer is not subjected to external failure mechanism, would predict that “end of life” would be reached in the year 2030, and has 10 years of operational service life remaining. “End of life” by ageing will be reached beyond the RIIIO T2 period.

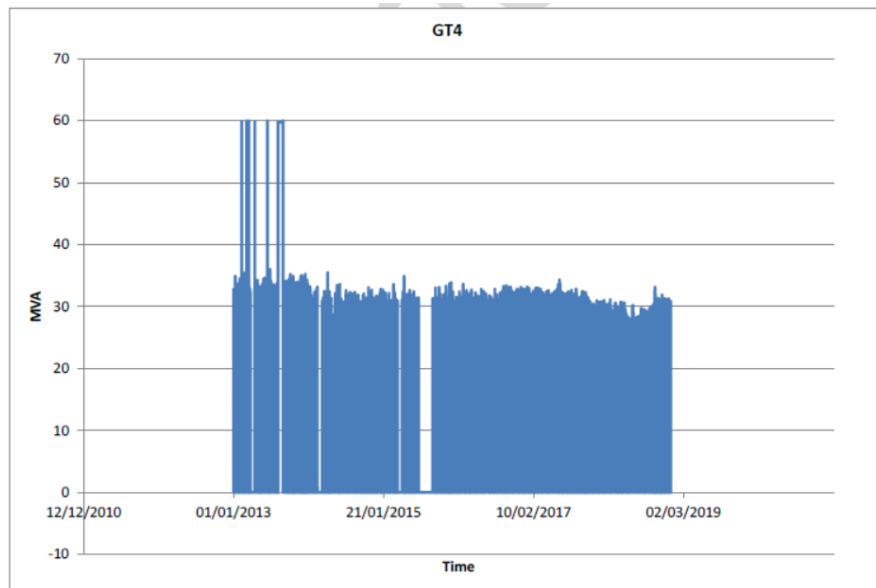
Figure 5.12 from section 5.6 of the document shows a measured load flow of GT4 for the period of 2013 to 2018. The transformer has a typical maximum load flow of around 35MVA, which is within the 50MVA rating of the transformer and at this load level the transformer would be operating in OFAF operation with the pumps and fans running.
