# **Sloy GT3 132/11kV Transformer**

**Level 1 Condition  
Assessment Report  
15th July 2020  
Report:  
SLOYGT3SHET200626  
FINAL**

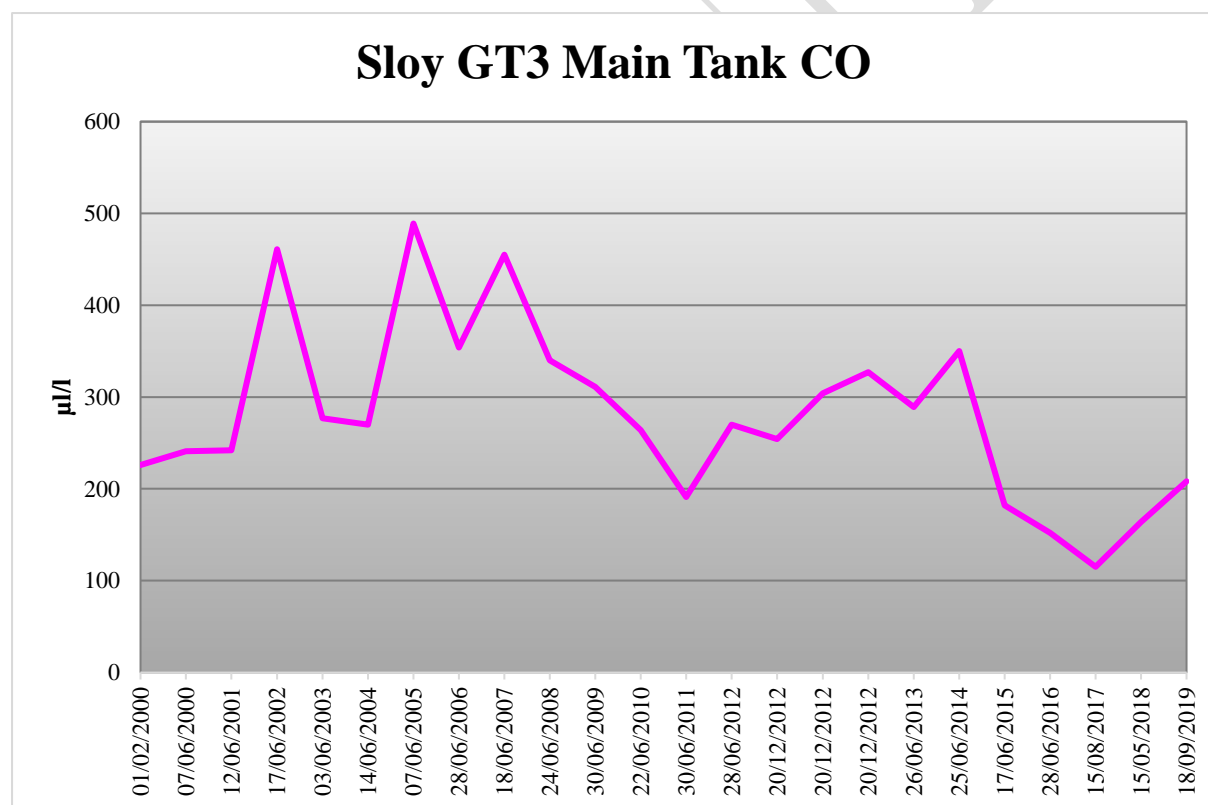
The CO characteristic is considered erratic with short periods of accelerated rates of CO generation indicative cellulose degradation yet, CO values remain below “typical values” specified in IEC 60599 over the sample period, peaking at 489 $\mu$ l/l in 2005. The paper insulation is likely to be in an aged condition.

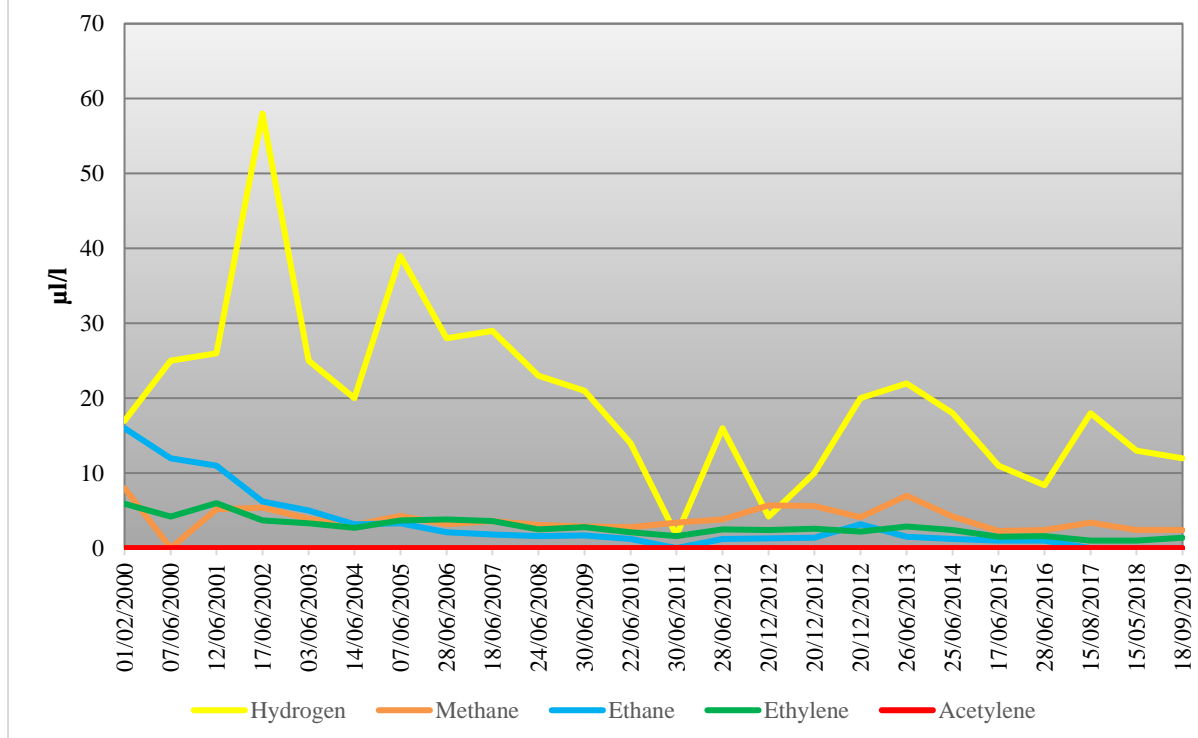
## Sloy GT3 Main Tank DGA

Hydrogen and the thermal gases methane, ethane and ethylene are all present in the DGA history. The dissolved diagnostic gas values measured in the final sample are all below the “typical concentration values” stated within IEC 60599.

Application of the gas ratios, as defined in IEC 60599, [0, 0.16, undefined] fails to highlight any abnormality with the diagnosis being a non-classification. Using the Duval’s triangle method of DGA interpretation, the same gas ratios define a “T2” condition, “Thermal faults,  $300^{\circ}\text{C} < T < 700^{\circ}\text{C}$ ”, however, it should be noted that the Duval method, being a closed system, will always result in a condition being identified. The magnitudes of dissolved gas levels are considered to be too low to accurately diagnose and in this case the DGA would be considered benign.

The DGA does not exhibit any evidence of partial discharge, discharge, or thermal abnormality. The DGA history can be described as benign.

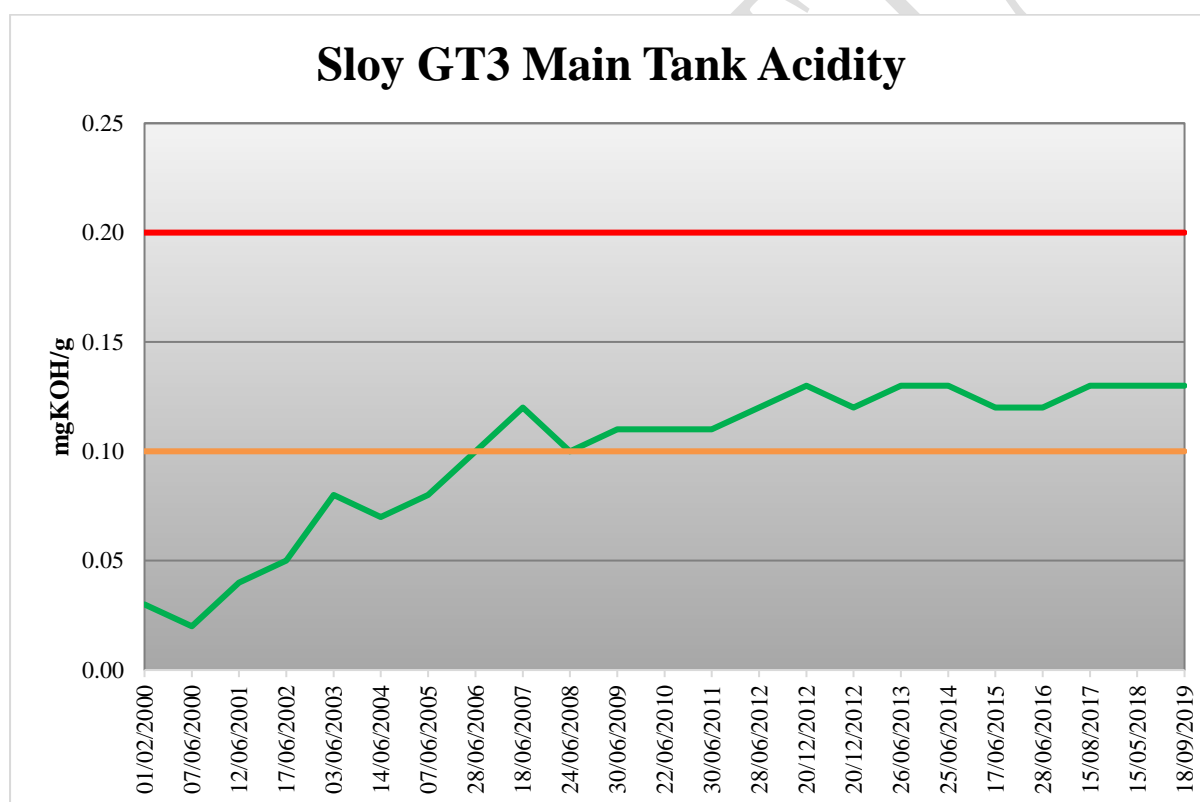
The historical acidity record has 23 samples taken in the period of 2000 to 2019. The acidity levels are found to be increasing over the sample range, indicative of oxidation of the oil. In the period of 2000 to 2005 all samples are categorised as “Good” as defined by IEC 60422 for category B apparatus, despite a clear increasing trend. The remaining samples, from 2006 to 2019 are all categorised as “Fair” and overall an increasing trend is exhibited. The acidity is considered acceptable, but to restore the acid concentrations to a level defined as “Good”, the oil would require to be regenerated.

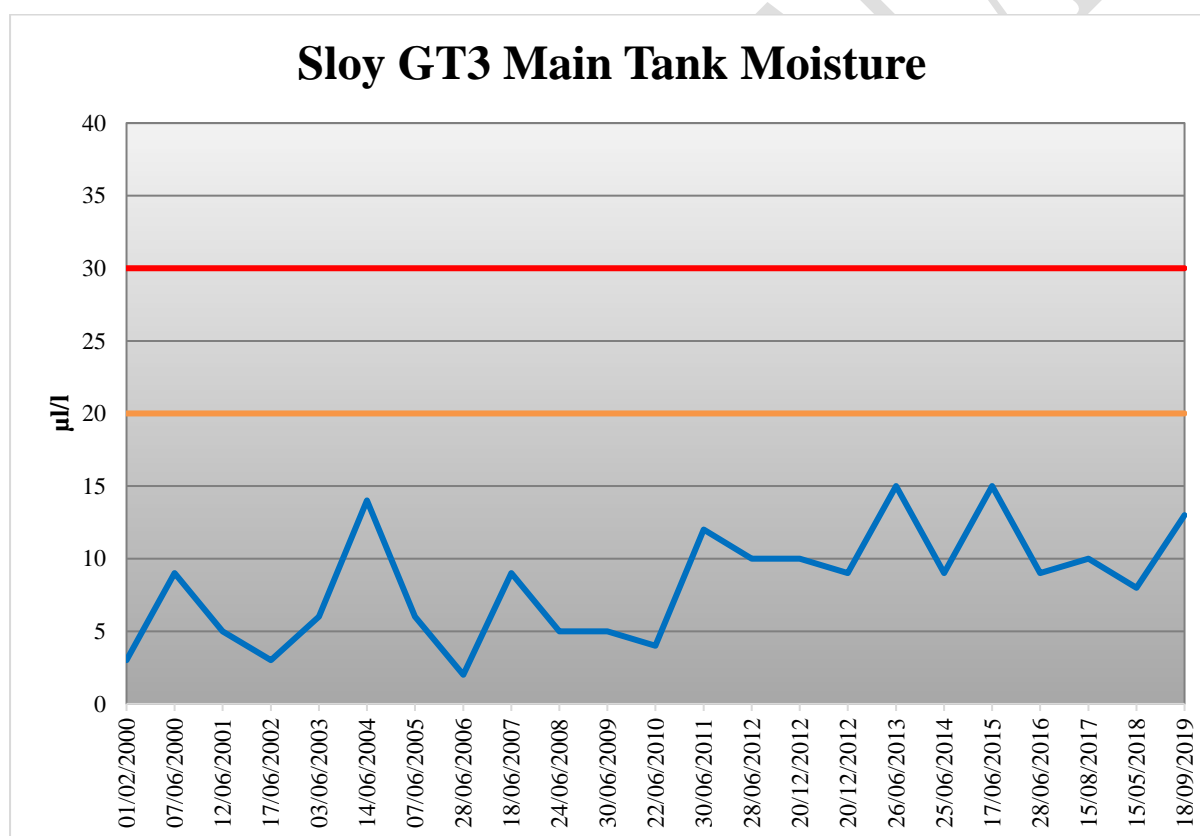
The historical moisture data spans 23 samples taken over the period of 2000 to the most recent sample in 2019. Over the operational life of the transformer the moisture levels are observed to be dynamic yet, moisture levels have consistently been categorised as “Good” as defined in IEC 60422, for category B apparatus. Moisture levels peak at 15µl/l in 2013 & 2015. The overall moisture trend is considered satisfactory.

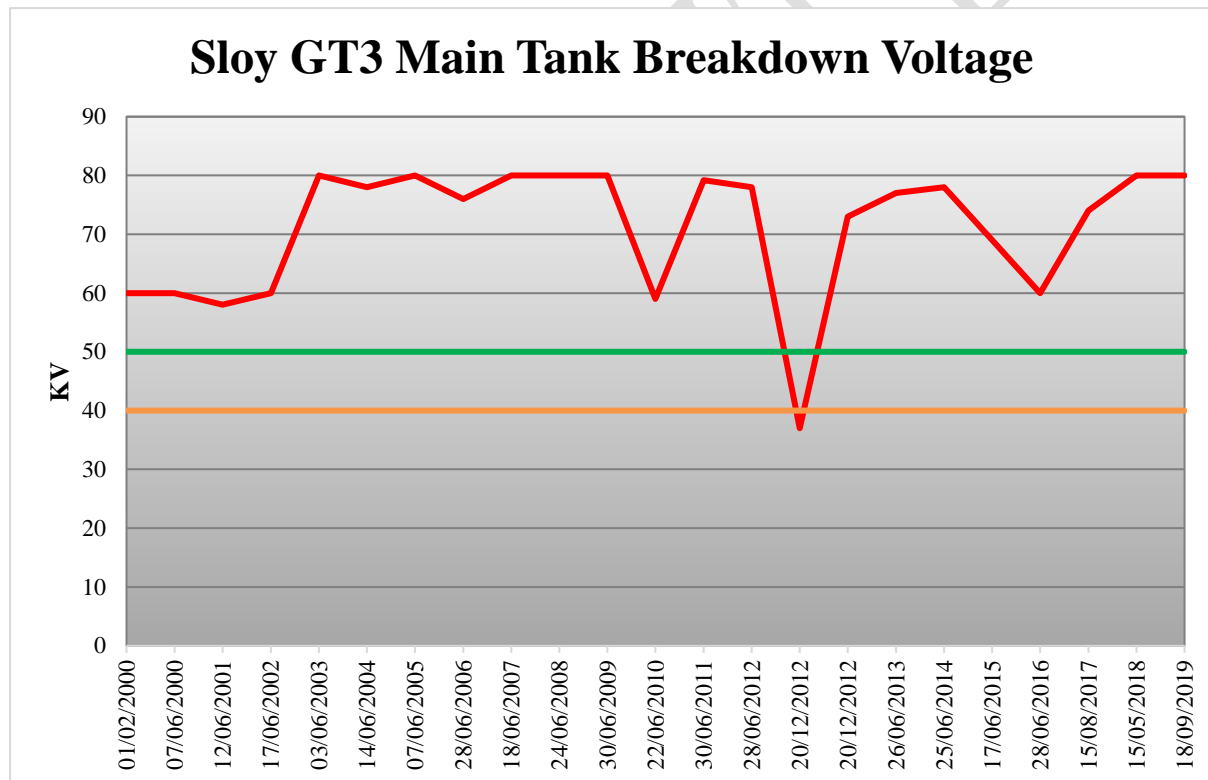
The historical breakdown voltage record spans from 2000 to the most recent sample in 2019. Over the available history, the breakdown voltage is predominantly categorised as “Good” as defined by IEC 60422. The trend exhibited is dynamic with the lowest value of 37kV recorded in December of 2012. This is considered to be due to poor sampling procedure or technique as a repeat sample taken on the same date returns a breakdown voltage level of 73kV. No correlations in reductions of breakdown

voltage and increased measured moisture are observed. The most recent breakdown voltage is categorised as “Good” and is considered representative of the breakdown voltage history.

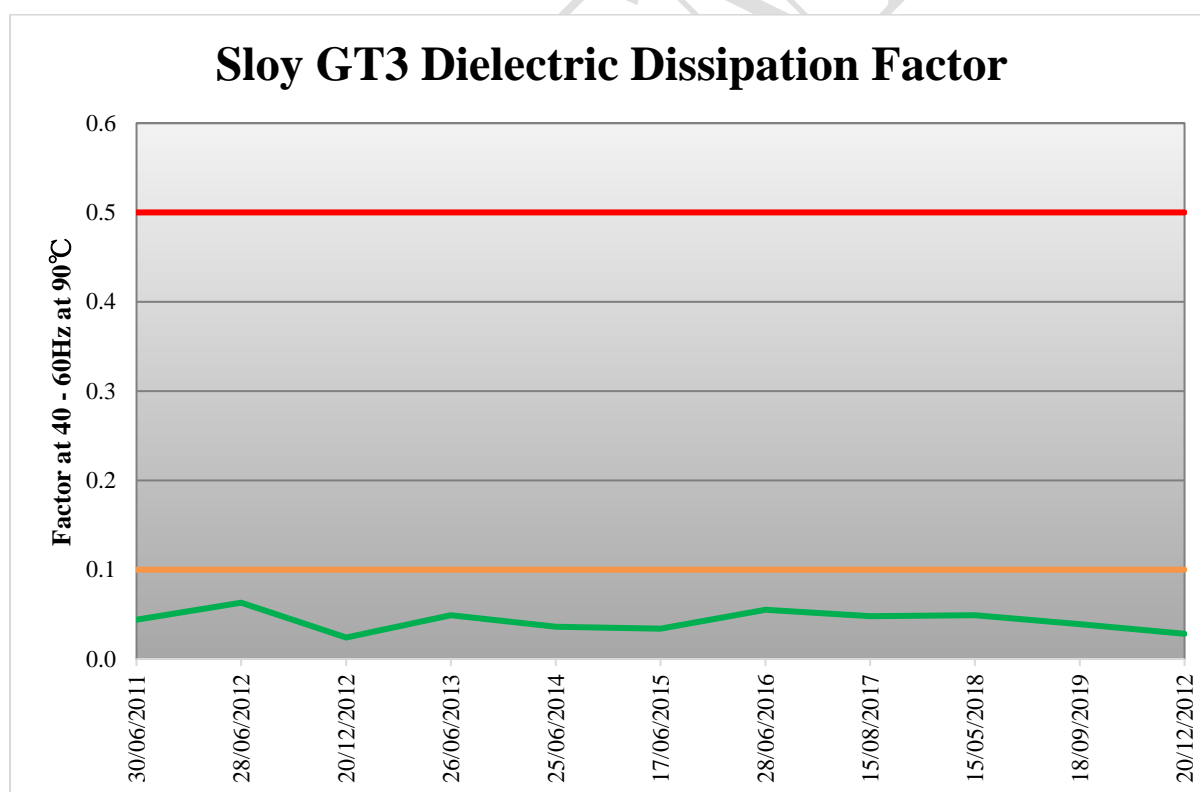
The Dielectric Dissipation Factor level, as defined by IEC 60422, is “Good” and is satisfactory.

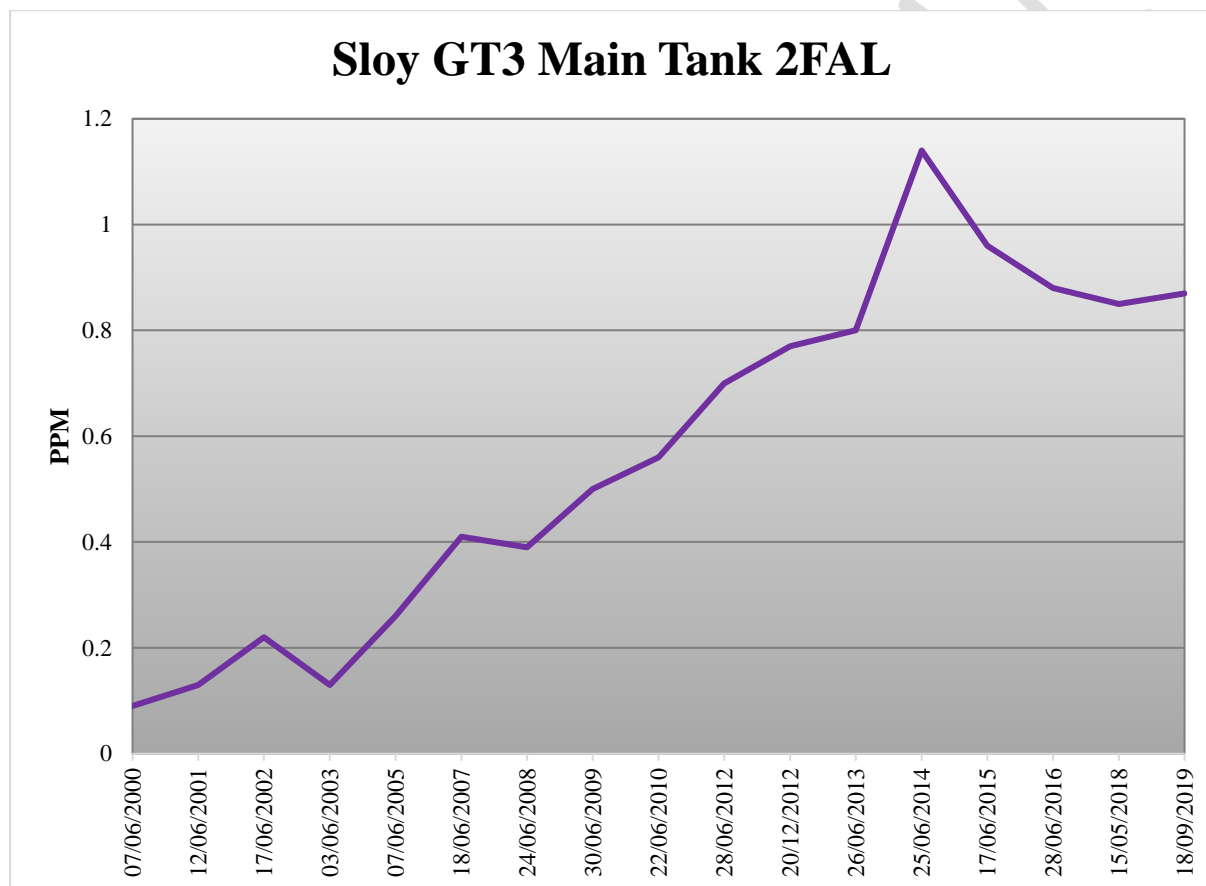
The 2FAL historical record spans from 2000 until the most recent sample, taken in September 2019. The 2FAL levels, overall, show an increasing trend over the sample period which is indicative of increasing or accelerated insulation ageing, which is particularly prominent between 2013 and 2014. A reduction in 2FAL levels between 2015 & 2018 is indicative of a dilution to the main tank oil by means of oil top ups or by oil processing. The final value recorded was 0.87 (Est DP 446), compared to the highest value recorded in the sampling period of 1.14 (Est DP 412). The link between measured 2FAL and estimated DP is reliant on an algorithmic relationship, of which there are five different variants. The Chengdong algorithm has been used to relate measured 2FAL to estimated DP. In order to estimate the DP of the insulation system, the highest value of measured 2FAL shall be used (From June 2014). Measured 2FAL of 1.14 gives an estimated DP of 412. The insulation within a new transformer has

typically a DP value of 1000. It is generally accepted within the industry that an estimated DP value of 200 is “end of life”. Application of this criteria, results in the transformer having an estimated 26% residual life remaining in the paper insulation. This suggests that the paper insulation is in an aged condition.

- Main tank oil should be sampled at 6 monthly intervals, in order to keep the levels of 2FAL under surveillance and to assess the ageing rate. This is in addition to routine sampling. On line monitoring of 2FAL is not presently an option as the technology is not mature.
- Electrical diagnostic testing. This is to assess the mechanical condition of the active part by Sweep Frequency Response Analysis (SFRA) and the condition of the insulation system by means of dielectric frequency response (DFR), 10kV Power Factor and 5kV Insulation Resistance. This will require an outage and the disconnection and removal of the 132kV & 11kV busbars.

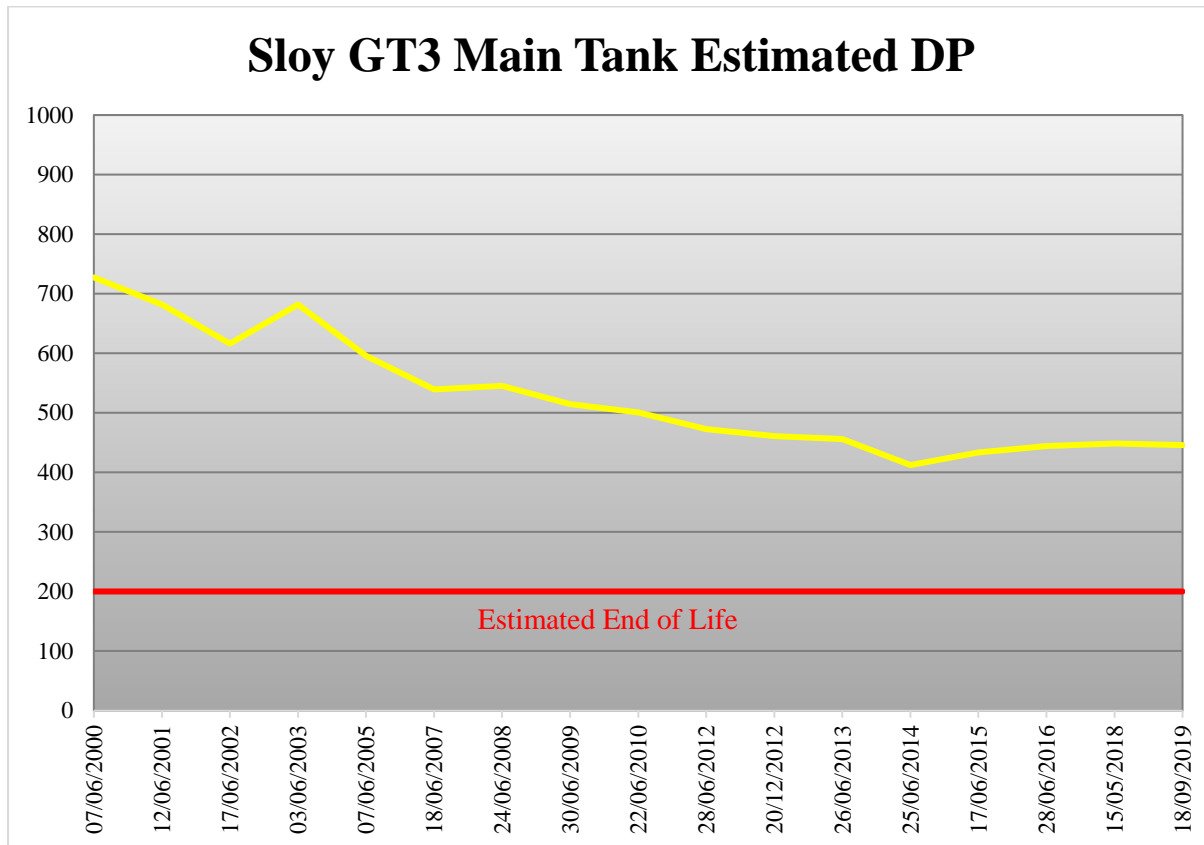
Between 2007 and 2014 there is an almost linear and sustained ageing rate, which is considered to be genuine. The oil intervention (either oil top up or oil processing) in 2014 has diluted the 2FAL in such a way as to manifest as an apparent increase in estimated DP which camouflages the true estimated DP in 2019, which will be in a worse condition than predicted. Extrapolation of the estimated DP between 2007 and 2014, based on the observable rate of ageing, and assuming that there is no deviation in that rate, or that the transformer is not subjected to external failure mechanism, would predict that “end of life” would be reached in the year 2026. The transformer has 6 years of operational service life remaining, which is within the RIIO T2 period.

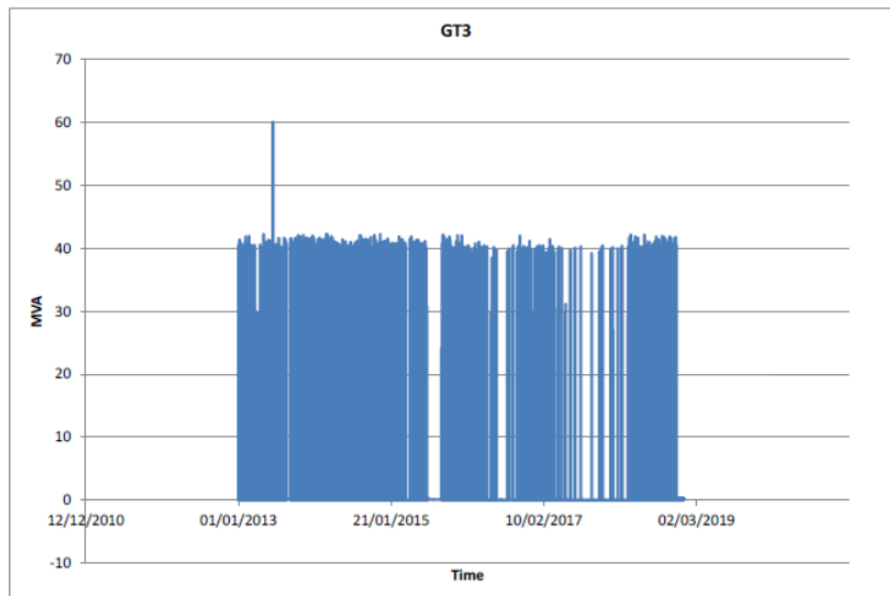
Figure 5.11 from section 5.6 of the document shows a measured load flow of GT3 for the period of 2013 to 2018. The transformer has a typical maximum load flow of around 42MVA, which is within the 50MVA rating of the transformer and at this load level the transformer would be operating in OFAF operation with the pumps and fans running. The step change duty cycle and high levels of loading of the transformer do not appear to have caused step changes in the generation of 2FAL, but there is evidence from the 2FAL that paper insulation is ageing.
