# **Kilmorack GT1 132/11kV Transformer**

**Level 1 Condition  
Assessment Report  
16th July 2020  
Report:  
KILOGT1SHET200629  
FINAL**

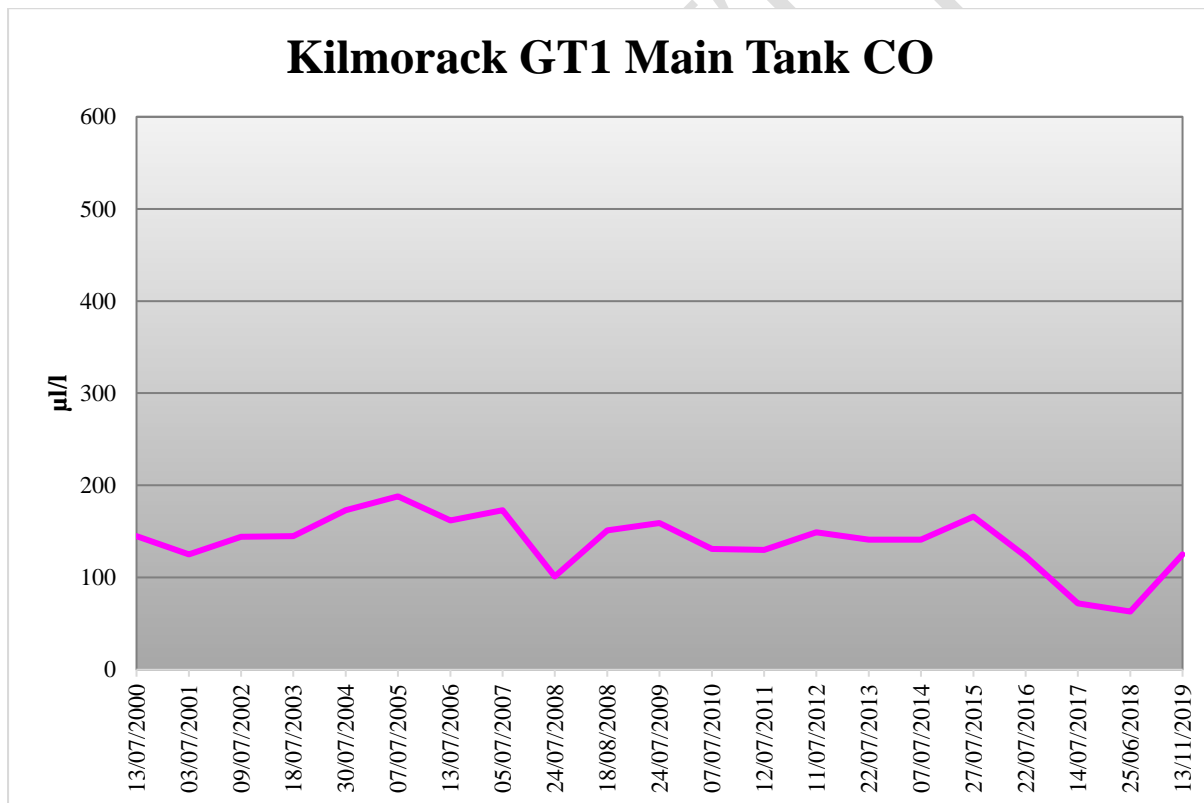
The CO characteristic is considered relatively stable and remains below “typical values” specified in IEC 60599 over the sample period, peaking at 188 $\mu$ l/l in 2005. The paper insulation is likely in reasonable condition for its age.

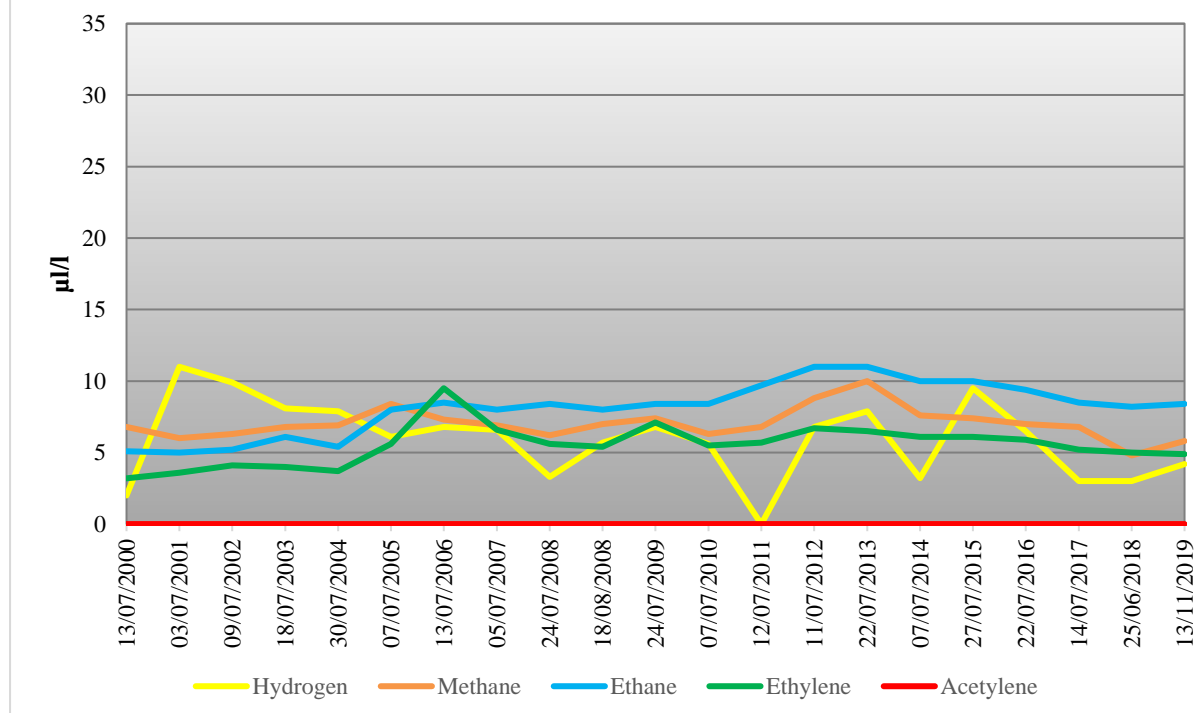
## Kilmorack GT1 Main Tank DGA

Thermal gases Methane, Ethane & Ethylene are present throughout the DGA history however, all remain at levels well below “typical values” specified in IEC 60599. There are two identifiable peaks in dissolved ethylene which have not manifested into a more serious underlying thermal condition.

Application of the gas ratios, as defined in IEC 60599,  $[0, 1.5, 0.58]$  fails to highlight any abnormality through a diagnosis of non-classification. Using the Duval’s triangle method of DGA interpretation, the same gas ratios define a “T2” condition, “Thermal faults,  $300^{\circ}\text{C} < T < 700^{\circ}\text{C}$ ”, however, it should be noted that the Duval method, being a closed system, will always result in a condition being identified. The magnitudes of dissolved gas levels are considered to be too low to accurately diagnose and in this case the DGA would be considered benign.

The DGA does not presently exhibit any evidence of partial discharge, discharge, or thermal abnormality. The DGA history can be described as benign, however the dissolved ethylene should be kept under surveillance.

- Frequency of oil sampling should be increased to monitor dissolved ethylene, moisture content and dielectric breakdown voltage. This should be done every 6 months.

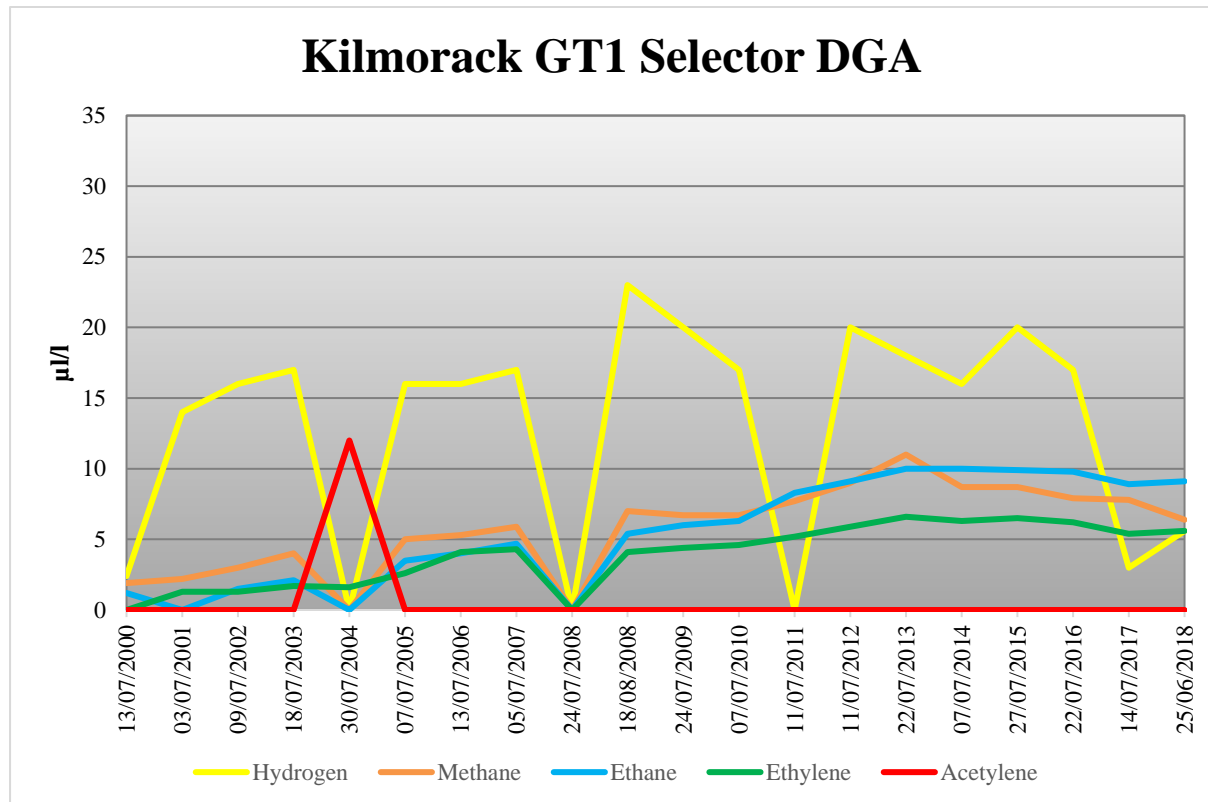
Thermal gases Methane, Ethane and Ethylene are all present in the DGA history, however, remain at low levels well below “typical values” specified in IEC 60599. Correlations in thermal gases are indicative of a potential high temperature thermal abnormality occurring at low levels. Also, the trend exhibited by thermal gases correlates with the trend displayed in the main tank DGA analysis which confirm communication between the main tank and the selector. Interventions have taken place in 2004 and 2008.

Application of the gas ratios, as defined in IEC 60599, [0.0, 1.0, 0.61] fails to highlight any abnormality through a diagnosis of non-classification. Using the Duval’s triangle method of DGA interpretation, the same gas ratios define a “T2” condition, “Thermal faults,  $300^{\circ}\text{C} < T < 700^{\circ}\text{C}$ ”, however, it should be noted that the Duval method, being a closed system, will always result in a condition being identified. The magnitudes of dissolved gas levels are considered to be too low to accurately diagnose and in this case the DGA would be considered benign.

The DGA does not presently exhibit any evidence of partial discharge, discharge, or thermal abnormality. The DGA history can be described as benign, however the dissolved ethylene should be kept under surveillance.

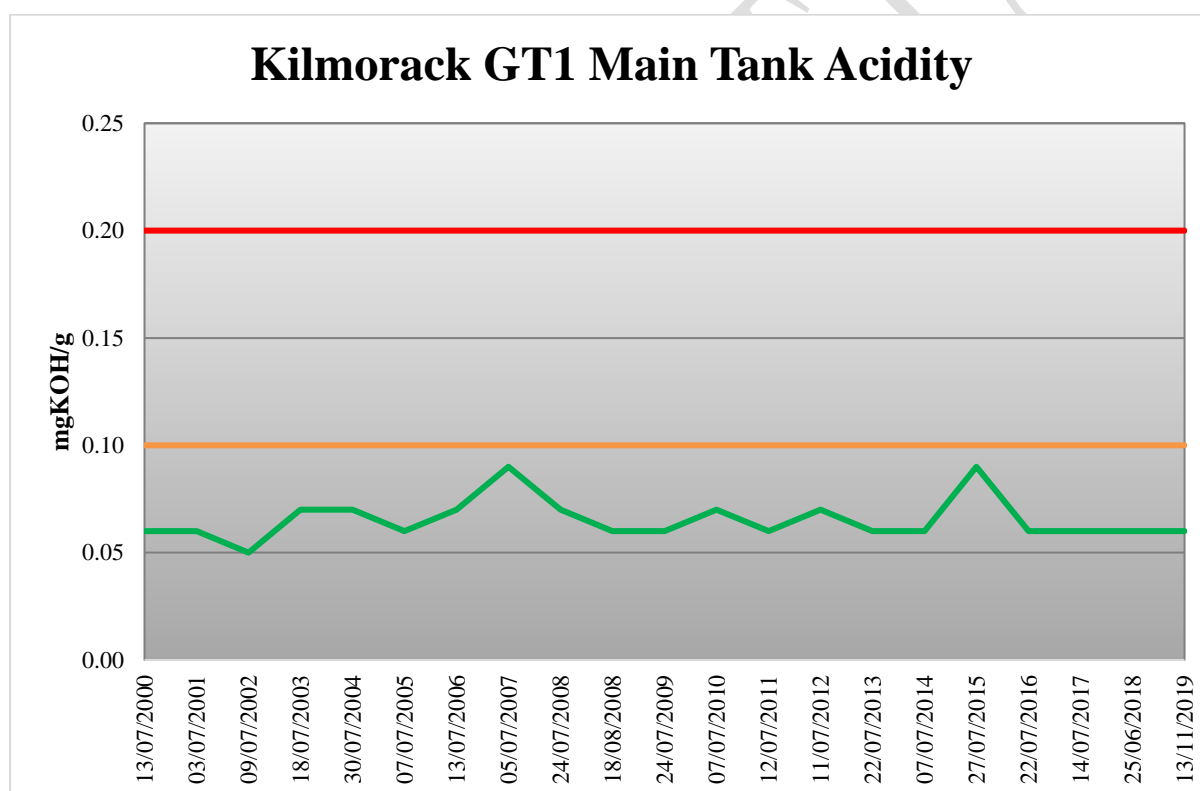
The historical acidity record contains 21 samples taken in the period of 2000 to 2019. The acidity levels are found to be relatively stable however, short periods of increased acidity content are indicative of oxidation of the main tank oil. Also, minor reductions observed are indicative of dilution by means of top ups to the main tank with new or reclaimed oil or an intervention. Over the sample range all results are consistently categorised as “Good” as defined by IEC 60422 for category B apparatus. Overall, the acidity is considered satisfactory.

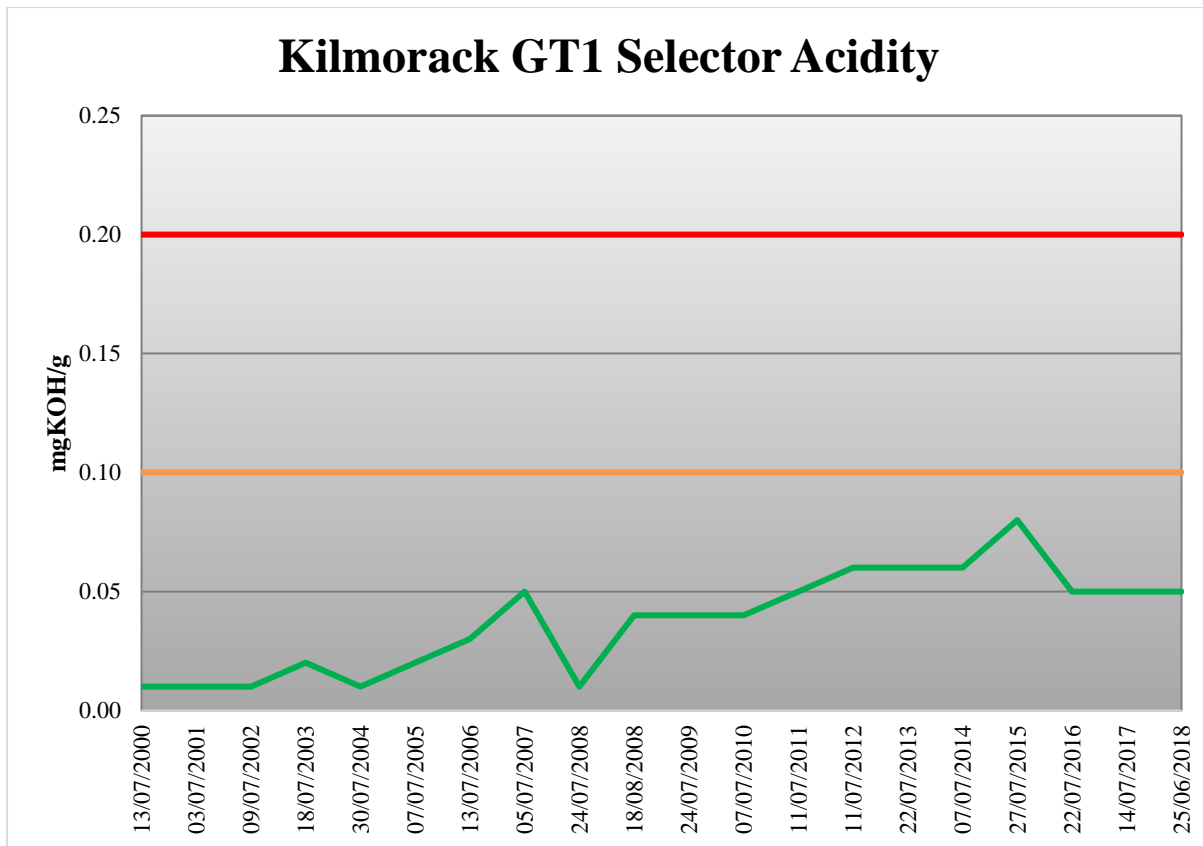
The historical acidity record contains 20 samples taken in the period of 2000 to 2018. The acidity levels are found to exhibit an overall increasing trend which is indicative of oxidation of the selector oil, which most likely is a result of main tank communication. Minor reductions observed are indicative of dilution by means of top ups or oil replacement during maintenance. Over the sample range all results are categorised as “Good” as defined by IEC 60422 for category B apparatus. The acidity is considered satisfactory.

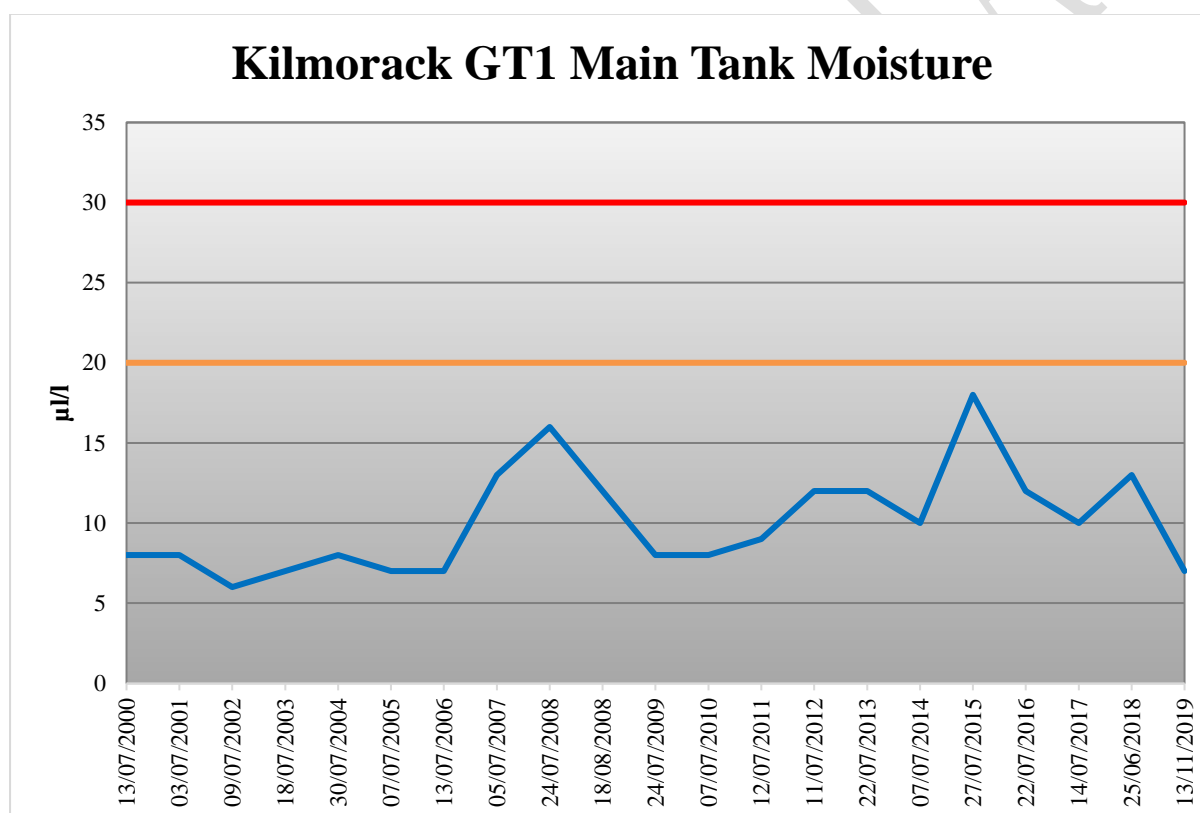
The historical moisture data spans 21 samples taken in the period of 2000 to 2019. Over the operational life of the transformer the moisture levels have been dynamic yet have consistently been categorised as “Good”, as detailed in IEC 60422. Moisture peaks at  $18\mu\text{l/l}$  in July 2015. The most recent moisture result of  $7\mu\text{l/l}$  is considered satisfactory and representative of recent historical results.

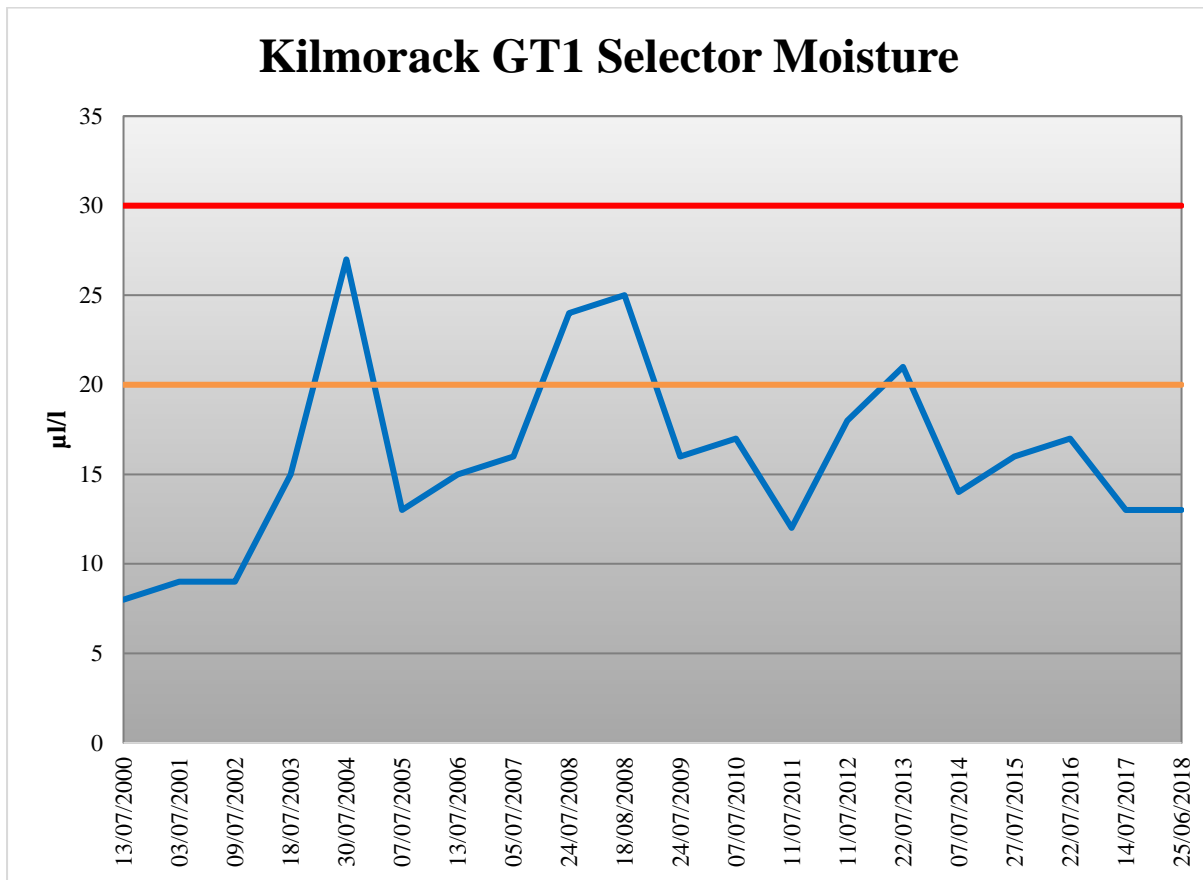
## Kilmorack GT1 Selector Moisture

The historical moisture data spans 20 samples taken over the period of 2000 to 2018. Over the operational life of the transformer the moisture levels have been dynamic and have exhibited an increasing trend. Moisture results have predominantly been categorised as “Good”, as detailed in IEC 60422 for category B apparatus yet have reached levels categorised as “Fair” on four separate occasions. A correlation in increased main tank moisture levels and peaks in selector moisture results is observed and suggests communication between the two. The peak value recorded in June 2004 was 27µl/l. The present moisture level is satisfactory and is fairly representative of the history.

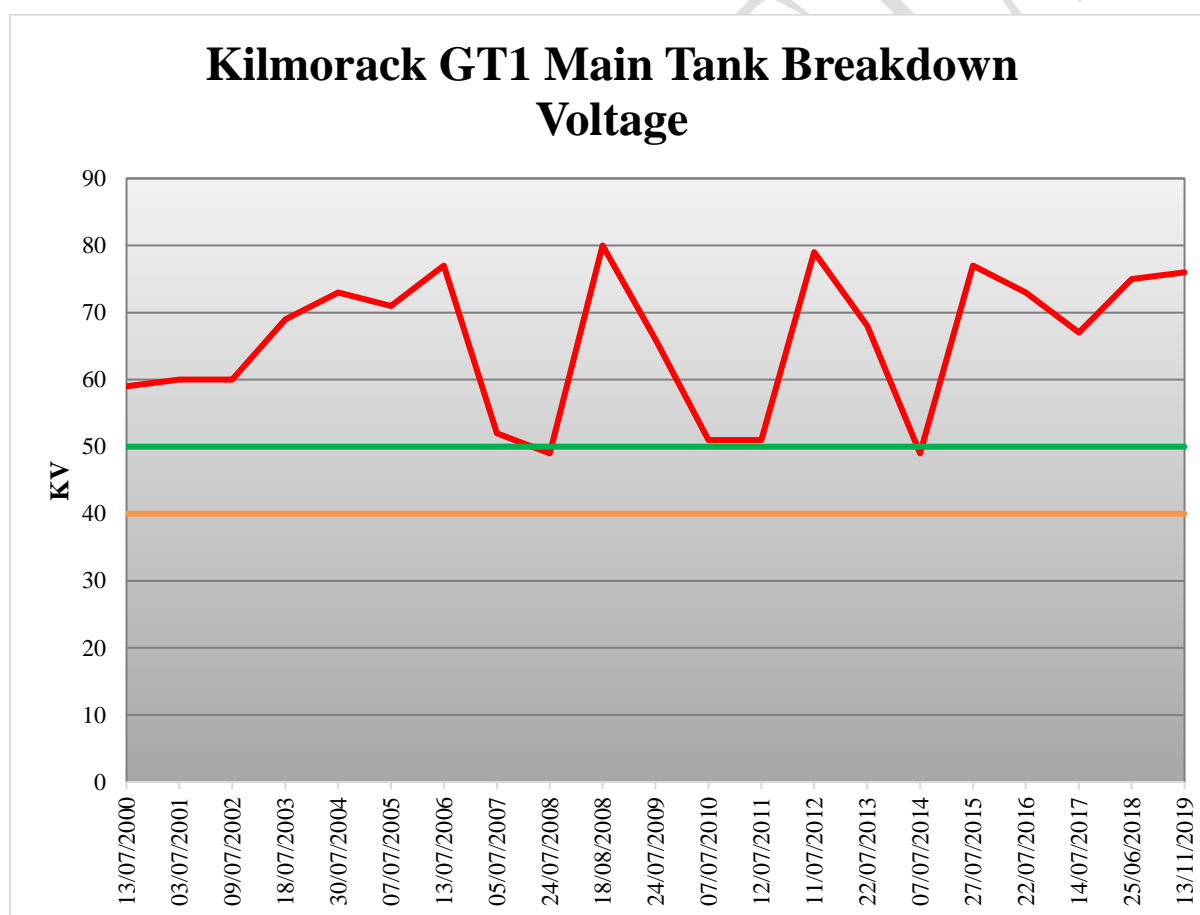
The historical breakdown voltage record spans from 2000 to the most recent sample in 2019. The breakdown voltage trend is observed to be dynamic over the sample range. Over the available history, the breakdown voltage is predominantly classed as "Good" as defined by IEC 60422. Although there are 2 samples within the "Fair" classification in July 2008 (49kV) & July 2014 (49kV). There is a correlation between increased main tank moisture levels and reduced breakdown voltage levels. The

most recent breakdown voltage is “Good” as defined by IEC 60422, and is considered representative of the breakdown voltage history.

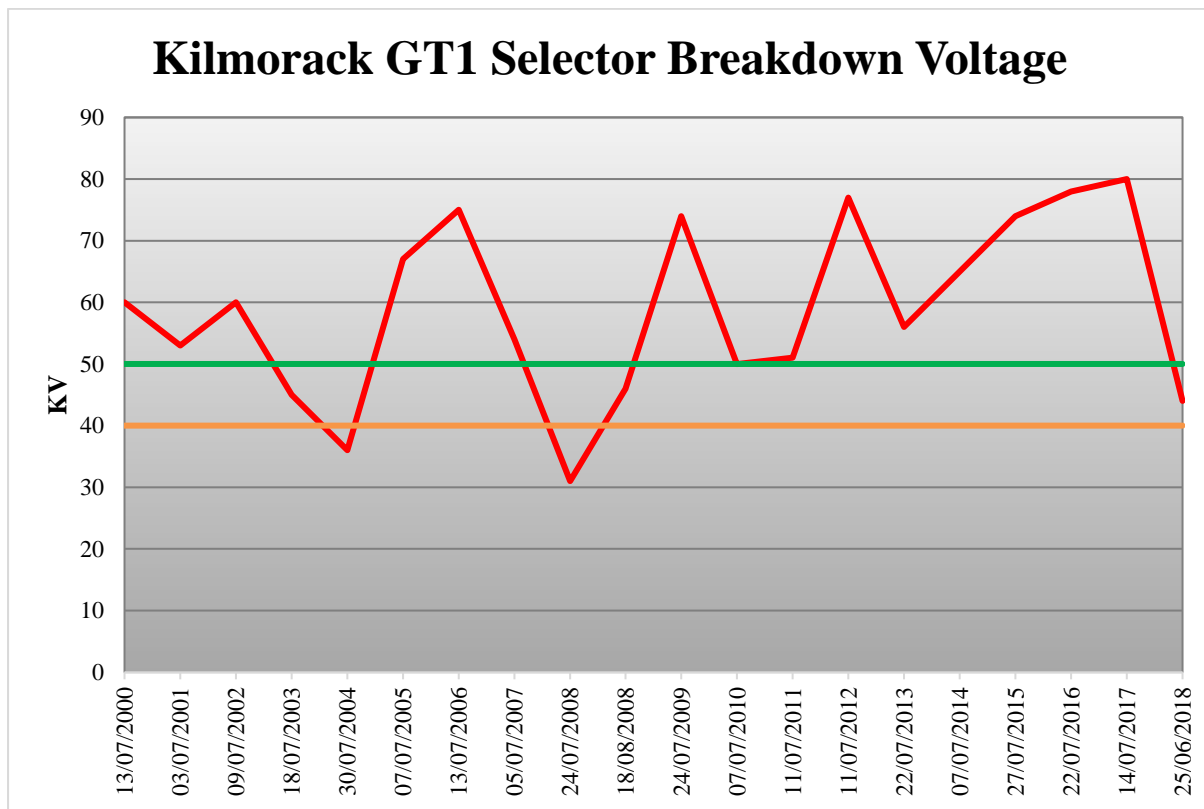
The historical breakdown voltage record spans from 2000 to the most recent sample in 2018. The breakdown voltage trend is observed to be very dynamic over the sample range. Over the available history, the breakdown voltage is predominantly classed as “Good” as defined by IEC 60422. Although there are 3 samples within the “Fair” classification in July 2003 (45kV), August 2008 (46kV) & July 2010 (50kV). Two samples also reach “Poor” categorisation in July 2004 (36kV) & July 2008 (31kV). There is a correlation between increased selector moisture levels and reduced breakdown voltage levels. The most recent breakdown voltage is “Fair” as defined by IEC 60422, and is considered to be fairly representative of the breakdown voltage history.

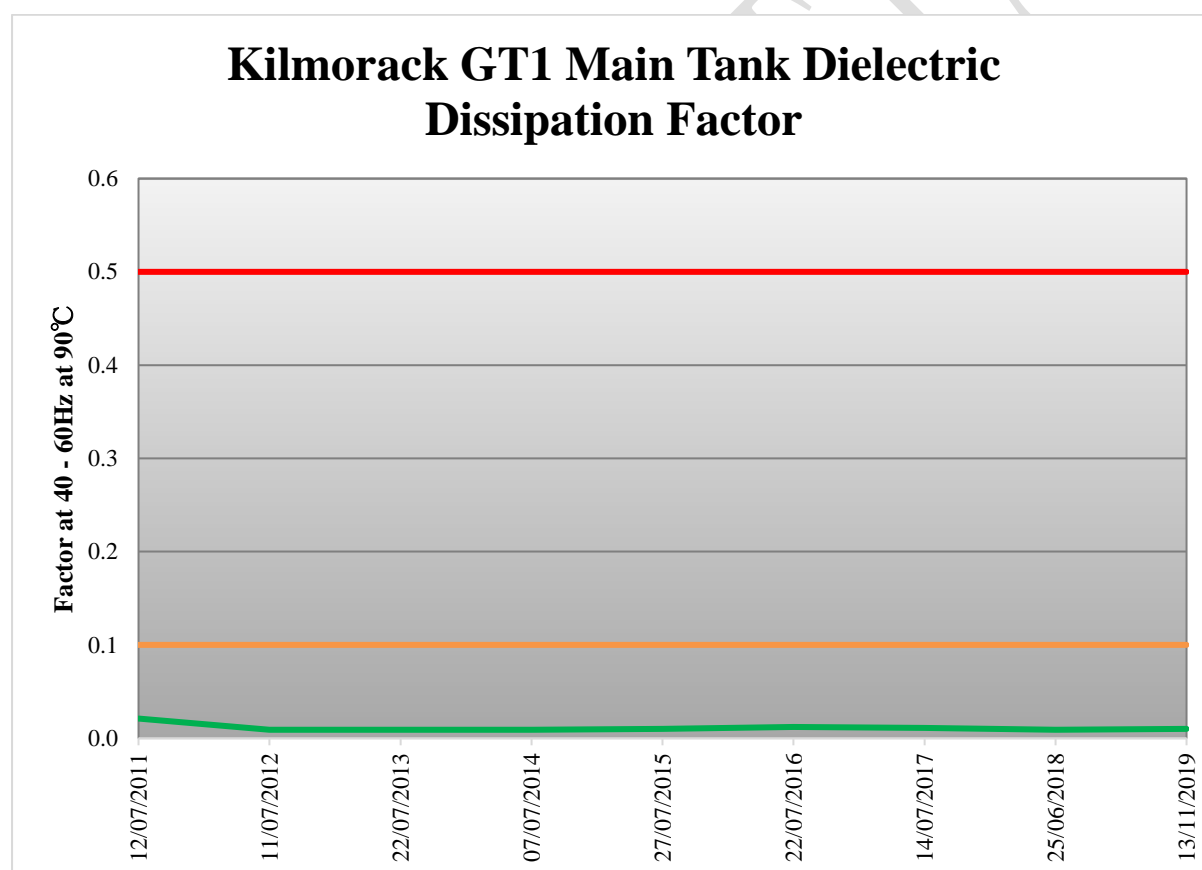
The dielectric dissipation factor trend is steady state and is constantly defined as “Good”. This result is satisfactory.

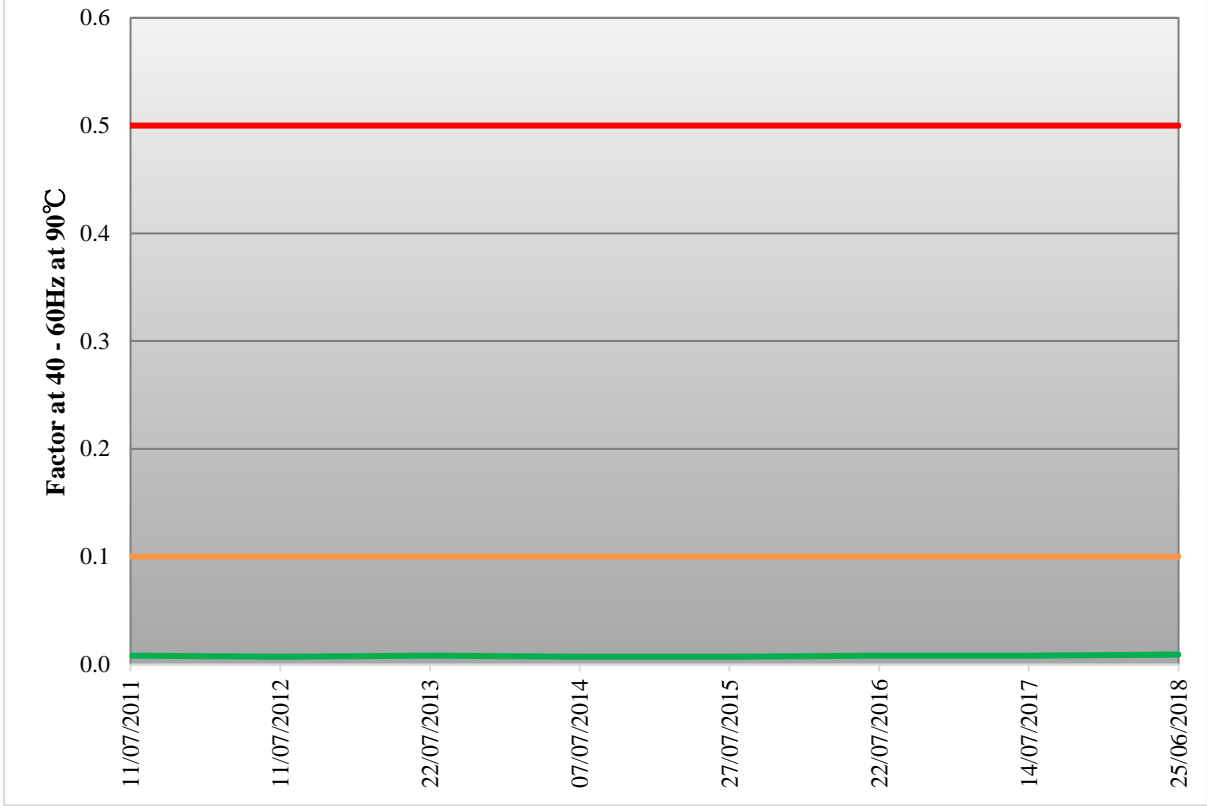
# Kilmorack GT1 Selector Dielectric Dissipation Factor

The dielectric dissipation factor trend is steady state and is constantly defined as “Good”. This result is satisfactory.

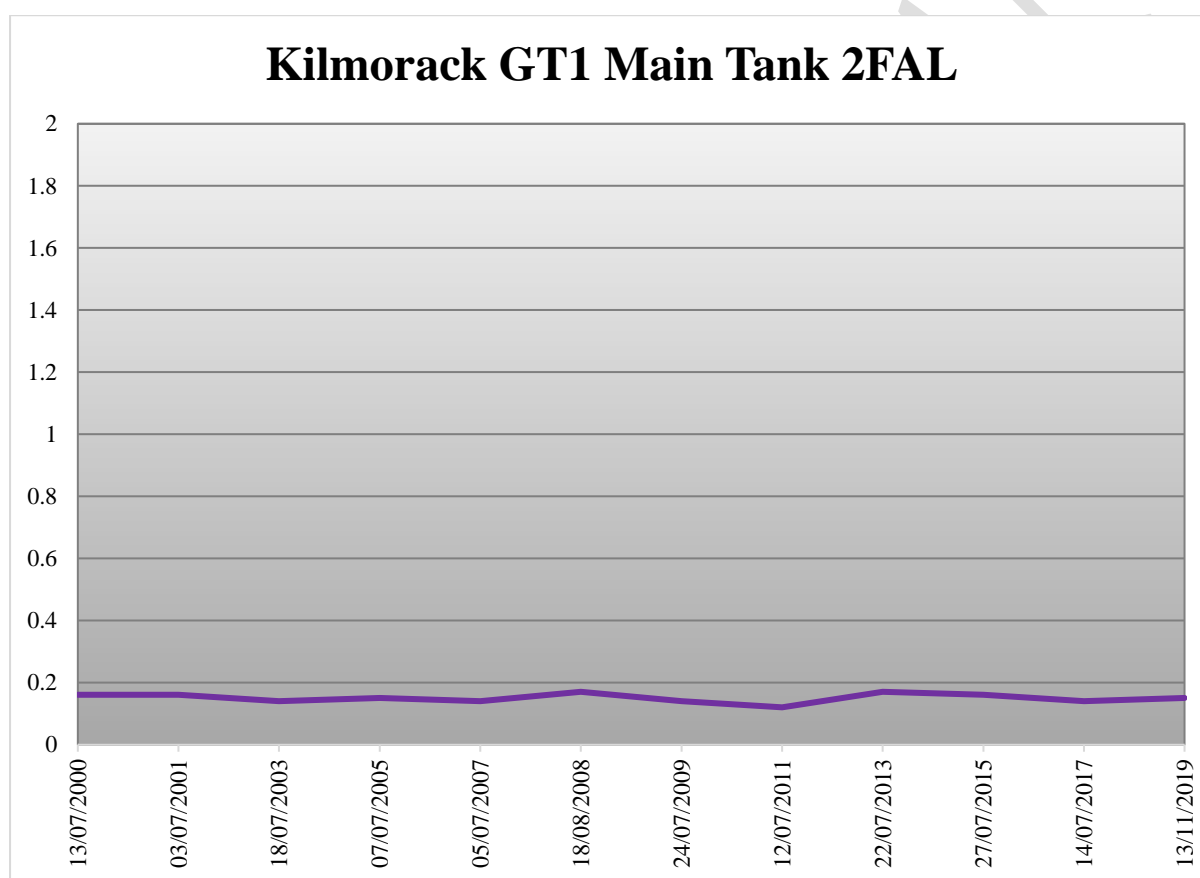
The 2FAL record spans from 2000 until the most recent sample, which was taken in November 2019. The 2FAL levels exhibits a relatively stable trend throughout the sample range. The final value recorded was 0.15 (Est DP 664), compared to the highest value recorded in the sampling period of 0.17 (Est DP 648). The link between measured 2FAL and estimated DP is reliant on an algorithmic relationship, of which there are five different variants. The Chengdong algorithm has been used to relate measured 2FAL to estimated DP. In order to estimate the DP of the insulation system, the highest value of measured 2FAL shall be used (From August 2008). The insulation within a new transformer has typically a DP value of 1000. It is generally accepted within the industry that an estimated DP value of 200 is “end of life”. Application of this criteria, results in the transformer having an estimated 56%

residual life remaining in the paper insulation. This suggests that the paper insulation is in a good condition given its age.
