Tummel Bridge GT1 132/11kV Transformer

**Level 1 Condition
Assessment Report
15th July 2020
Report:
TUMBGT1SHET200627
FINAL**

Ian B B Hunter

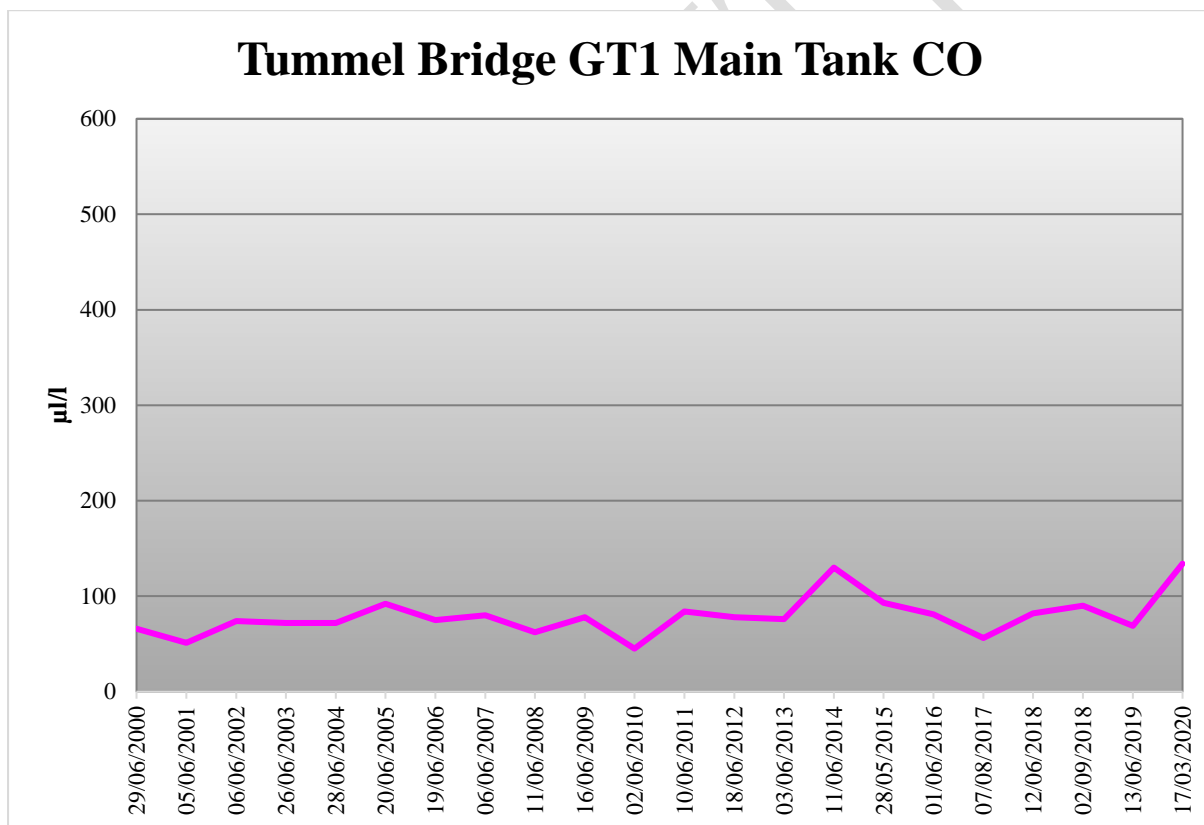
As the values of dissolved Carbon Monoxide (CO) are several orders of magnitude greater than all other diagnostic gases, the CO history is plotted separately for clarity.

The CO characteristic is considered to be relatively stable and at low levels over the sample period with no substantial increases in CO values. CO consistently remains below “typical values” specified in IEC 60599 over the sample period therefore, the paper insulation is likely in good condition.

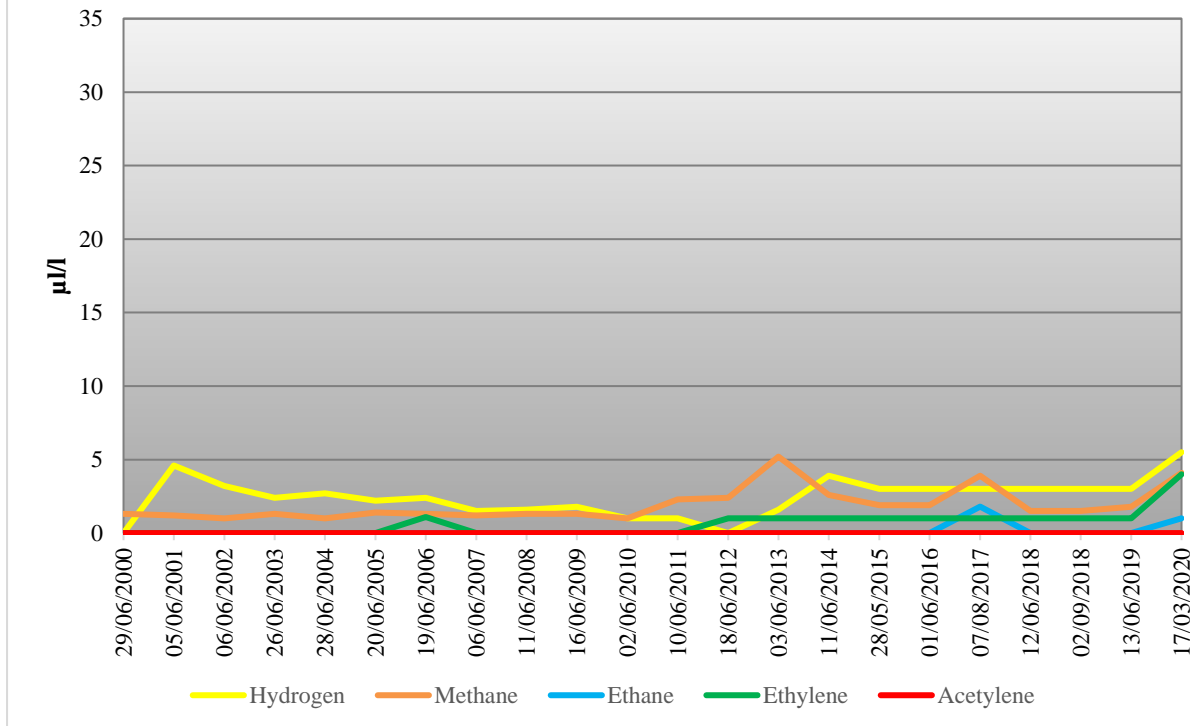
Tummel Bridge GT1 Main Tank DGA

Hydrogen and thermal gases Methane, Ethane and Ethylene are all present in the DGA history however, all remain at low levels well below “typical Values” specified in IEC 60599.

Application of the gas ratios, as defined in IEC 60599, $[0, 0.66, 4]$ fails to highlight any abnormality through a diagnosis of non-classification. Using the Duval’s triangle method of DGA interpretation, the same gas ratios define a “T3” condition, “Thermal faults, $T > 700^{\circ}\text{C}$ ”, however, it should be noted that the Duval method, which is a closed system, will always result in a condition being identified. The magnitudes of dissolved gas levels are considered to be too low to accurately diagnose and in this case the DGA would be considered benign.

It should be noted that between 2019 and 2020 there has been a slight increase in dissolved ethylene, with residual quantities of dissolved methane and ethane. Whilst these magnitudes of dissolved gases are still at low level, the dissolved ethylene should be kept under surveillance, in order to check for the manifestation of a thermal abnormality.

It should be noted that between 2019 and 2020 there has been a slight increase in the main tank dissolved ethylene, with residual quantities of dissolved methane and ethane. Whilst these magnitudes of dissolved gases are still at low level, the dissolved ethylene should be kept under surveillance, in order to check for the manifestation of a thermal abnormality.

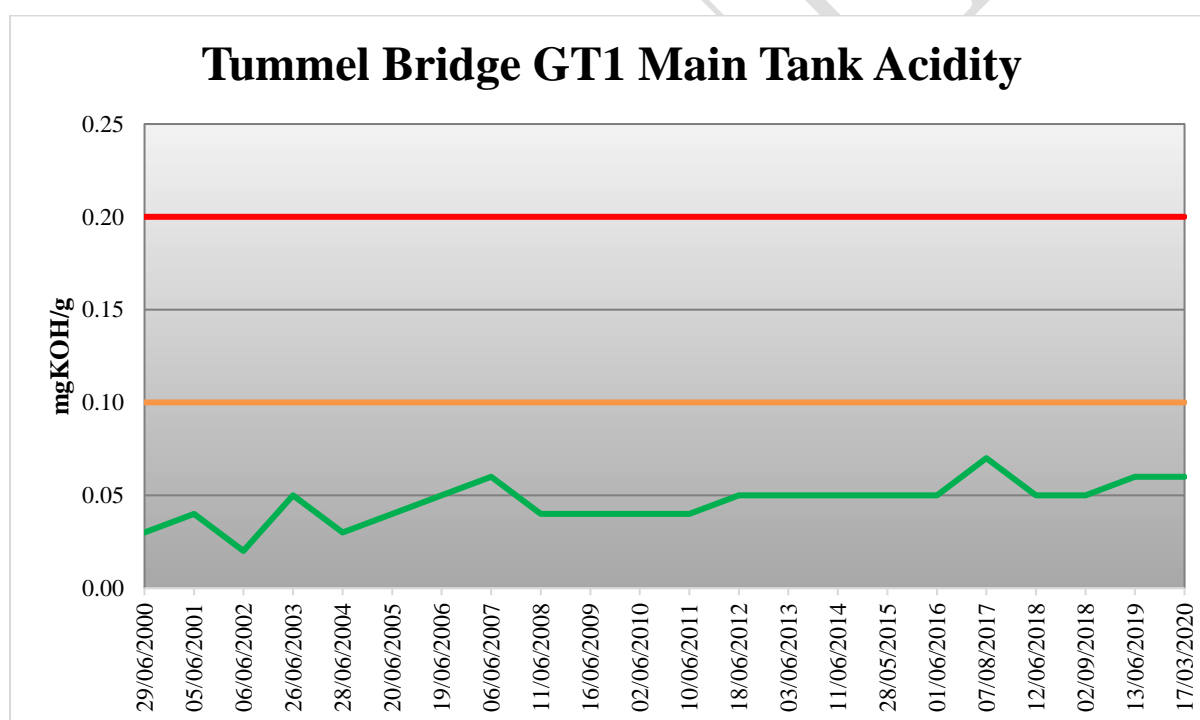
The historical acidity record contains 22 samples taken in the period of 2000 to 2020. The acidity levels are found to exhibit a very minor increasing trend over the sample period which is indicative of minor oxidation of the oil. Over the entire historical sample range all results can be categorised as “Good” as defined by IEC 60422 for category B apparatus. The acidity is considered satisfactory.

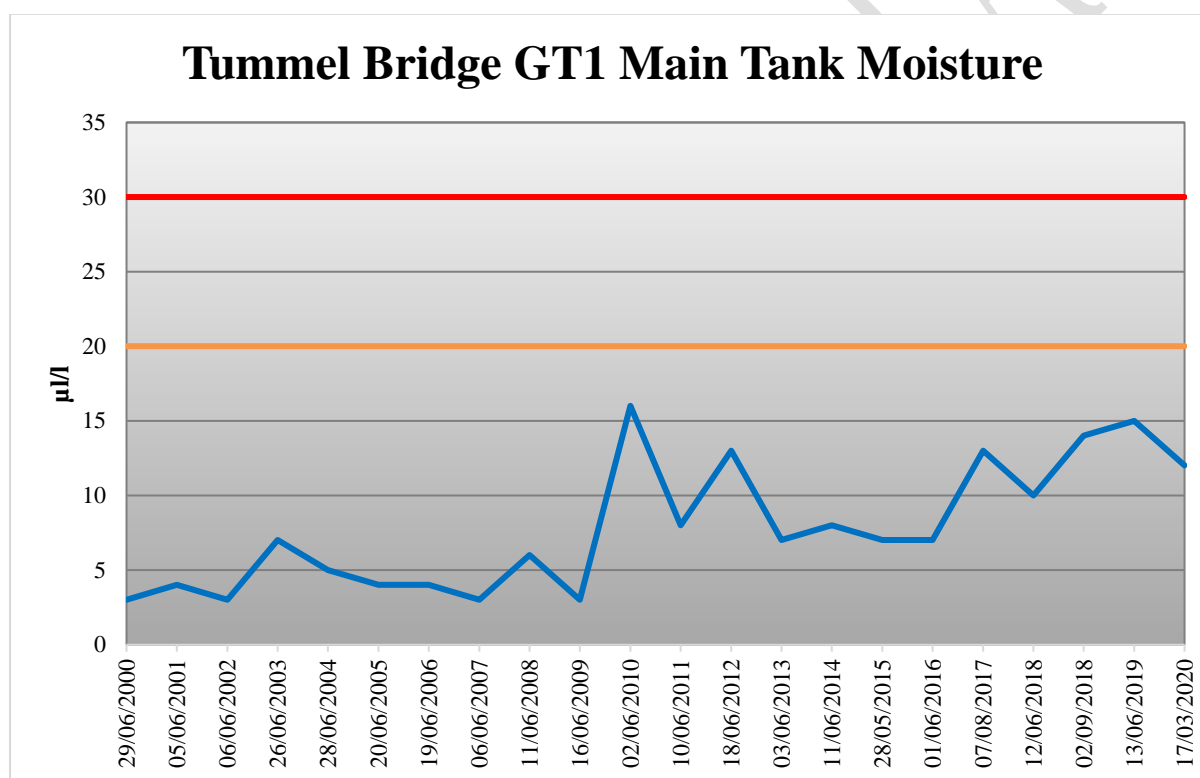
The moisture data spans 22 samples taken over the period of 2000 to 2020. Over the operational life of the transformer the moisture levels have been dynamic yet have consistently been categorised as “Good” as defined by IEC 60422, for category B apparatus. The peak moisture value is recorded in June 2010 at 16 $\mu\text{l/l}$. The overall moisture trend is satisfactory.

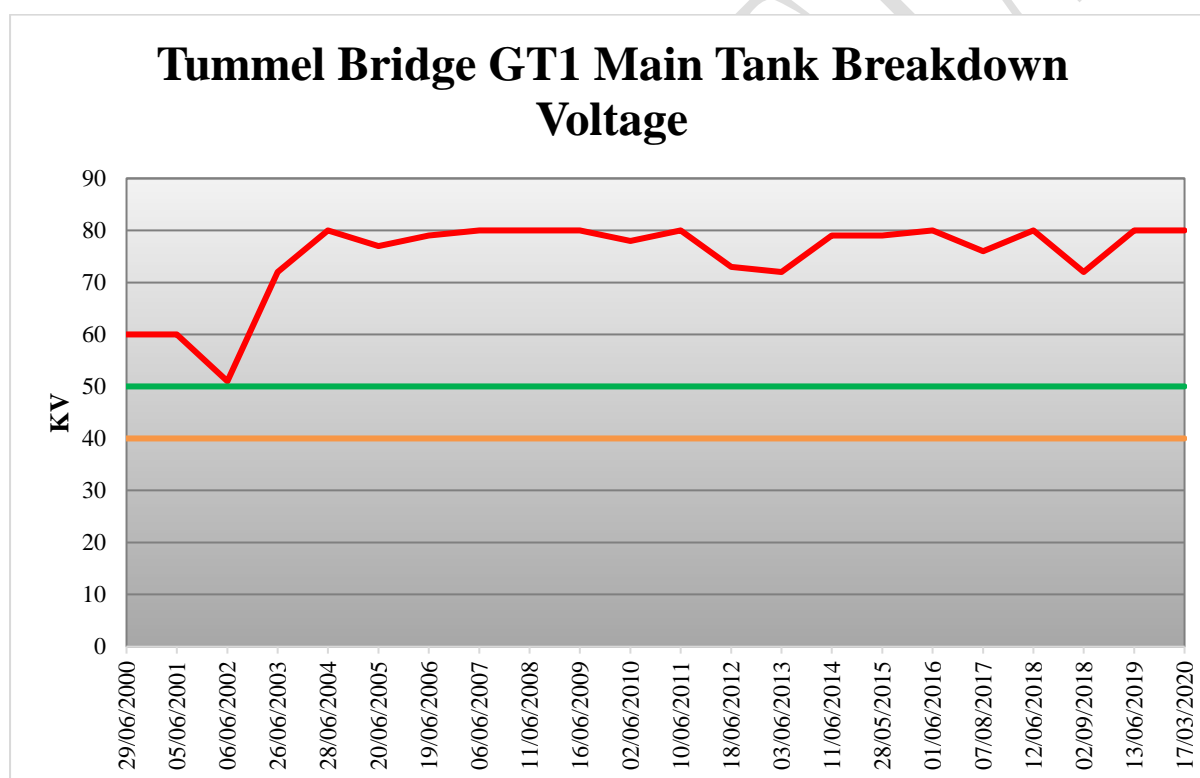
The historical breakdown voltage record spans from 2000 to 2020 and includes 22 samples. Over the sample period the breakdown voltage is consistently categorised as “Good”, as defined by IEC 60422. The overall trend exhibited is relatively stable, no correlation between reduced breakdown voltage level and increased moisture content are apparent. The overall breakdown voltage level trend is satisfactory.

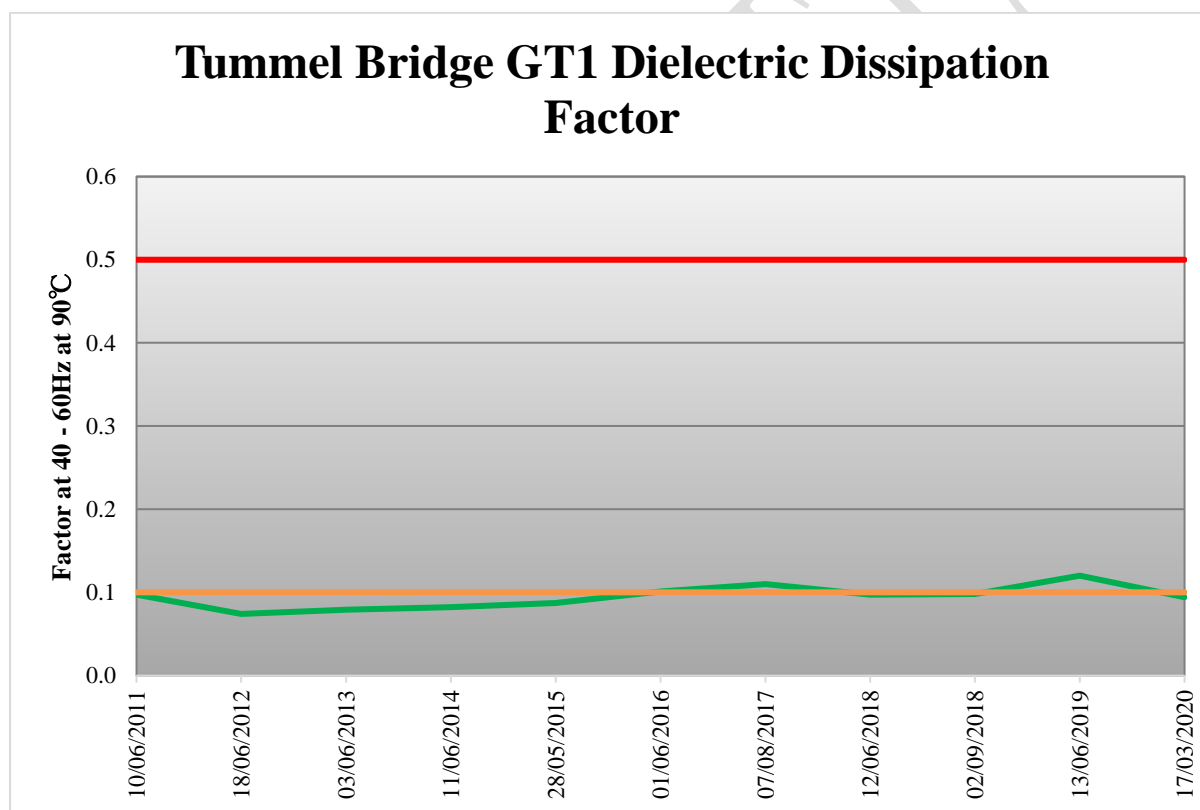
The dielectric dissipation factor spans the period of 2011 to 2020 and includes 11 samples. Over the sample period, the trend exhibited is dynamic with consistent fluctuations between levels categorised as “Good” & “Fair”, as defined by IEC 60422 for category B apparatus. It may be prudent to increase the sampling frequency of GT1 due to the fluctuations in results. The most recent results for dielectric dissipation factor is “Good” but is not wholly representative of the historical sample range.

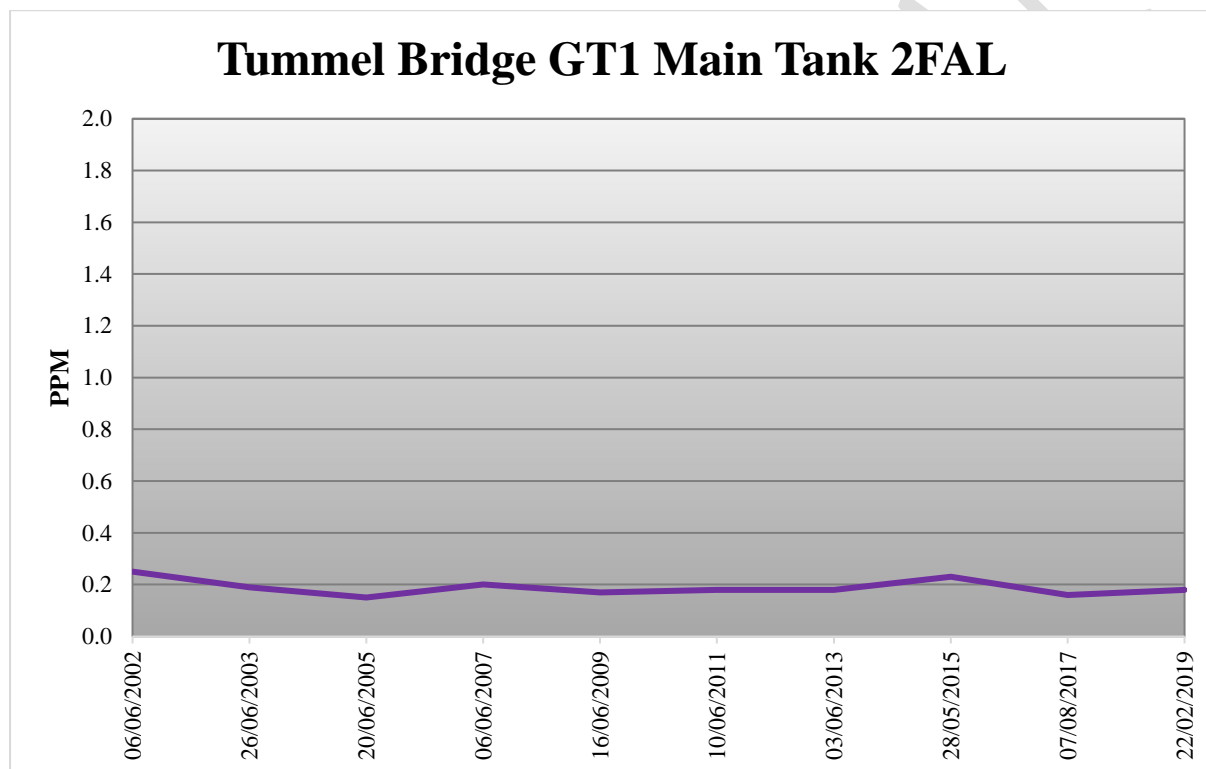
The 2FAL record spans from 2002 until the most recent sample, which was taken in February 2019. The 2FAL levels are relatively stable over the sample period with minor fluctuations observed. The final value recorded was 0.18 (Est DP 641), compared to the highest value recorded in the sampling period of 0.25 (Est DP 601). The link between measured 2FAL and estimated DP is also tenuous and is reliant on an algorithmic relationship, of which there are five different variants. The Chengdong algorithm has been used to relate measured 2FAL to estimated DP. In order to estimate the DP of the insulation system, the highest value of measured 2FAL shall be used (From June 2002). Measured 2FAL of 0.25 gives an estimated DP of 601. The insulation within a new transformer has typically a DP value of 1000. It is generally accepted within the industry that an estimated DP value of 200 is “end of life”. Application of this criteria, results in the transformer having an estimated 50% residual life remaining in the paper insulation. This suggests that the paper insulation is in good condition.

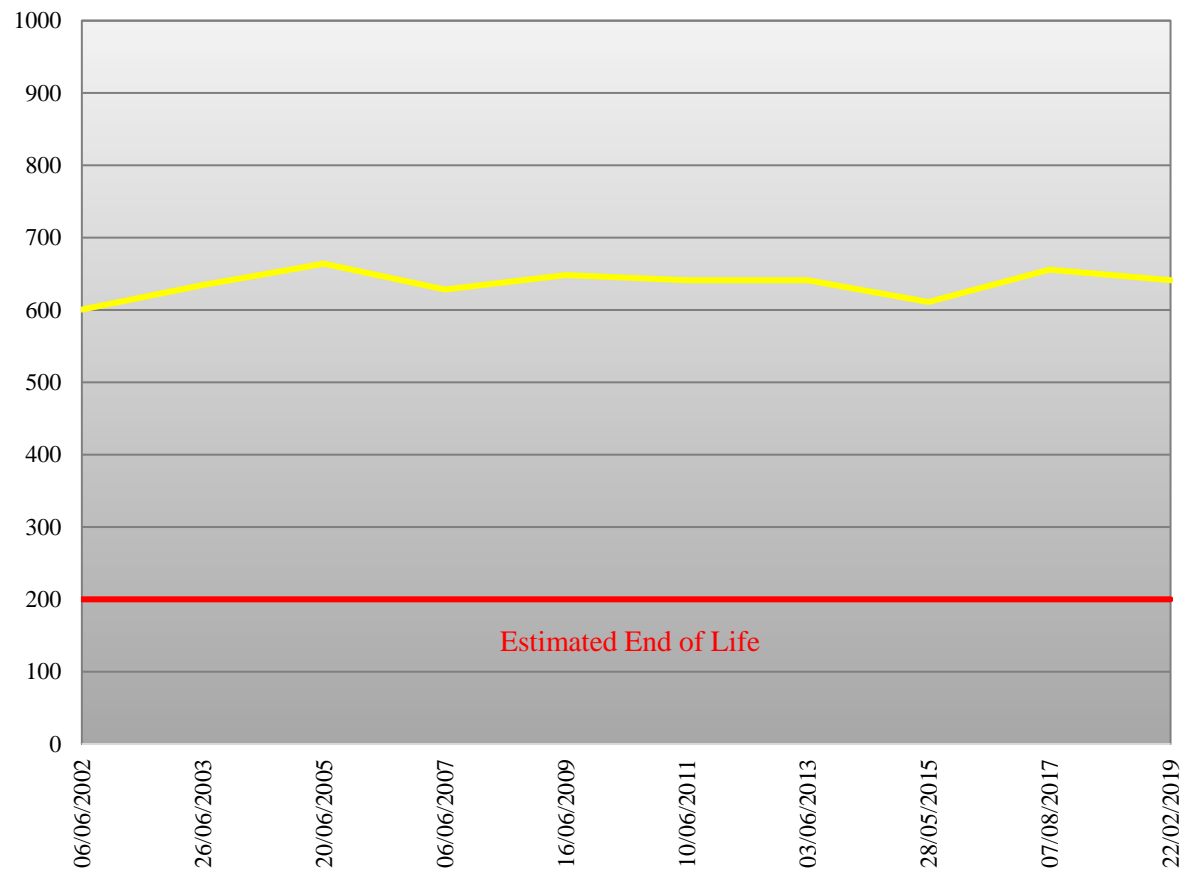
Tummel Bridge GT1 Main Tank DP

Measured 2FAL of 0.25 gives an estimated DP of 601. The insulation within a new transformer has typically a DP value of 1000. It is generally accepted within the industry that an estimated DP value of 200 is “end of life”. Application of this criteria, results in the transformer having an estimated 50% residual life remaining in the paper insulation. This suggests that the paper insulation is in good condition.

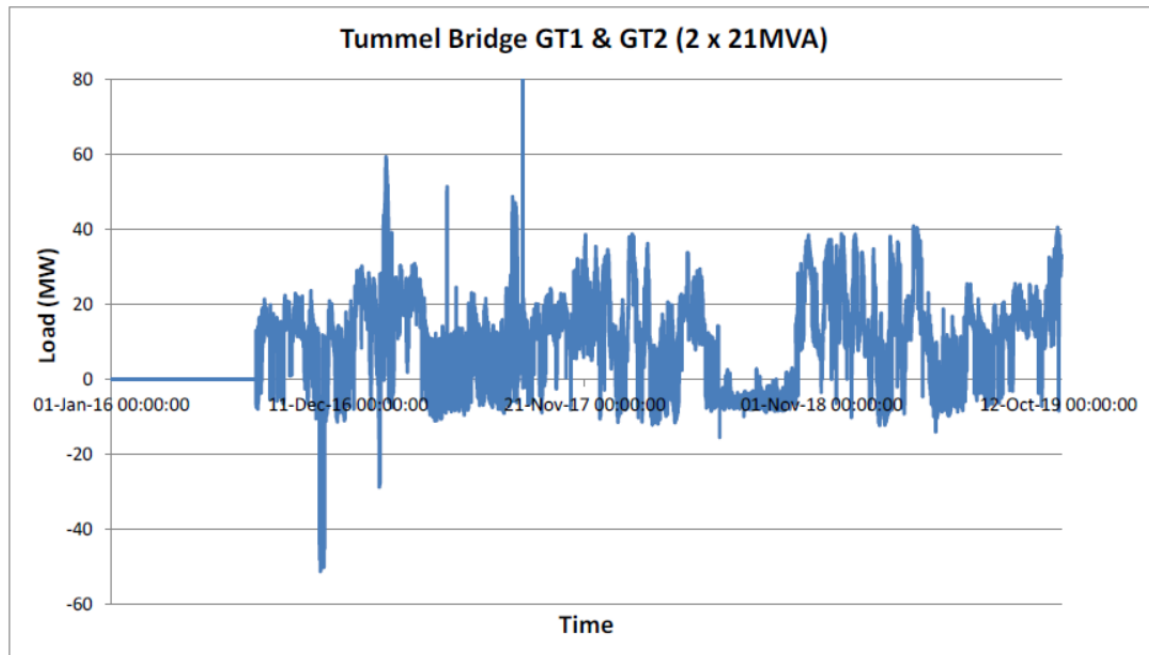
Figure 5.11 from section 5.7 of the document shows a measured combined load flow for GT1 & GT2 for the period of 2016 to 2019. The transformers have a typical maximum combined load flow of around 40MVA, which is within the 42MVA transformer capacity of the substation. There have been three periods of overloading recorded, where the combined transformer capacity has been exceeded. It is not clear from the load flow the exact magnitude or durations of these overloads.

Transformers have an inherent overload capability, which is dependent on the magnitude and duration of the overload. Sustained overload would result in accelerated degradation of the paper winding insulation and would be evidenced in the oil analysis by elevated and increasing levels of CO in the DGA and levels of 2FAL. This is not evident in GT1.
