St Fillans GT1 132/11kV Transformer

**Level 1 Condition
Assessment Report
15th July 2020
Report:
SFILGT1SHET200629
FINAL**

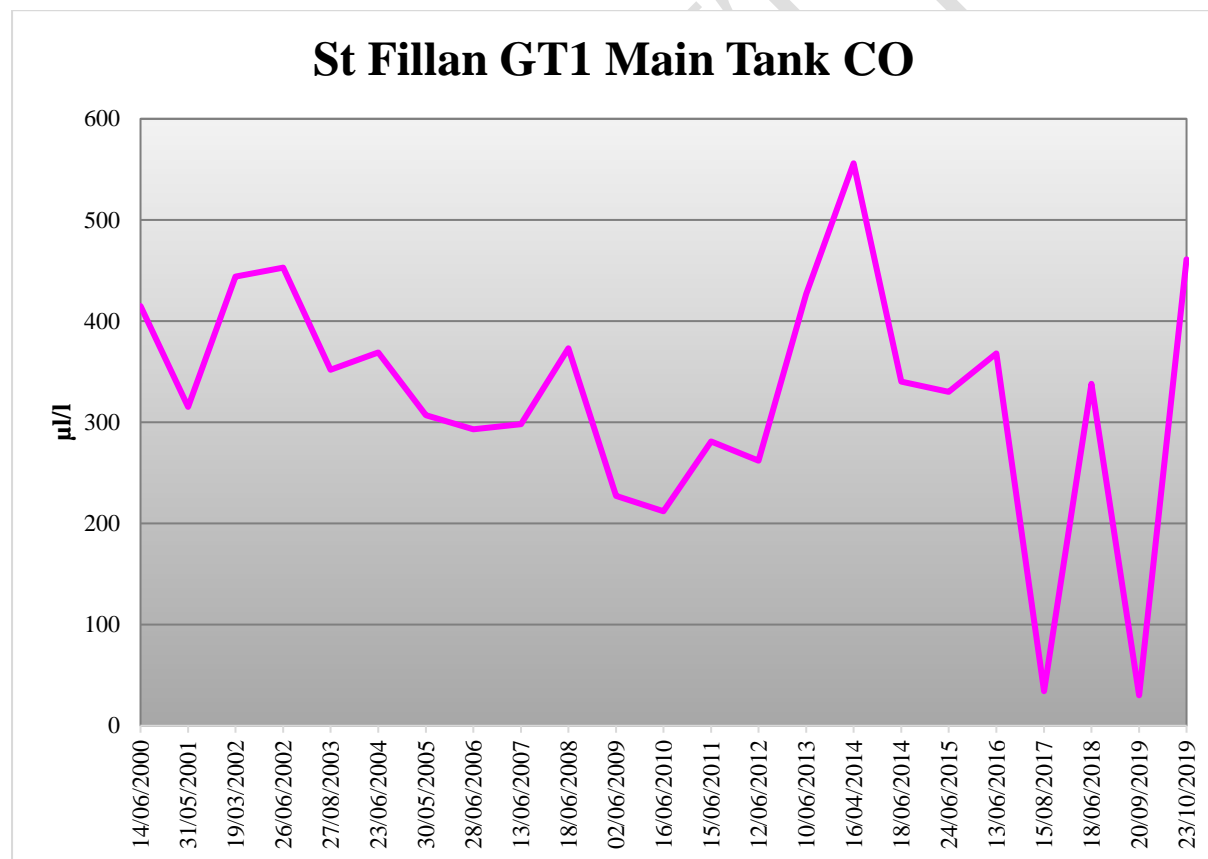
As the values of dissolved Carbon Monoxide (CO) are several orders of magnitude greater than all other diagnostic gases, the CO history is plotted separately for clarity.

The CO characteristic is considered dynamic but remains within “typical values” specified in IEC 60599 over the sample period, peaking at 556 μ l/l in 2014. Concentrations of CO at this magnitude is indicative of cellulose degradation. The paper insulation is likely in an aged condition.

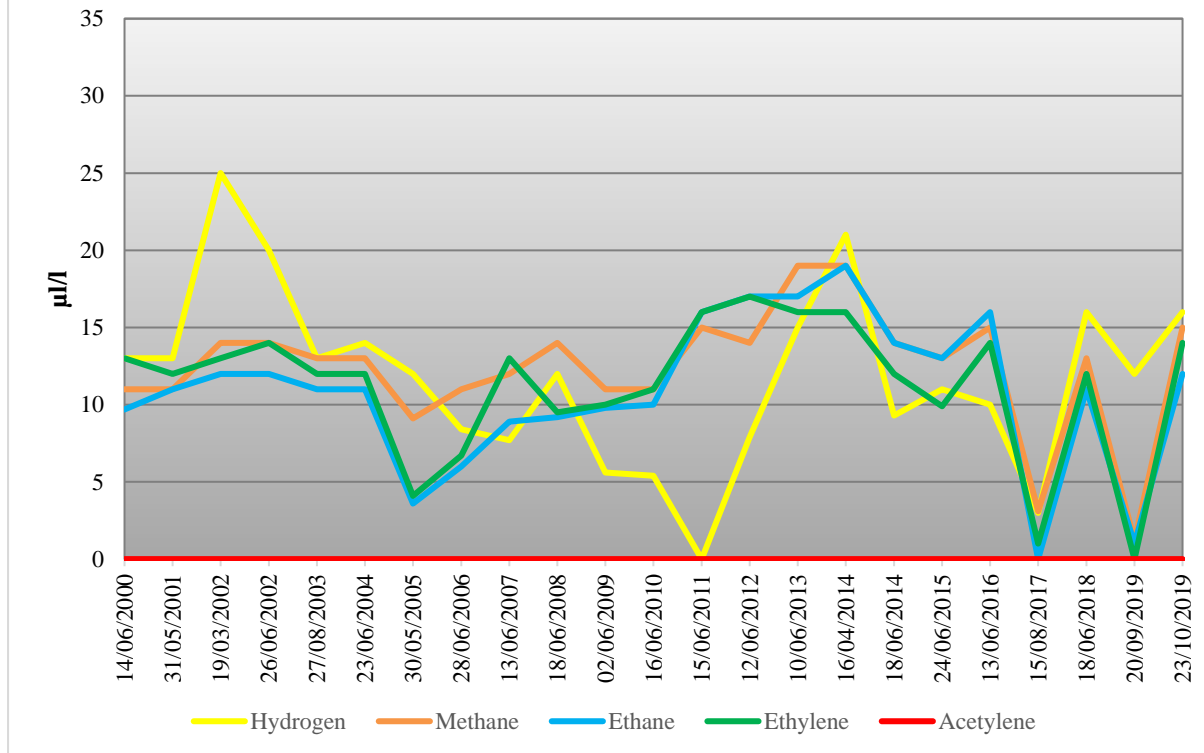
St Fillan GT1 Main Tank DGA

Hydrogen and thermal gases methane, ethane & ethylene are present throughout the DGA history however, all remain at levels well below “typical values” specified in IEC 60599. A dynamic trend in dissolved ethylene could merit increased sampling frequency due to the presence of an underlying thermal abnormality.

There is a correlation between dissolved CO, methane, ethane & ethylene trends which suggests that the thermal abnormality is causing ageing of the paper insulation. It is considered that the dissolved methane is a residual effect of the dissolved ethylene, but there could be a contribution to this by a low level partial discharge, normally characterised by the presence of hydrogen and methane. If this partial discharge was to exist it would most likely be undetectable by other means due to the low level of activity.

Application of the gas ratios, as defined in IEC 60599, [0,0.93,1.16] fails to highlight any abnormality through a diagnosis of non-classification. Using the Duval’s triangle method of DGA interpretation, the same gas ratios define a “T2” condition, “Thermal faults, 300°C < T < 700°C”, however, it should be noted that the Duval method, being a closed system, will always result in a condition being identified.

Analysis of the oil data shows no indication of discharge but there appears to be a thermal abnormality within the main tank.

Thermal abnormality present over entire sample range. Dissolved ethylene should be kept under surveillance.

- Inspection and assessment of the moisture management system.
- Following detailed inspection continue with routine inspection.
- Increase the oil sampling frequency to 6 months to keep the dissolved ethylene under surveillance.

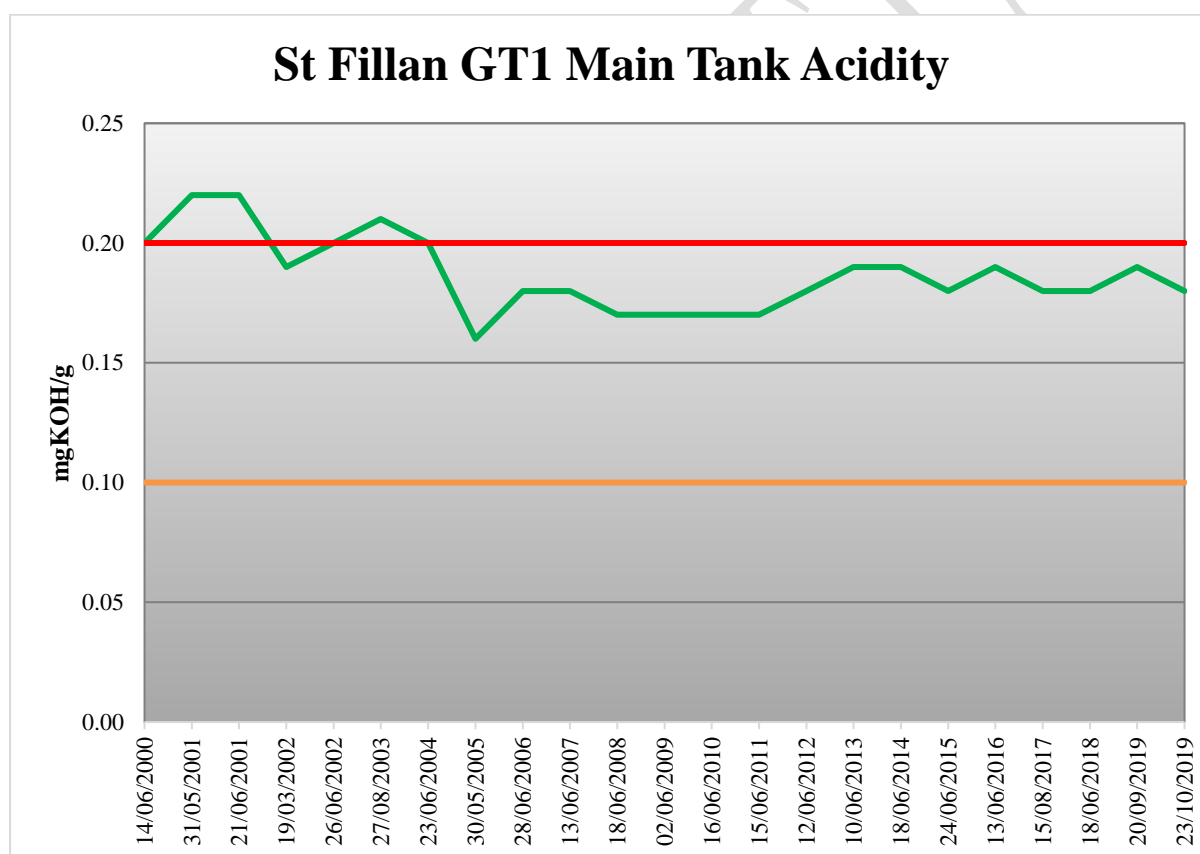
The historical acidity record contains 23 samples taken in the period of 2000 to 2019. The acidity levels are found to exhibit a minor decreasing trend over the sample range indicative of a dilution effect caused by top ups of new or reclaimed oil. The oil is oxidised but exhibits a stable level of acidity. Over the sample range acidity levels have reached levels categorised as “Poor” on six occasions. All remaining samples are categorised as “Fair” as defined by IEC 60422 for category B apparatus. Overall, the

acidity is considered unsatisfactory and would require to be regenerated to restore the acidity level to “Good” as defined by IEC 60422.

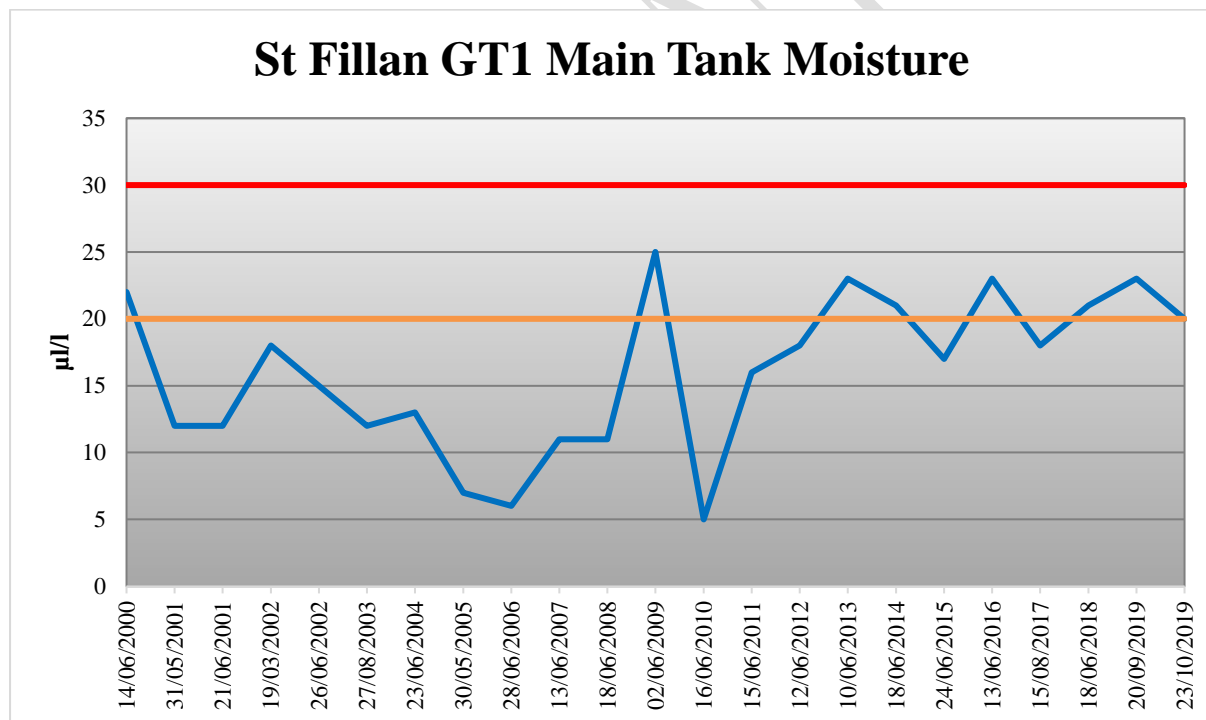
The historical moisture data spans 23 samples taken over the period of 2000 to 2019. Over the operational life of the transformer the moisture levels have been dynamic and have exhibited an increasing trend. Moisture results have predominantly been categorised as “Good”, as detailed in IEC 60422 for category B apparatus. A total of 7 samples are categorised as “Fair”. The peak value recorded in June 2009 was 25 $\mu\text{l/l}$. The overall moisture trend is acceptable but would require reconditioning to restore the levels to a category of “Good” as defined in IEC 60422.

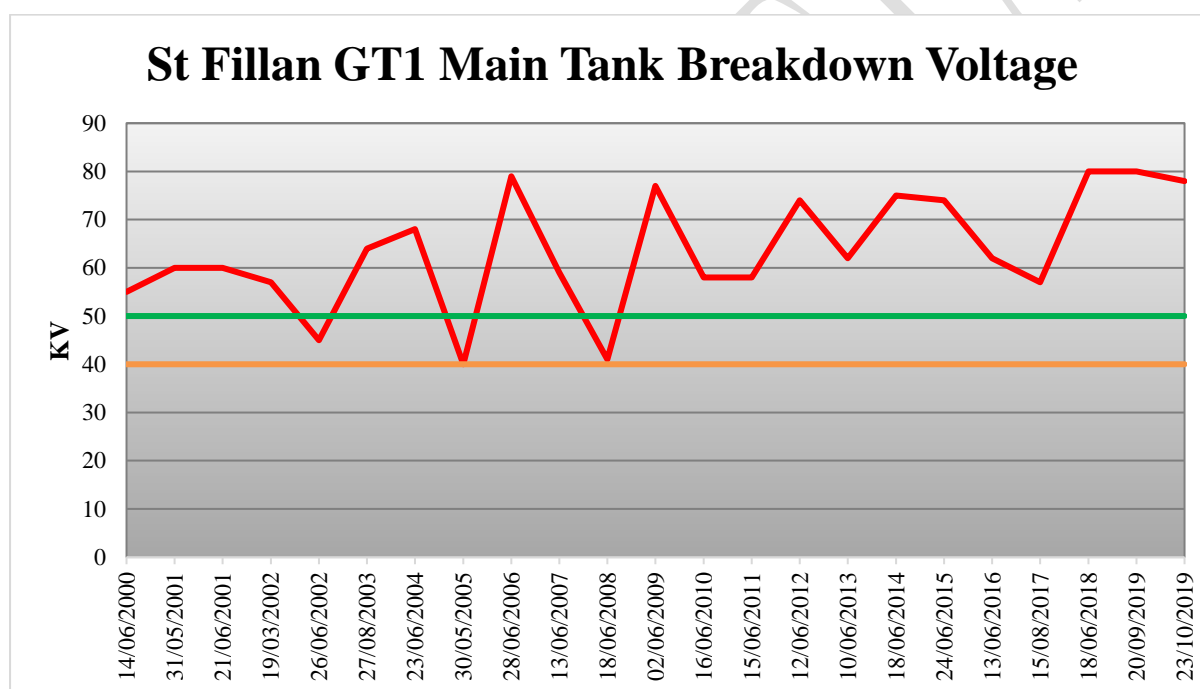
The historical breakdown voltage record spans the period of 2000 to 2019 and is inclusive of 23 samples. With the exception 3 samples from June 2002, May 2005 & June 2008 which are categorised as “Fair” as detailed in IEC 60422, all samples are “Good”. Breakdown voltage levels are dynamic throughout the sample range yet display an overall increasing trend. No substantial correlation in reductions is breakdown voltage levels with increased moisture content of the main tank are observed. Overall, the breakdown voltage level trend is satisfactory.

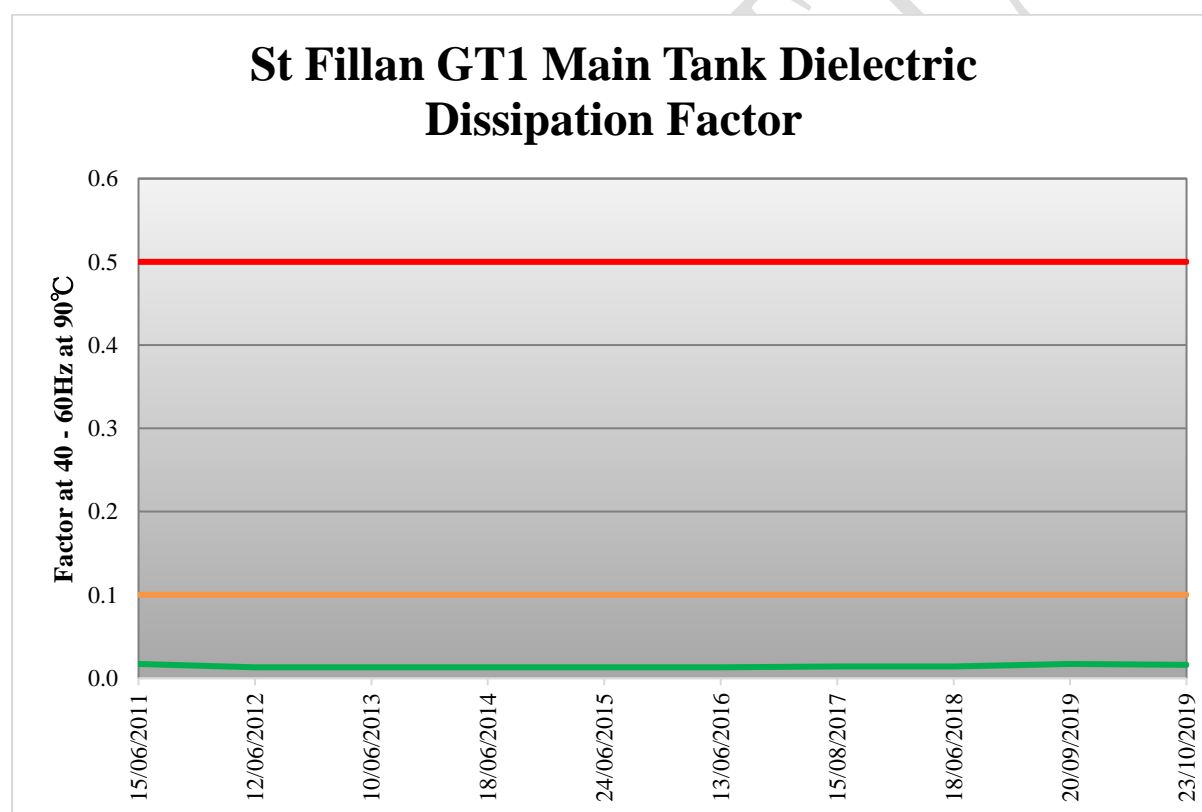
The dielectric dissipation factor trend is steady state and is constantly defined as “Good”. This result is satisfactory.

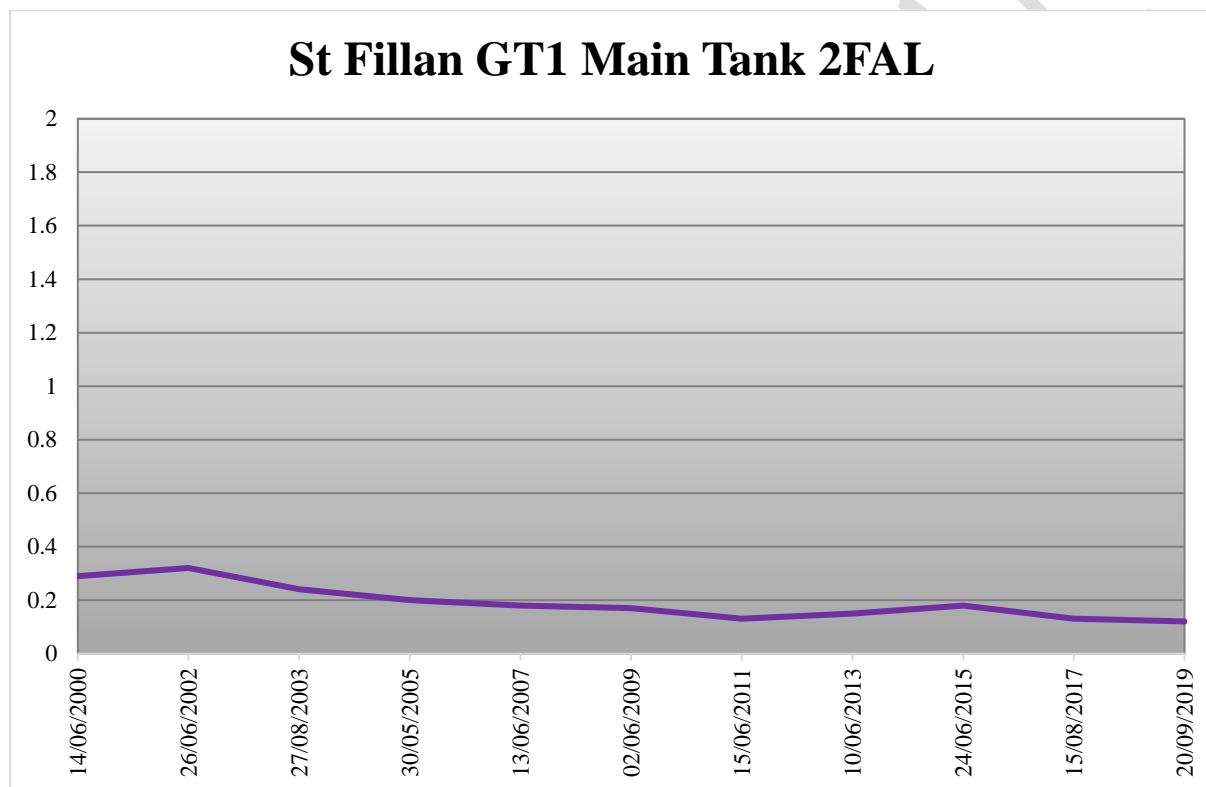
The 2FAL record spans from 2000 until the most recent sample, which was taken in September 2019. The 2FAL characteristic exhibits a decreasing trend over the sample range, reductions in 2FAL levels are indicative of a dilution effect by means of top ups or oils system interventions. The final value recorded was 0.12 (Est DP 649), compared to the highest value recorded in the sampling period of 0.32 (Est DP 527). The link between measured 2FAL and estimated DP is reliant on an algorithmic relationship, of which there are five different variants. The Chengdong algorithm has been used to relate measured 2FAL to estimated DP. In order to estimate the DP of the insulation system, the highest value of measured 2FAL shall be used (From June 2002). The insulation within a new transformer has typically a DP value of 1000. It is generally accepted within the industry that an estimated DP value of 200 is “end of life”. Application of this criteria, results in the transformer having an estimated 40% residual life remaining in the paper insulation. This suggests that the paper insulation is in an aged condition.

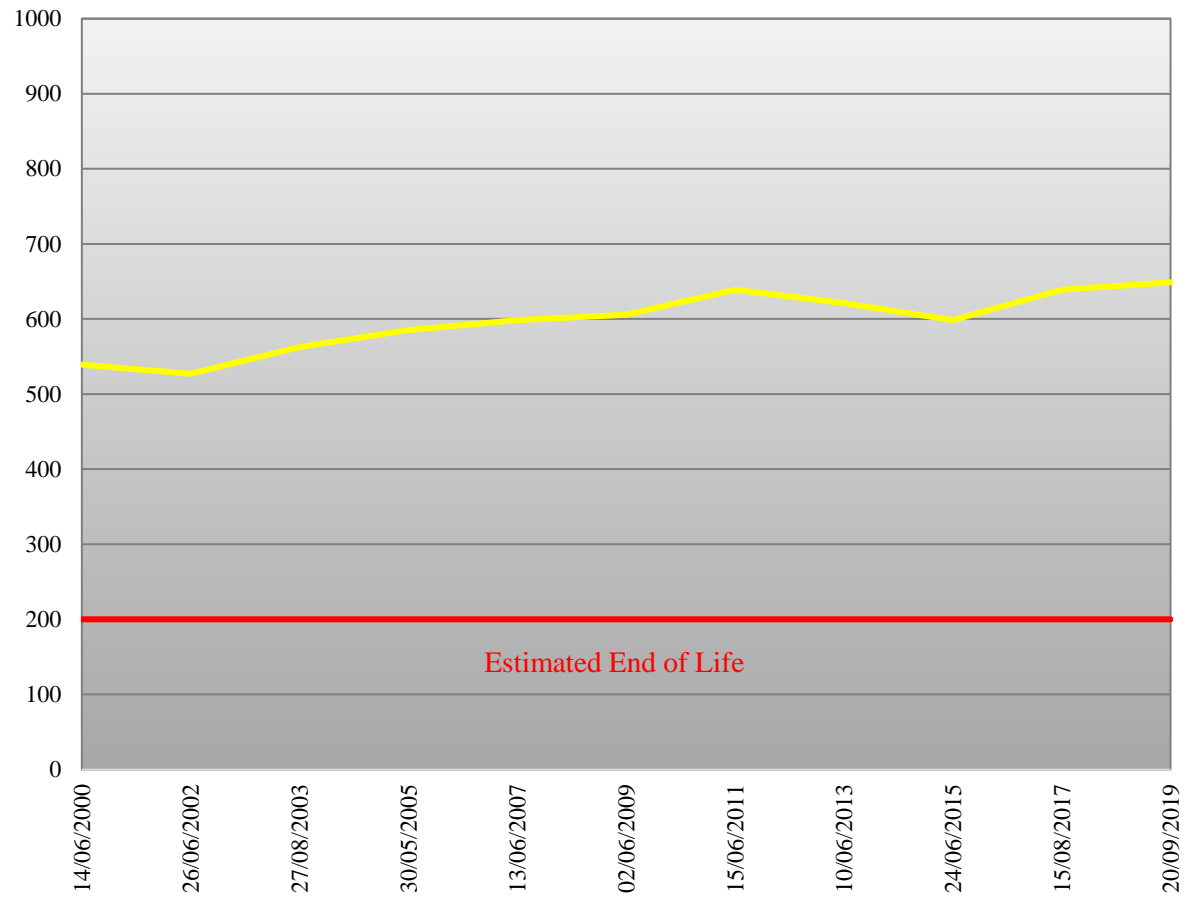
St Fillans GT1 Main Tank DP

The highest value of measured 2FAL recorded (From June 2002) was measured as 0.32 which equates to an estimated DP of 527. The insulation within a new transformer has typically a DP value of 1000. It is generally accepted within the industry that an estimated DP value of 200 is "end of life". Application of this criteria, results in the transformer having an estimated 40% residual life remaining in the paper insulation. This suggests that the paper insulation is in an aged condition. As the historical estimated DP has exhibited a rising trend since 2002, it is evident that this has been due to dilution of

the main tank oil by means of top ups of new or reclaimed oil. This would render the estimated DP redundant as an ageing indicator, as what is presented by the oil analysis will be over optimistic in the true DP value.

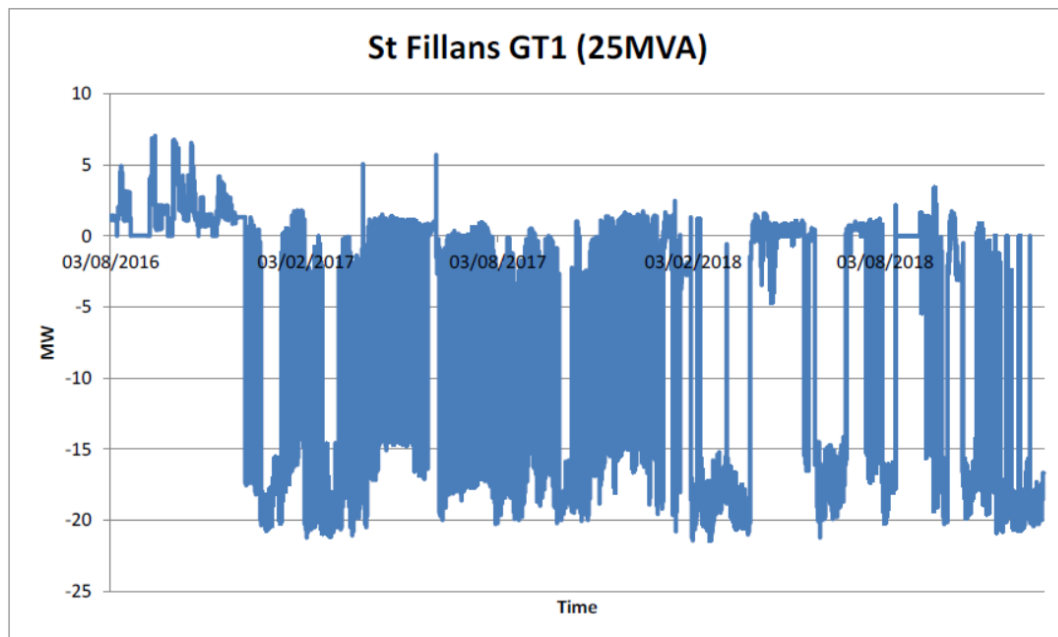
Figure 5.10 seen above, from document section 5.7, displays the load profile of GT1 for the period of August 2016 to December 2018. It should be noted that the negative values displayed are due to St Fillans Power Station being distribution connected. As seen from above, GT1 maximum loading is displayed as approximately 21MVA which is within the 25MVA ONAN rating of the transformer. This indicates that the transformer has no excessive loading. Based on historical oil data made available, no substantial reduction in life expectancy can be associated with the loading of transformer GT1.
