## **Appendix 1**

# **Warehouse Condition Report**

**August 2020**

This report contains a summary of findings from site visits to strategic stores at:  
SSE Port Caroline, Dundee  
SSE Tealing Substation,  
SSE Fanellen, Beaulieu.  
The visits were conducted on 15<sup>th</sup>/16<sup>th</sup> July 2020.

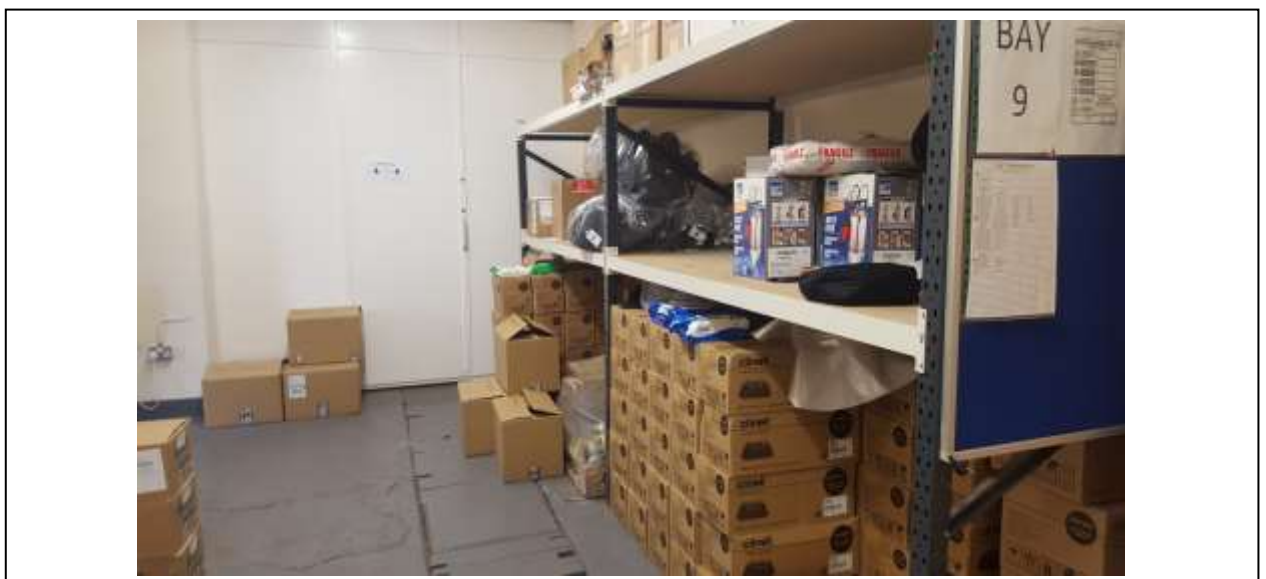
**Figure 1: Carolina Port-Storage of Small Items in Office**

Smaller items are stored internally in disused office space within the building (See Figure 1). These areas are clean and dry. But result in stock having to be manually handled through office doorways.

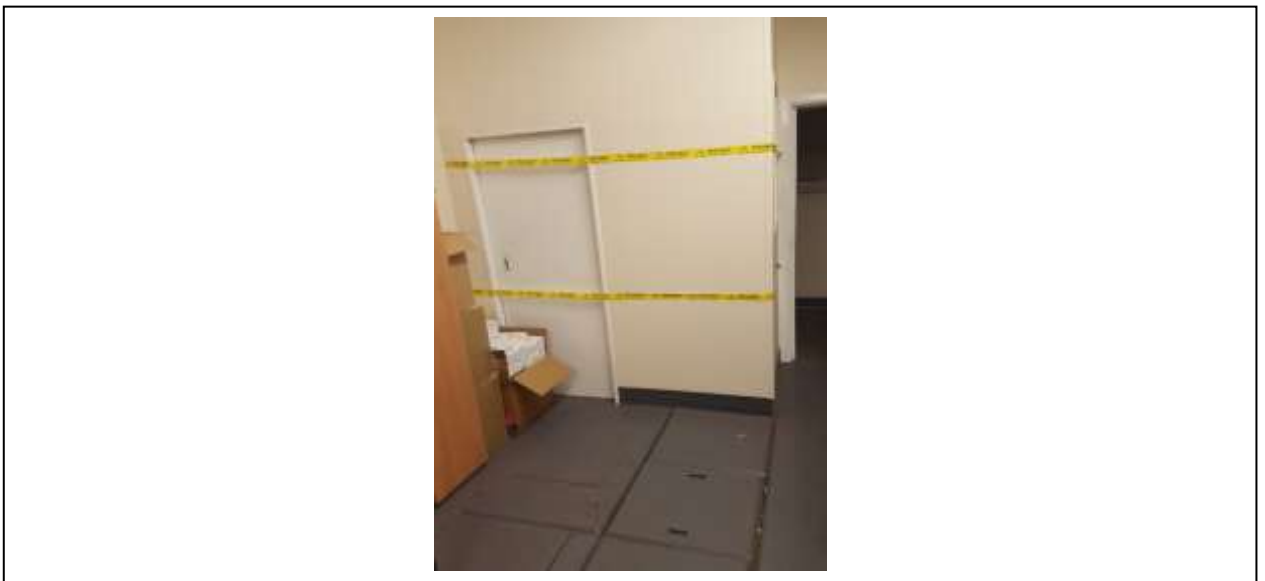
**Figure 2: Carolina Port- Areas sealed off due to Asbestos**

The building itself is in very poor condition having been constructed in the late 1940s early 1950s. Throughout the building, areas are cordoned off due to the presence of significant

amounts of asbestos in the building's construction. (See Figure 2). Internally, cable ducting runs beneath the floor throughout the building leading to uneven surfaces and route-ways for vermin.

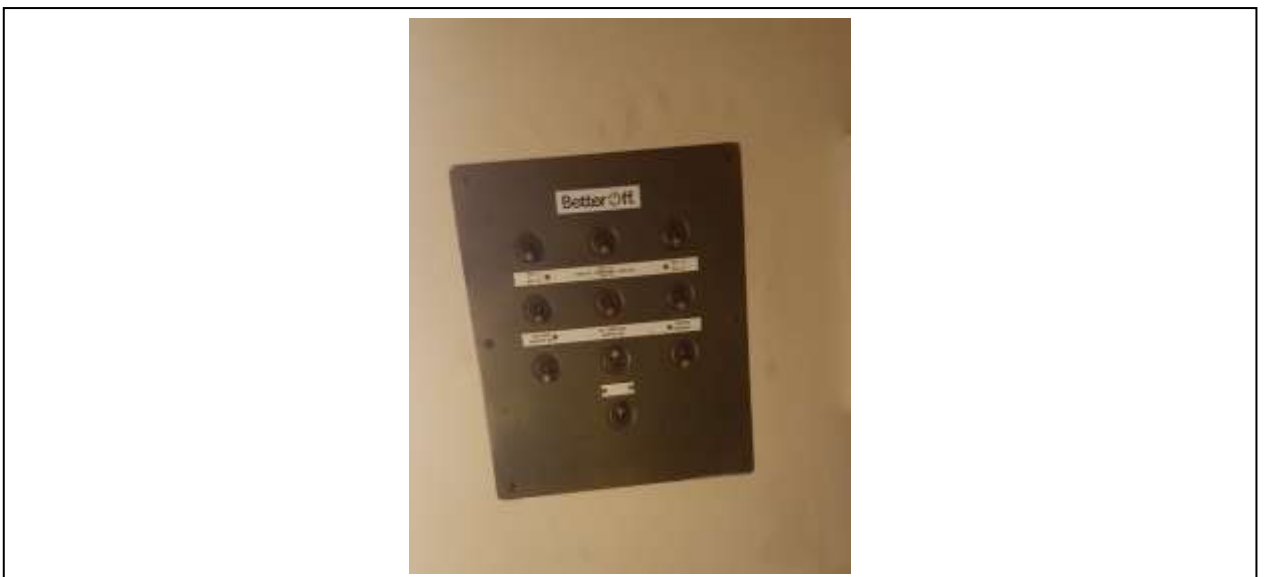
**Figure 3: Carolina Port- Light Switches**

Whilst maintained and tested compliance with legislative requirements by SSE Property Services the electrical installation within the building originates from its original construction and is not to modern standards. (See Figure 3).

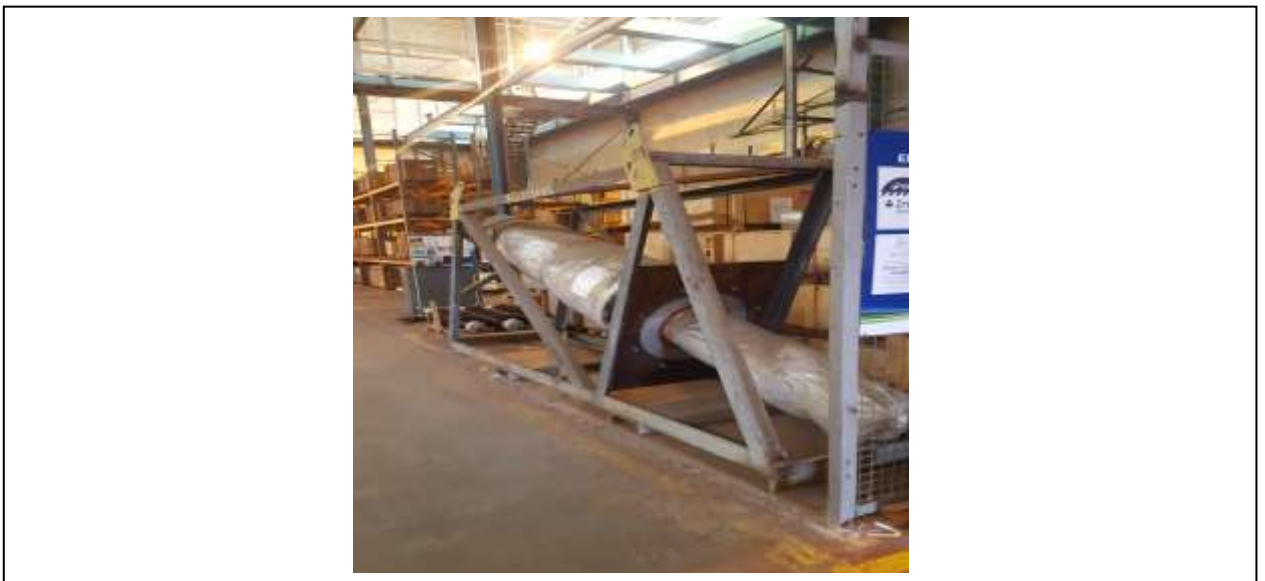
**Figure 4: Carolina Port- Internal Storage Showing Dust**

The storage area was well ordered and managed with good levels of housekeeping. However, all stock was covered significant dust contamination from the outside hard standing and adjacent grain dryer (See Figure 4). Racking was in good condition and had been regularly inspected. Normal lifting operations are conducted by a standard industrial forklift truck.

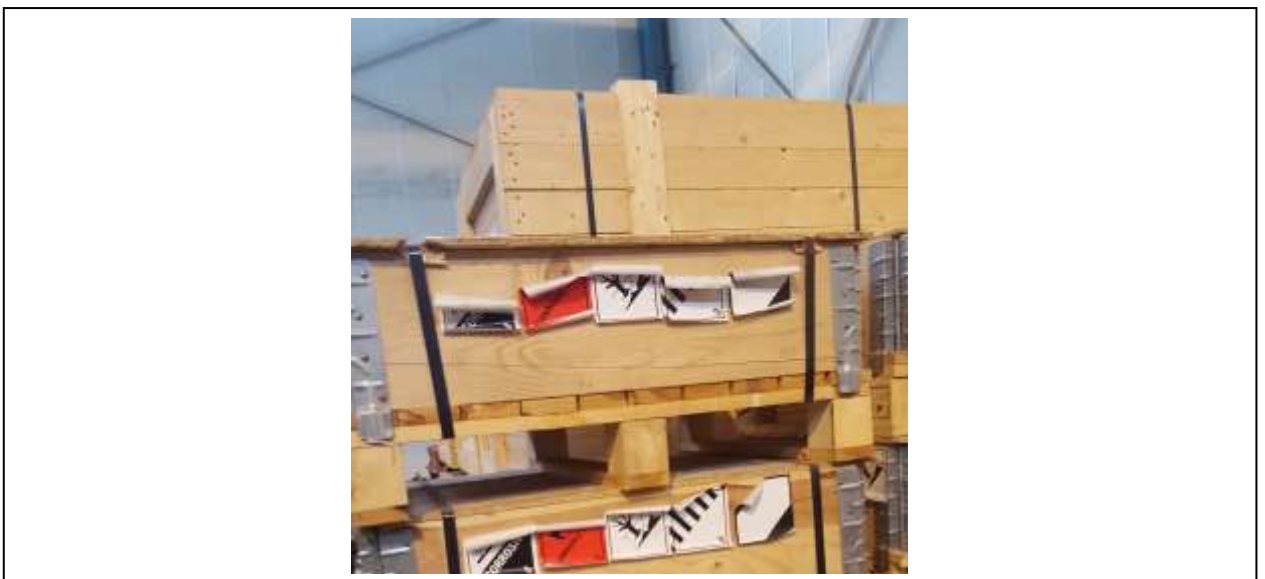
**Figure 5: Carolina Port: Moisture Effects on Labelling Internally**

The damp conditions had led to the rendering useless of hazardous goods material marking, leading to a requirement to remark such packaging prior to transport, in order to avoid the risk of legislative non-compliance. (See Figure 5).

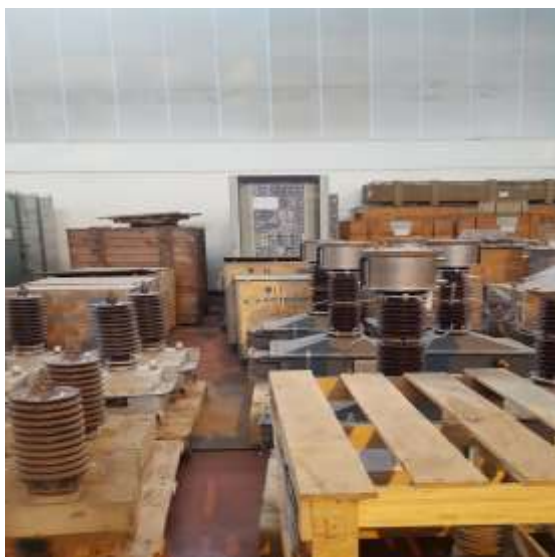
**Figure 6: Carolina Port - High Stock Levels**

Stock levels in the storage area were high leading to a requirement to move materials on multiple occasions in order to extract and place other items. This has the potential to result in increased level of damage and risk to personnel (See Figure 6).

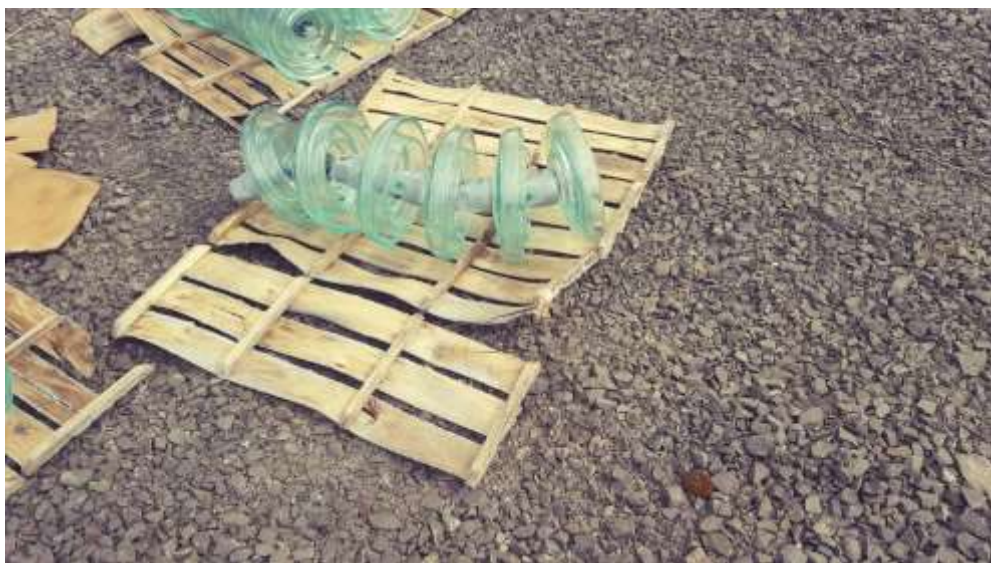
**Figure 8: Carolina Port - Degraded Packaging of Stock Held Inside**

Whilst there was no standing water within the warehouse facility, even in midsummer the warehouse atmosphere was damp. This had the result that dust had become caked to equipment. The damp atmosphere has also led to the degradation of packaging materials, resulting in their unsuitability for purpose and significant danger to personnel caused by packaging collapse during the lifting operations. This packaging degradation has resulted in the packaging in some instances itself being a damaging influence on the stored materials (See Figure 8).

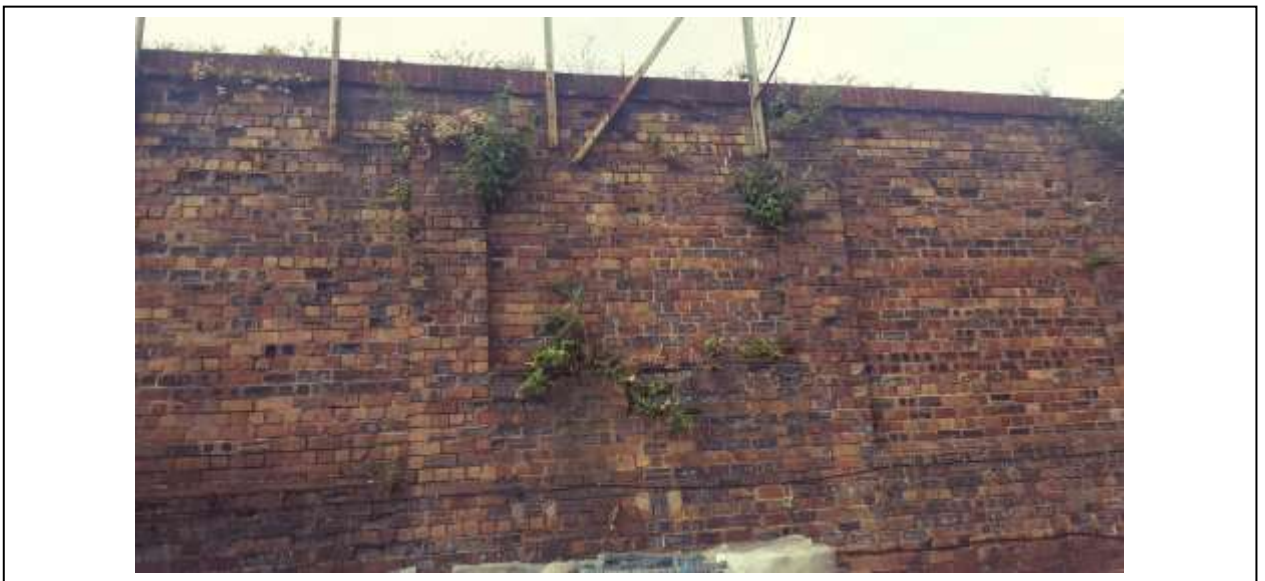
**Figure 10: Carolina Port – Boundary Wall**

Some surrounding walls, which appear on the original construction, have significant levels of plant growth, suggesting damage to their structure, with the potential for collapse (See Figure 10).

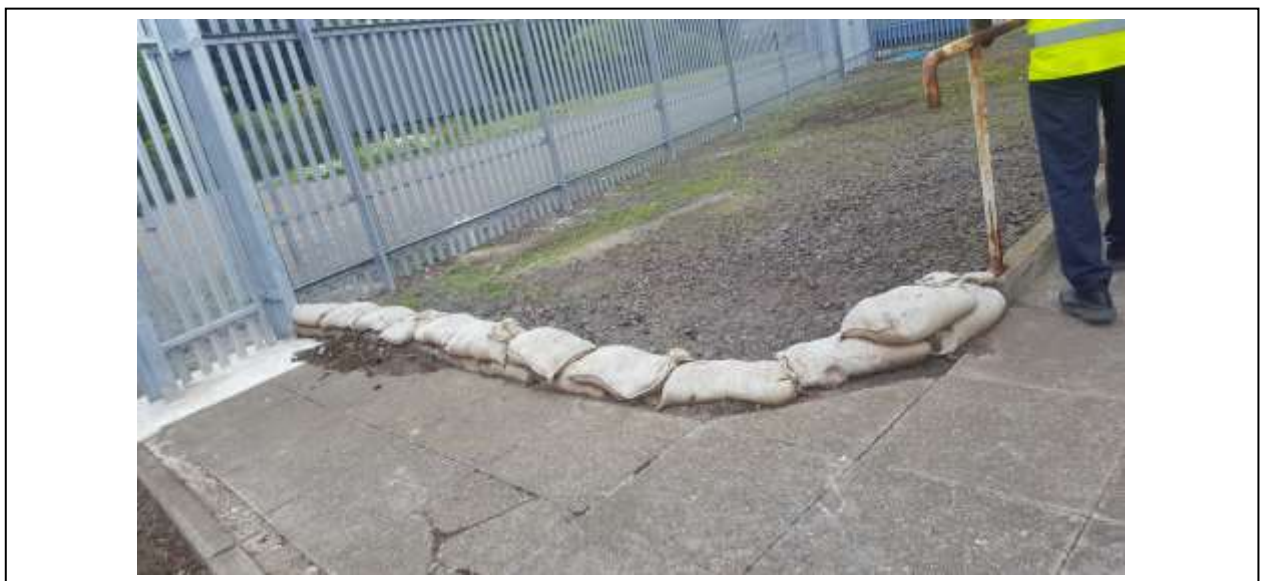
**Figure 12; Carolina Port - Evidence of Flooding**

Drainage to the site appears to be in poor condition, with efforts having been made using sandbags to prevent water ingress from drainage water from other areas of the dock. At high water conditions, caused by high tides and storm surges, water backs up the drains from the nearby River Tay and causes flooding (See Figure 12).

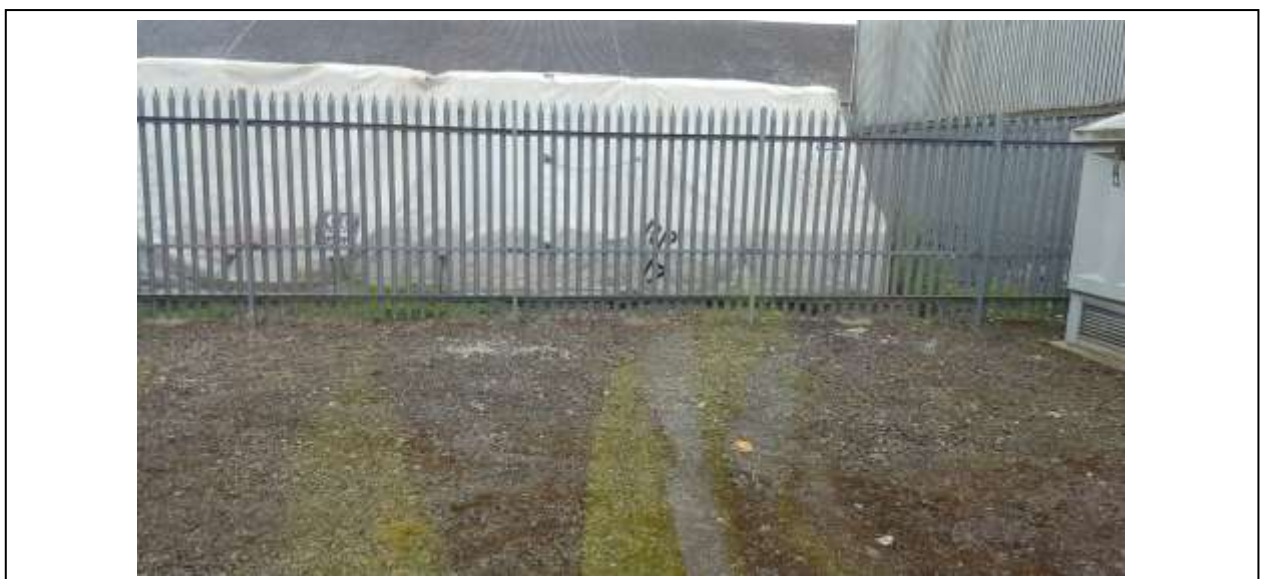
**Figure 13: Carolina Port - Adjacent Fertilizer Storage**

Adjacent to one area of the boundary fence is a large store of fertilizer (See Figure 13). This has the potential to be a significant accelerant in a fire. Next to this fertilizer and again in close proximity to the storage building is a large pile of abandoned wooden pallets (See Figure 14). This represents a significant fire risk. The infestation of seagulls has led to the rapid growth of moss and bird droppings. Whilst these are regularly swept up, accumulations occur, again leading to fire hazard.

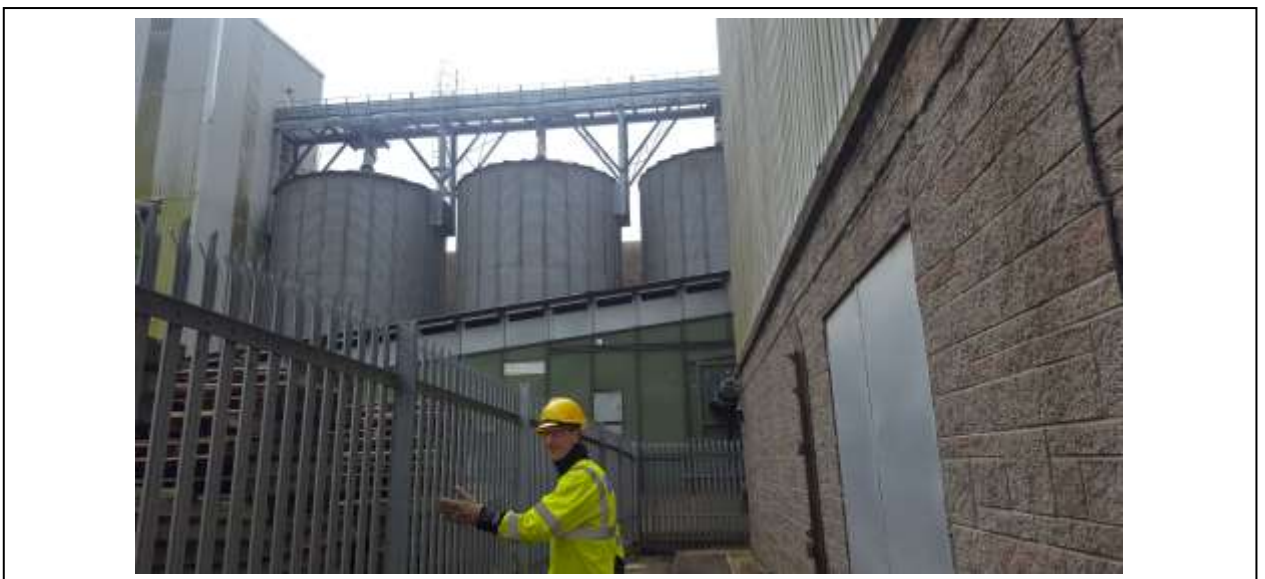
**Figure 15: Carolina Port - Proximity of Grain Dryer**

The store itself consists of the former 132kv substation building of the dismantled Dundee power station. This building is the only tangible structure remaining from power station, the rest of the site having been utilised for the construction of various warehousing and grain drying facilities. This has resulted in the old site being split by palisade fencing and the construction of the warehousing and grain drying facilities in close proximity to this boundary. This leaves a gap of approximately 8 to 10 feet between buildings (See Figure 15).

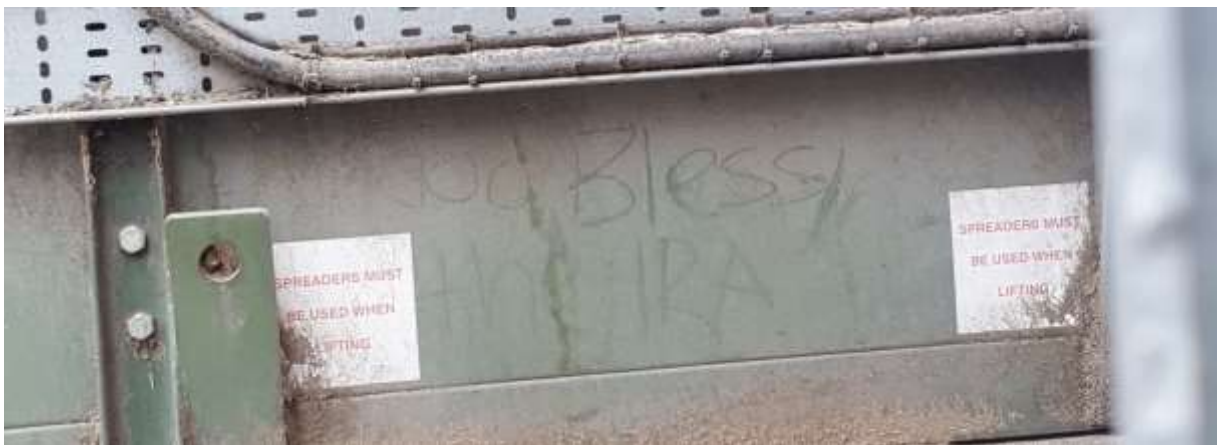
**Figure 16: Port Caroline - Extremist Graffiti**

Republican extremist views and anti-British sentiments (See Figure 16). This could potentially give concern that criminal damage to the associated infrastructure may occur.

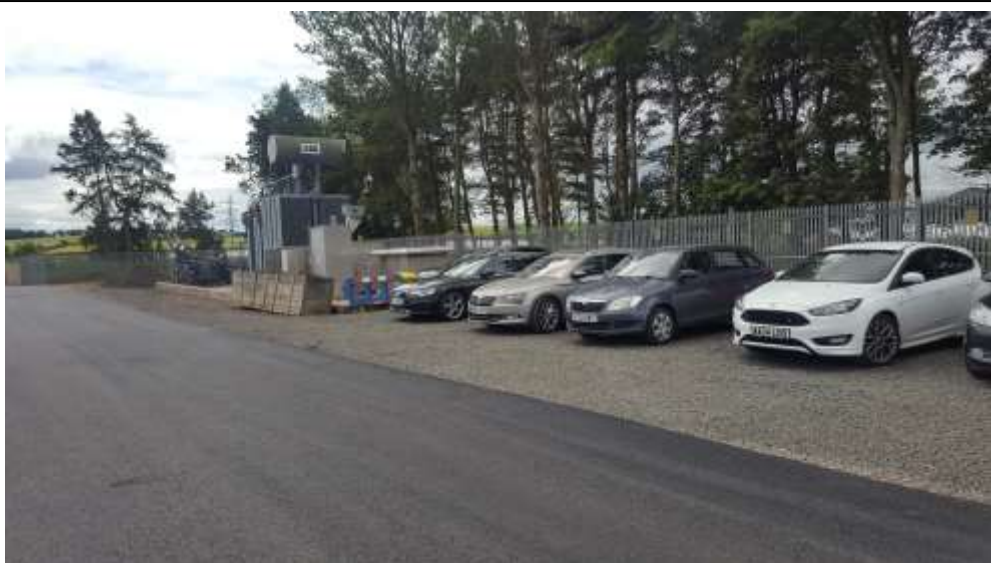
**Figure 17: Tealing - Storage Area/Carpark**

Presently the storage area is also being used for car parking for contractors working on a substation project (See Figure 17). This results in a large number of personnel having access to the storage area with the opportunity for criminal damage and tampering with equipment (See Figure 24).

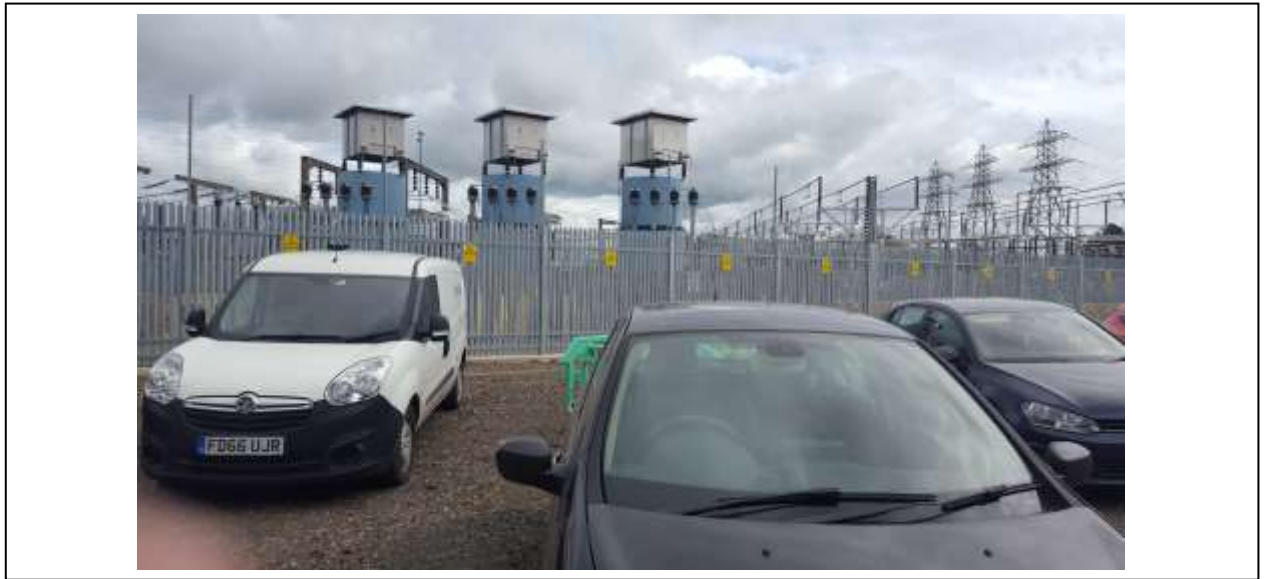
**Figure 18: Tealing - Proximity of Sub-station**

The storage area is immediately adjacent to the existing substation, with only a security fence separating the two. (See Figure 18). This creates a number of risks. In the first instance a catastrophic failure of the live substation equipment, which is a foreseeable event, could lead to the destruction or damage of the store equipment and to significant injury to personnel. Such an occurrence could potentially lead to severe disruption as failed equipment may conceivably destroy the failed equipment's own backup replacement.

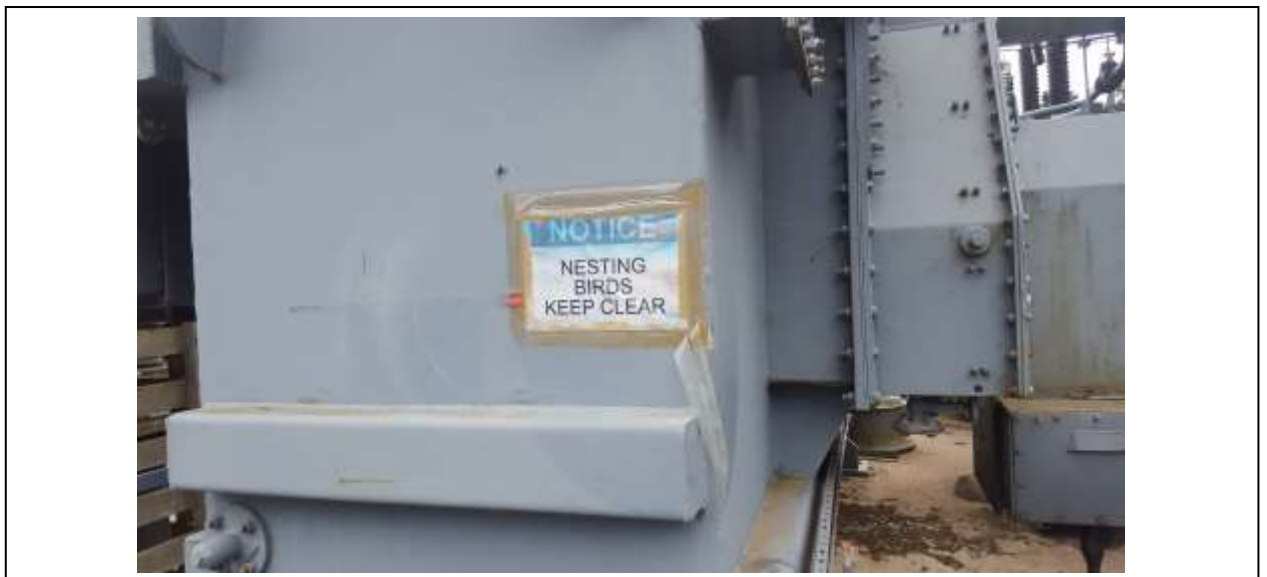
**Figure 19: Tealing - Nesting Birds**

The stored equipment is regularly used as a location for nesting birds (See Figure 19). This has the potential not only to damage the equipment, should birds enter important components, but also the potential to cause a breach of the Environmental Protection Act 1981 and Wildlife and Countryside Act, should equipment need to be retrieved for use whilst the nests are occupied. The worst-case scenario could conceivably see a protected species taking up residence in a unique piece of equipment.

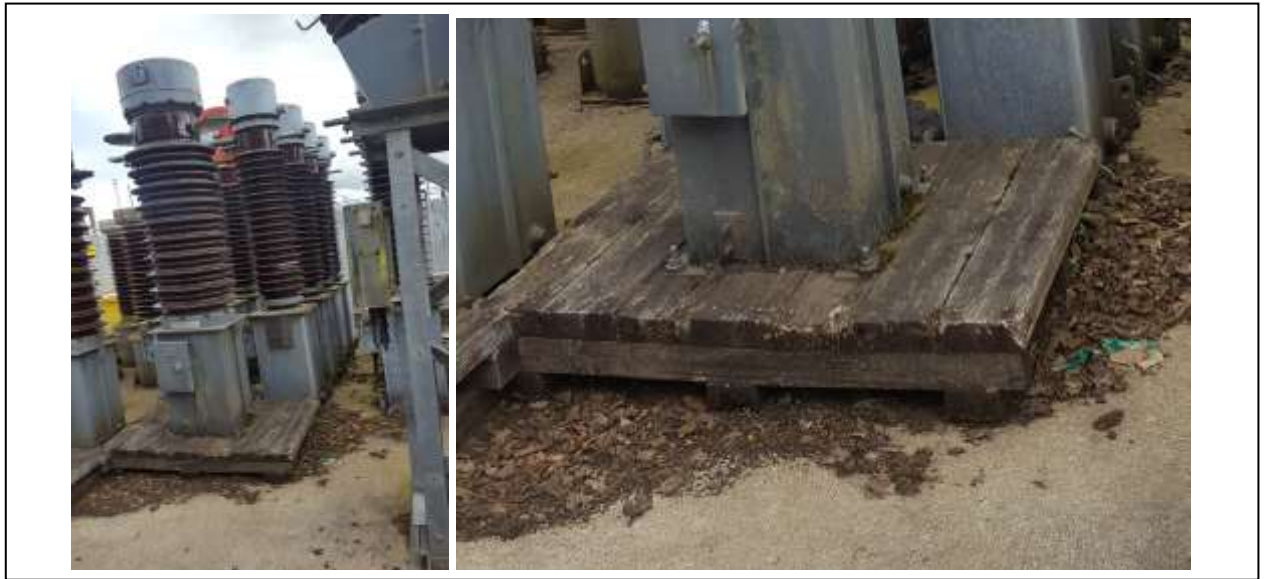
**Figure 20: Tealing - Pallet Deterioration**

Being stored outside, both equipment and packaging deteriorates. This could lead to danger to both personnel and equipment when the stock is retrieved for use. (See Figure 20).

Some pallets on which heavy equipment is stored appear to be rotting and collapsing leading to risk of collapse and damage to equipment and any personnel in the area (See Figure 20).

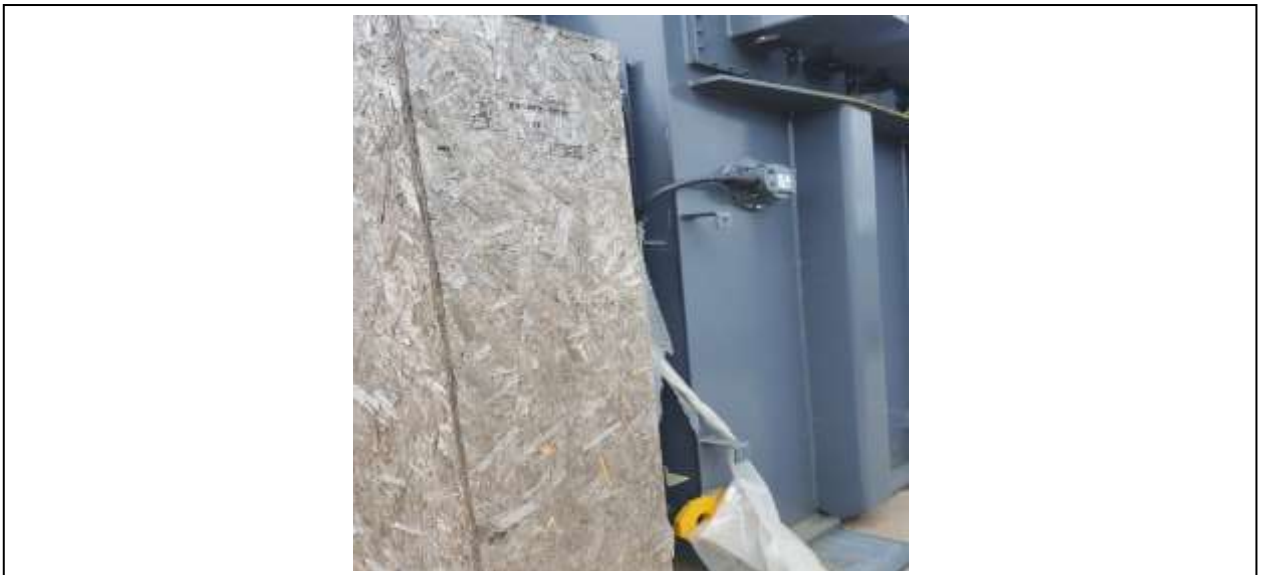
**Figure 23: Tealing – Packaging Deterioration**

Packing designed to protect vital control elements is deteriorating in the outside conditions. (See Figure 23).

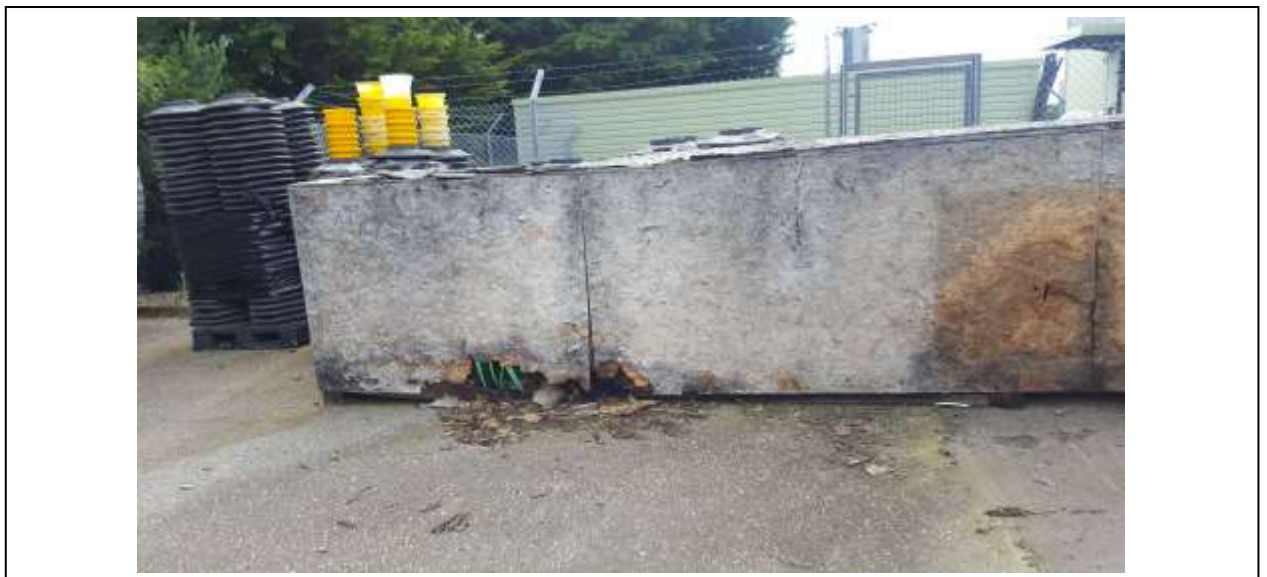
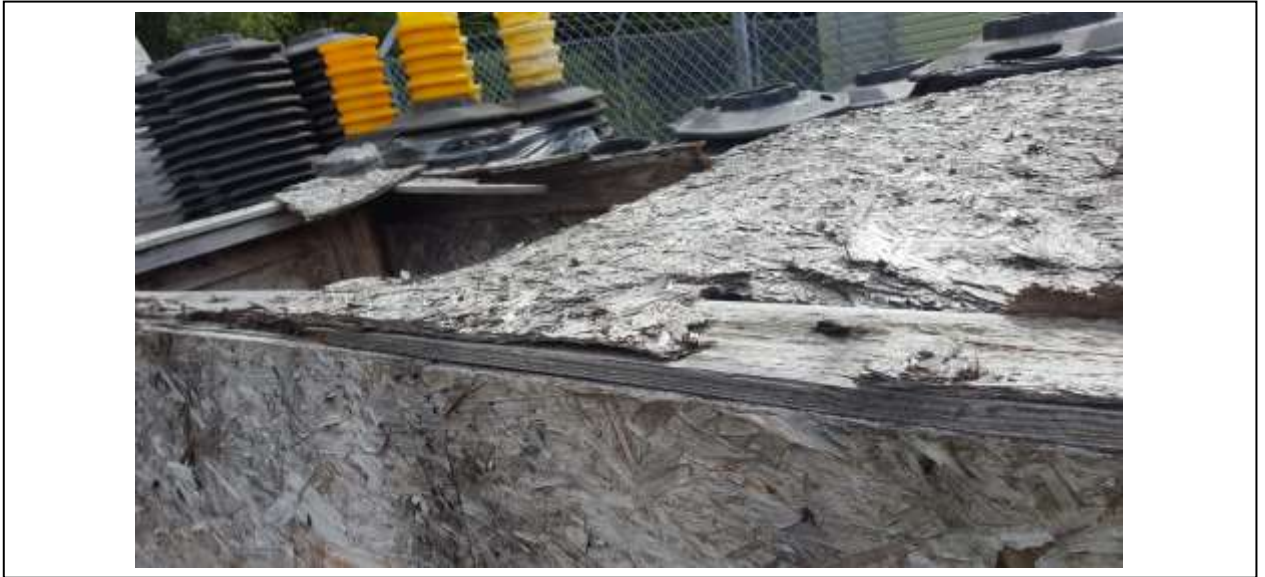
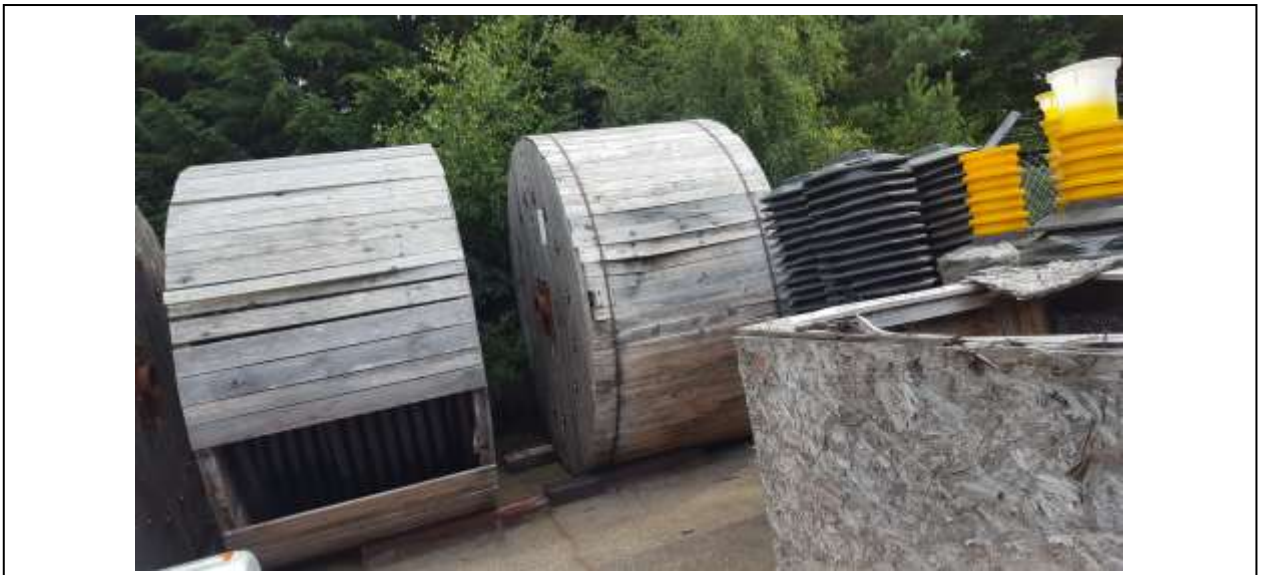
Storage outside has led to the degradation of both stored materials and packaging. There was much evidence of packing materials now being unsuitable and dangerous for subsequent lifting (See Figures 31,32 & 33).

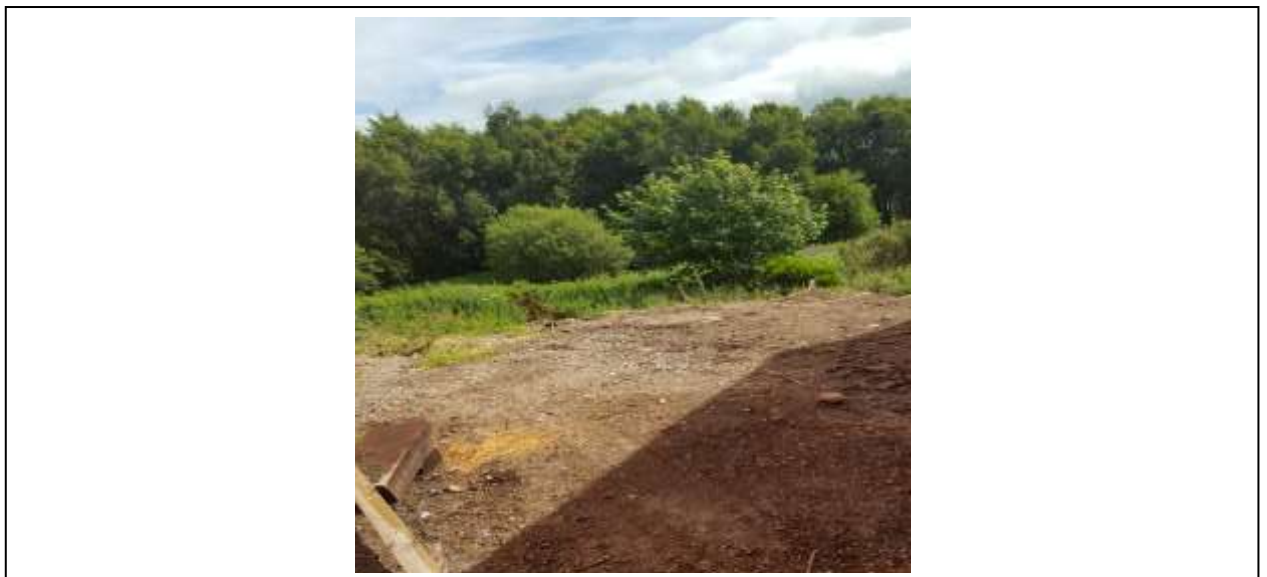
**Figure 35: Fanellan - Open Access to Site**

Security of the site is poor. Whilst the site is protected by remotely monitored CCTV, response to intruders would be via a verbal warning and notification of the local police. The site is to all intents and purposes open (See Figure 35). with only a gate over the yard vehicle access and a short run of cosmetic wooden fencing at the front of the building which is in poor condition (See Figure 30). There would be little to prevent intruders accessing the site to commit criminal damage or theft. Should these intruders be injured it would be difficult to defend the situation that SSE had done everything practicable to prevent their access into a dangerous environment. The major source of security seems to be the remoteness and the anonymous nature of the operation however a short search of the Internet reveals photographs of the site taken by members of the public and so-called urban explorers. See <https://www.geograph.org.uk/photo/2754792>

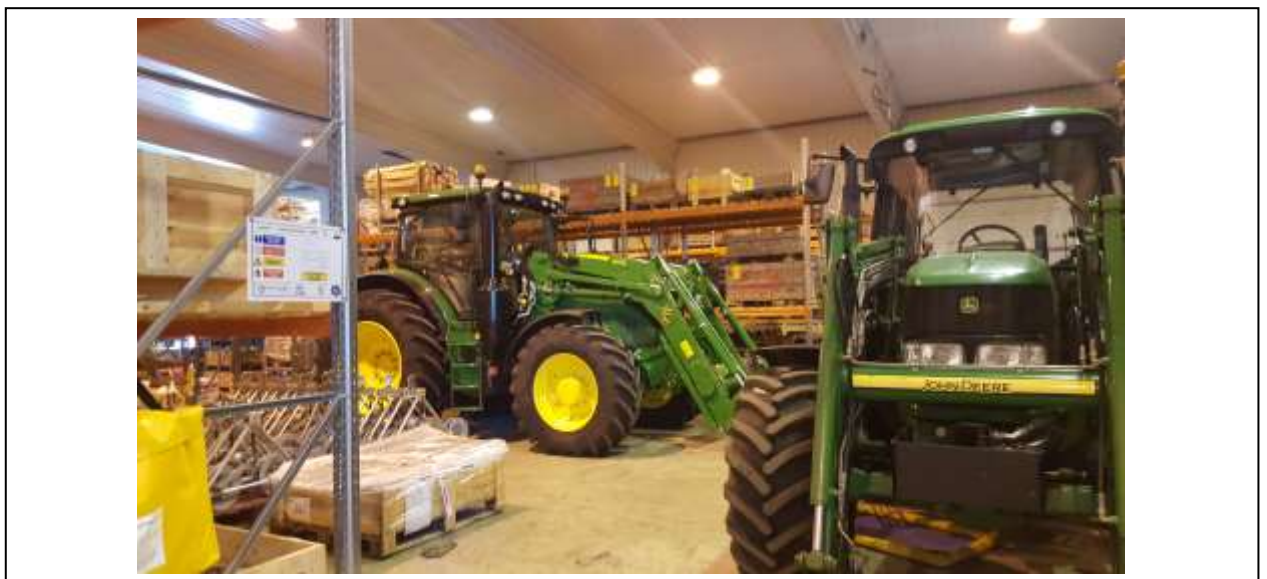
**Figure 37: Fanellan -High Internal Stock Levels**

The principle issue with the site and storage warehouse is lack of space See Figure 37 & 38). This leads to regular multiple movement of stock in order to accommodate new inventory and access existing materials. Consequently, this leads to significant increase in risk of damage to sensitive equipment such as ceramics and also to all the inherent risks of any lifting operation.

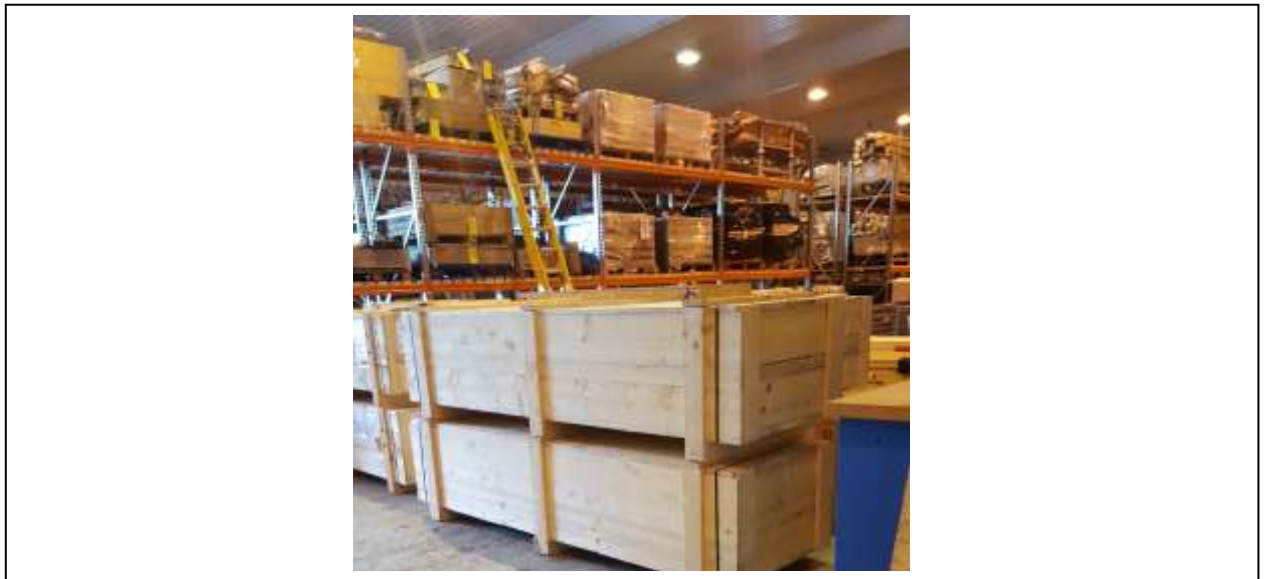
**Figure 38: Fanellan - High Internal Stock Level**

Much of the stock is held in crates and packaging designed for limited movement. The repeated movement of stock has caused damage and destruction of packing materials (See Figure 38). Because of the lack of space some materials intrude on traffic areas resulting in the increase of the likelihood of impact with moving vehicles and equipment.

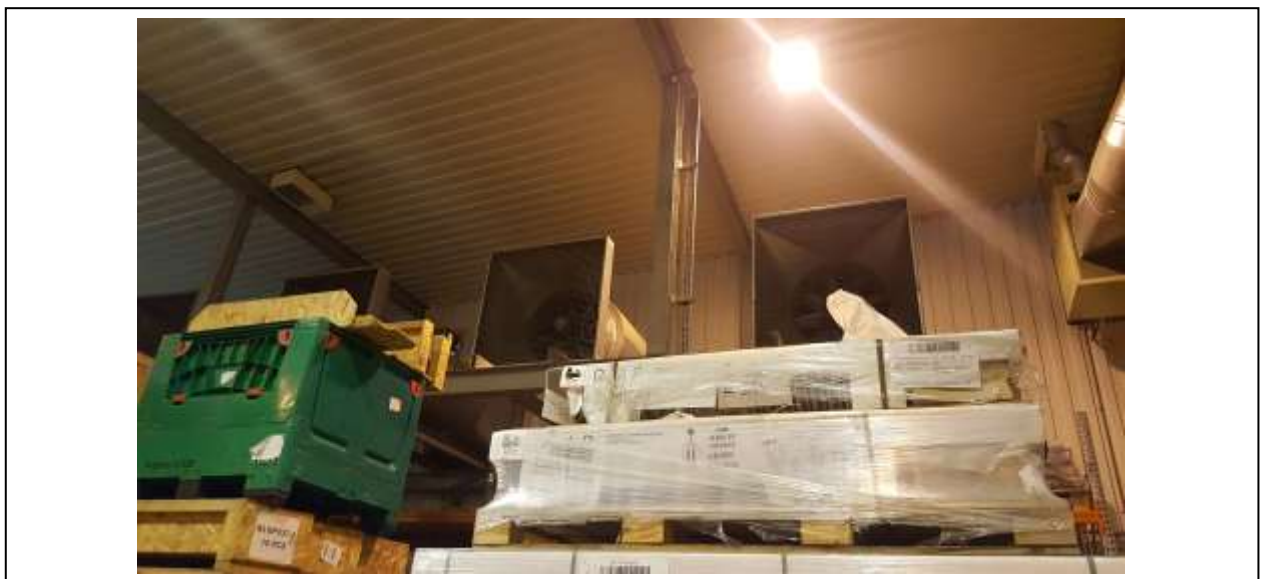
**Figure 39: Fanellan - Low Roof Height and Ventilation/Low Lighting Levels**

Lifting operations are undertaken utilising a standard industrial lift truck, with any other lifting involving contract lifts by external contractors. Some equipment stored inside is delivered by third party vehicles with lorry mounted cranes. Due to the low height of the building, lifting using these cranes is difficult, particularly with tall items stored vertically, as it is difficult for the crane to position itself directly above the lift. This potentially can lead to load swing causing impact damage to stock and personnel (See Figure 39).
