Aigas GT1 132/11kV Transformer

**Level 1 Condition
Assessment Report
16th July 2020
Report:
AIGASGT1SHET200629
FINAL**

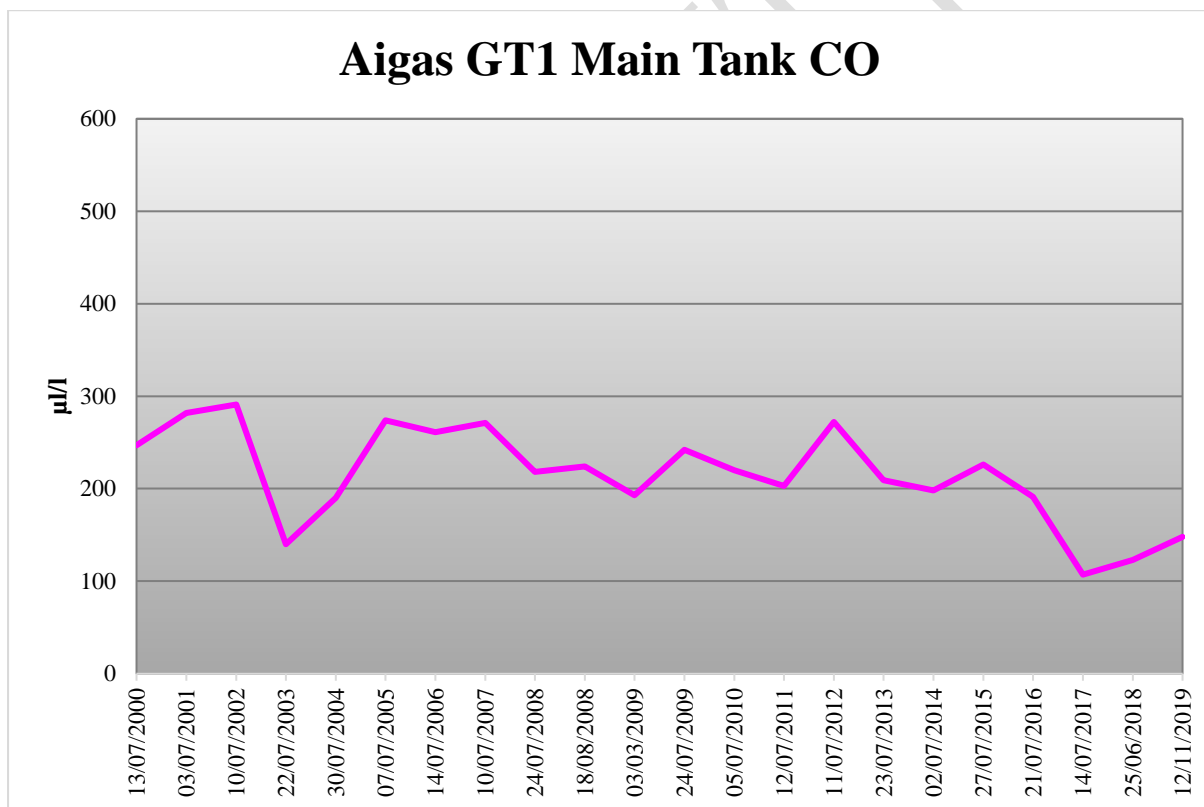
As the values of dissolved Carbon Monoxide (CO) are several orders of magnitude greater than all other diagnostic gases, the CO history is plotted separately for clarity.

The CO characteristic is dynamic and exhibits an, overall, decreasing trend. All Values remain below “typical values” specified in IEC 60599 over the sample period, peaking at 291 μ l/l in 2002. The paper insulation is likely in reasonable condition for its age.

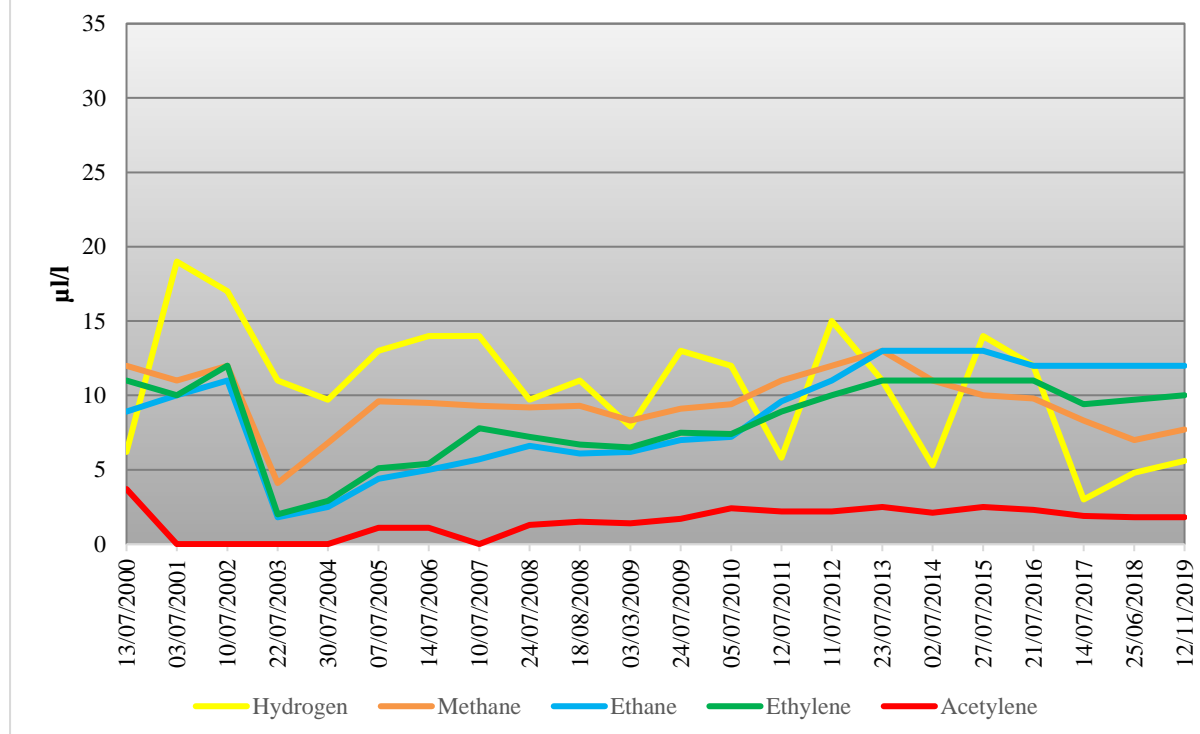
Aigas GT1 Main Tank DGA

All diagnostic gases are present throughout the DGA history however, all remain at levels well below “typical values” specified in IEC 60599.

Application of the gas ratios, as defined in IEC 60599, [0.18, 1.3, 0.83] diagnoses a “T1” fault condition, defined as a “Thermal fault < 300°C”. Using the Duval’s triangle method of DGA interpretation, the same gas ratios define a “T3” condition, “Thermal faults, T > 700°C”, however, it should be noted that with the Duval method, being a closed system, will always result in a condition being identified. The magnitudes of dissolved gas levels are considered to be too low to accurately diagnose with the IEC methodology.

The DGA does not exhibit any evidence of partial discharge or discharge abnormality, however there is a trend of dissolved ethylene, which is indicative of a thermal abnormality, which is low level at this stage but has been present throughout the DGA history. Assuming that the main tank and tap changer are communicating there is a degree of equilibrium between the main tank and tap changer dissolved ethylene levels. To identify of the source of the dissolved ethylene electrical testing would be required.

None. Dissolved ethylene should be kept under surveillance.

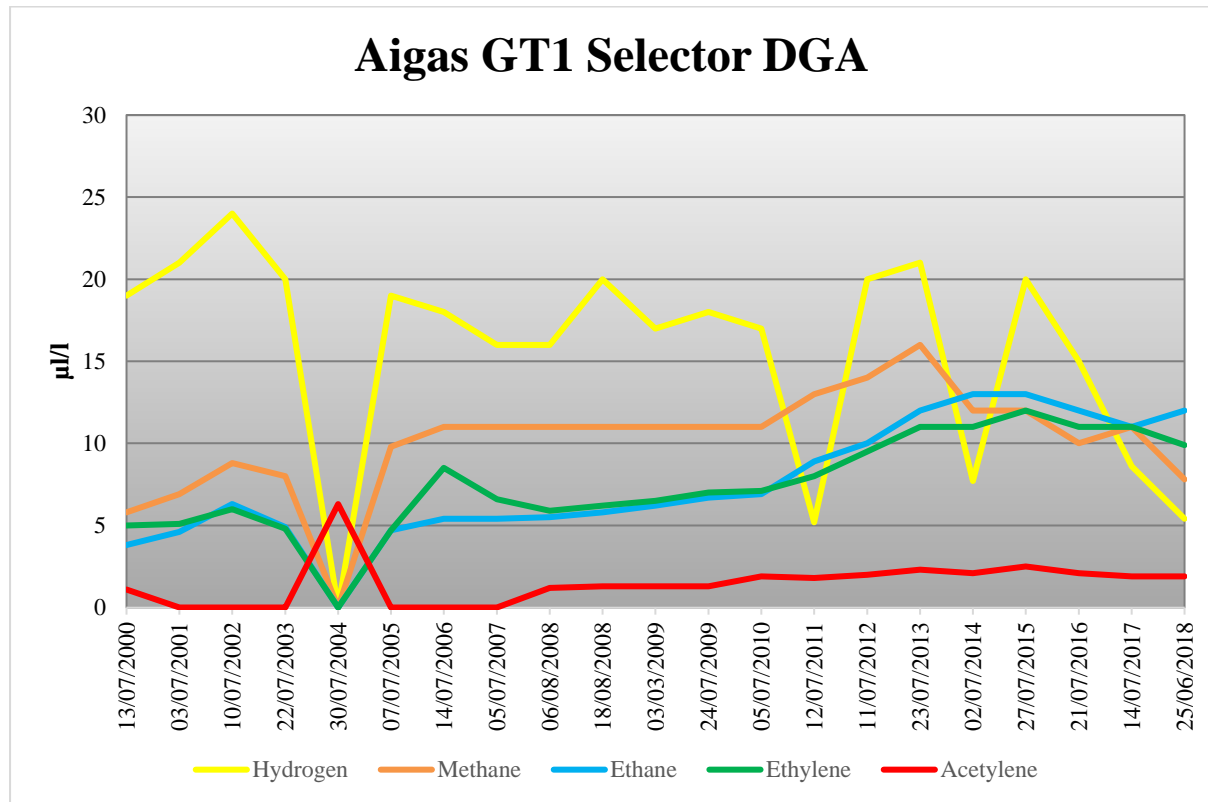
Application of the gas ratios, as defined in IEC 60599, [0.19,1.6,0.825], highlights a “T1” fault condition characterised by “Thermal fault < 300°C”, although it should be noted that all diagnostic gases are well below the “typical values” as quoted in the standard. Using the Duval’s triangle method of DGA interpretation, the same gas ratios define a “T3” condition, “Thermal faults, T > 700°C”, however, it should be noted that the Duval method being a closed system will always result in a condition being identified. There has been a tap changer maintenance in 2004 as characterised by the simultaneous reduction in dissolved gases.

The DGA does not exhibit any evidence of partial discharge or discharge abnormality, however there is a trend of dissolved ethylene, which is indicative of a thermal abnormality, which is low level at this stage but has been present throughout the DGA history. Assuming that the main tank and tap changer are communicating there is a degree of equilibrium between the main tank and tap changer dissolved ethylene levels. To identify of the source of the dissolved ethylene electrical testing would be required.

None. Dissolved ethylene should be kept under surveillance.

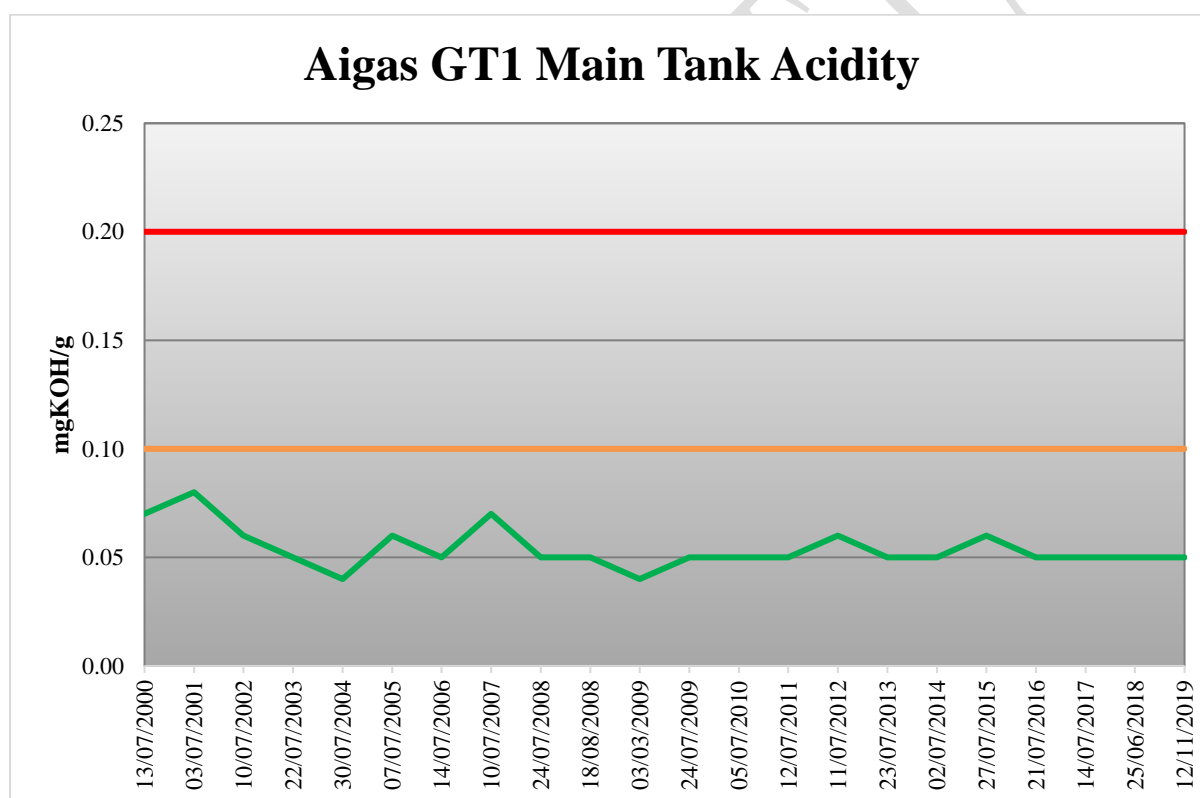
The historical acidity record spans the period of 2000 to 2019 and includes 22 samples. The acidity levels are found to be relatively stable over the sample period however, a reduction in acidity levels between July 2001 & July 2002 could be indicative of a dilution of the main tank oil by means of oil top ups. Acidity levels are consistently categorised as “Good” as defined by IEC 60422. The most recent acidity result of 0.05 mgKOH/g is satisfactory and considered representative of recent historical results.

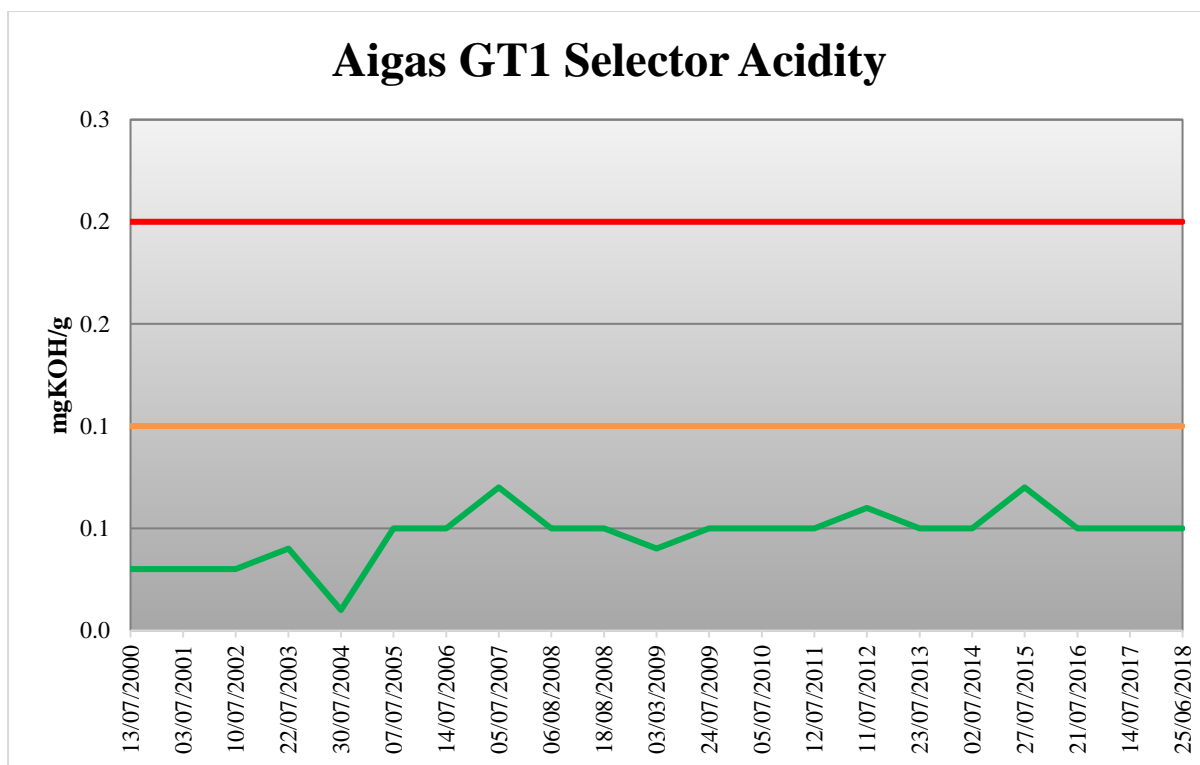
The historical selector acidity record contains 21 samples taken in the period of 2000 to 2018. The acidity levels are, overall, relatively stable and all samples in the historical range are categorised as “Good” as defined by IEC 60422. The most recent acidity result of satisfactory and considered representative of recent historical results.

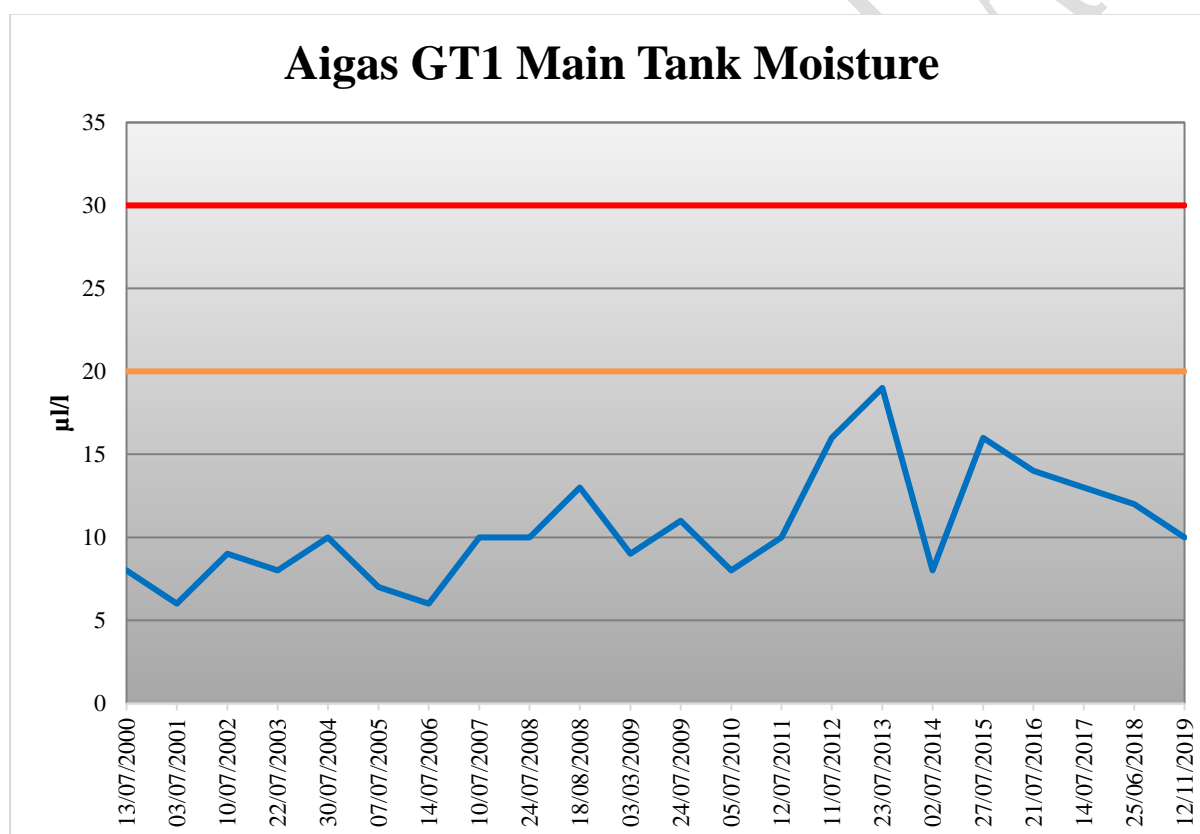
The historical moisture data spans 22 samples over the period of 2000 to 2019. Over the operational lifetime of the transformer the moisture levels have exhibited a dynamic characteristic which, overall exhibits an increasing trend. All moisture results are categorised as “Good” as defined by IEC 60422, for category B apparatus. Moisture levels peak in July 2013 at 19 $\mu\text{l/l}$. The most recent moisture result of 10 $\mu\text{l/l}$ is categorised as “Good” and is representative of historical moisture.

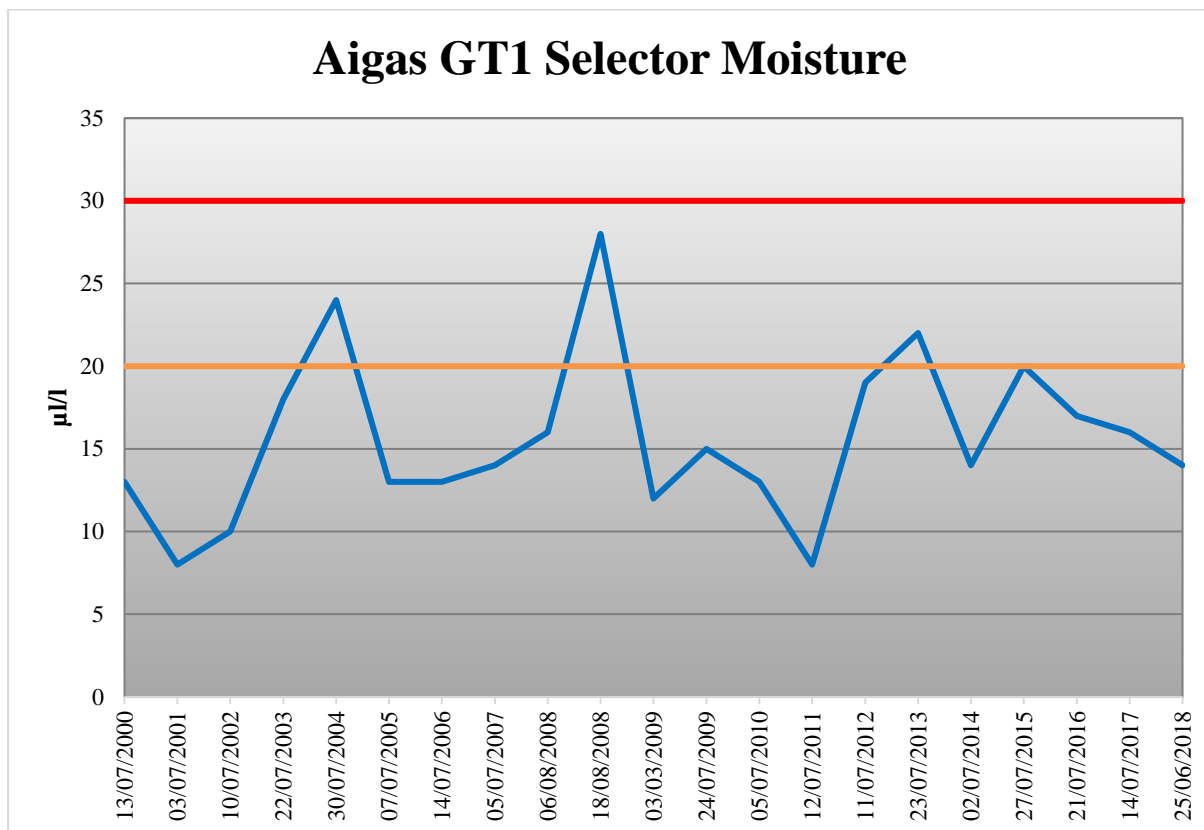
The historical selector moisture data spans 21 samples over the period of 2000 to 2020. Over the operational life of the selector moisture levels have been dynamic, this has resulted in a fluctuation between a categorisation of “Good” & “Fair”, as defined by IEC 60422. Correlation in moisture peaks between the selector & the main tank are observed at each peak moisture value dated, July 2004, August 2008, July 2013 & July 2015 indicating that the tap changer oil is communicating with the main tank. Peak moisture value in the selector is recorded as 28µl/l in August 2008.

This would suggest that selector moisture management should be improved.

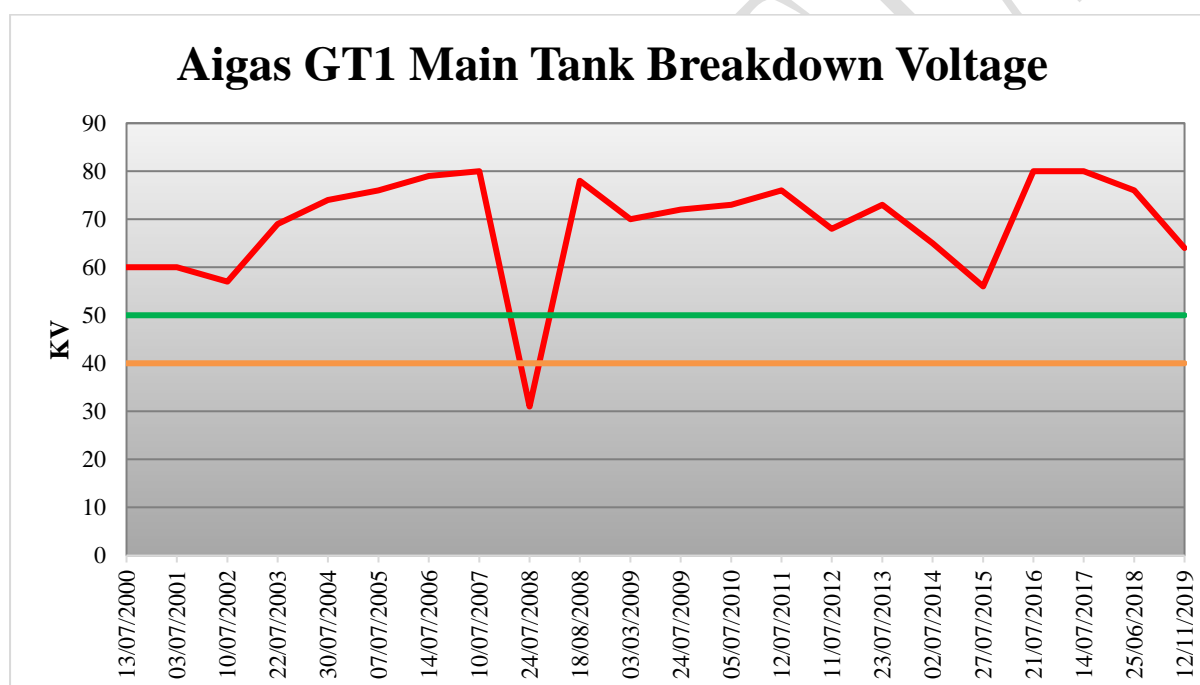
The historical breakdown voltage record spans the period of 2000 to 2019 and is inclusive of 22 samples. Except for the result from July 2008 (31kV) categorised as “Poor”, all breakdown voltage levels are “Good” as defined by IEC 60422. The reduction in breakdown voltage in July 2008 is likely the result of poor sampling techniques as the following sample, taken 3 weeks later, records a “Good” breakdown voltage level of 78kV. No correlation between substantial increases in main tank moisture levels are observed in July 2008. Reduction in breakdown voltage results from July 2015 correlates with increased moisture levels within the main tank. A dynamic trend is exhibited by breakdown voltage levels however, overall results are satisfactory.

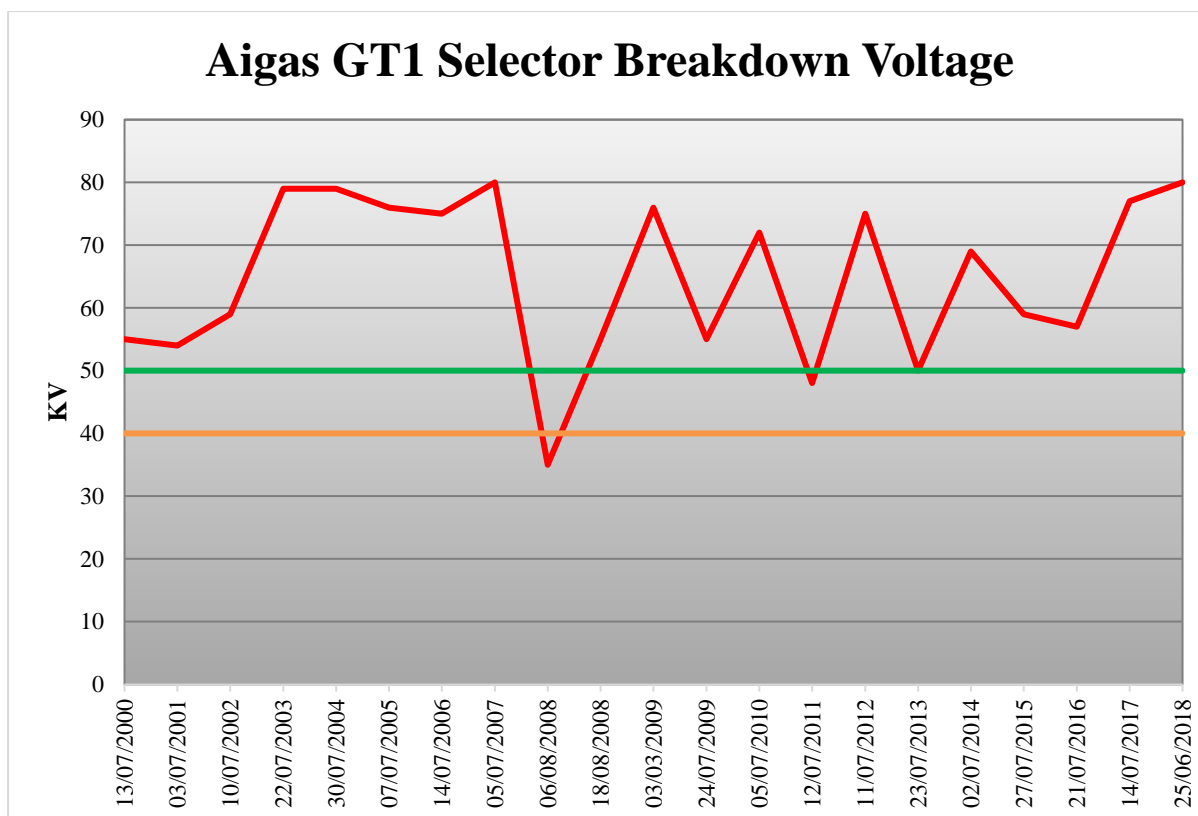
The selector historical breakdown voltage record spans the period of 2000 to 2018 and is inclusive of 21 samples. Except for samples from August 2008 (35kV), July 2011 (48kV) & July 2013 (50kV) categorised as “Fair”, all breakdown voltage results are categorised as “Good” as defined in IEC 60422. Despite this overall categorisation, an erratic trend is displayed in the results. A clear correlation exists between reduced breakdown voltage results and an increased moisture content within the selector. Overall breakdown voltage results are satisfactory however, fluctuations in results suggest moisture management issues must be addressed.

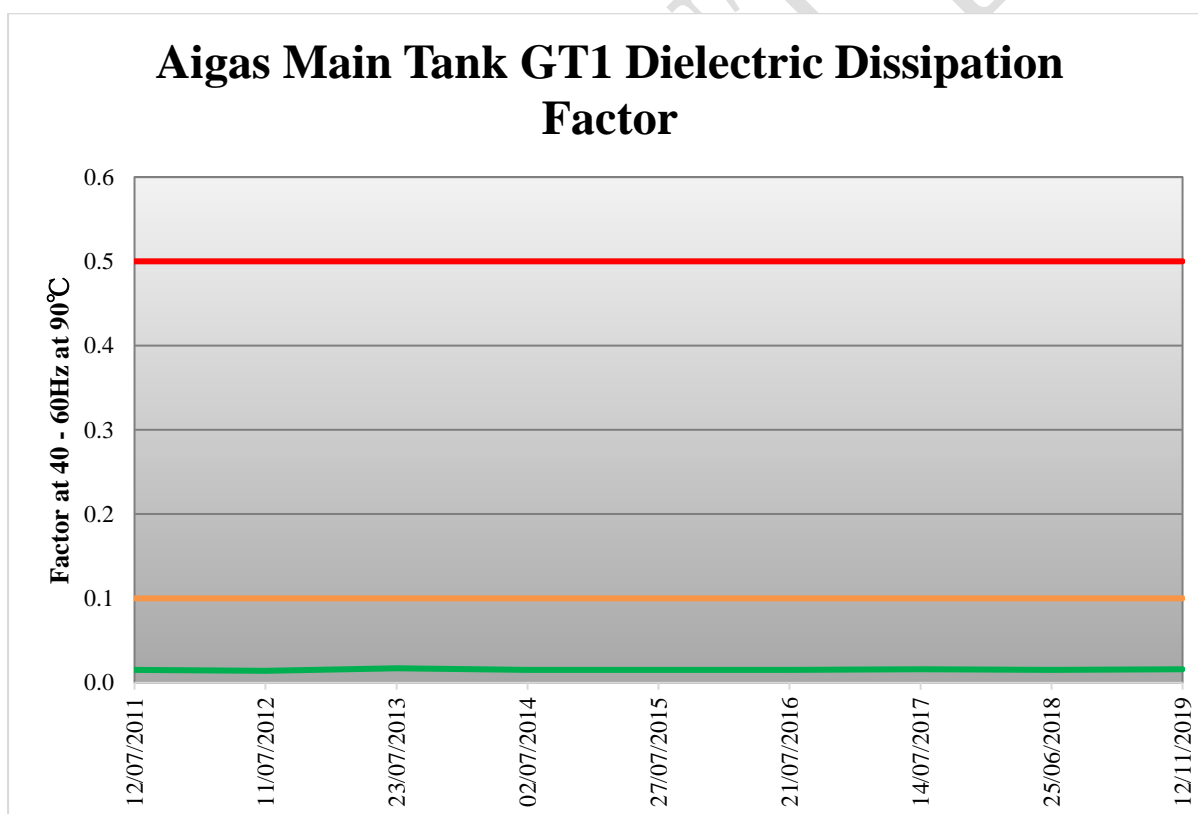
The dielectric dissipation factor is consistently categorised as “Good” as defined by IEC 60422. Results are satisfactory.

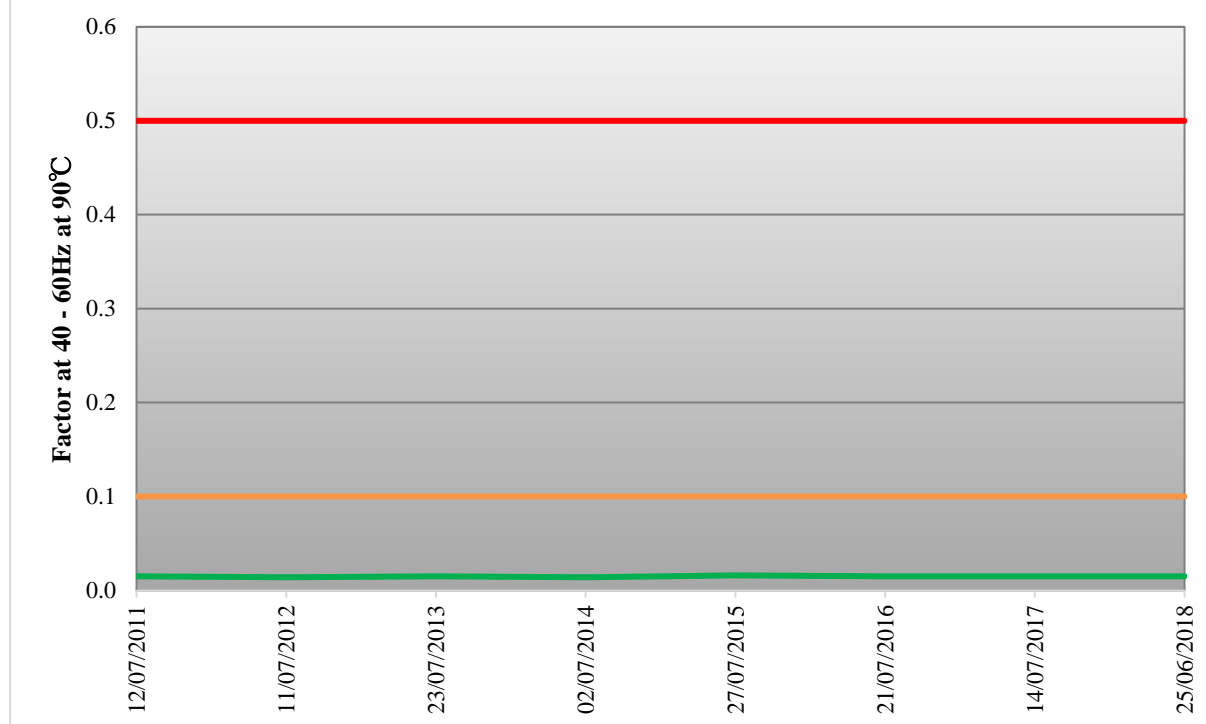
Aigas GT1 Selector Dielectric Dissipation Factor

The dielectric dissipation factor is consistently categorised as “Good” as defined by IEC 60422. Results are satisfactory.

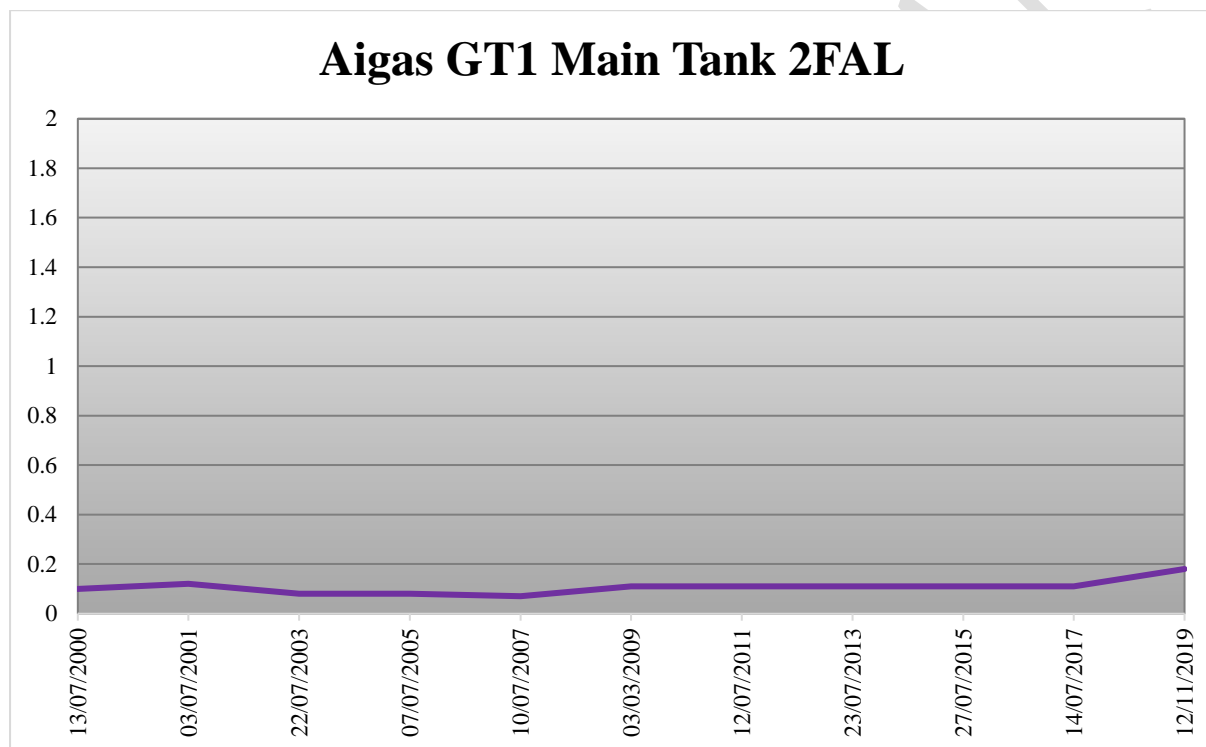
The 2FAL record spans from 2000 until the most recent sample, which was taken in November 2019. The 2FAL levels an almost stable trend over the sample period with small increases noted in 2001 and 2009 which is most likely an indication of dilution of 2FAL levels by means of oil top ups. The final value recorded was 0.18 (Est DP 641), and also represents the peak value over the sample range. The link between measured 2FAL and estimated DP is reliant on an algorithmic relationship, of which there are five different variants. The Chengdong algorithm has been used to relate measured 2FAL to estimated DP. In order to estimate the DP of the insulation system, the highest value of measured 2FAL shall be used (From November 2019). Measured 2FAL of 0.18 gives an estimated DP of 641. The insulation within a new transformer has typically a DP value of 1000. It is generally accepted within the industry that an estimated DP value of 200 is “end of life”. Application of this criteria, results in the transformer having an estimated 55% residual life remaining in the paper insulation. This suggests that the paper insulation is in good condition given its age.

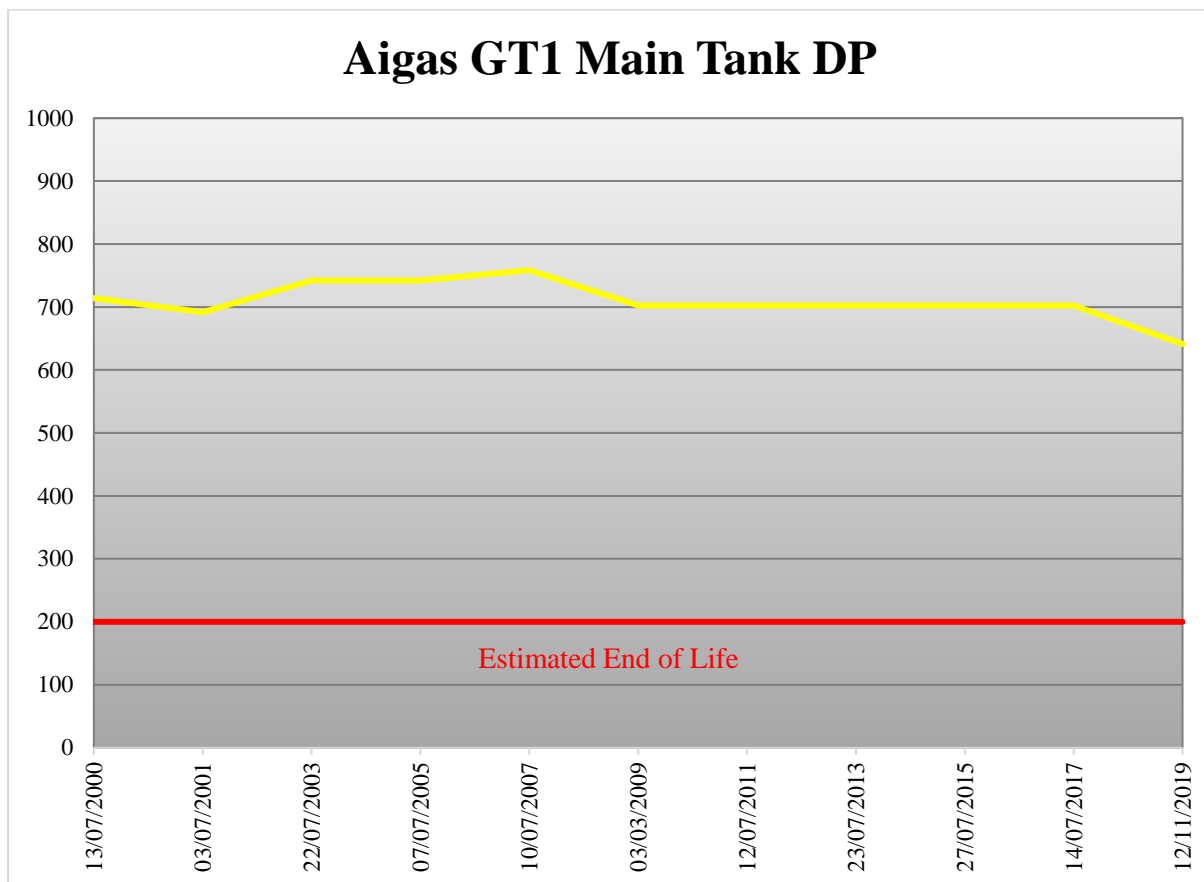
This figure is considered to be optimistic as the 2FAL has been diluted and with the 2FAL level being used to estimate the DP of the paper insulation, the estimated DP is most likely lower than the predicted figure.
