Gwynt y Môr OFTO plc

Income Adjusting Event Claim for the [REDACTED] Repair associated with repairing cable failure to SSEC3 that occurred on 15 October 2020

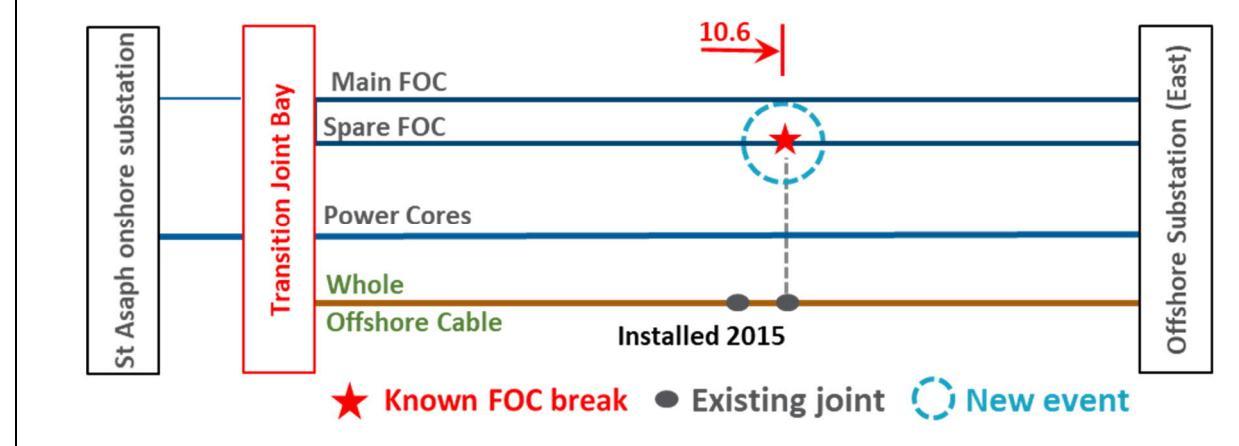
- 1 January 2020 All fibres broken in Spare FOC
 - FOC Fault has developed between May 2019 (last time the Spare FOC was tested) and January 2020.
 - Exact location is not known but in the vicinity (or even within) one of the joints installed in 2015.
 - No impact on operational capability, all communications in Main FOC continue to operate.
 - No evidence that this FOC fault would cause a power fault, so the appropriate approach is to maintain availability of the asset for the windfarm operator and the consumers.
 - If there was compelling evidence a power fault would result and this was the only FOC Fault then Licensee could remove it with cable and joints from its spares (1000m and 463m of cable plus three cable joints as per good industry practice).

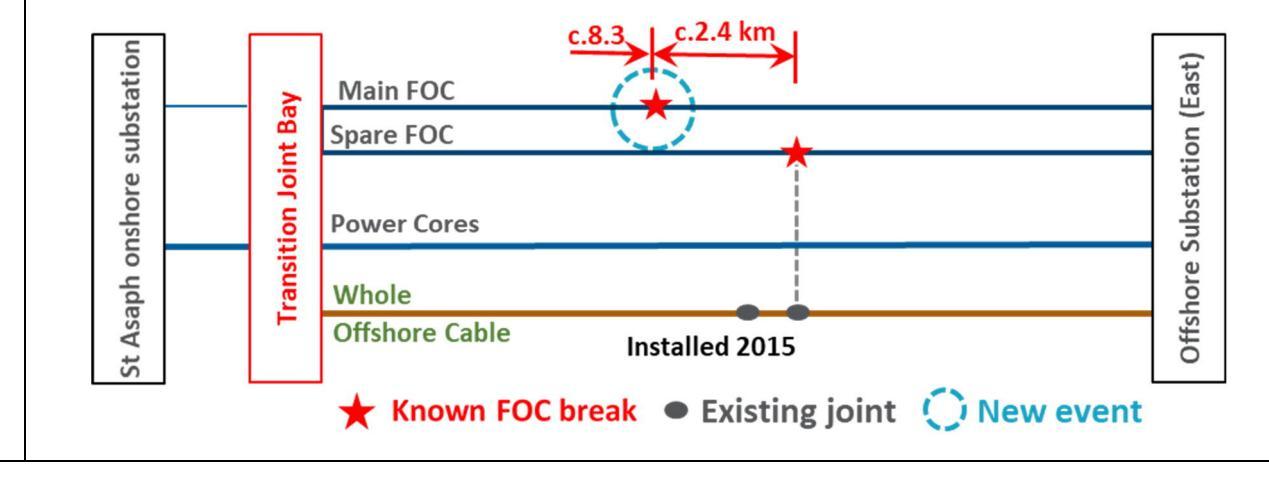
2 February 2020 - All fibres broken in Main FOC

- Fault time known as the Main FOC as communications to the OSP failed triggering alarms.
- Exact location is not known but c. 2.4km onshore from the FOC Fault in the Spare FOC.
- The Licensee does not have enough cable in its spares to remove both FOC faults
- Requires c.3.0km of cable to remove these faults in one repair (delivery c.8 months from order).
- No loss of functionality, communications diverted down spare fibres within SSEC1 cable.
- No compelling evidence that these FOC faults would cause a power fault, so the appropriate approach is to maintain availability of the asset for the windfarm operator and the consumers.
- The Licensee increased frequency of OTDR testing to check developing status of the FOCs

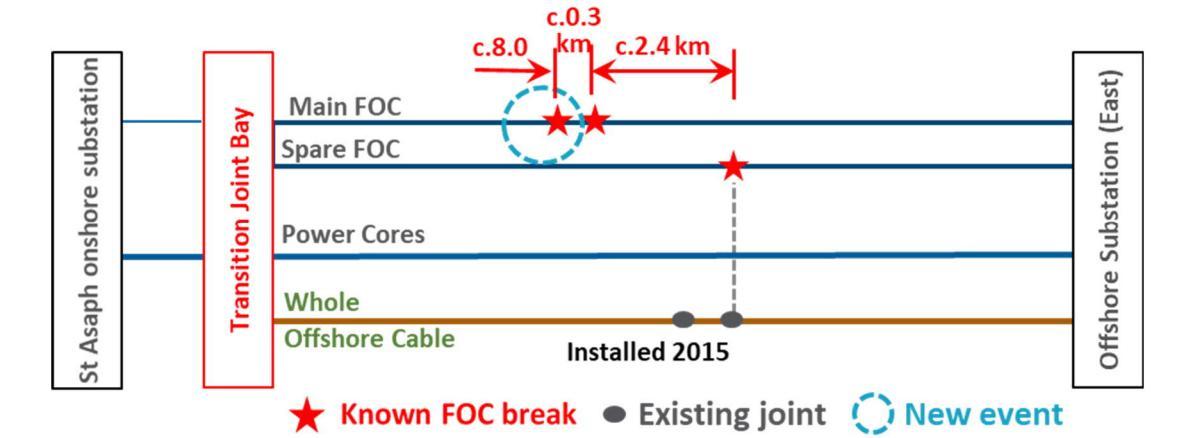
3 May 2020 - New information for Main FOC

- New OTDR tests indicate a new FOC fault in the Main FOC (or the previous fault had extended). Exact location is not known but c. 0.3km inshore from the Feb-20 FOC Fault in the Main FOC.
- Impossible to determine extent of any damage between the two faults in the Main FOC.
- The Licensee does not have enough cable in its spares to remove all these faults. Requires c.3.5km of cable to remove these faults in one repair (delivery c.8 months from order).
- Still no compelling evidence that these FOC faults would cause a power core fault.
- The Licensee approached cable suppliers for new cable and issued an ITT to its Framework Repair contractors to conduct a potential repair.

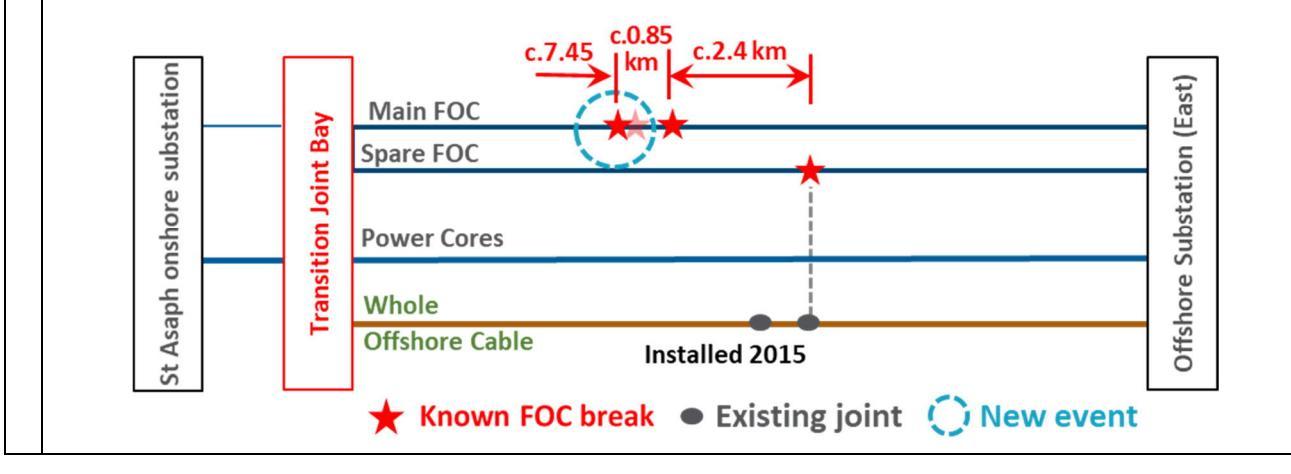
4 June – August 2020 - Further testing

- New OTDR tests and Distributed Acoustic Sensing (DAS) improved the fault location accuracy. The Main FOC is now broken c. 0.85km inshore from the Feb-20 FOC Fault location.

- A Line Resonance Analysis (LIRA) test in June showed no degradation in the power core insulation compared to a similar test in November 2018; A Partial Discharge (PD) test in August was inconclusive; too much background noise common when testing long cables.

- The Licensee does not have enough cable in its spares to remove all these faults. Require c.4.0km of cable to remove these faults in one repair (delivery c.8 months from order).

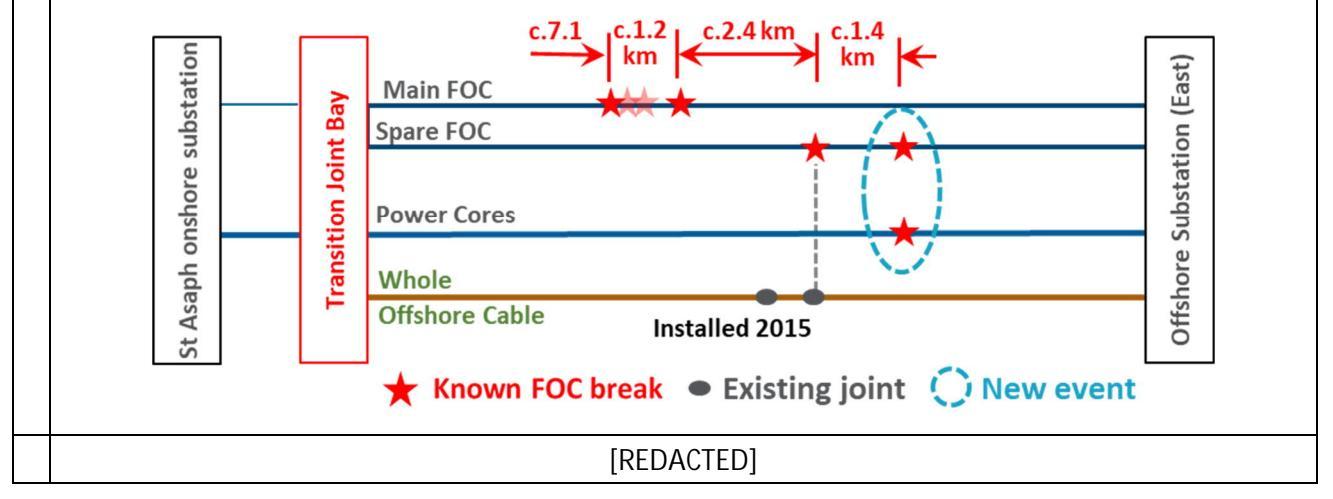
- 5 15 October 2020 SSEC3 Power Core Fault
 - Power core faulted on 15 October. OTDR tests show the Spare FOC is also broken in same place.
 - Exact location is not known but c.1.4km offshore from the previous FOC Fault in the Spare FOC.
 - Also Main FOC fault had moved c.1.2km inshore from the Feb-20 FOC Fault in the Main FOC.
 - The Licensee can repair the power fault but does not have enough cable to remove the FOC faults.
 - c.5.5km of cable is needed to remove all the faults in one repair (delivery c.8 months from order).
 - The Licensee made plans to repair the power core fault and return SSEC3 to service [REDACTED].

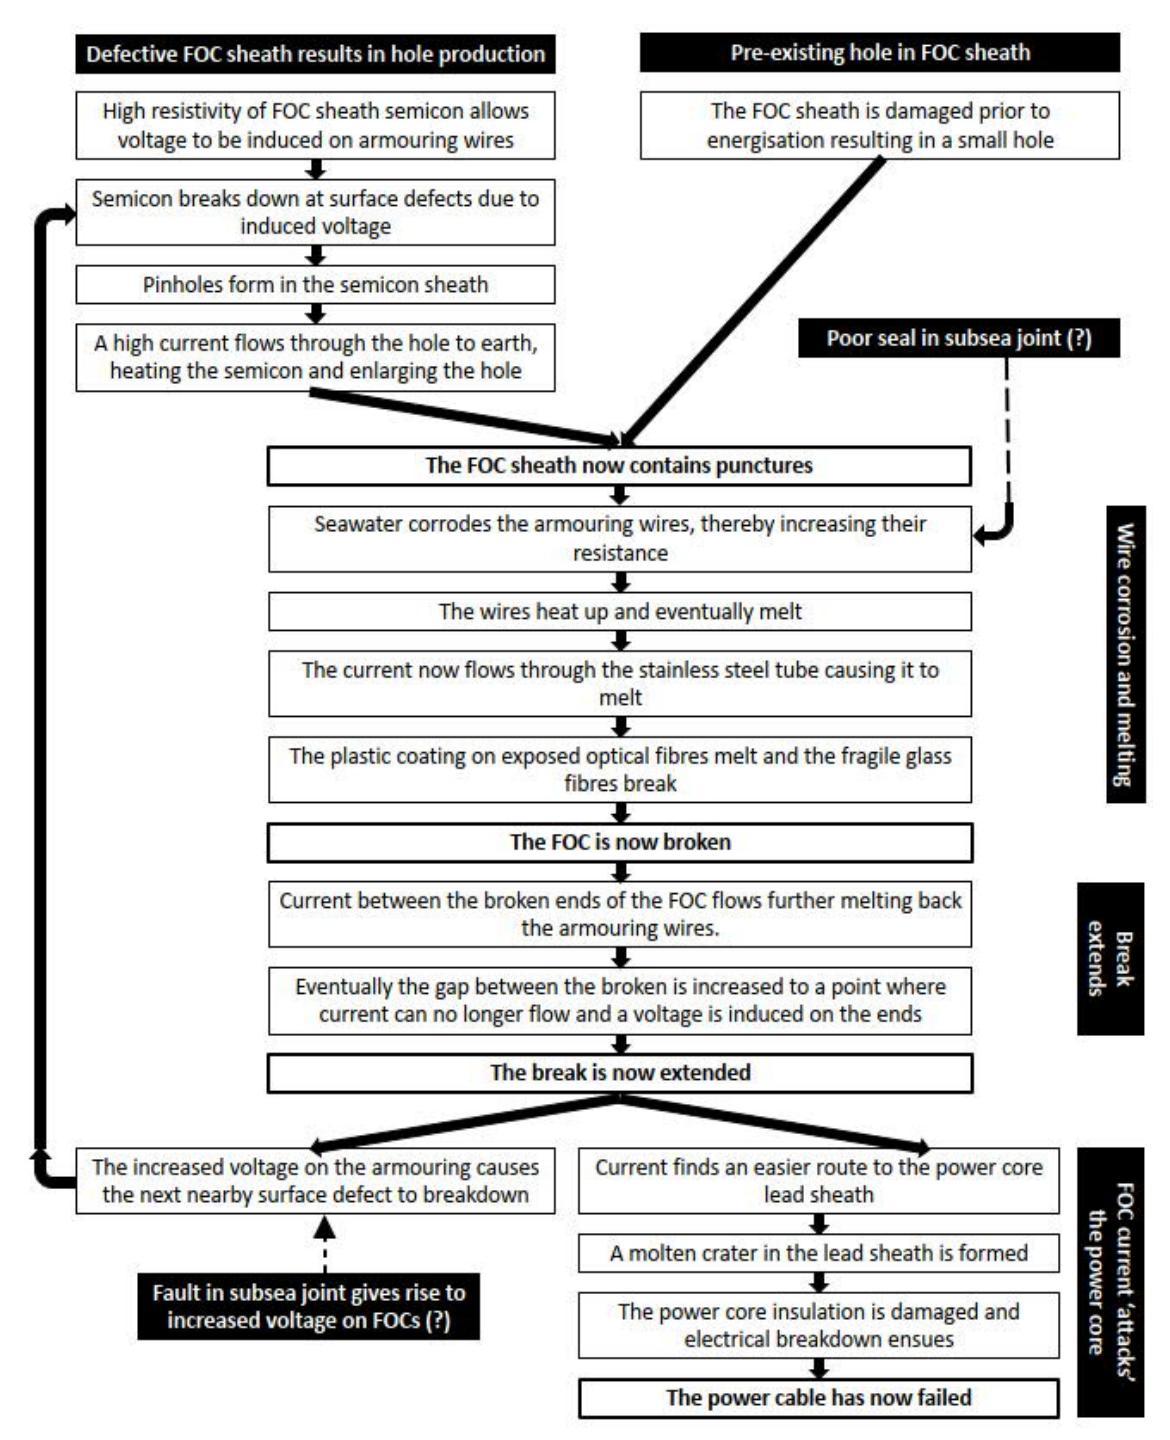
Figure 2: Sequence of events leading to failure of the power cable proposed in the SDC Report (Figure 12, page 33)

- (c) The RCA Technical Report shows that the failure of the FOC leading to the failure of the power core, was very much in line with the proposed sequence of events in the SDC Report; see Figure below.
