# Storm Arwen

# **Technical Review of DNO Response**

Office of Gas and Electricity Markets 22 April 2022

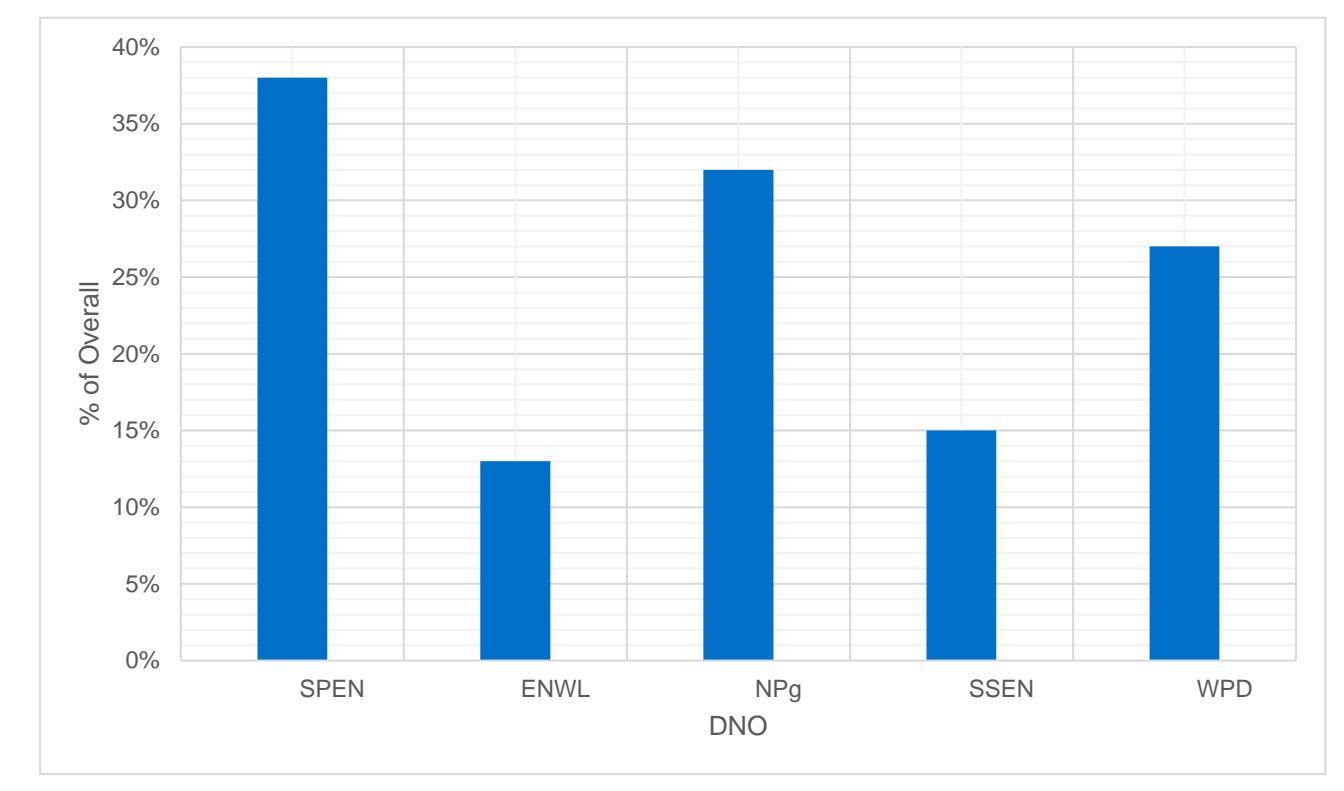
Figure 24: Proportion of damaged poles rated at HI4 and above

This shows a broad spectrum of results across companies and not the expected common link between condition and failure rate.
