Gwynt y Môr OFTO plc (the Licensee) – Income adjusting Event (IAE) Notice pursuant to amended standard licence condition E12-J3 (the Condition) regarding failure of subsea export cable 3 (SSEC3)

ANNEX 1 - Evidence to support the costs being claimed under this IAE Notice

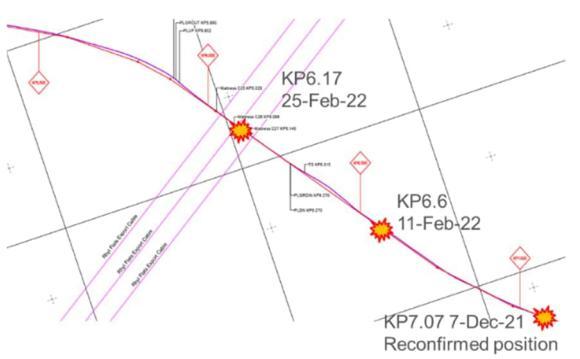
had already advised that the onshore end of the repair should start at least 500m further onshore from the last known FOC break.

The first of these new FOC breaks put the starting point of the repair at KP6.1 which was right on top of the point where the Licensee's cables cross over the top of the cables serving the Rhyl Flats Windfarm. This effectively meant that the starting point for the repair would need to move even further towards the shore to avoid placing a joint on or close the Rhyl Flats crossing. The new starting point was set at KP5.5. This location did not change when the second of the new FOC breaks was identified. The new repair scope between KP 5.5 and KP 12.5 meant that the Licensee needed to:

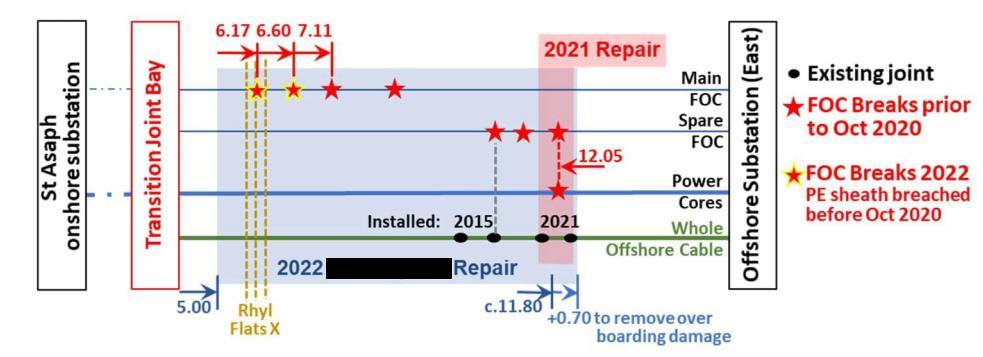
The final repair plan is therefore between KP5.0 and KP12.5 requiring 7.5km of cable (from the original 8.5km ordered in March 2021). This is set out in the schematic below.
