Quality of Service Incentive Scheme – Exceptional Events

Appointed Examiner's Report			
Reporting year 2010/11			
DNO	SEPD		
Cause	Catastrophic failure of 33kV switchgear		
Date of event	26 June 2010

Title:	Exceptional Events Report – SEPD – catastrophic failure – Portsmouth Grid Substation resulting in loss of customers' supplies – 26 June 2010		
Reference:	E 2010/11 – SEPD		
Issue:	Final Version 1.0		
Date:	28 July 2011		
Electronic Doc F	f: M:\BPIUSER\Projects\Current\UK Ofgem - EE one-offs for 2010- 11/SEPD - 26 Jun '10/ Reports/final report v1.0.doc

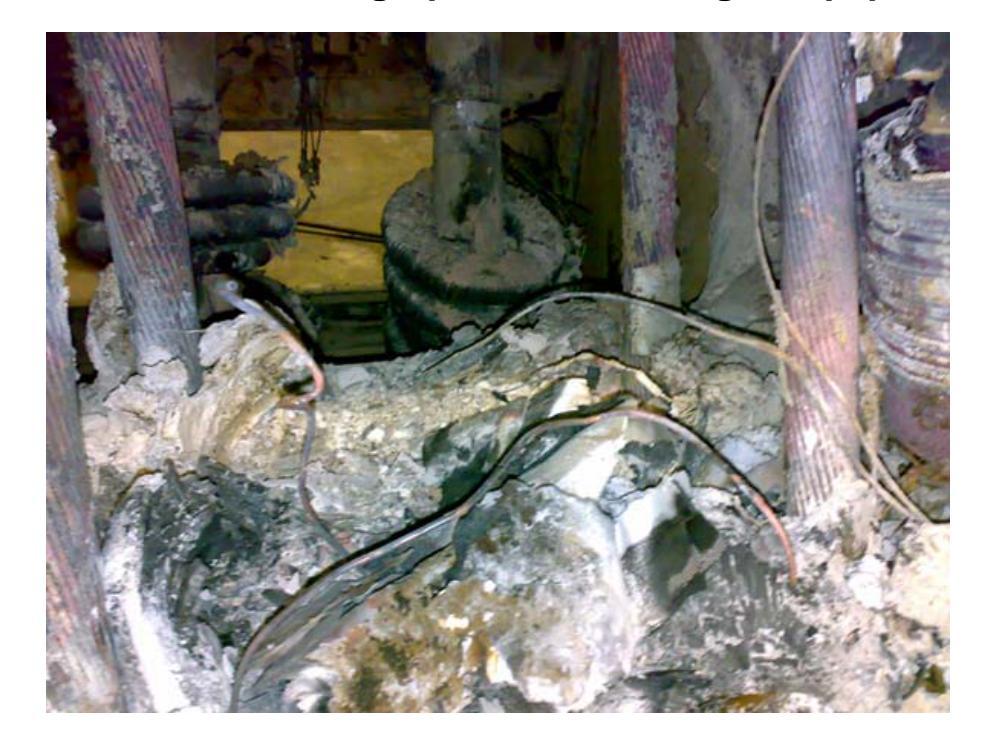
A6. Although much of the evidence was destroyed in the fire it appears that the initial fault was a failure of the CT's within C1T0, beginning as a phase-to-earth fault and developing into a phase-to-phase fault between red and yellow connections within the compartment. The fault and the subsequent fire damaged the circuit-breaker which lost its insulating SF₆ gas and led to an electrical breakdown across the circuit-breaker contacts which then re-energised the transformer cables from the 33kV busbars.

- 2.2 The fire service's contemporaneous observations and SEPD's post-incident investigation pointed to a failure within the CT chamber of 33kV circuit-breaker C1T0. SEPD's photographs 1 and 2 show the severe damage to the CT chamber and surrounding components of the fixed portion of switchgear.

Photograph 1 – Rear of cable box showing single-core cables and CTs at the rear

- 2.22 The AE is also pleased to note that SEPD has replaced the whole of the affected 33kV switchboard to prevent a re-occurrence.

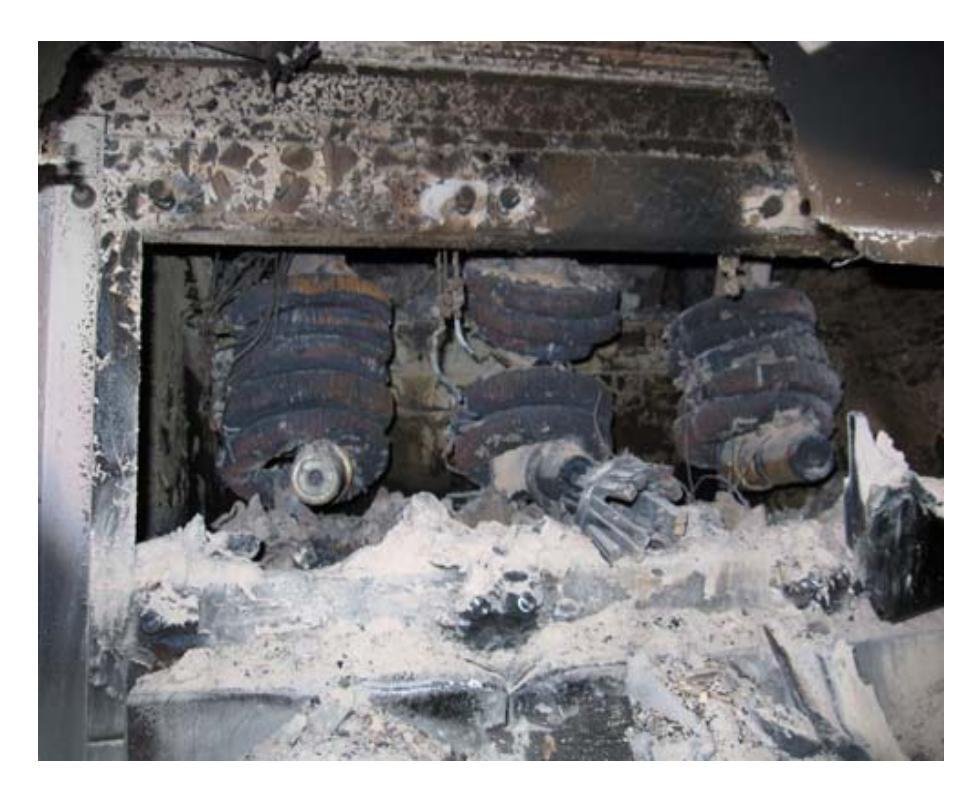
Photograph 2 – The CTs and connections to the circuit-breaker truck

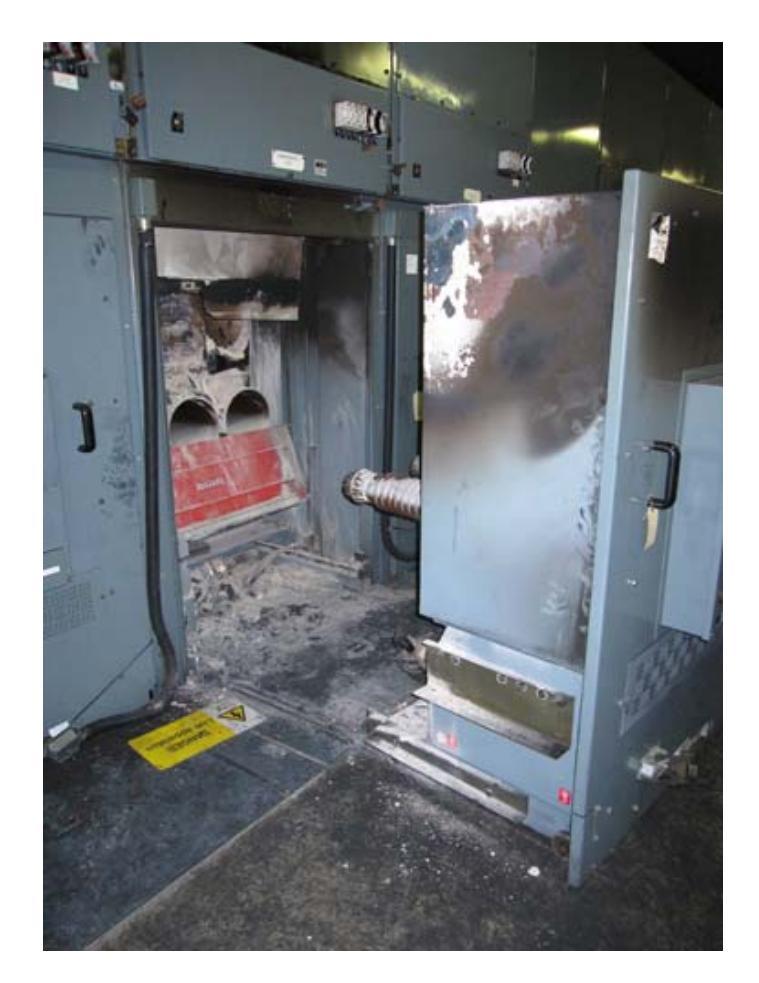
- 2.3 SEPD's photographs 3 and 4 show the extensive damage to the withdrawable portion of C1T0.
- 2.4 SEPD's photograph 5 shows another view of the extensive damage to the fixed portion and SEPD's photograph 6 shows an undamaged arrangement.

Photograph 3 – View of withdrawn circuit-breaker truck C1T0

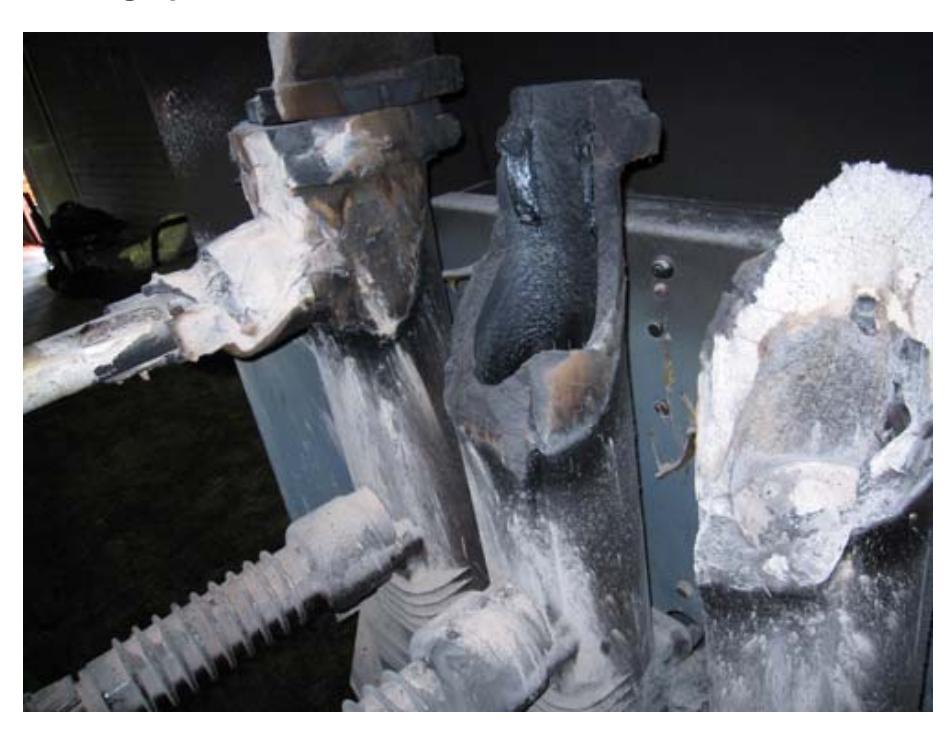
Photograph 4 – The irreparably damaged SF6 interrupters on C1T0

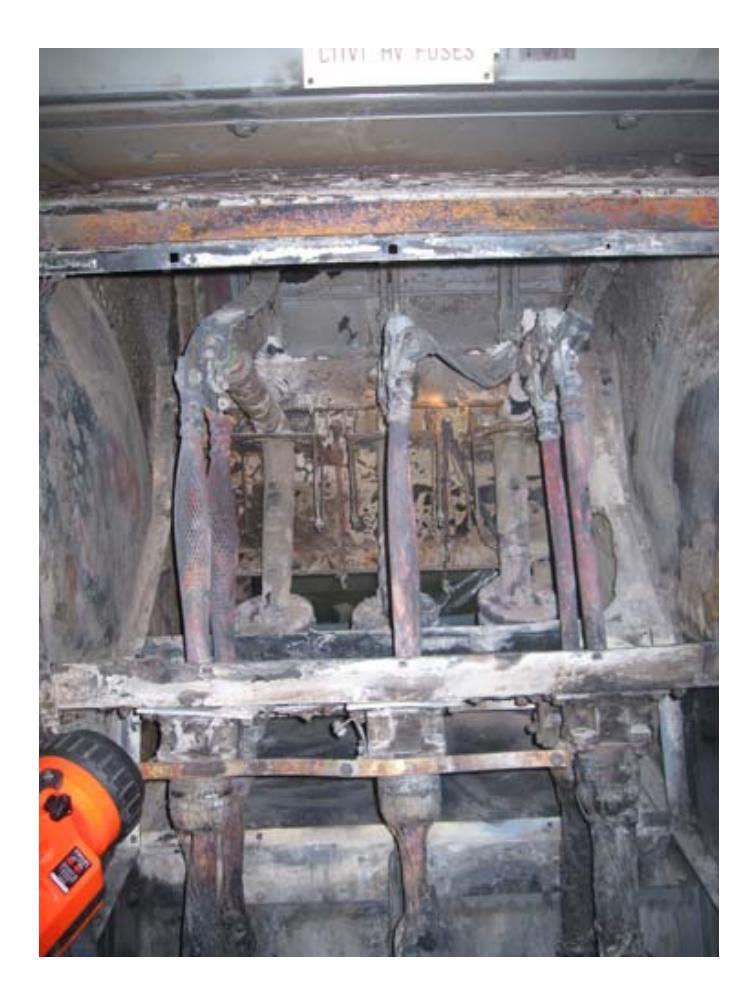
Photograph 5 – Irreparable damage to cable box and CTs

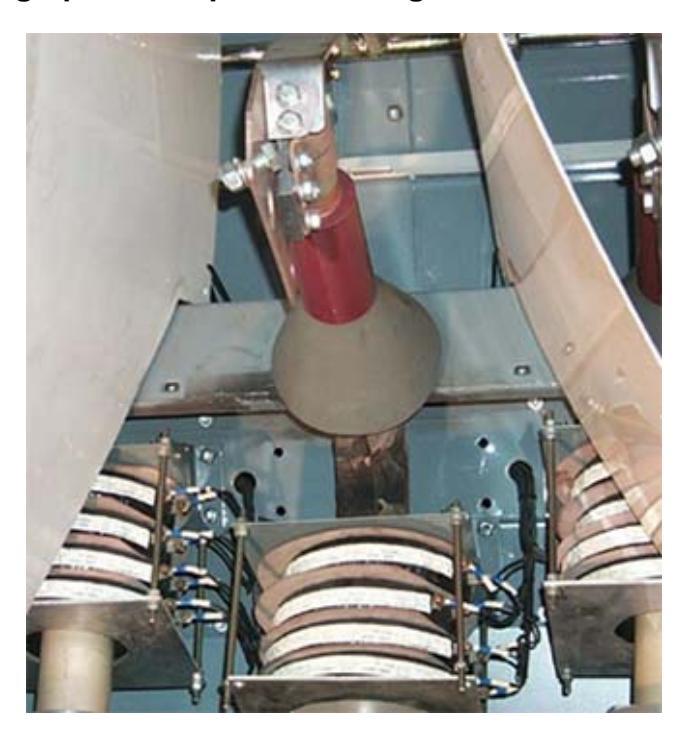
Photograph 6 – CT arrangement in an undamaged panel
