# CERT Demonstration Action UK Park Homes SCHEME REF: SSEN09132

# Alba Report 21050 Appendix 1

# Thermographic Data Pilot Project

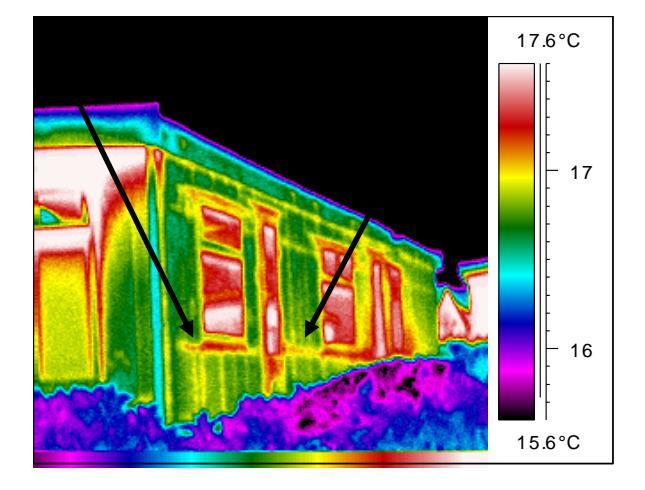
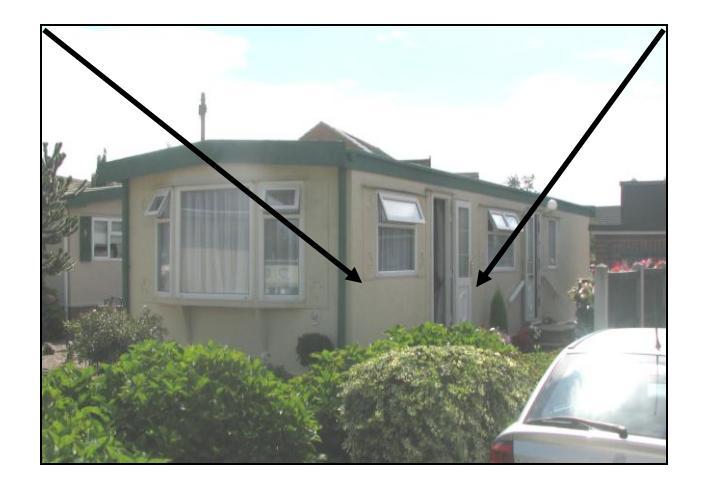
#### GMST 42

In the thermal image "pre-improvement", it is clear that significant heat loss is occurring across the building envelope and that this can be attributed to thermal bridging across the timber frame construction in addition to warm air leakage at critical junction details.

The thermographic inspection also identified a number of anomalies that were indicative of significant heat loss, occurring across the floor construction.

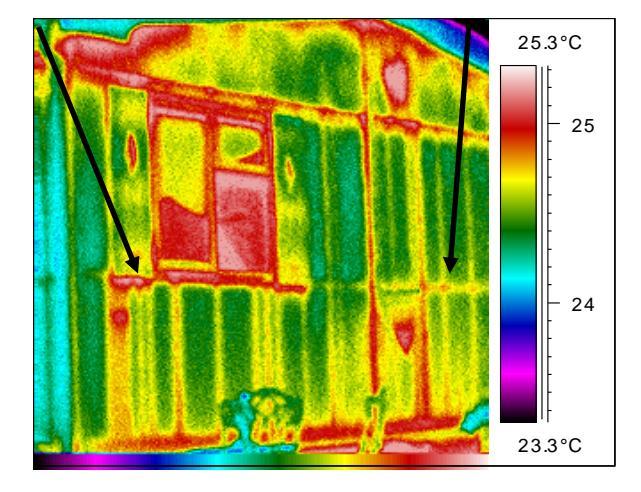
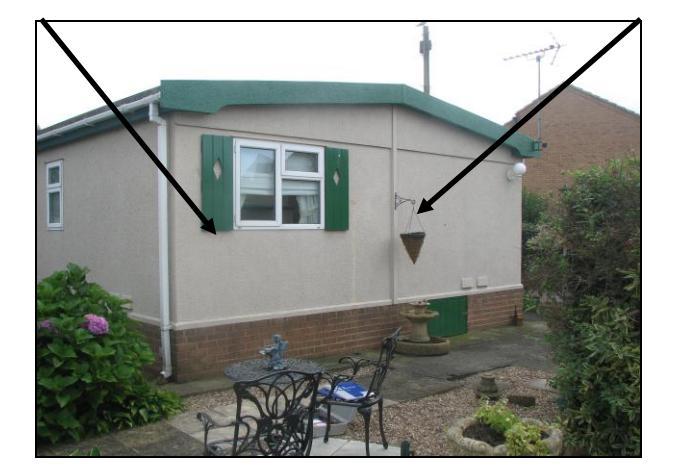
GMST 45

In the thermal image "pre-improvement", it is clear that significant heat loss is occurring across the building envelope and that this can be attributed to thermal bridging across the timber frame construction in addition to warm air leakage at critical junction details.

The thermographic inspection also identified a number of anomalies that were indicative of significant heat loss, occurring across the floor construction.

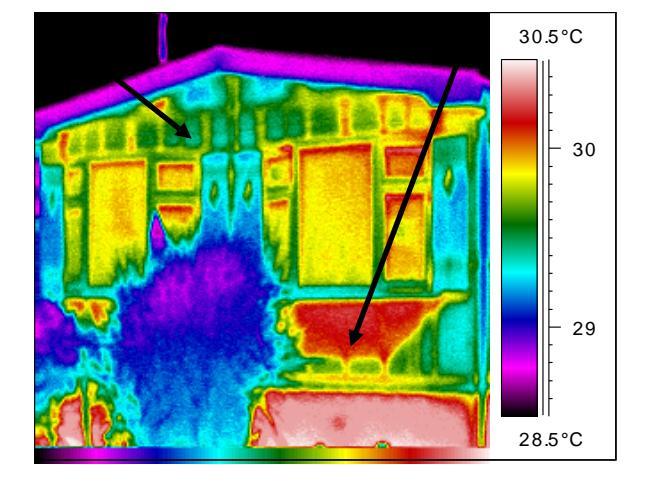
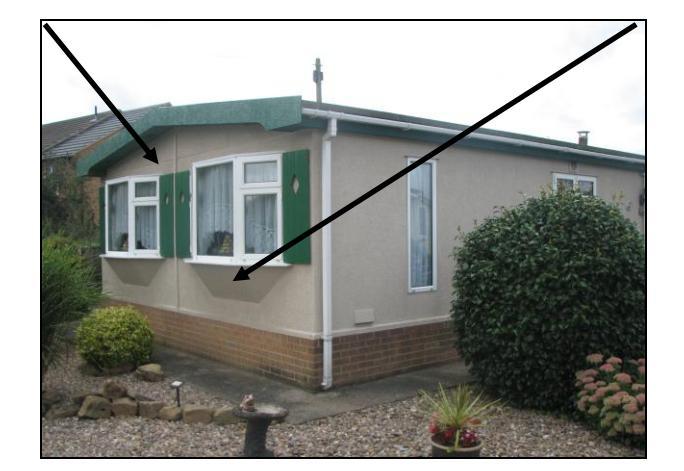
#### GMST 45

In the thermal image "pre-improvement", it is clear that significant heat loss is occurring across the building envelope and that this can be attributed to thermal bridging across the timber frame construction in addition to warm air leakage at critical junction details.

The thermographic inspection also identified a number of anomalies that were indicative of significant heat loss, occurring across the floor construction.

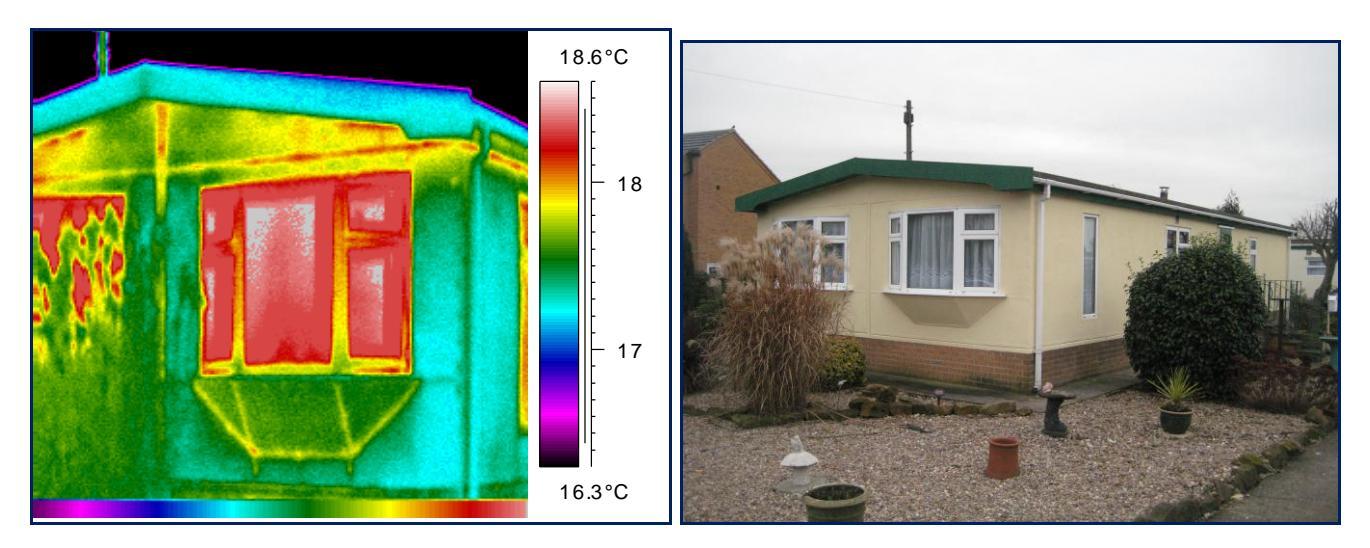
It can be seen in the above thermal image "post-improvement" that the number of heat-loss pathways across the building envelope have been significantly reduced ( i.e. when compared to the "pre-improvement" image )

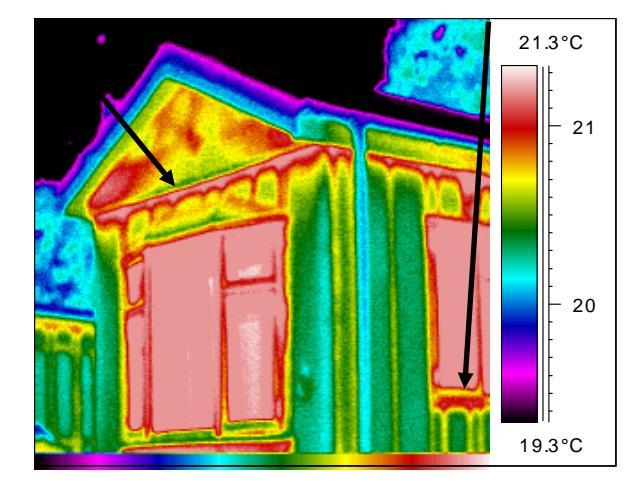
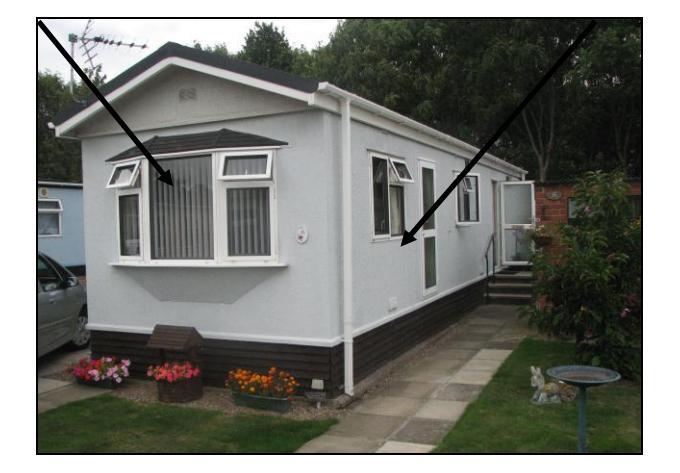
#### GMST 6

In the thermal image "pre-improvement", it is clear that significant heat loss is occurring across the building envelope and that this can be attributed to thermal bridging across the timber frame construction in addition to warm air leakage at critical junction details.

The thermographic inspection also identified a number of anomalies that were indicative of significant heat loss, occurring across the floor construction.

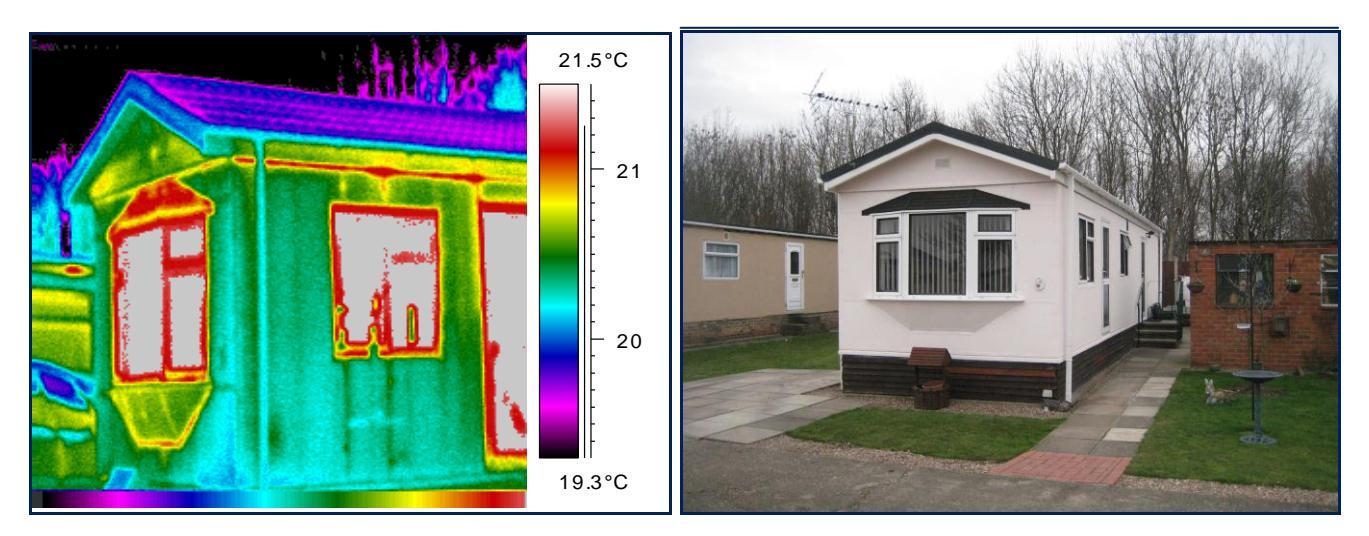
It can be seen in the above thermal image "post-improvement" that the number of heat-loss pathways across the building envelope have been significantly reduced ( i.e. when compared to the "pre-improvement" image )

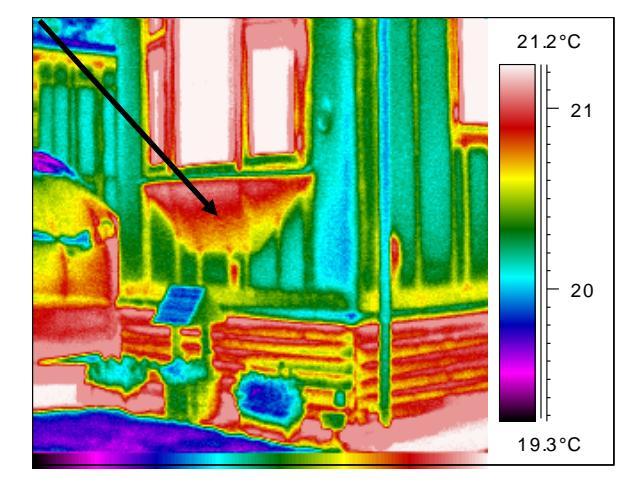
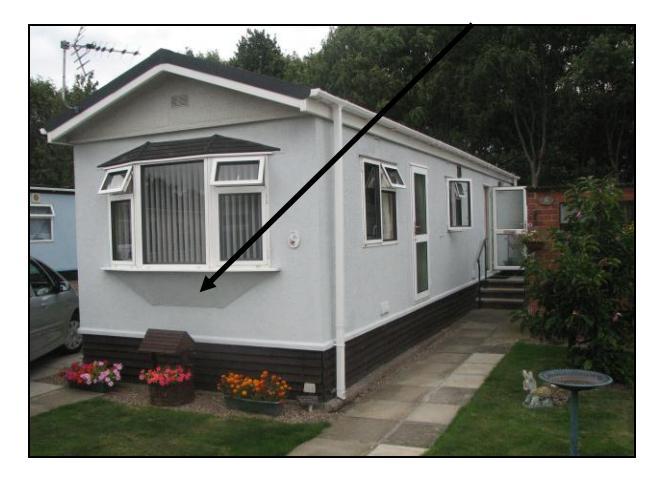
#### GMST 6

In the thermal image "pre-improvement", it is clear that significant heat loss is occurring across the building envelope and that this can be attributed to thermal bridging across the timber frame construction in addition to warm air leakage at critical junction details.

The thermographic inspection also identified a number of anomalies that were indicative of significant heat loss, occurring across the floor construction.

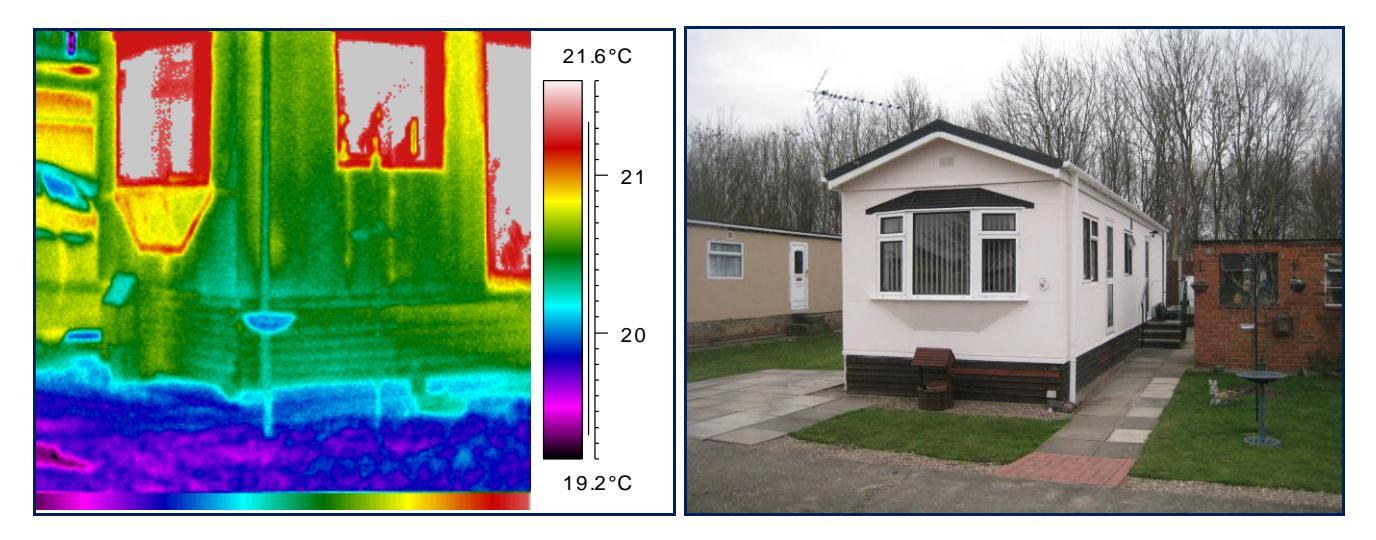
It can be seen in the above thermal image "post-improvement" that the number of heat-loss pathways across the building envelope have been significantly reduced ( i.e. when compared to the "pre-improvement" image )

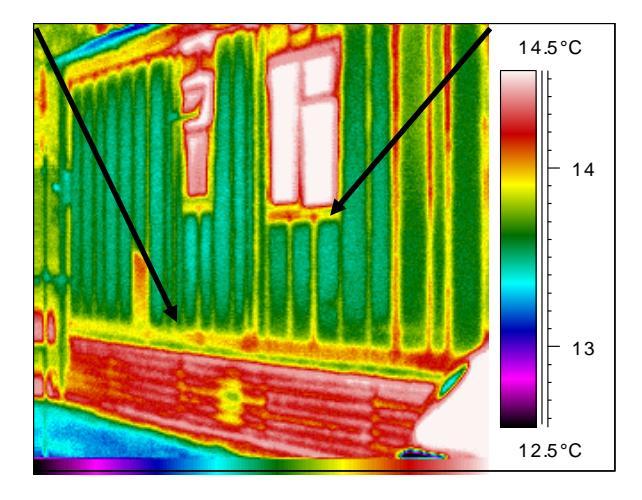
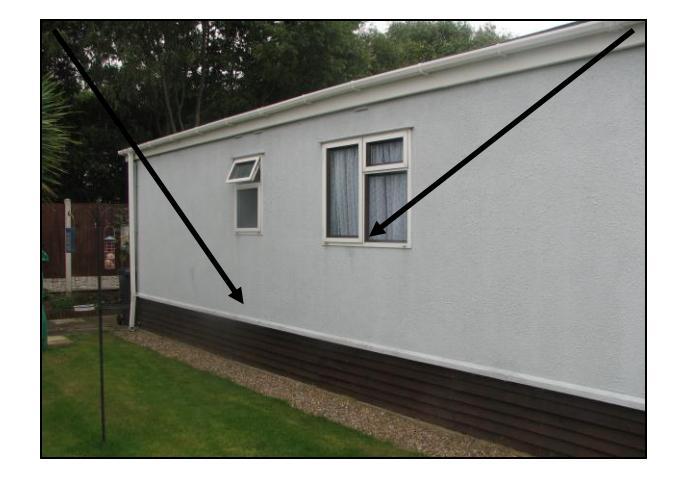
#### GMST 6

In the thermal image "pre-improvement", it is clear that significant heat loss is occurring across the building envelope and that this can be attributed to thermal bridging across the timber frame construction in addition to warm air leakage at critical junction details.

The thermographic inspection also identified a number of anomalies that were indicative of significant heat loss, occurring across the floor construction.

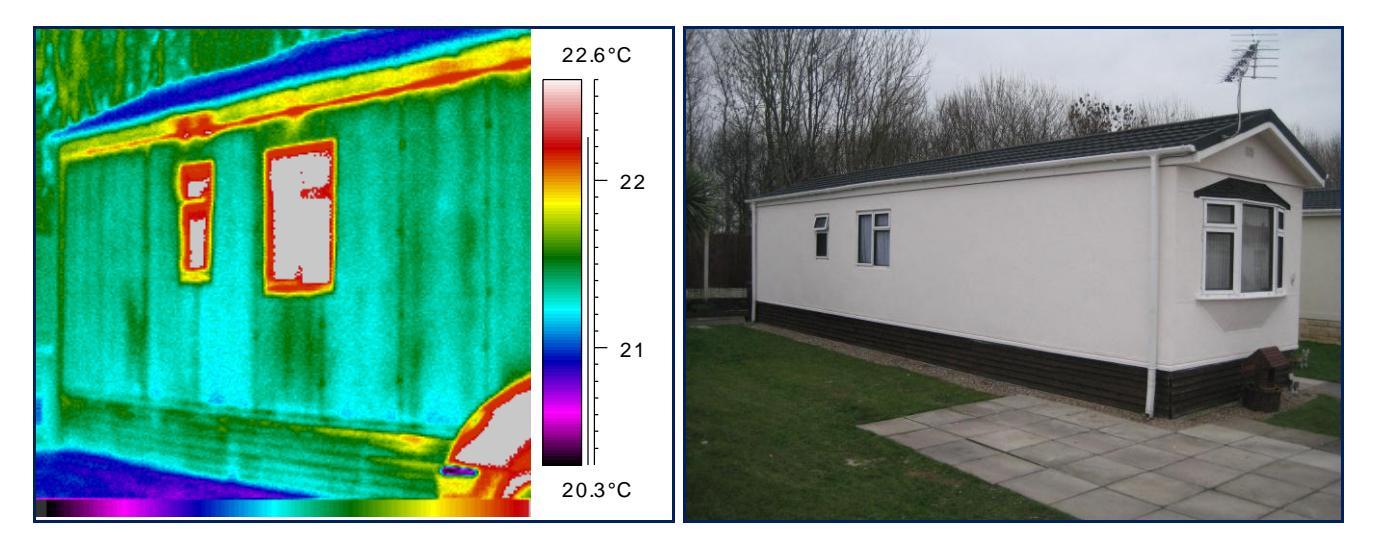
It can be seen in the above thermal image "post-improvement" that the number of heat-loss pathways across the building envelope have been significantly reduced ( i.e. when compared to the "pre-improvement" image )

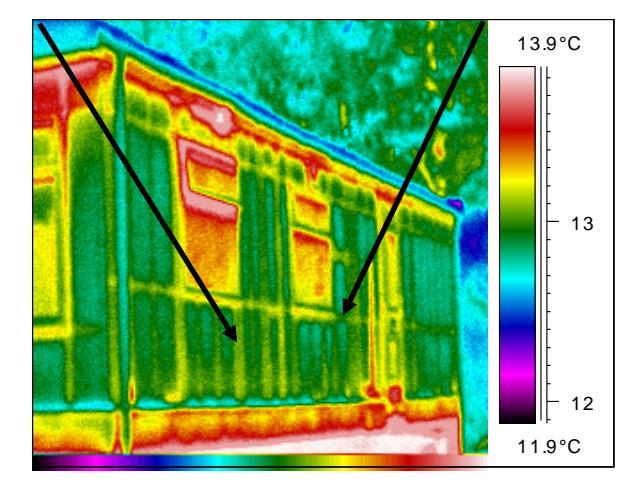
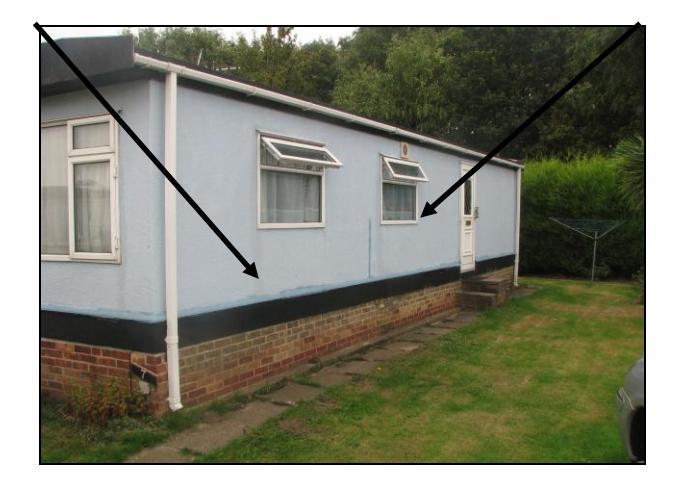
#### GMST 7

In the thermal image "pre-improvement", it is clear that significant heat loss is occurring across the building envelope and that this can be attributed to thermal bridging across the timber frame construction in addition to warm air leakage at critical junction details.

The thermographic inspection also identified a number of anomalies that were indicative of significant heat loss, occurring across the floor construction.

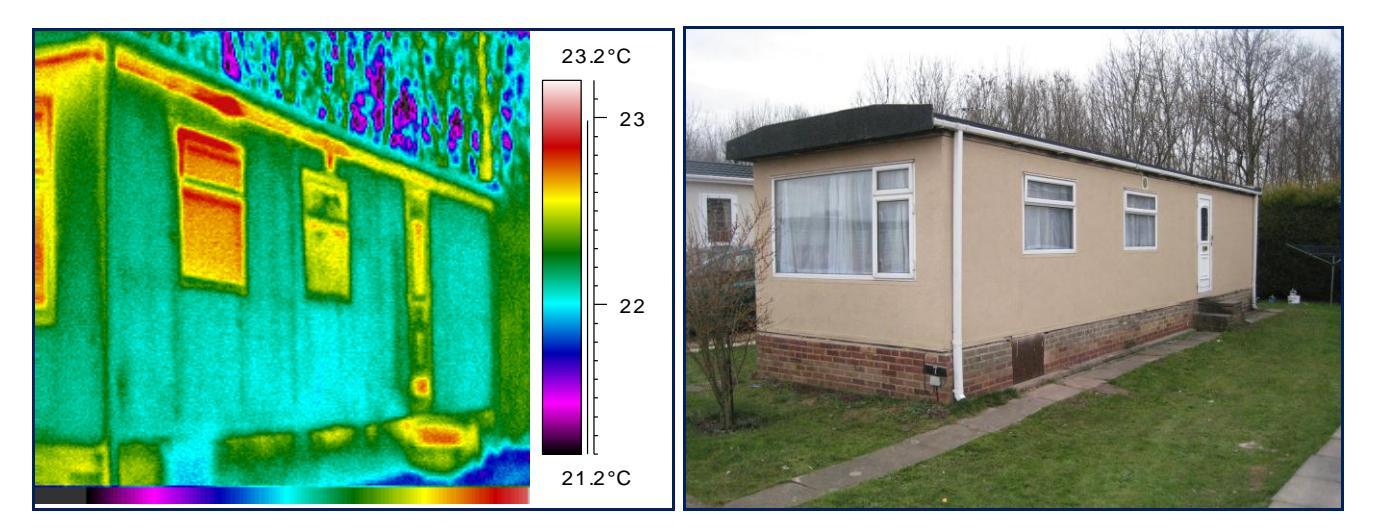
It can be seen in the above thermal image "post-improvement" that the number of heat-loss pathways across the building envelope have been significantly reduced ( i.e. when compared to the "pre-improvement" image )

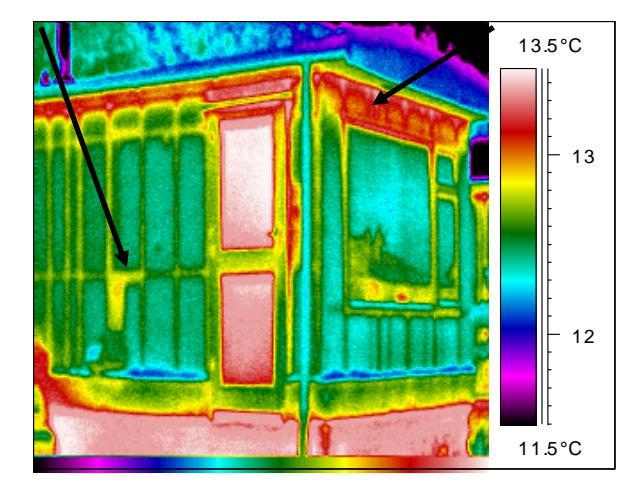
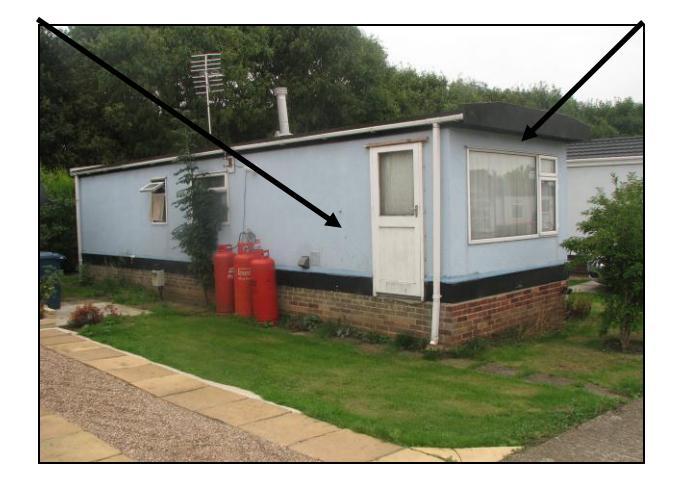
#### GMST 7

In the thermal image "pre-improvement", it is clear that significant heat loss is occurring across the building envelope and that this can be attributed to thermal bridging across the timber frame construction in addition to warm air leakage at critical junction details.

The thermographic inspection also identified a number of anomalies that were indicative of significant heat loss, occurring across the floor construction.

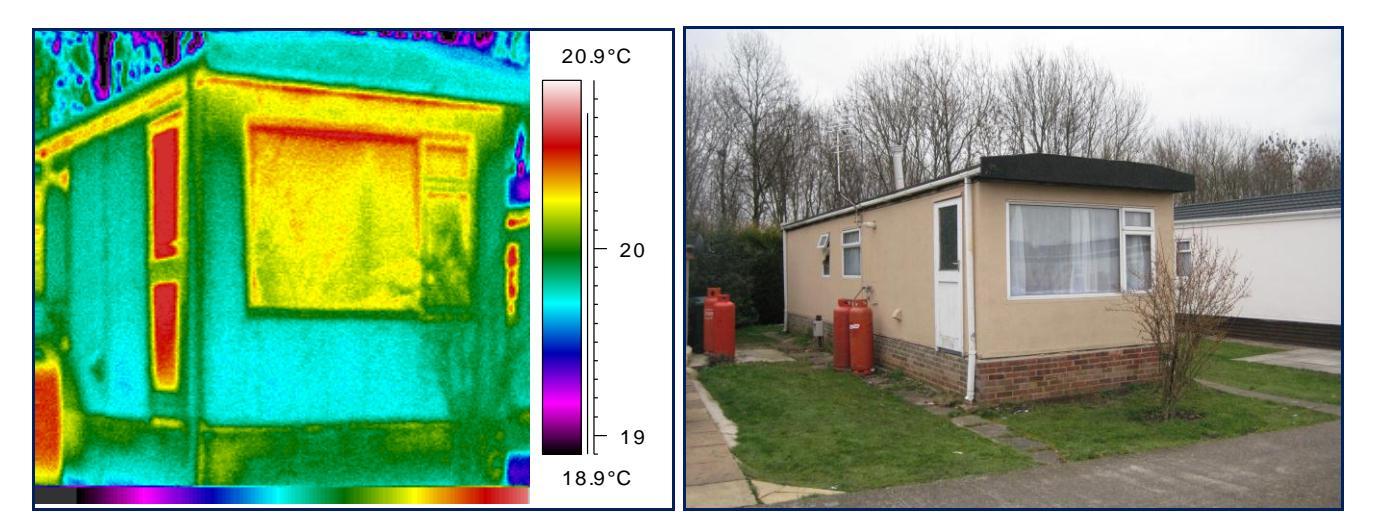
It can be seen in the above thermal image "post-improvement" that the number of heat-loss pathways across the building envelope have been significantly reduced ( i.e. when compared to the "pre-improvement" image )

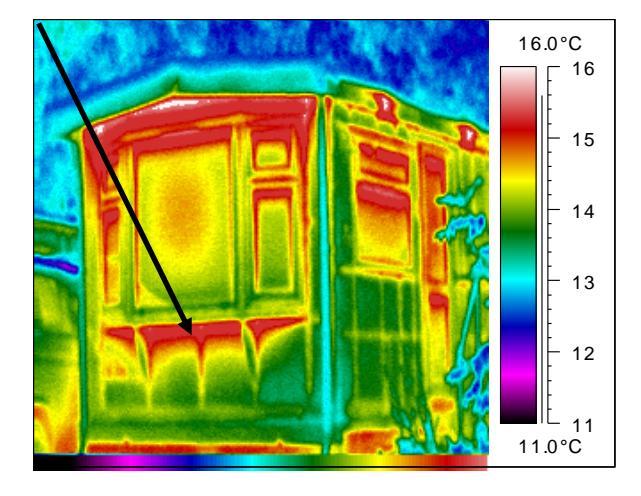
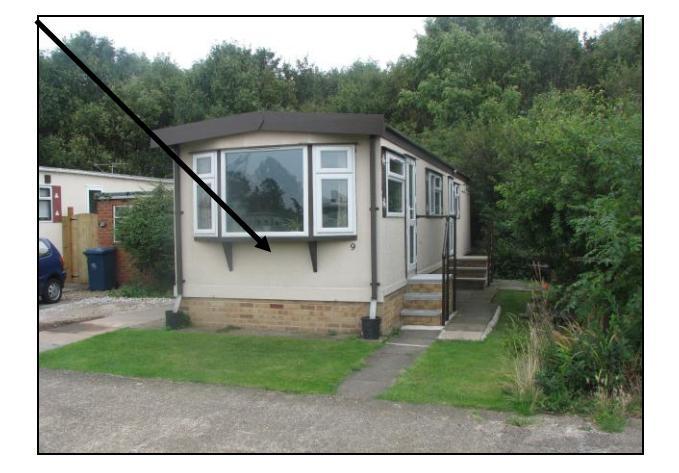
#### GMST 9

In the thermal image "pre-improvement", it is clear that significant heat loss is occurring across the building envelope and that this can be attributed to thermal bridging across the timber frame construction in addition to warm air leakage at critical junction details.

The thermographic inspection also identified a number of anomalies that were indicative of significant heat loss, occurring across the floor construction.

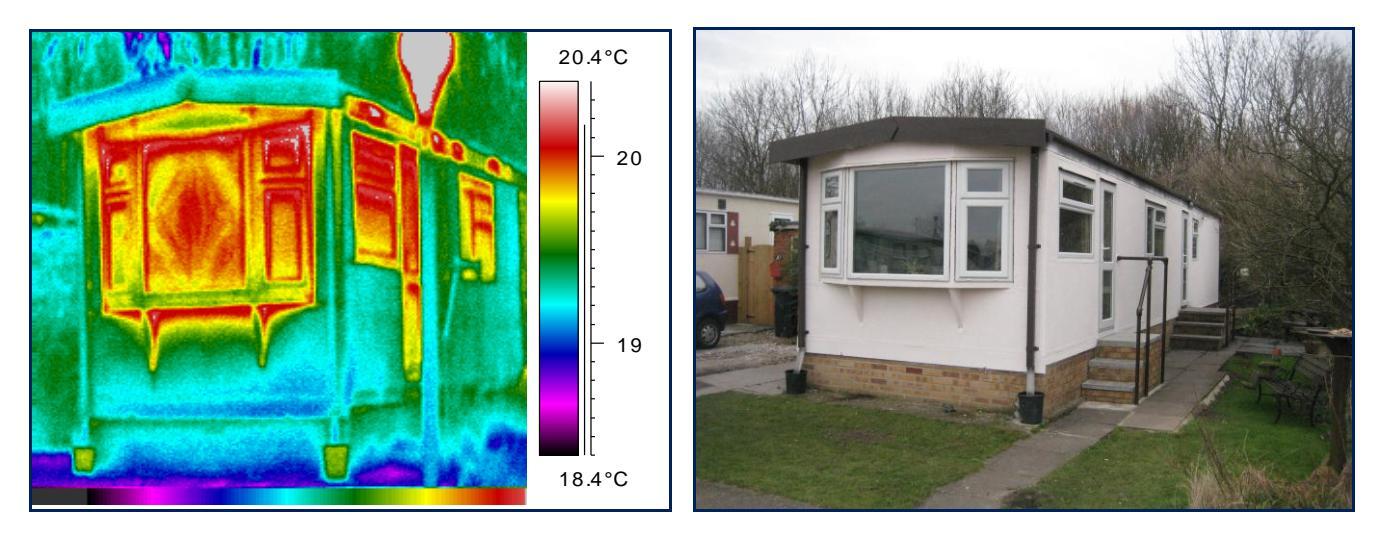
It can be seen in the above thermal image "post-improvement" that the number of heat-loss pathways across the building envelope have been significantly reduced ( i.e. when compared to the "pre-improvement" image )

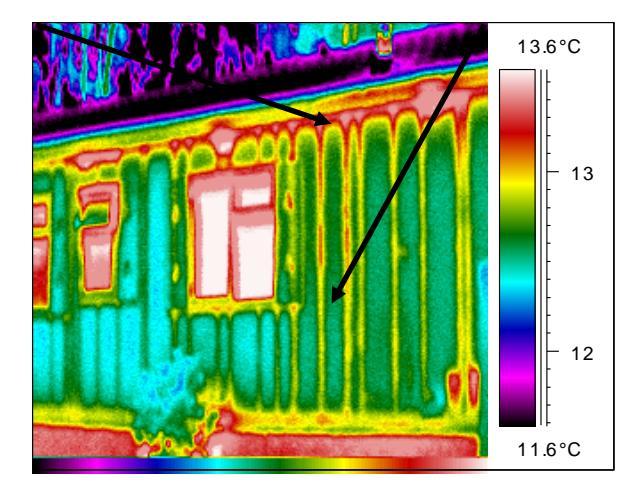
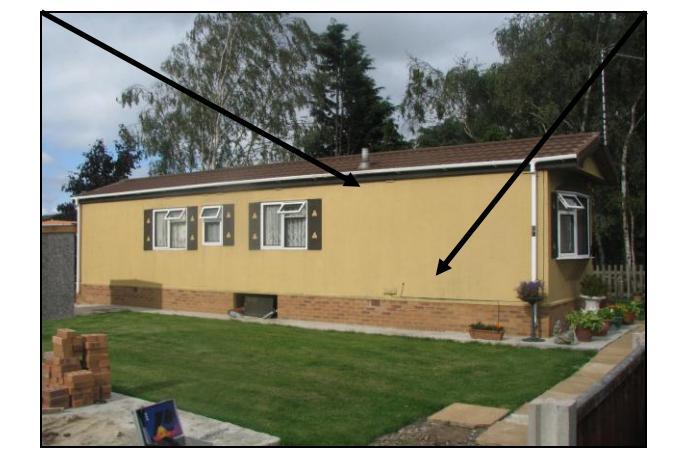
#### GMST 13

In the thermal image "pre-improvement", it is clear that significant heat loss is occurring across the building envelope and that this can be attributed to thermal bridging across the timber frame construction in addition to warm air leakage at critical junction details.

The thermographic inspection also identified a number of anomalies that were indicative of significant heat loss, occurring across the floor construction.

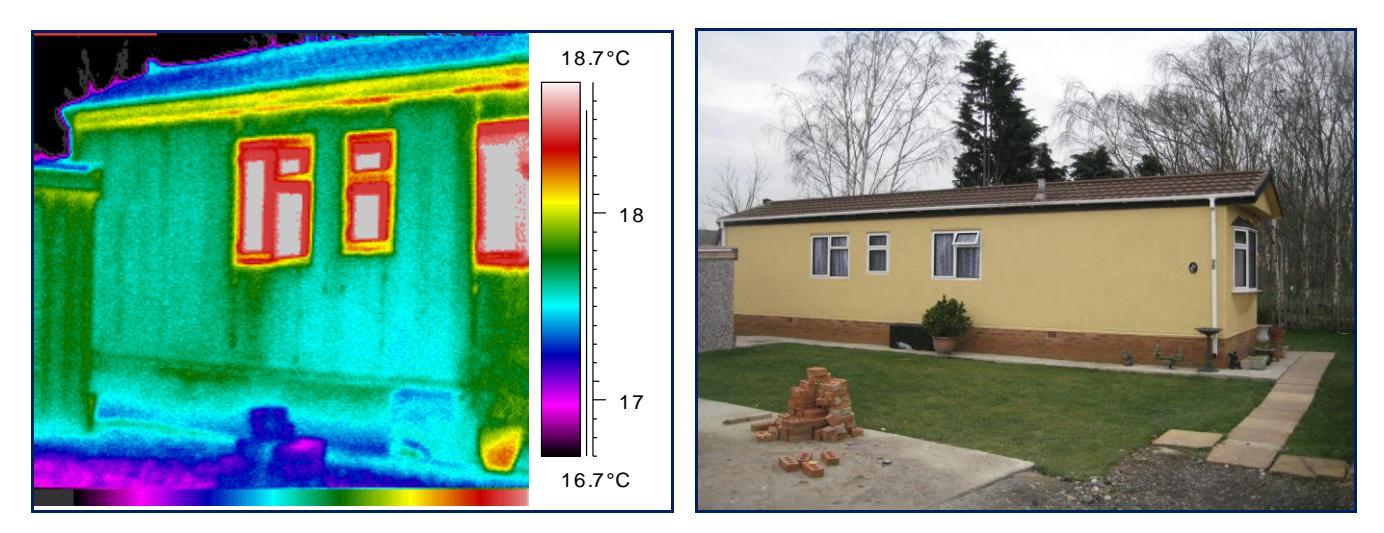
It can be seen in the above thermal image "post-improvement" that the number of heat-loss pathways across the building envelope have been significantly reduced ( i.e. when compared to the "pre-improvement" image )
