## Permali (A-Type) Meter Installations

### **Background**

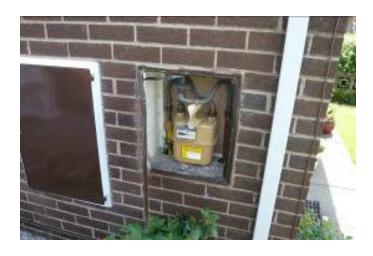
- Early 1970s Permali developed external gas meter box
- Some service and/or installation pipes routed within cavity walls
- Gas Safe guidance "At Risk" situation.
  - The supply should be isolated at ECV.
- Proportion of original population have already been replaced
  - c20,000 remaining
