### **Gwynt y Môr OFTO plc (the Licensee) – Income Adjusting Event (IAE) Notice pursuant to amended standard licence condition E12-J3 (the Condition) regarding failure of subsea export cable 3 (SSEC3)**

The Licensee submits this IAE Notice seeking recovery of further costs incurred in resolving issues arising from a latent defect that exists in the PE sheath of the fibre optic cable contained within SSEC3. The Licensee does not have recourse to its insurance policies to recover the costs which are being claimed and submits this IAE Notice on the grounds of Uninsurability.

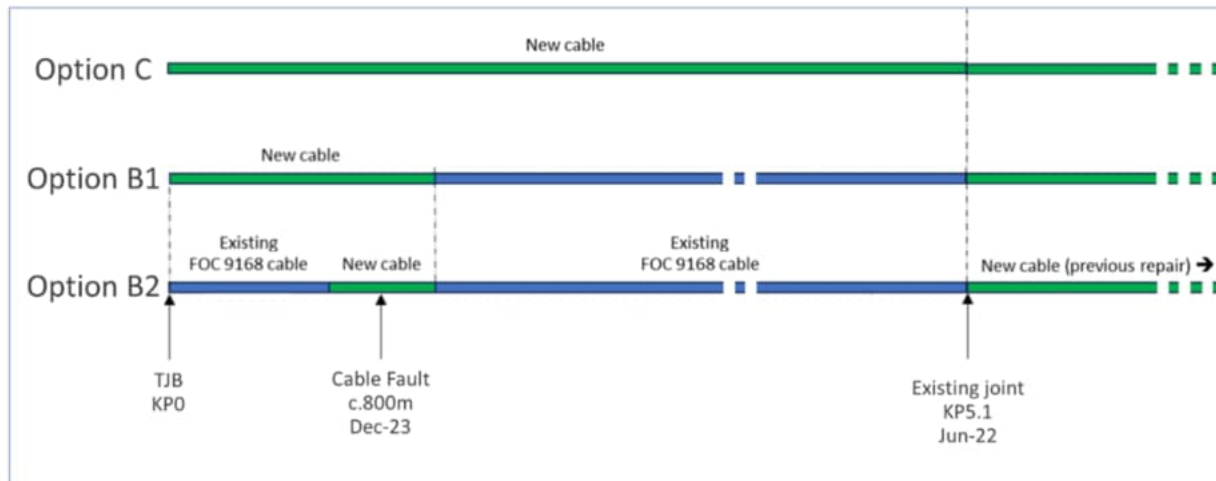
- The first stage being a local repair from the TJB to just beyond the fault location (option B1 in image below) using the strategic spares that the Licensee has available (as per good industry practice). This repair was the Stage 3 Repair completed in 2024.
- The second stage being to remove cable up to c.KP5.1 (option C in the image below) as it is clear that the SSEC3 cable containing the defective FOC 9168 cannot be considered stable and should now be replaced between the TJB and KP5.1. This is the Stage 4 Repair that will be completed in 2025.

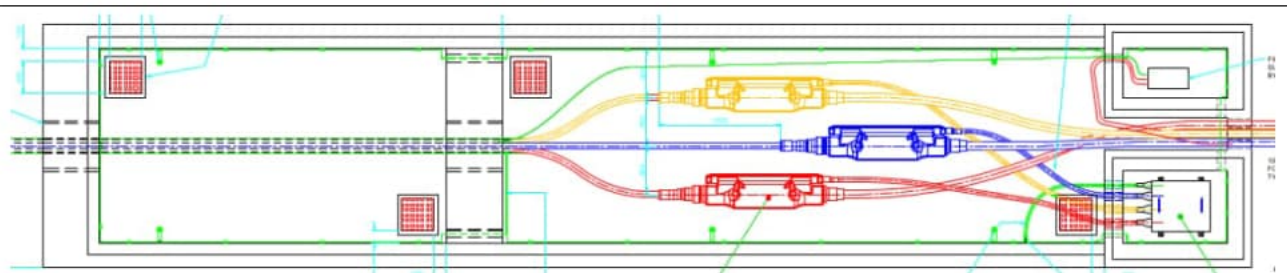
**Plan view of Joint arrangement in the TJB prior to the 2023 Fault.**

Three NKT in-line joints connect each phase of the export cable coming in from the left to each onshore cable going out to the right.

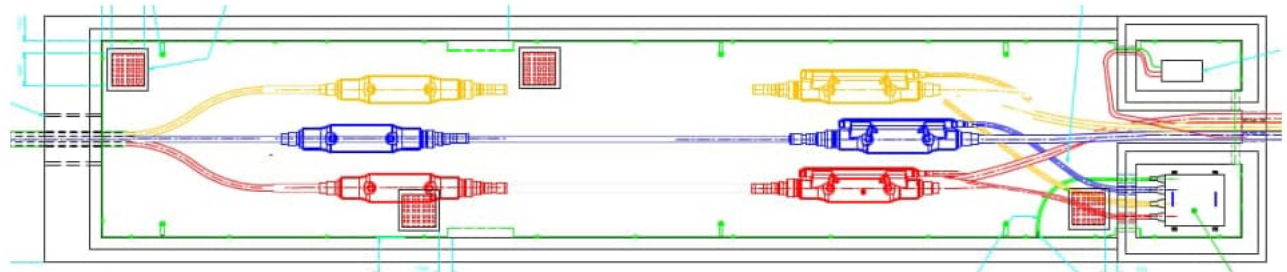
**Plan view of Joint arrangement in the TJB after the Stage 3 Repair.**

The existing NKT joints were retained and NKT export cable was cut to expose long tails so that new joints could be made (as far to the left end of the TJB) between the tails and each of the conductors of the new export cable.

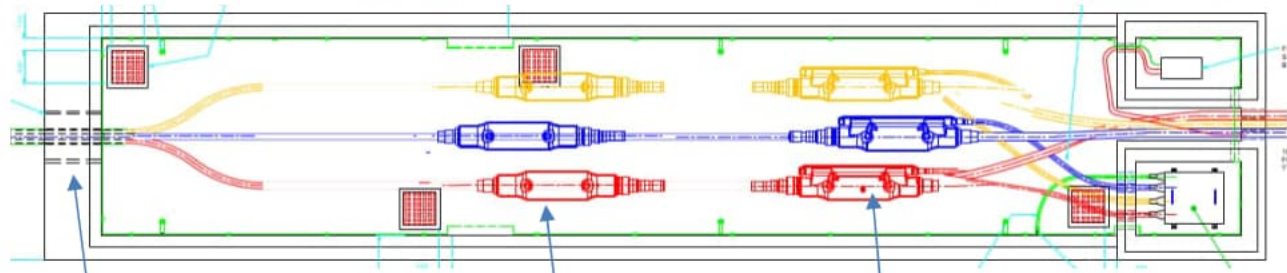
**Plan view of Joint arrangement in the TJB after the Stage 4 Repair (Proposed).**

The existing NKT joints were retained and new joints will be made between the tails and each of the conductors of the new export cable. The joints and export cable installed in 2024 are removed and the new joints are made between the NKT joints and the joints that had been installed in 2024.

The tails need to be manipulated to achieve this and there is a risk of damage to the NKT joint. For this reason we will have a spare NKT joint ready.

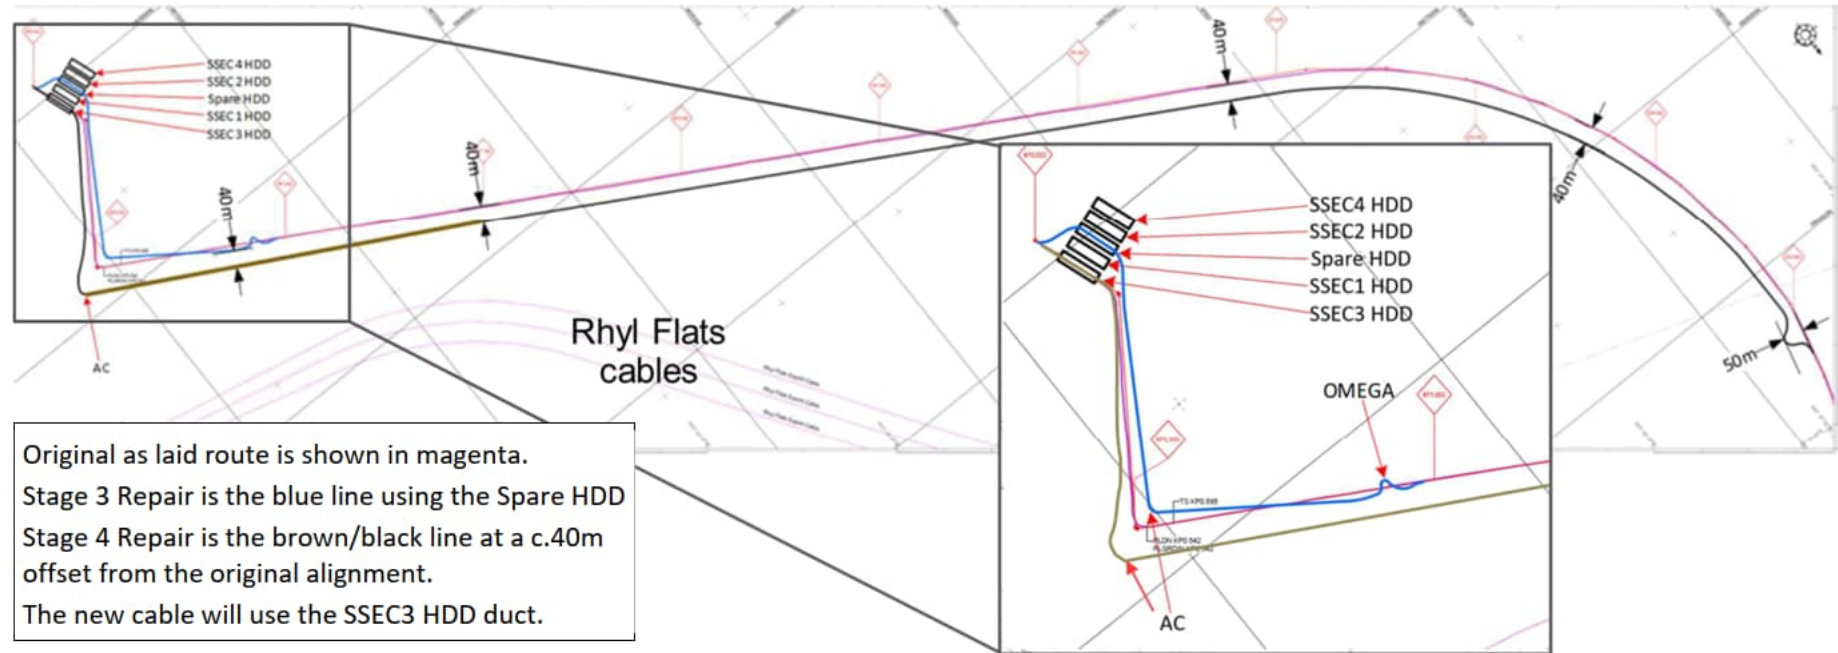
C6.2 The schematic for the repair is shown below. Important features are:

- (a) The new cable will revert to pass through the SSEC3 HDD duct under the railway.
- (b) The new alignment is c.40m offset from the original so that the cable can be laid out before the outage commences
- (c) There is a more pronounced alignment at c.KP0.5 so that the turning point is further up the beach (addresses a lesson learned from Stage 3 Repair).
- (d) The proximity of the Rhyl Flats Cables will be reflected in the Repair Contractor's anchor handling plan.

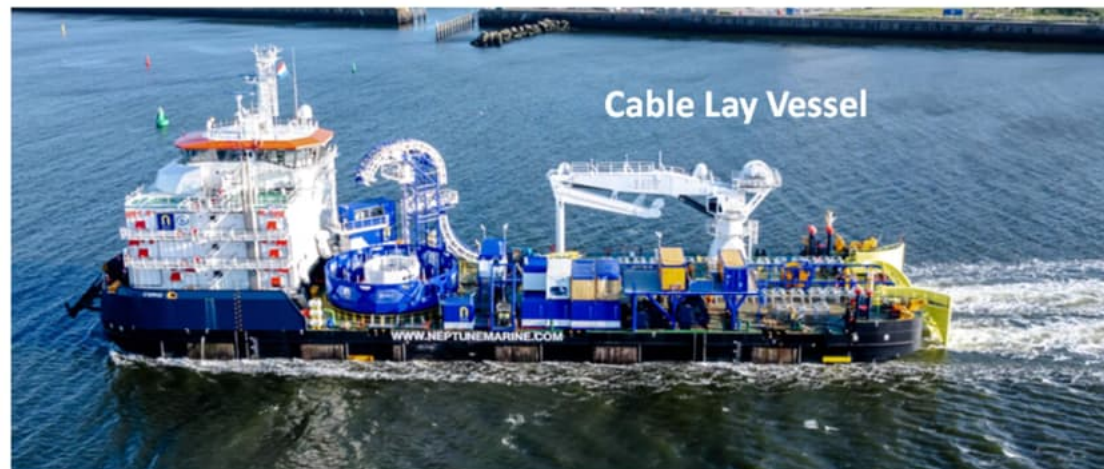
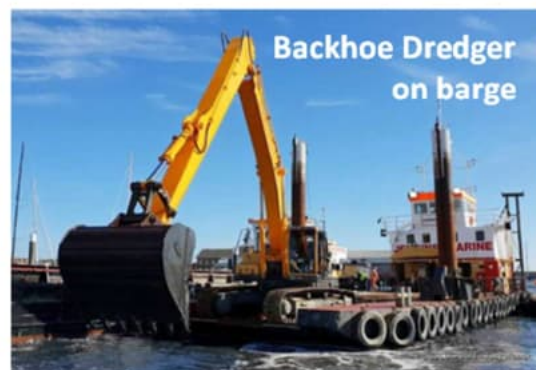
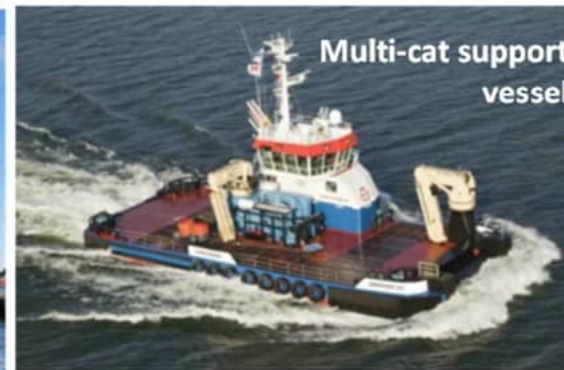
C6.3 The following vessels have been contracted for this repair:

- (a) A purpose-built cable lay vessel [REDACTED] from the Repair Contractor's own vessel fleet.
- (b) A flat bottom barge with an excavator, to create a trench through the heavy clay just below the seabed out to c.KP1.5
- (c) a multi-cat vessel, to carry out cable cutting, cable de-burial and re-burial and other support activities, and
- (d) an anchor-handling tug for the flat bottom barge and the Cable lay vessel (when operating in shallow waters – dynamic positioning capability is not effective in shallow depth)
- (e) crew transfer vessels (CTV)s for ferrying personnel between vessels and between vessels and shore

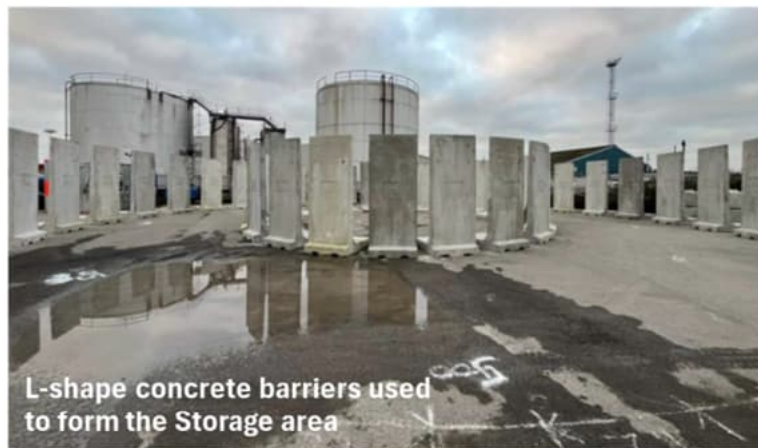
L-shape concrete barriers used to form the Storage area

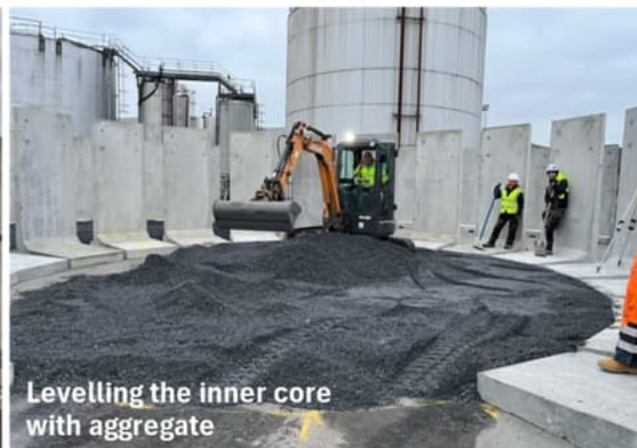
Levelling the inner core with aggregate

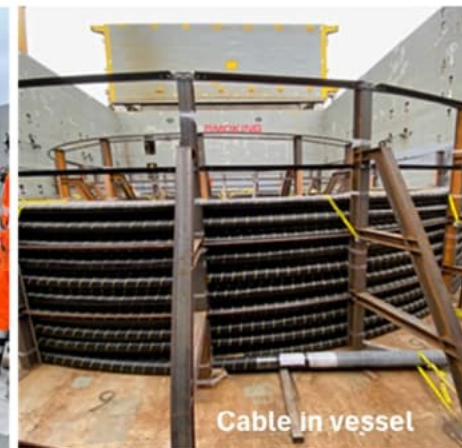
Cable in vessel

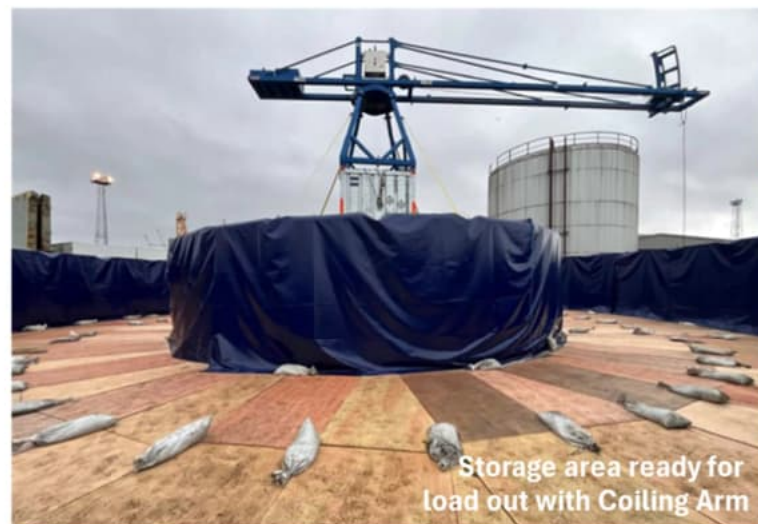
Storage area ready for load out with Coiling Arm

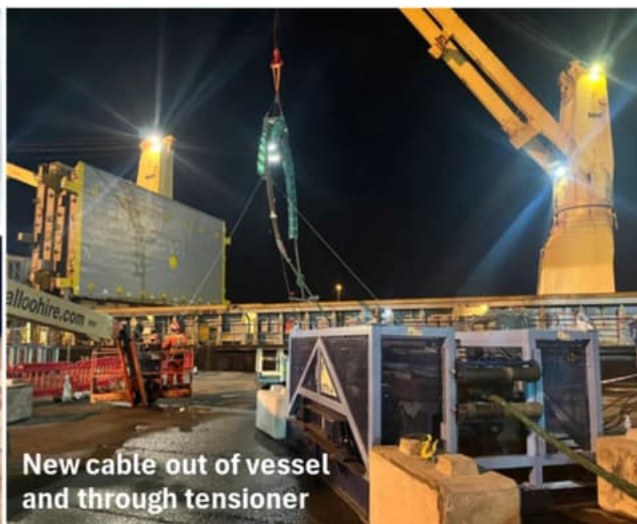
New cable out of vessel and through tensioner

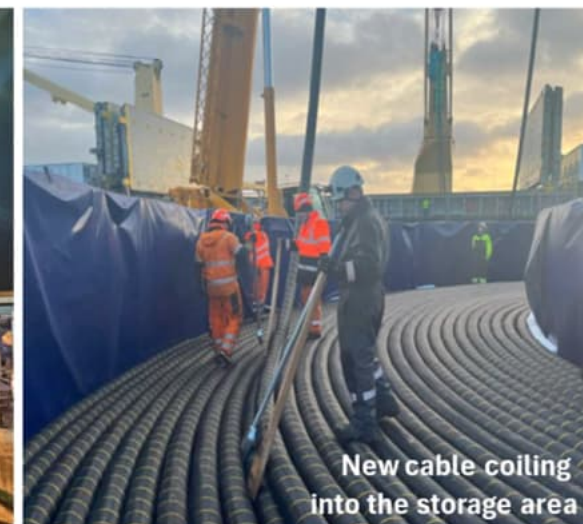
New cable coiling into the storage area
