**Appointed examiner's audit of Exceptional Event Claim -
UK Power Networks (Southeast)
33kV Incident at Newhaven Grid Substation
21 August 2013**

Title: UK Power Networks (Southern) – Audit of Exceptional Event Claim – UKPN (SPN) – Newhaven Grid Substation – 21 August 2013

Reference: ep/Ofgem/SPN/21 Aug '13

Date: 27 May 2015

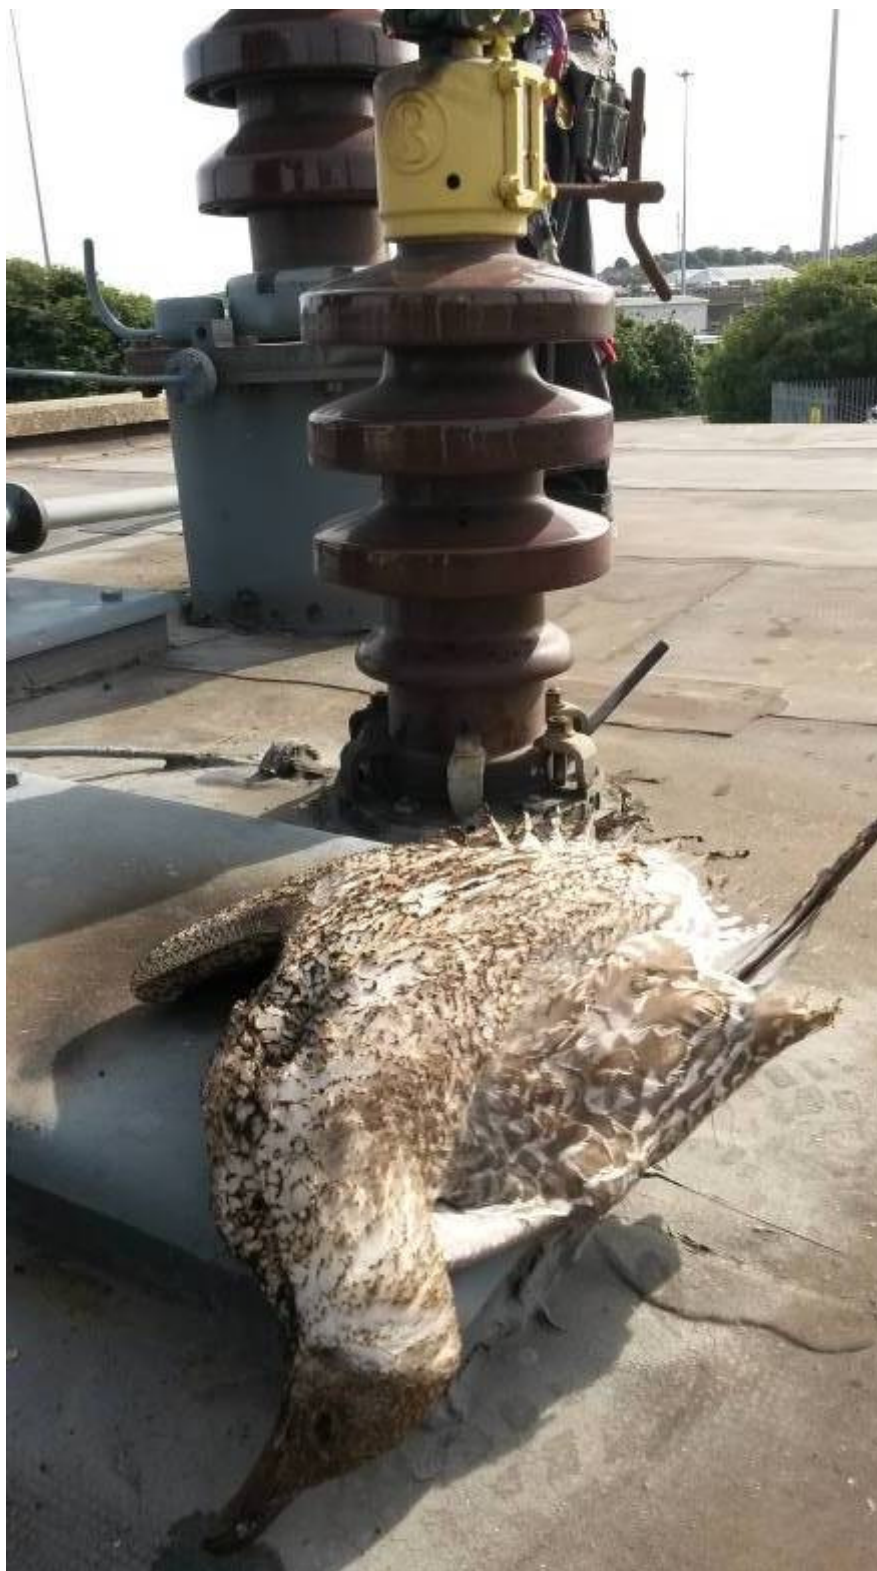
Photograph 1 – The dead sea-bird on the roof of the noise enclosure

- A2. A photograph of the dead sea-bird was given to the AE during the audit visit. *[AE's note: UKPN's photograph clearly shows the dead sea-bird in relation to the 33kV bushing on top of the noise enclosure].*

- A3. The dead sea-bird was found directly below the yellow-phase 33kV overhead conductor on the noise enclosure of the number 2 132/33kV transformer at Newhaven Grid substation.

- A4. There are no previous incidents caused by sea-birds at this location and, as shown in the photograph, the bird in question was very large

54. UKPN's photograph 1, taken at the time of the incident shows the dead sea-bird below the 33kV exposed conductors on the roof of the noise enclosure surrounding the number 2 132/33kV Grid Transformer at Newhaven Grid Substation.

A8. From the evidence gathered from site and the lack of previous incidents of this type it was concluded that anti vermin guards would not add to the protection at the site and, as they themselves can in the long term have a detrimental effect on network performance, no further action has been taken at this time.

62. The dead sea-bird found below the exposed 33kV conductors is consistent with an electric arc having occurred and with the operation of overcurrent relays that detected a flashover of the 33kV conductors within the protection zone of the 132/33kV Grid Transformer which, in turn, inter-tripped the number 2 132kV circuit-breaker at Lewes 132kV Substation.
63. The AE has studied the running arrangements of UKPN's 132/33kV distribution network supplying its Newhaven Grid Substation and concludes that UKPN's protection systems worked correctly to clear the incident from UKPN's distribution system.
64. The AE commends UKPN's control engineers for analysing the situation, contacting UKPN's person in charge of the outage on the number 1 circuit and for restoring supplies as rapidly as possible, thereby minimising the duration of the interruption.

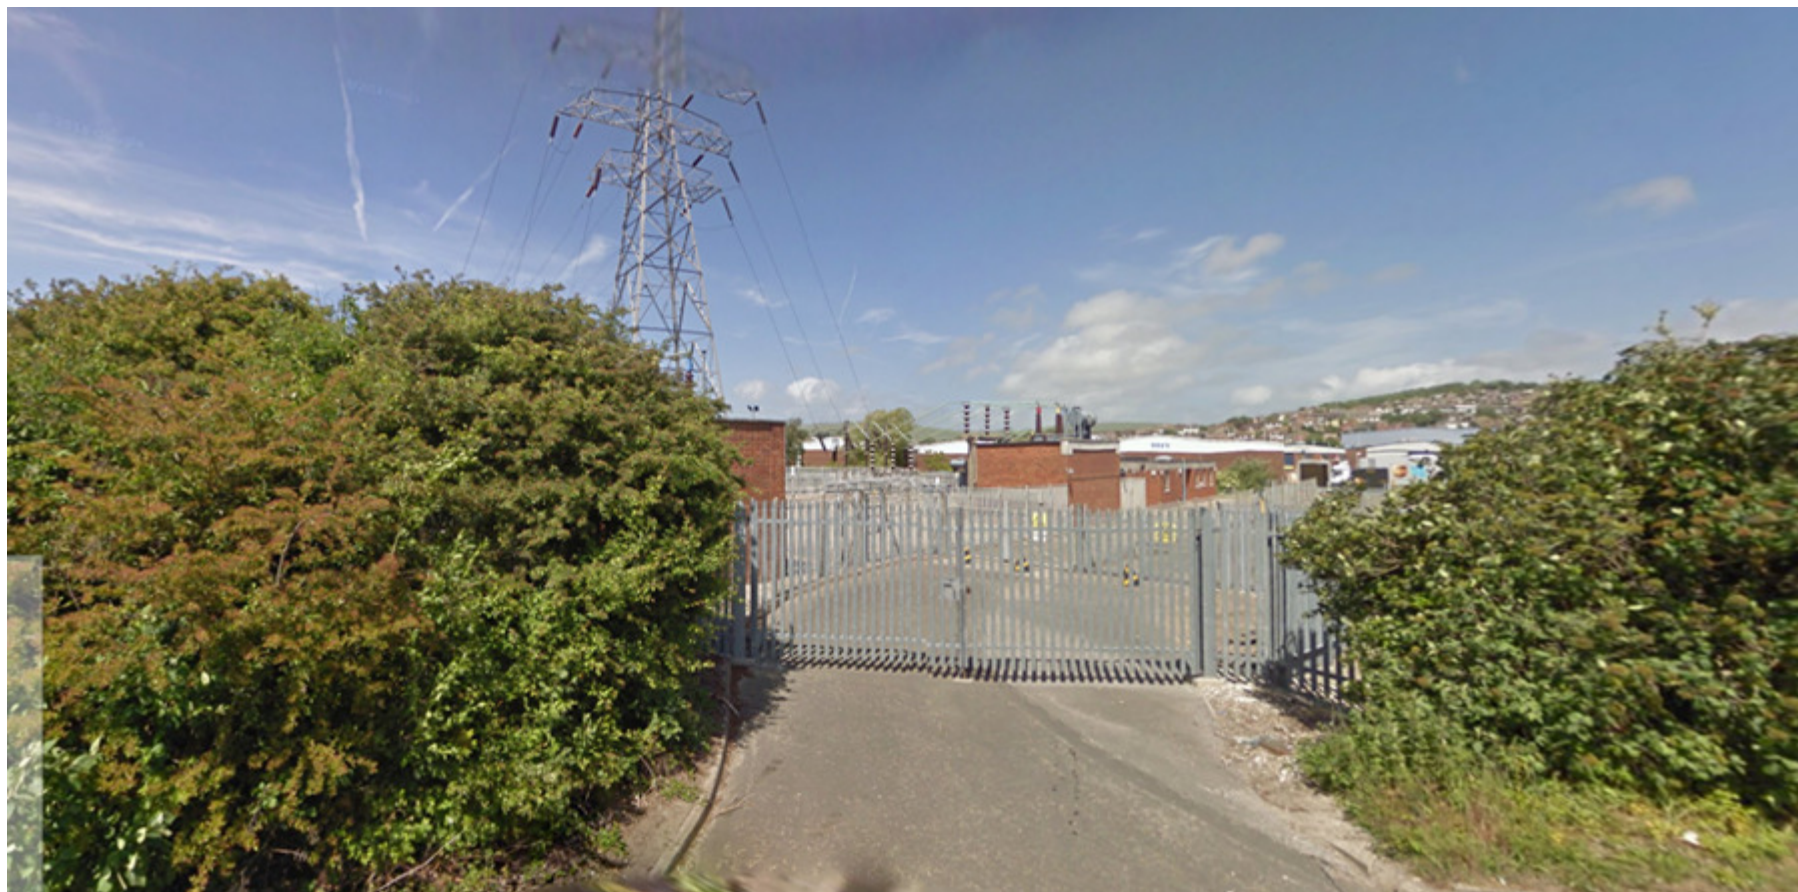
Photograph 2 – Street-level view of Newhaven Grid Substation

55. UKPN's photograph 2 shows the street-level view of Newhaven Grid Substation with the noise-enclosures and projecting bushings visible beyond the 'unclimbable' palisade fencing.

53. Images from "Google Maps" dating before the incident show UKPN's Newhaven Grid Substation to be surrounded by an 'unclimbable' palisade fence in accordance with accepted UK practice for this type of substation. The fence is in good condition and carries statutory warning notices.

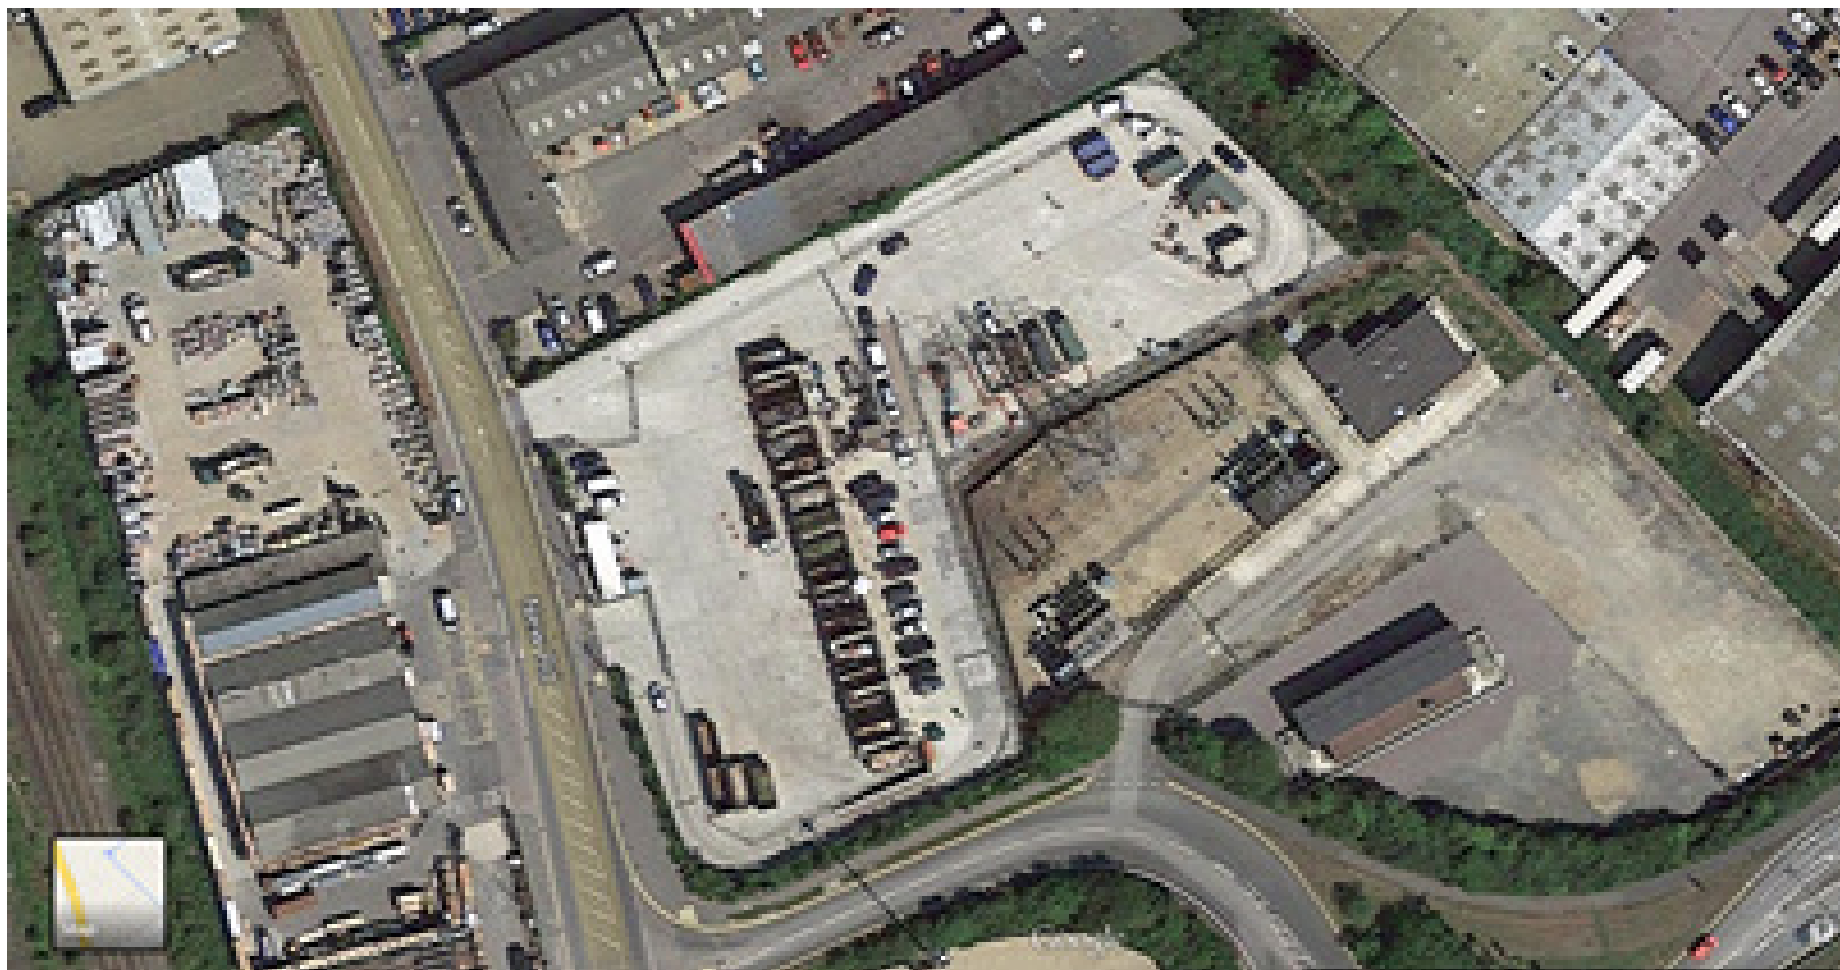
Photograph 3 – Aerial view of Newhaven Grid Substation taken from “Google Earth”

56. A general view of Newhaven Grid Substation can be gauged from UKPN's photograph 3, taken from "Google Earth".
57. UKPN's measurement systems clearly show the tripping of the number 2 132kV Lewes Grid Substation feed Newhaven Grid Substation circuit-breaker at Lewes 132kV at 09:27 on 21 August 2013.
