**Preliminary report into the recent electricity
transmission faults affecting South London
and East Birmingham**

30 September 2003

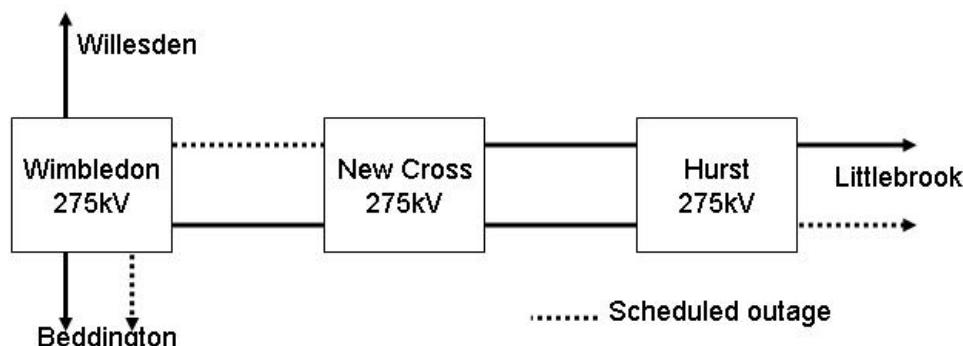
FIGURE 1.1

- 1.1 The 275kV transmission system in south London consists of three 'mesh' substations at Hurst, New Cross and Wimbledon¹⁰. EDF then provide the distribution connection between these substations and consumers in the area, including large users such as NetworkRail and London Underground. Following the incident supplies were lost from Hurst, New Cross and part of Wimbledon.
- 1.2 Prior to the event three of the nine circuits were out of service for scheduled maintenance. This had been coordinated and agreed with the distribution network operator (DNO) EDF. This is shown very simply in Figure 1.1 below:

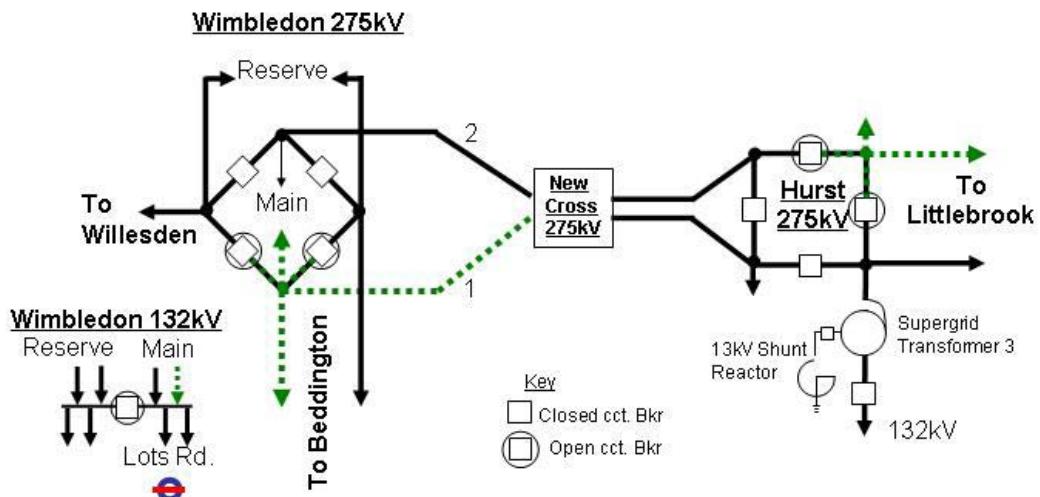
FIGURE 1.2

- 1.3 Two of the scheduled circuit outages were part of a major upgrade to mesh corner [1] at Wimbledon, which is illustrated in slightly more detail by Figure 1.2 below:

- 1.4 This diagram also indicates that for the initially planned 3 month outage duration of the Wimbledon mesh corner, the supplies to the Main section of the Wimbledon 132kV busbars were supported solely from diagonally opposed mesh corner 3. This section of busbar supplies Lots Road, one of the four main points in London where London Underground derives power. In the event of a fault affecting this mesh corner, supplies would be lost, although they could be rapidly restored by post fault switching - closing the open Bus Coupler circuit breakers between the Wimbledon 132kV main and reserve busbars. (Busbar sections 3 and 4). Note ideally this would operate normally closed, but safety considerations prevent this because it would increase potential fault currents above equipment ratings.
