Quality of Service Incentive Scheme – Exceptional Events

Appointed Examiner's Report	
Reporting year	2010/11
DNO	ENWL
Cause	Theft of 132/33kV Grid Transformer components
Date of event	27 October 2010

Title: Exceptional Events Report – ENWL – theft – Wigan Grid Substation resulting in loss of customers' supplies – 27 October 2010

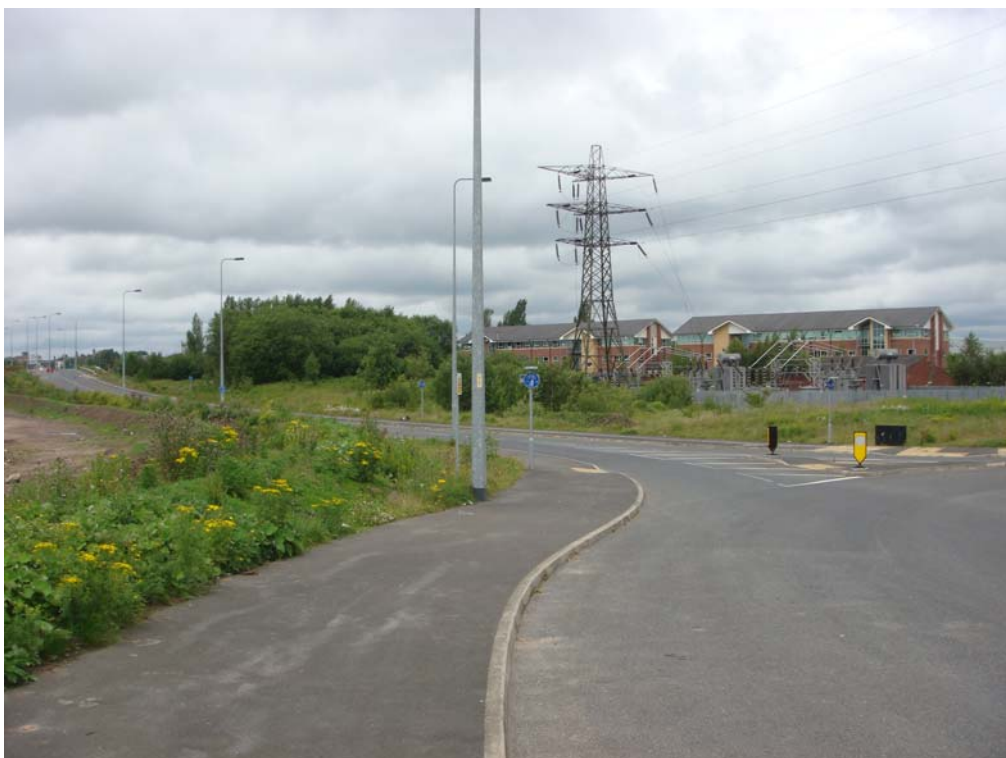
- 2.10 A general view of the location of ENWL's Wigan Grid Substation is shown in the AE's photograph 4.
- 2.11 ENWL's measurement systems confirm the tripping of GT2 at 22:06 and the de-energising of GT1 at 22:36 on 27 October 2010, both as reported in ENWL's SoF.

Photograph 4 – General view of the location
