Quality of Service Incentive Scheme – Exceptional Events

Appointed Examiner's Report	
Reporting year	2010/11
DNO	CE Electric – NEDL Licensed Area
Cause	Vandalism to 132kV insulators on a lattice steel tower
Date of event	26 June 2010

Title: Exceptional Events Report – NEDL – vandalism damage - Stella South to Annfield n°1 132kV feeder resulting in loss of customers' supplies – 26 June 2010

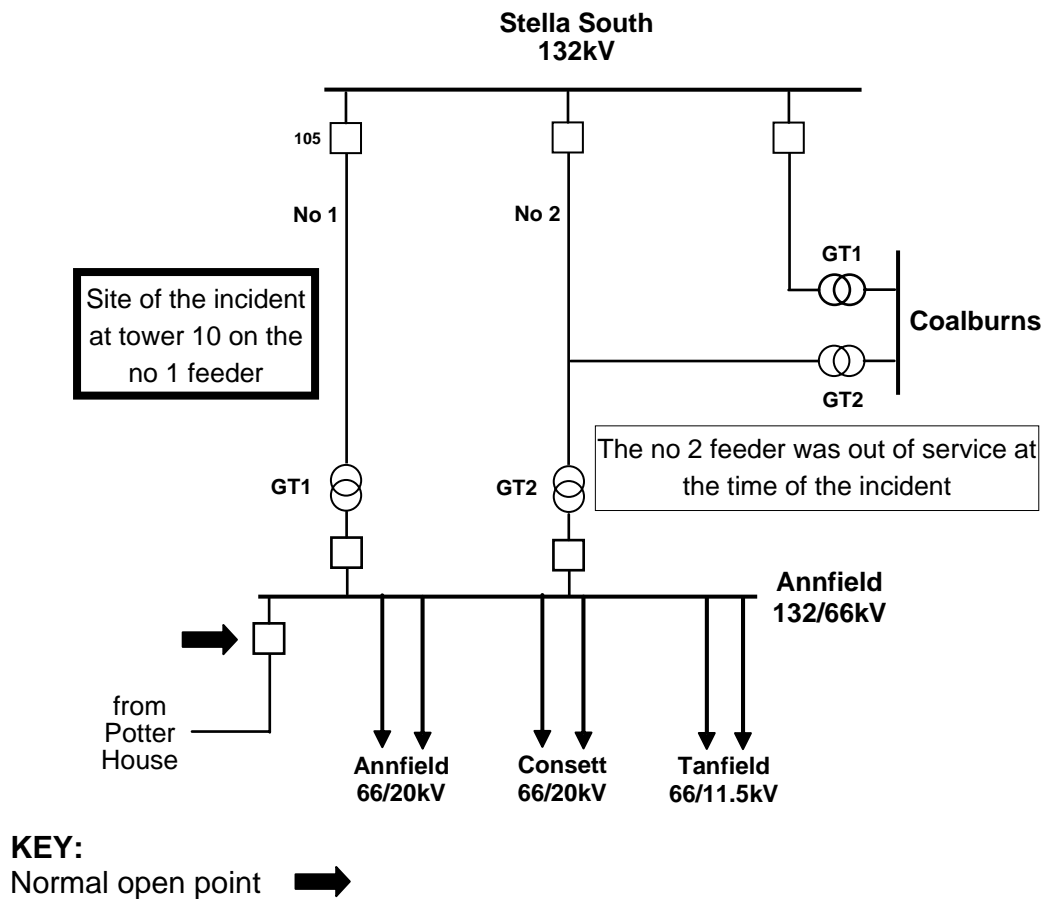
Figure 1 – Simplified Network Diagram of NEDL's 132/66kV distribution network affected by the incident

- 1.4 The weather over the two weeks prior to the incident was dry. However, it was raining on the day of the incident and the lack of insulation due to the vandal damage resulted in a flashover from the live conductors to the earthed tower, resulting in loss of the 132kV infeed to Annfield 132/66kV substation.

- 1.5 Supplies to the customers fed from NEDL's Annfield, Consett and Tanfield Primary Substations were interrupted.
- 1.6 Prior to commencing supply restoration by tele-controlled switching, NEDL's control engineer contacted the engineer responsible for the maintenance work on the n°2 feeder to ensure that there were no safety issues to be considered.

- 1.7 42,967 of NEDL's customers' supplies were interrupted for periods of between twelve and twenty four minutes.
- 1.8 A simplified view of the section of NEDL's 132/66kV network affected by this event is shown in Figure 1.
