Quality of Service Incentive Scheme – Exceptional Events

Appointed Examiner's Report	
Reporting year	2011/12
DNO	Western Power Distribution – East Midlands Licensed Area
Cause	Catastrophic failure of 33kV Switchgear
Date of event	12 October 2011

Title: Exceptional Events Report – WPD East Midlands – Winster BSP – catastrophic failure of 33kV switchgear – 12 October 2011

Reference: EE 2011/12 – WPD(EM)

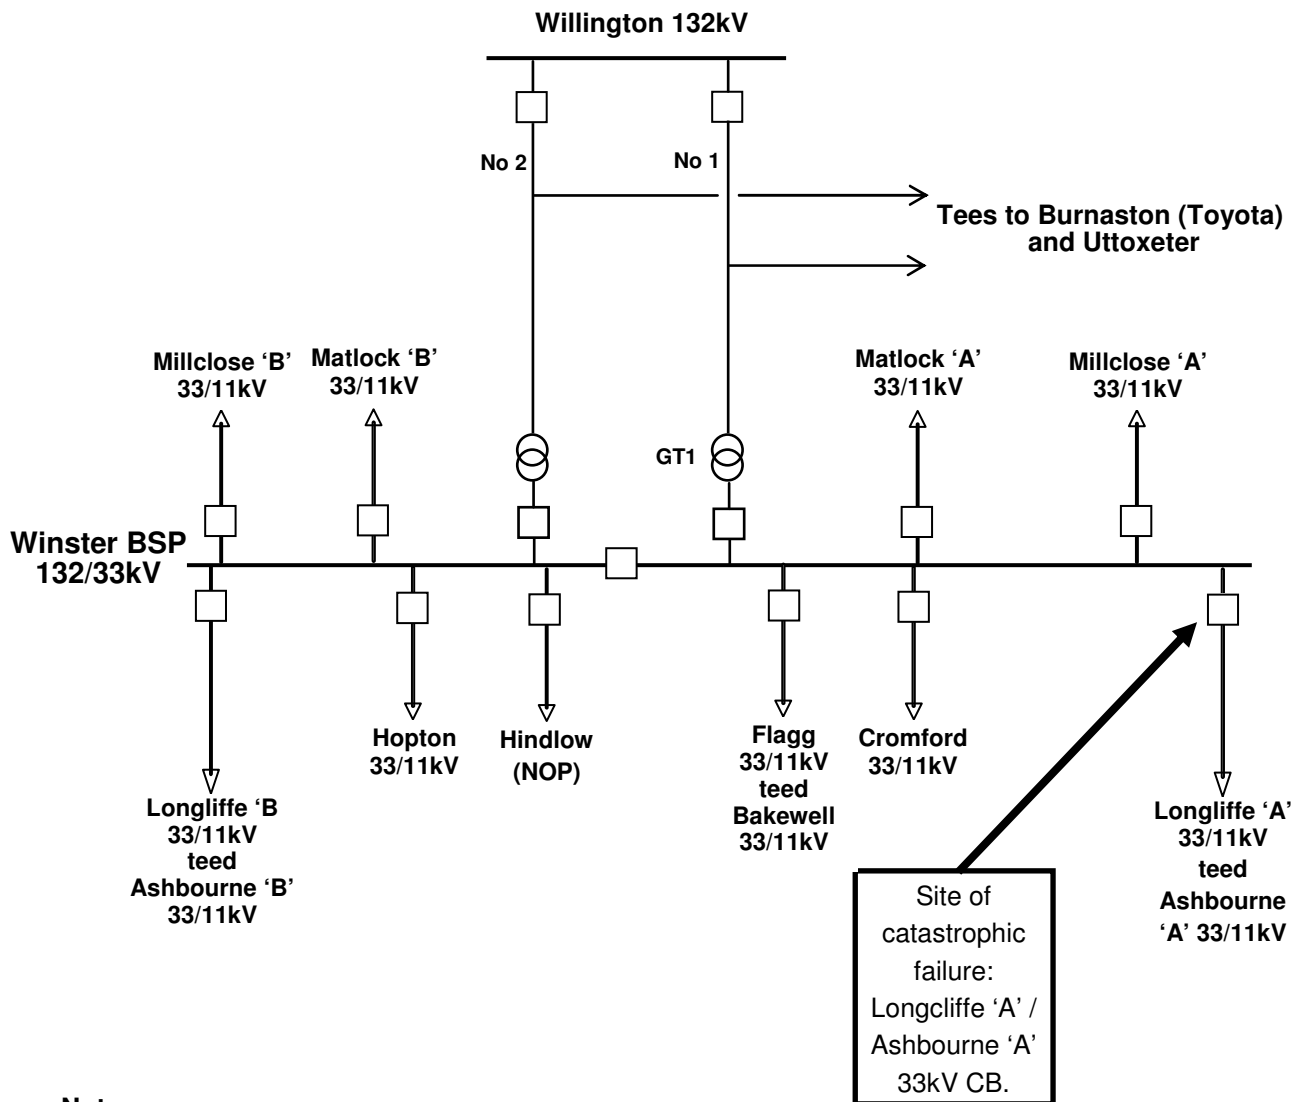
Figure 1 – Simplified Network Diagram of WPD's 132/33kV distribution network affected by the incident

- 1.14 A simplified view of the section of WPD's 132/33kV network affected by this event is shown in Figure 1.

1. Supplies to WPD's customers fed from Hindlow 33/11kV Primary Substation were not interrupted by this incident as the 33kV feeder from Winster is normally open at Hindlow.
2. The SLD is for illustration purposes only - the physical disposition of the circuit-breakers is not necessarily that which obtained on site
