Quality of Service Incentive Scheme – Exceptional Events

Appointed Examiner's Report	
Reporting year	2011/12
DNO	Southern Electric Power Distribution
Cause	Windborne material damaging 33kV switchgear
Date of event	18 July 2011

Title: Exceptional Events Report – SEPD – Norrington Grid Substation – damage to 33kV switchgear – 18 July 2011

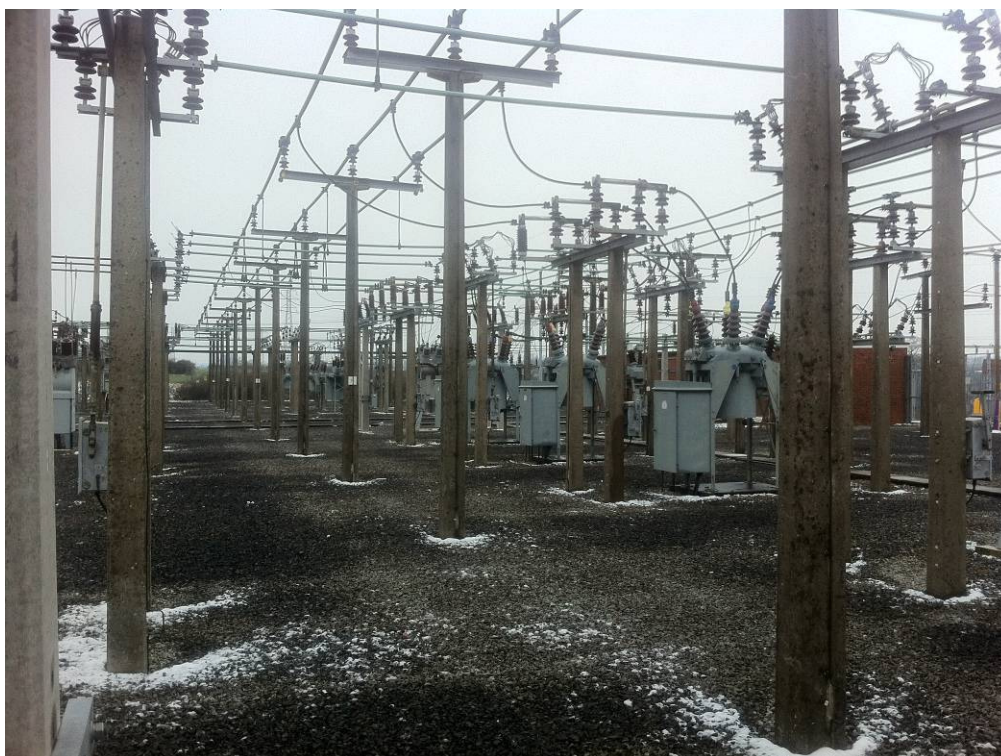
- 2.8 Photograph 4 shows a general view of SEPD's Norrington Grid Substation. The reserve busbar can be seen in the upper central portion of the photograph. The bus coupler circuit-breaker is in the photograph to the right of centre.

Photograph 4 – General view of the outdoor 33kV switchgear at SPED's Norrington Grid Substation
