Quality of Service Incentive Scheme – Exceptional Events

Appointed Examiner's Report	
Reporting year	2011/12
DNO	Northern Powergrid – Northeast Licensed Area
Cause	The disruptive failure of an 11kV circuit-breaker during the clearance of an 11kV cable fault
Date of event	17 December 2011

Title: Exceptional Events Report – Northern Powergrid (Northeast) – Harrogate 132/11kV Primary Substation – disruptive failure of an 11kV circuit-breaker during the clearance of an 11kV cable fault – 17 December 2011
Reference: EE 2011/12 – NPG(NE)
Issue: Final Version 1.0
Date: 26 March 2012
Electronic Doc Ref: M:\BPIUSER\Projects\Current\UK Ofgem - EE one-offs for 2011/12/NPG(NE)/Reports

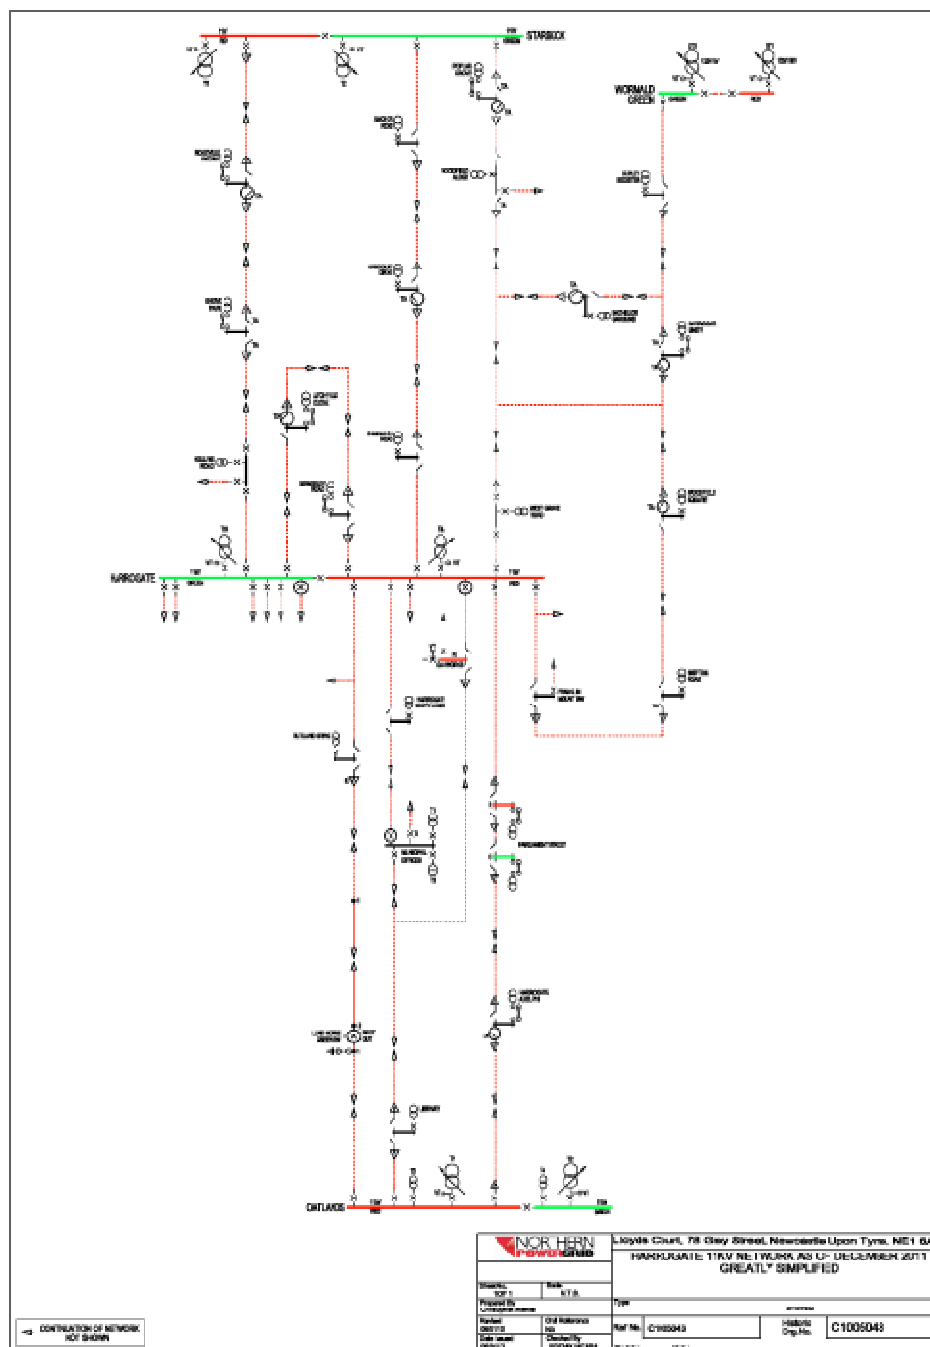
Figure 1 – Simplified Network Diagram of Northern Powergrid's 11kV distribution network affected by the incident

- 1.12 24,203 of Northern Powergrid's customers' supplies were interrupted for periods of up to five hours. Due to the nature of this incident, some of these customers suffered three separate interruptions before final restoration was achieved.
- 1.13 A simplified view of the section of Northern Powergrid's 11kV network affected by this event is shown in Figure 1.
