**Appointed examiner's audit of Exceptional Event Claim -
Northern Powergrid (Northeast)
33kV Incident at Scarborough Grid Substation
11 April 2013**

Title: Northern Powergrid – Audit of Exceptional Event Claim – Northern Powergrid (Northeast) – Scarborough Grid Substation – 11 April 2013

Reference: ep/Ofgem/NPG/11 Apr '13

Date: 18 October 2014

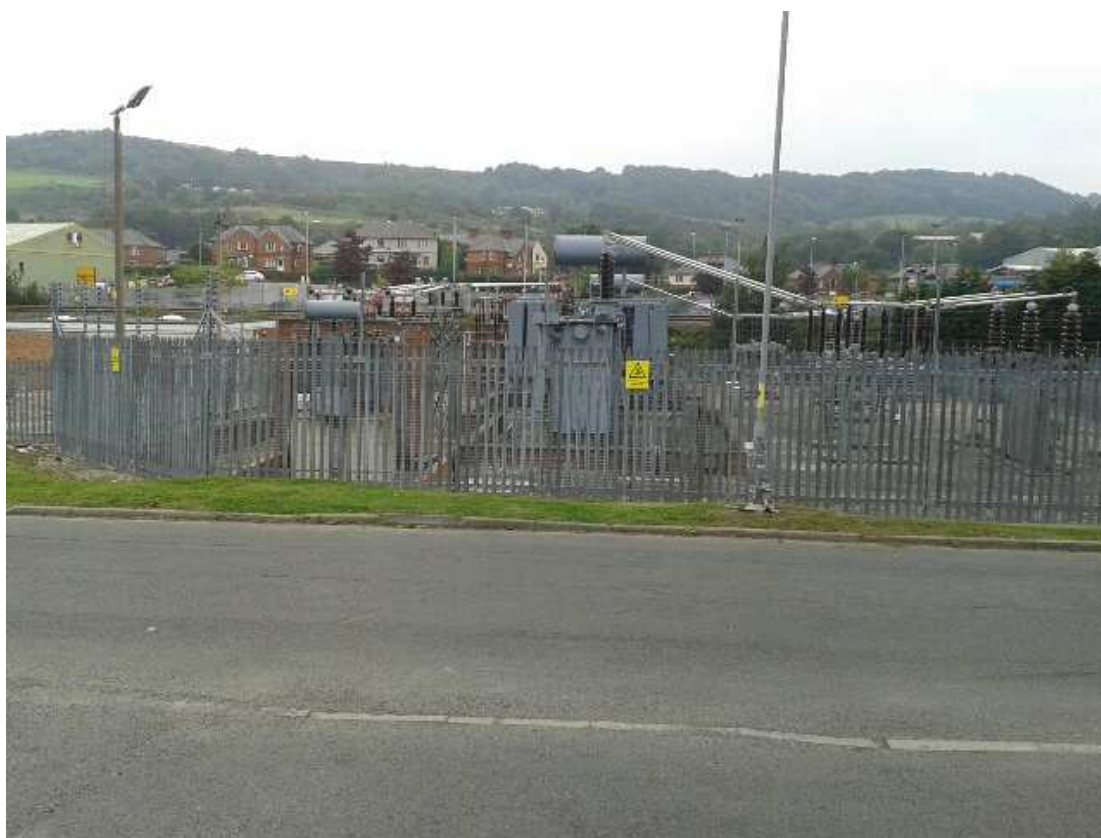
81. NPG's photograph 6 is a general view of its 132/33kV Scarborough Grid Substation.
82. NPG's measurement systems clearly show the tripping of the number 1 132kV Scarborough Grid Substation feed Malton Grid Substation feed Knapton Generation circuit-breaker at Osbaldwick Grid Substation at 07:10 on 11 April 2014

Photograph 6 - A general view of NPG's 132/33kV Scarborough Grid Substation
