**Appointed examiner's audit of Exceptional Event Claim -  
Electricity Northwest Limited - Blackburn Group  
30 April 2013**

Title: ENWL – Audit of Exceptional Event Claim – Blackburn Group – 30 April 2013

Reference: ep/Ofgem/ENWL/30 Apr '13

Date: 29 November 2014

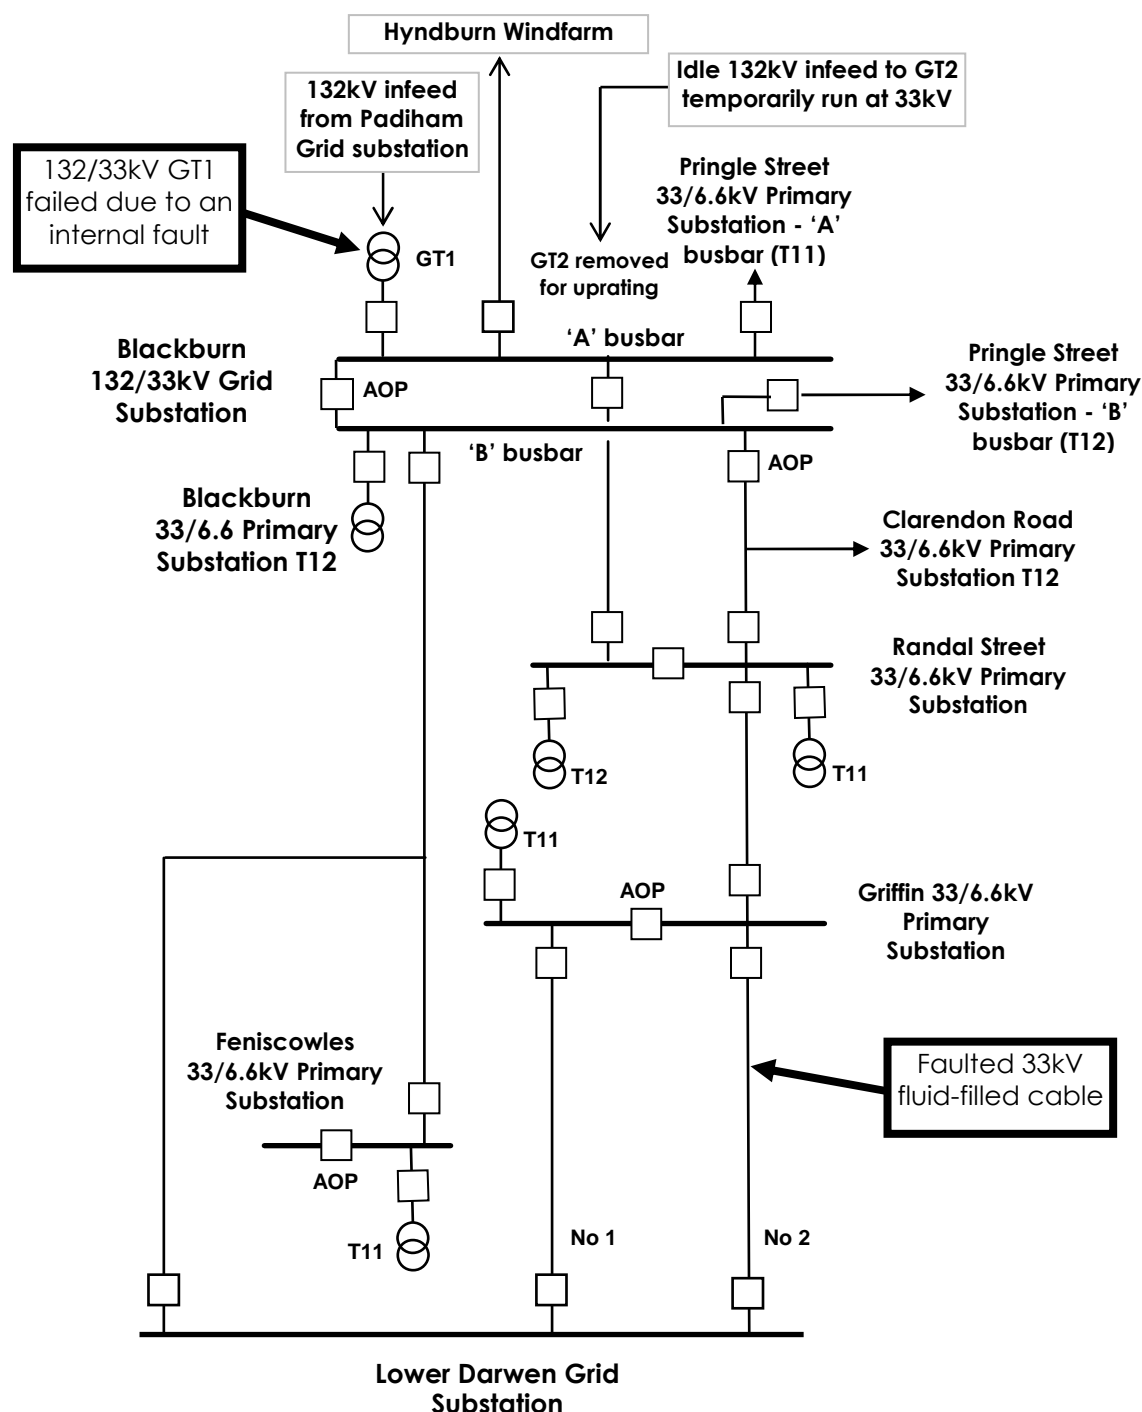
Figure 1 – Simplified Network Diagram of ENWL's 132/33/6.6kV distribution networks affected by the incident

46. As shown in Figure 1; at this stage the 33kV circuit from Lower Darwen Grid Substation to Blackburn Grid Substation feed Feniscowles Primary Substation was supplying the 'A' busbar at Blackburn Grid Substation; Feniscowles and Griffin Primary Substation loads were being supplied via the number 1 33kV circuit from Lower Darwen Grid Substation to Griffin 'A' busbar; and the number 2 33kV circuit from Lower Darwen Grid Substation to Griffin Grid Substation was supplying the 'B' busbar at Blackburn Grid Substation via Randal Street Primary Substation.

A22. The A and B in the above table refer to the demand fed from section A busbar and section B busbar at Blackburn Grid respectively. Following the fault on GT1 the customers fed from Blackburn Grid were split between the two busbars with each fed via one of the interconnectors from Lower Darwen. *[AE's note: this running arrangement is shown in the schematic diagram of Figure 1 of this report].*
