**Appointed examiner's audit of Exceptional Event Claim -
UK Power Networks (Eastern)
33kV Incident at Barnet Grid Substation
03 November 2013**

Title: UK Power Networks (Eastern) – Audit of Exceptional Event Claim
– UKPN (EPN) – Barnet Grid Substation – 03 November 2013

Reference: ep/Ofgem/EPN/03 Nov '13

Date: 25 May 2015

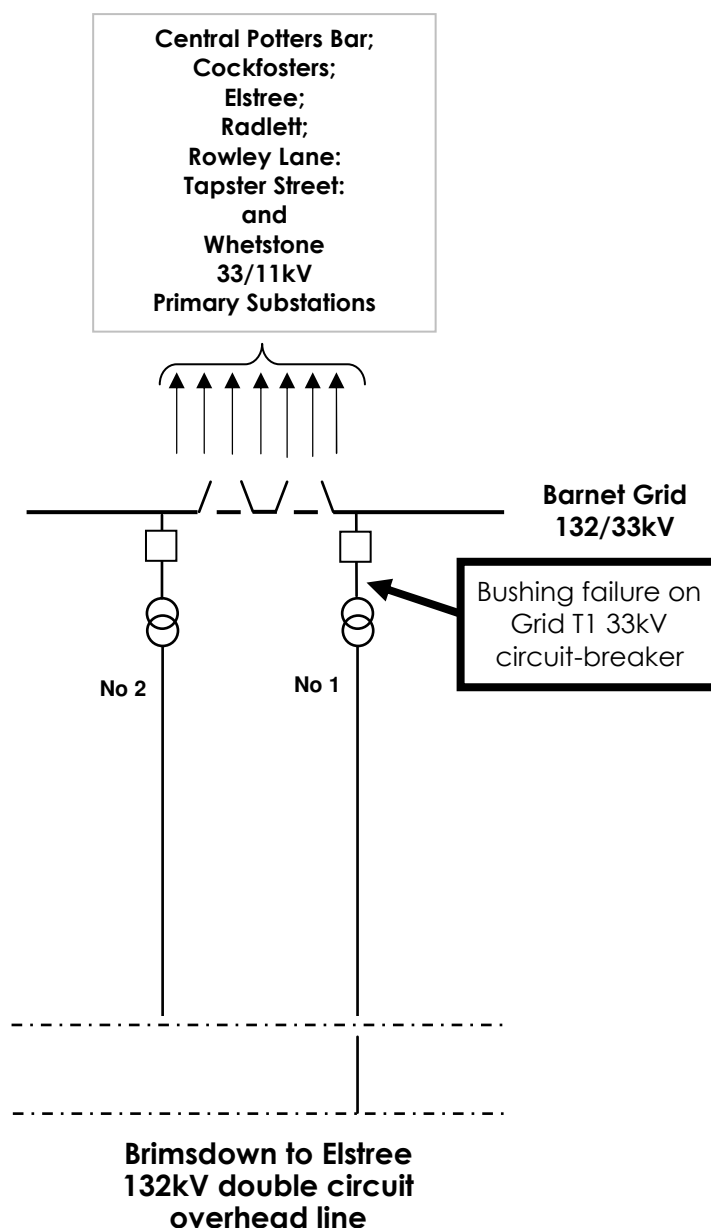
Figure 1 – Simplified Network Diagram of UKPN's 132/33kV distribution networks affected by the incident

17. A simplified view of the sections of UKPN's 132/33kV networks affected by this event is shown in Figure 1.

1. Only the salient items of switchgear are shown.
2. UKPN's network was running normally at the time of the incident.
3. UKPN's control engineer used tele-controlled switching to restore supplies via alternative 11kV sources.
4. The damaged circuit-breaker was isolated and the number 2 132kV infeed was re-energised.
5. The outgoing 33kV feeders from Barnet Grid Substation are shown schematically.

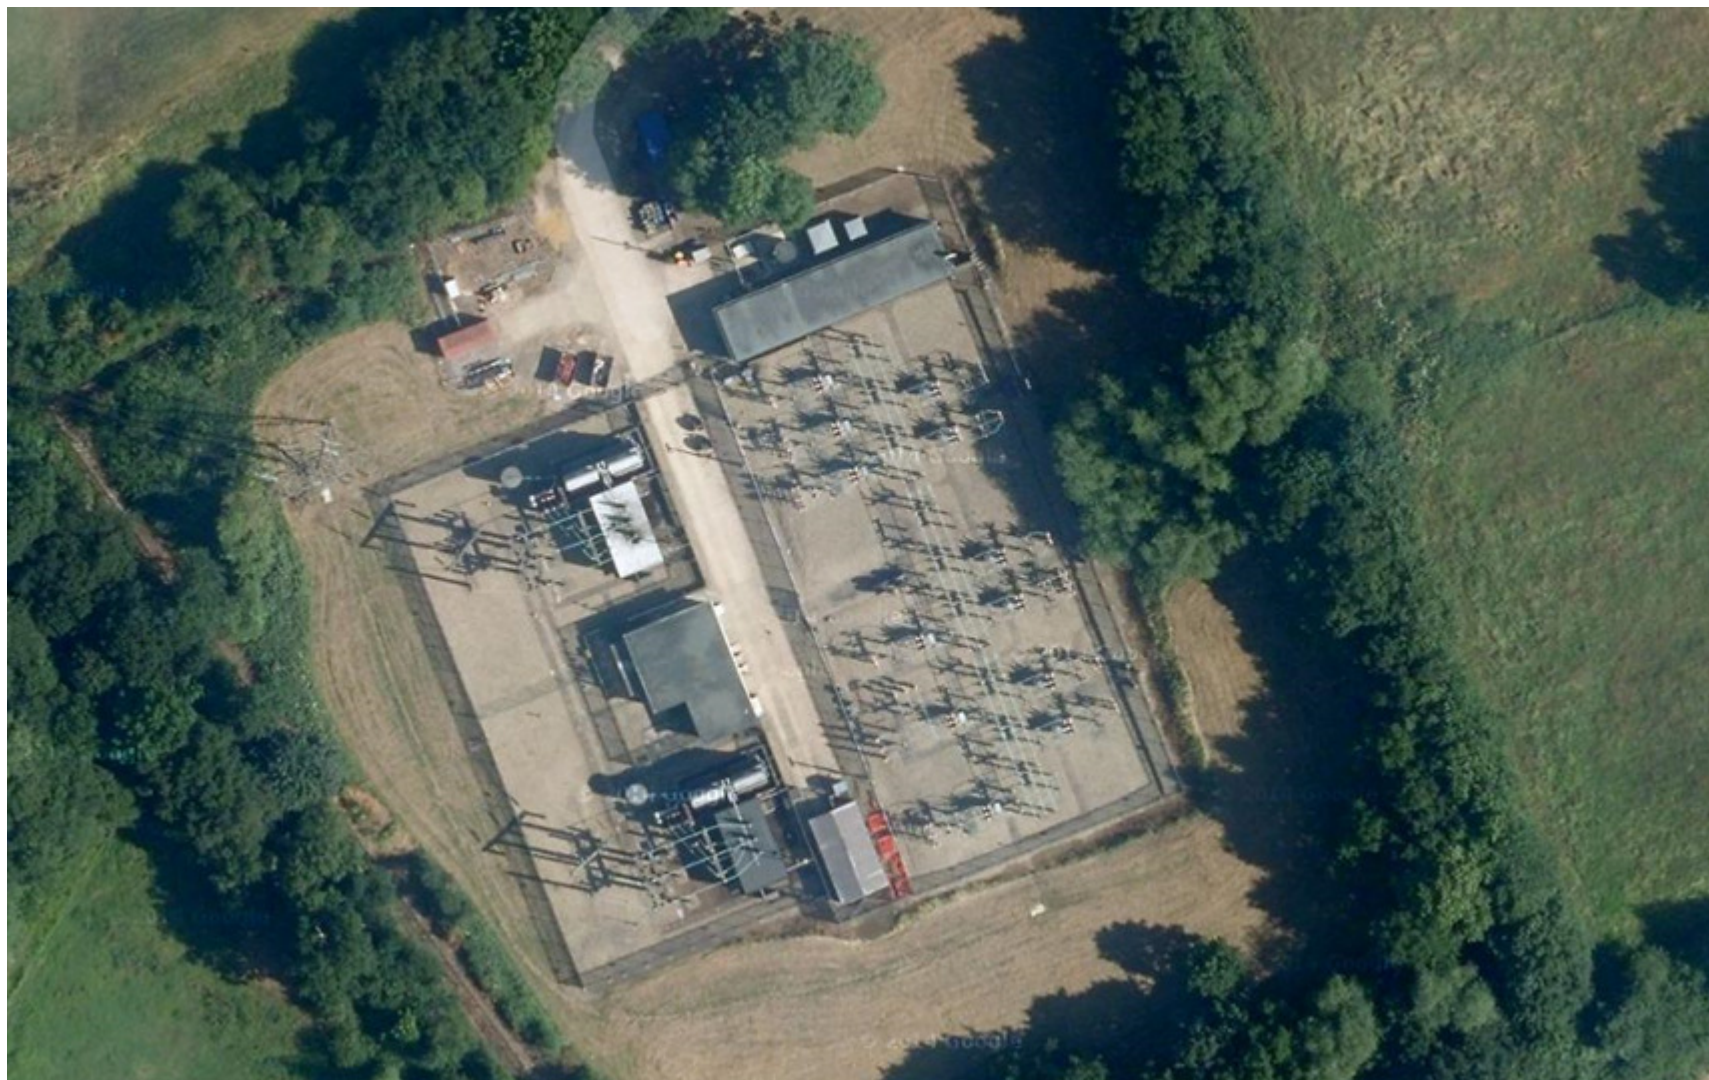
Photograph 3 – Aerial view of Barnet Grid Substation taken from “Google Earth”

40. A general view of Barnet Grid Substation can be gauged from UKPN's photograph 3, taken from "Google Earth".
41. UKPN's measurement systems clearly show the loss of 132kV infeeds to its Barnet Grid Substation when the circuit-breakers controlling them tripped at 11:09 on 03 November 2013.
